**Appendix -** (for general location details shown in the photographs, refer to Figures 1 and 3)

## **Pagham Harbour Photographs 2001 to 2019**

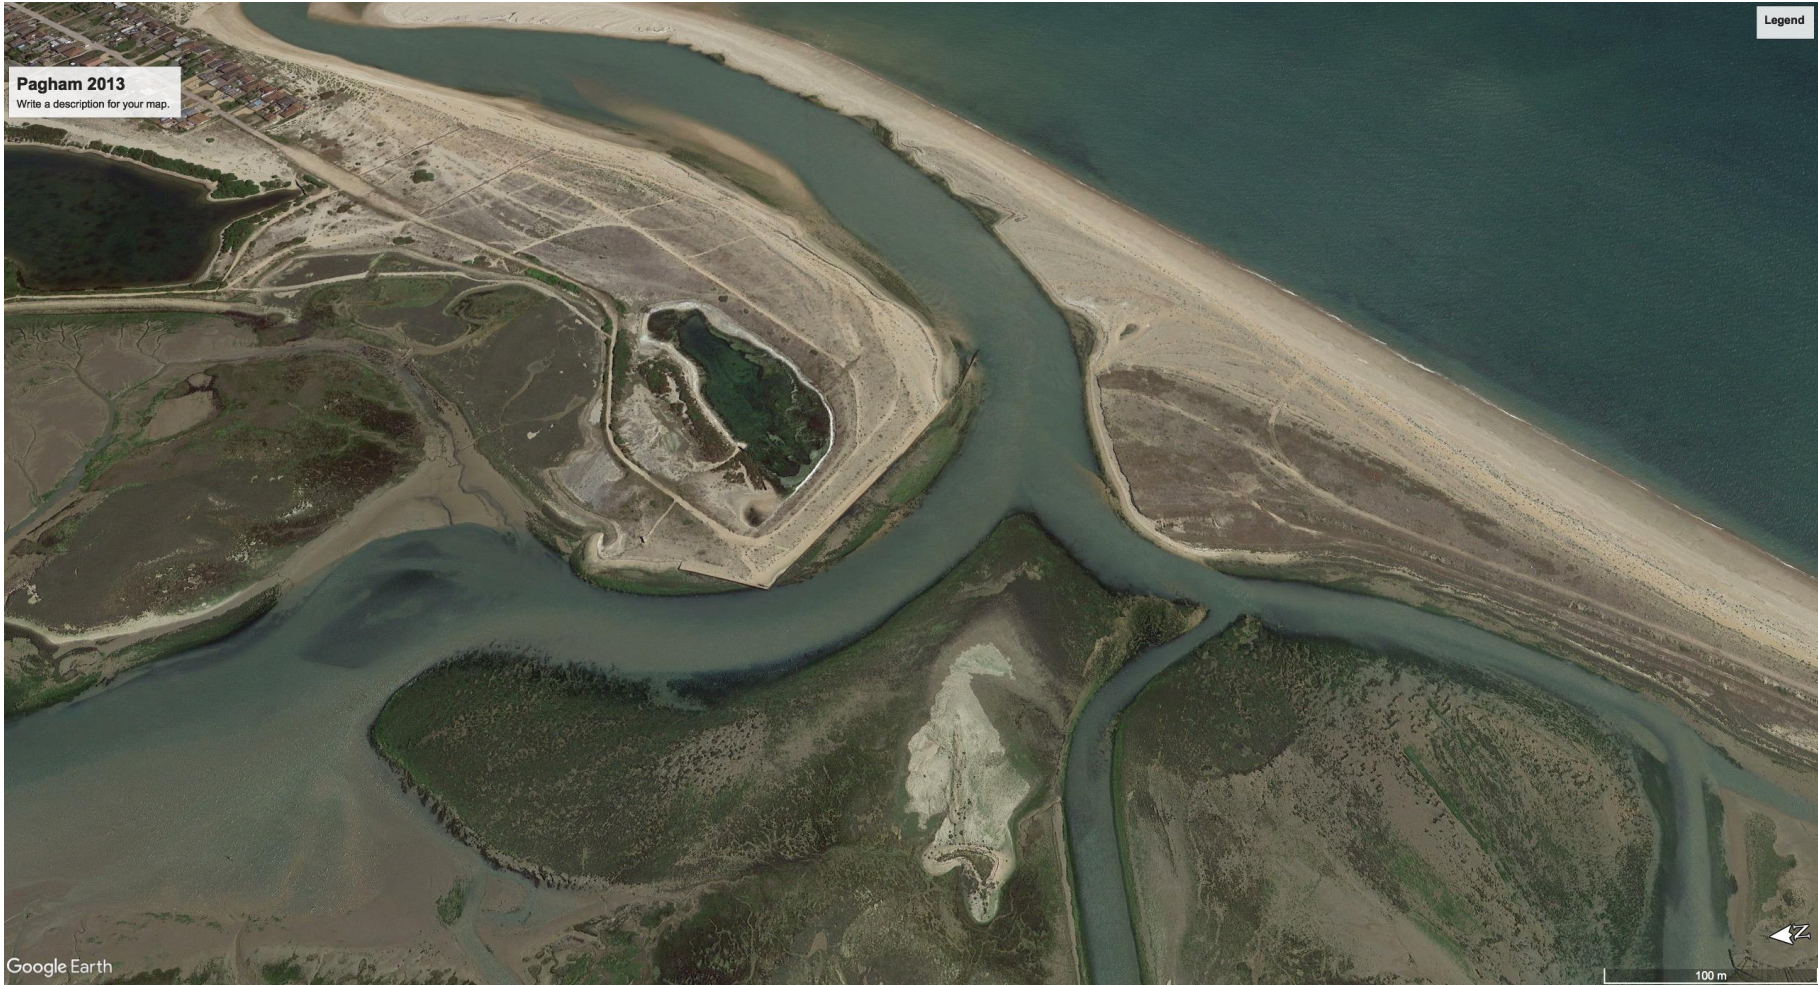
Photograph 16 – taken June 2013

Evidence of Pagham Spit accretion presenting a more parallel orientation to the inside face of CN Spit.

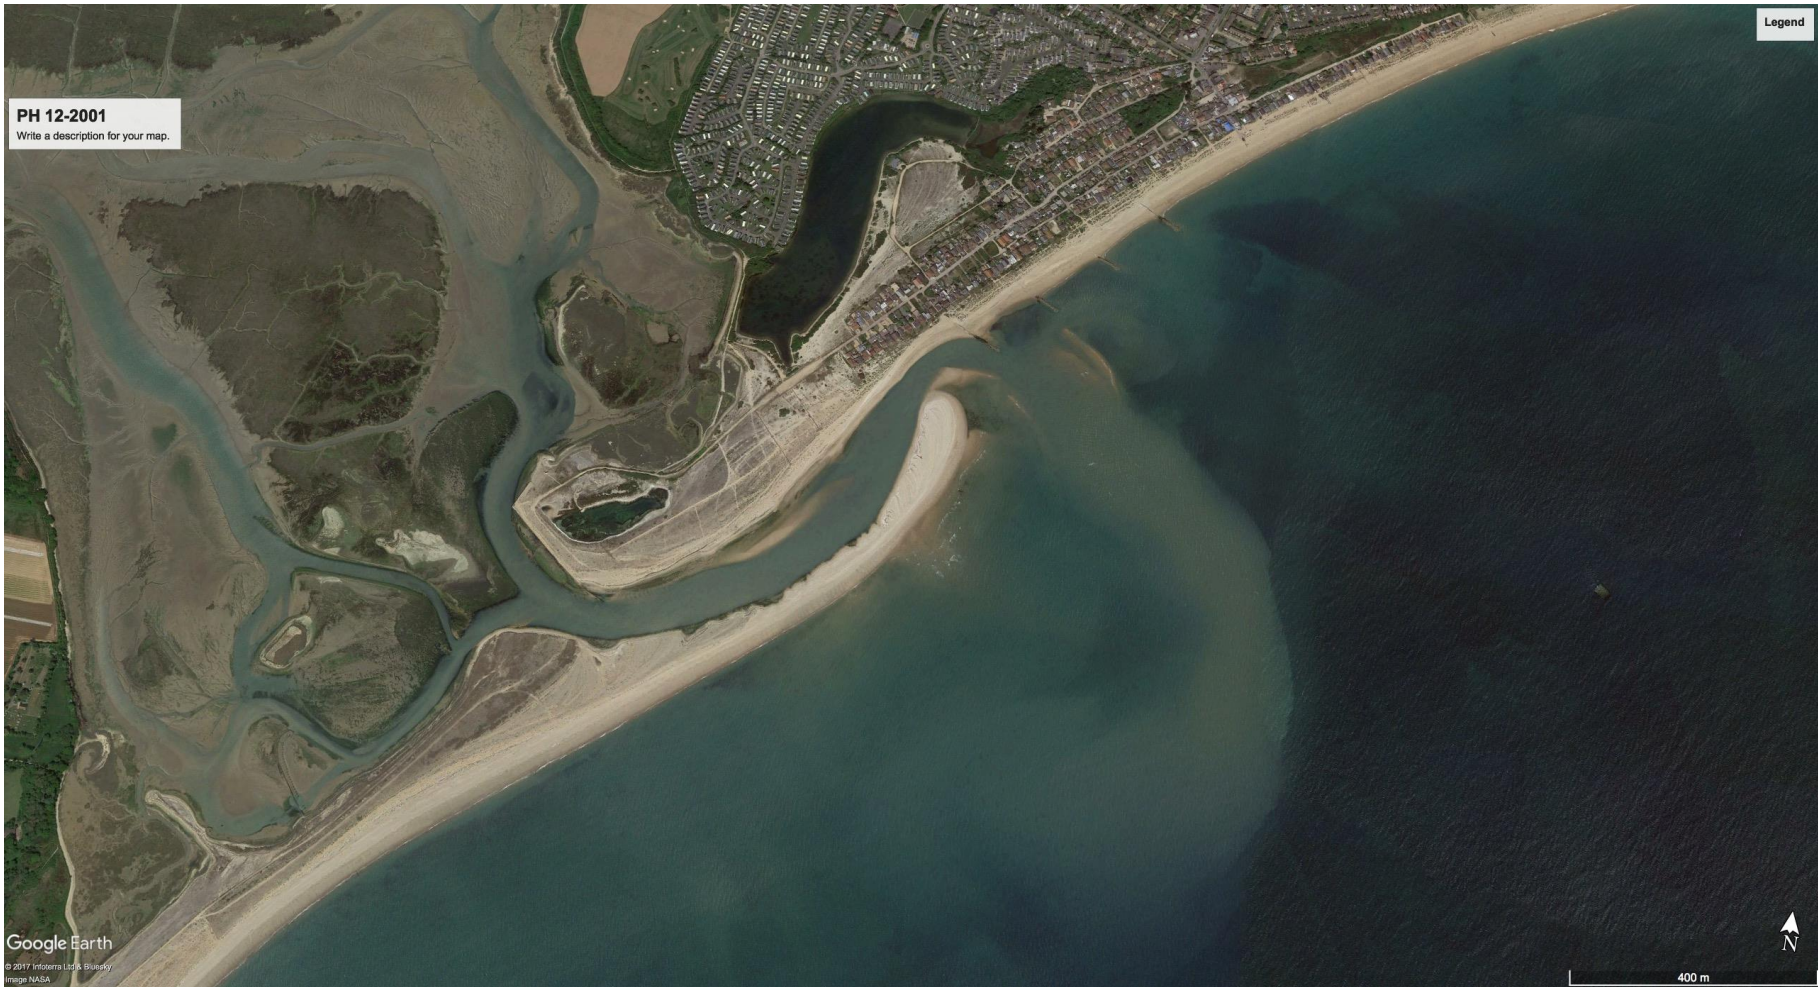
Photograph 17 – taken June 2013

Evidence of Pagham Spit accretion presenting a more parallel orientation to the inside face of CN Spit.

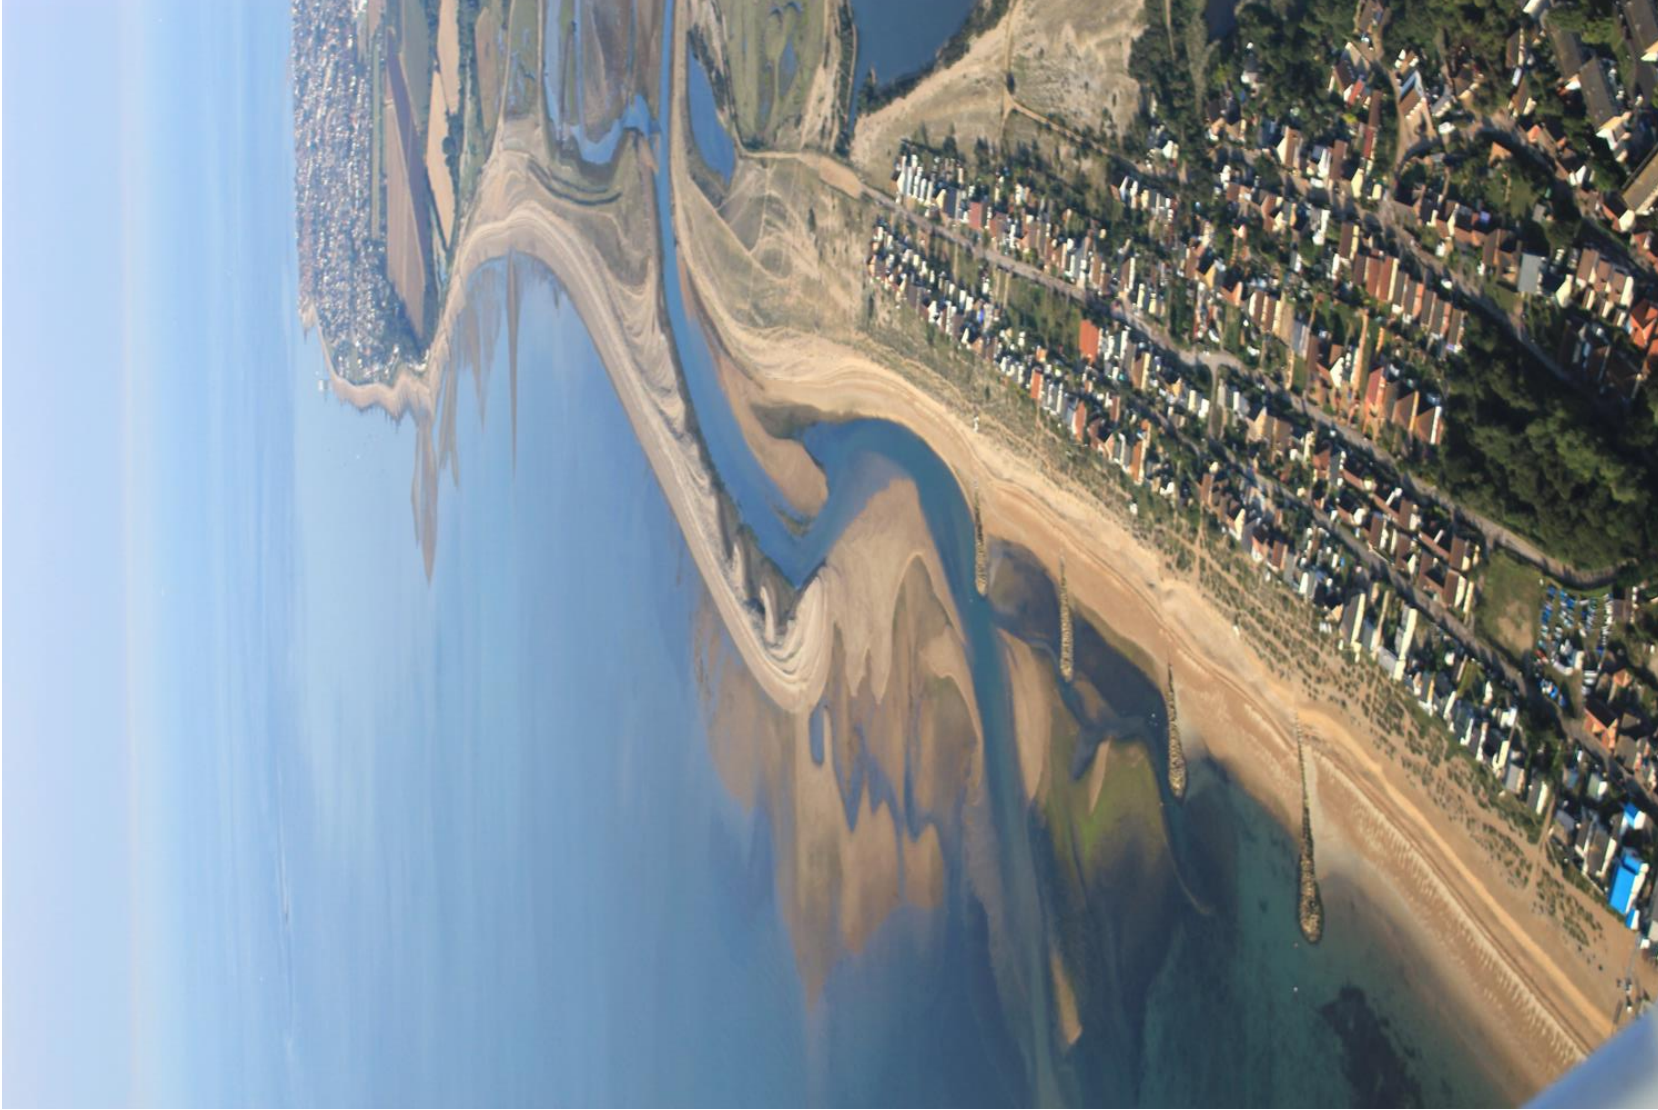
**Photograph 18** – taken January 2014

Further accretion along Pagham Spit. Delta sea bed shaping similar to early 2000's. In this prolonged condition there will be increased tidal energy losses compared to channel outlet conditions in early 2000's affecting tidal exchange with the harbour.

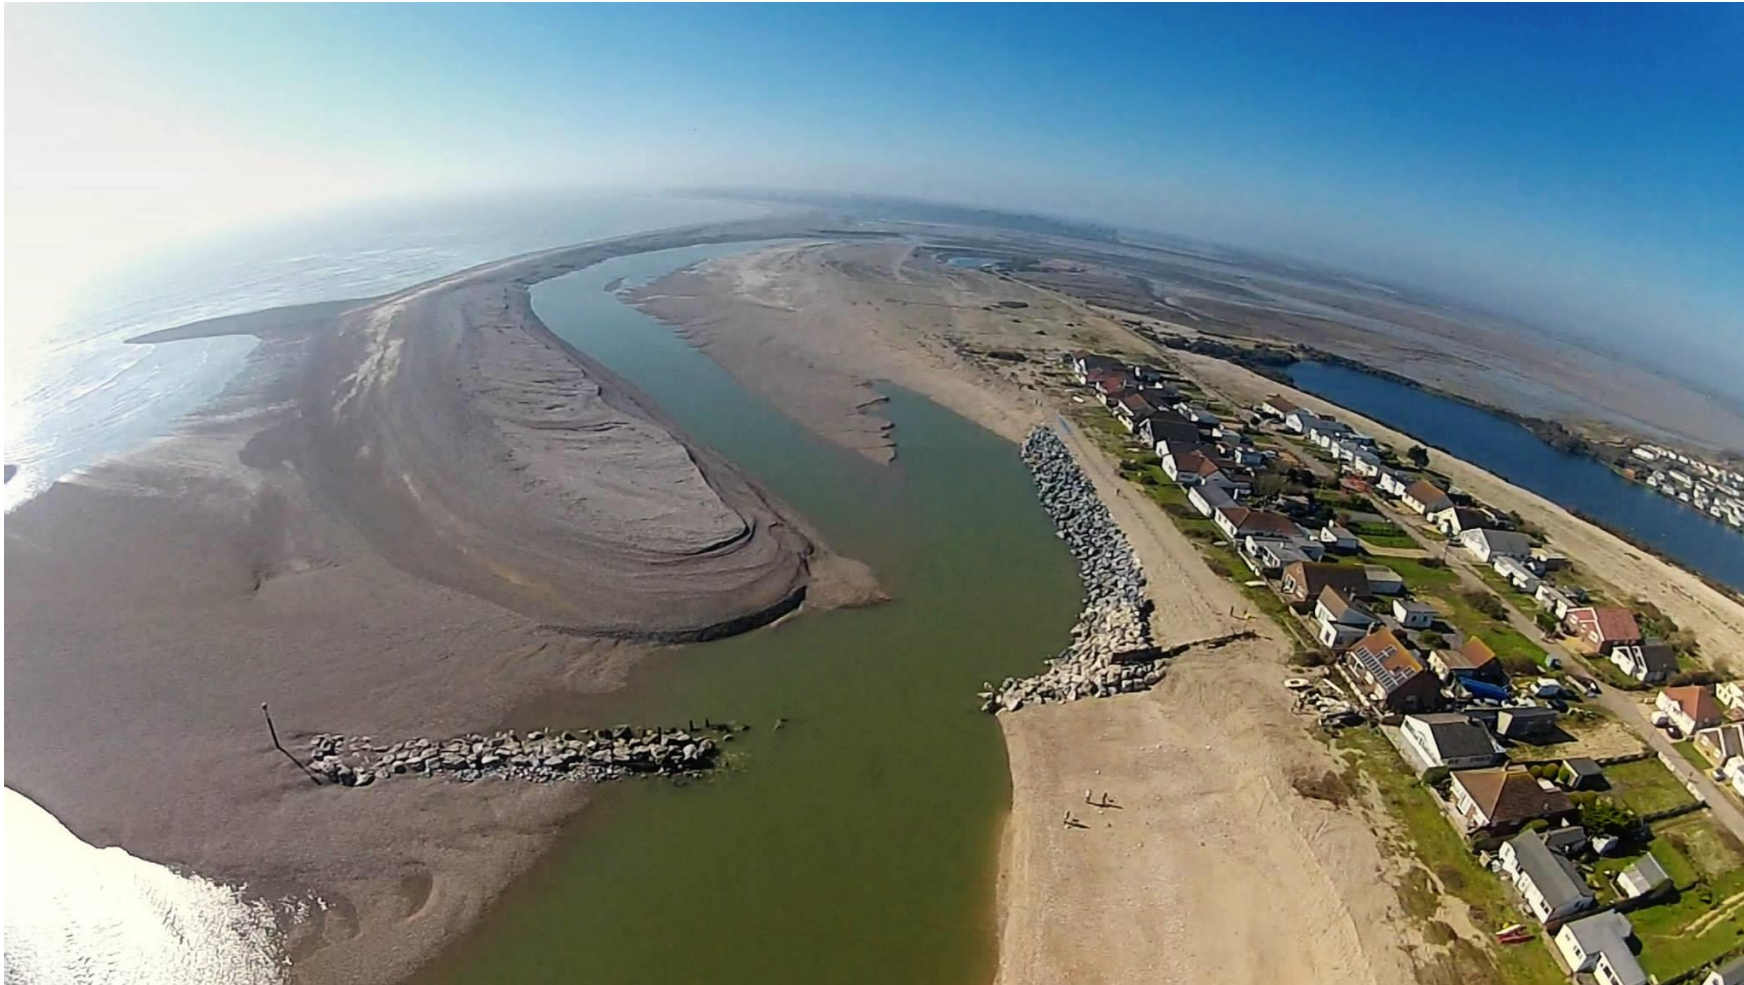
**Photograph 19** – taken 15.03.2014

Further accretion along Pagham Spit. Delta sea bed shaping similar to early 2000's. In this prolonged condition there will be increased tidal energy losses compared to channel outlet conditions in early 2000's affecting tidal exchange with the harbour.

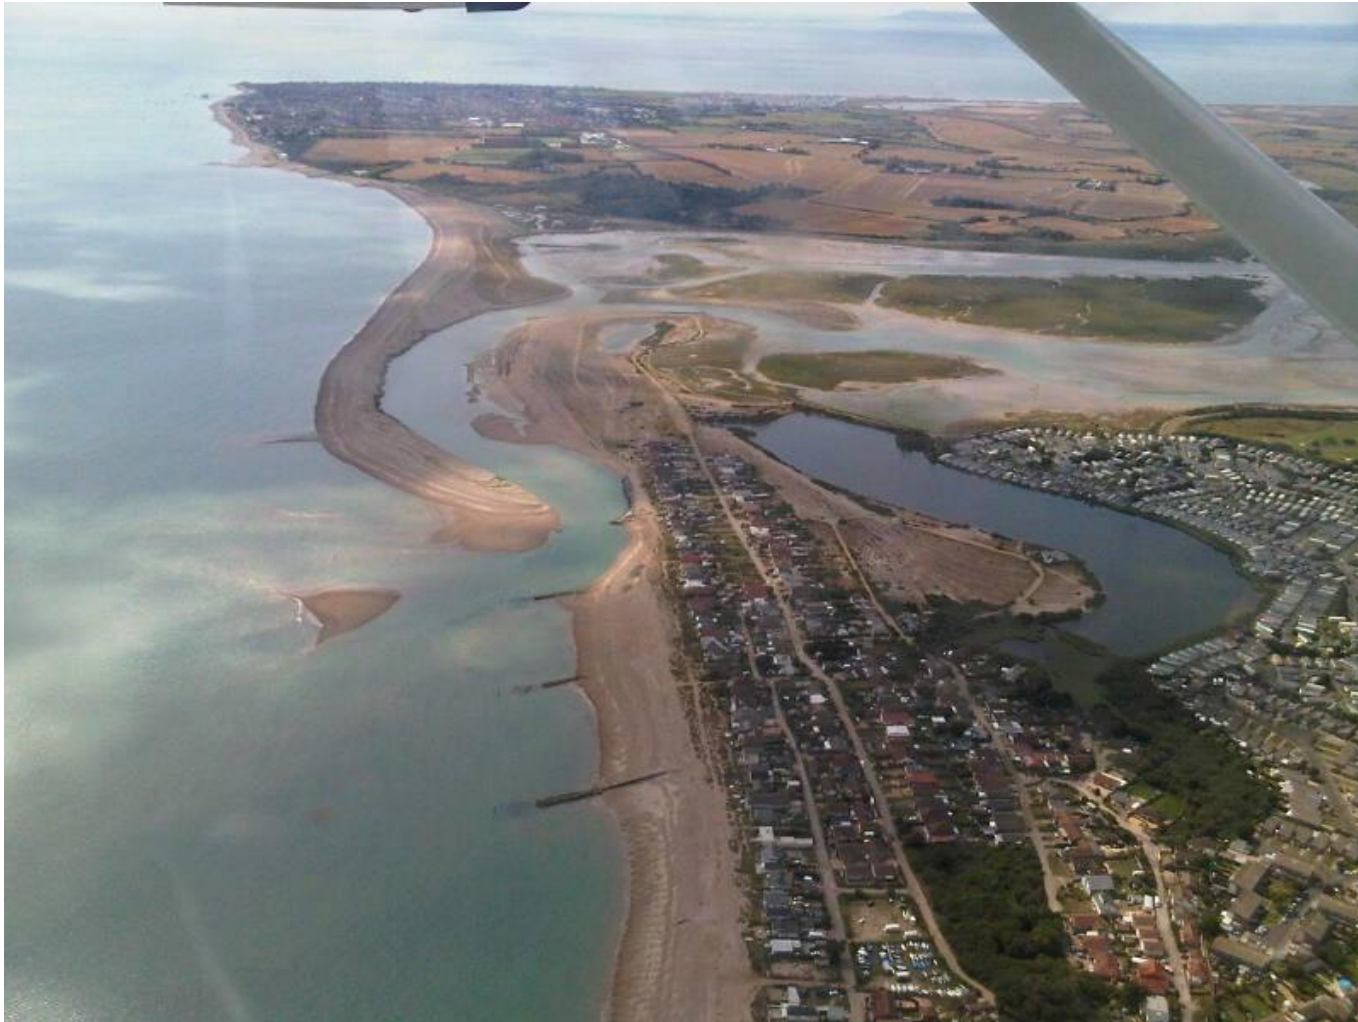
**Photograph 20** – taken 22.08.2014

Further accretion along Pagham Spit. Delta sea bed shaping similar to early 2000's. In this prolonged condition there will be increased tidal energy losses compared to channel outlet conditions in early 2000's affecting tidal exchange with the harbour.

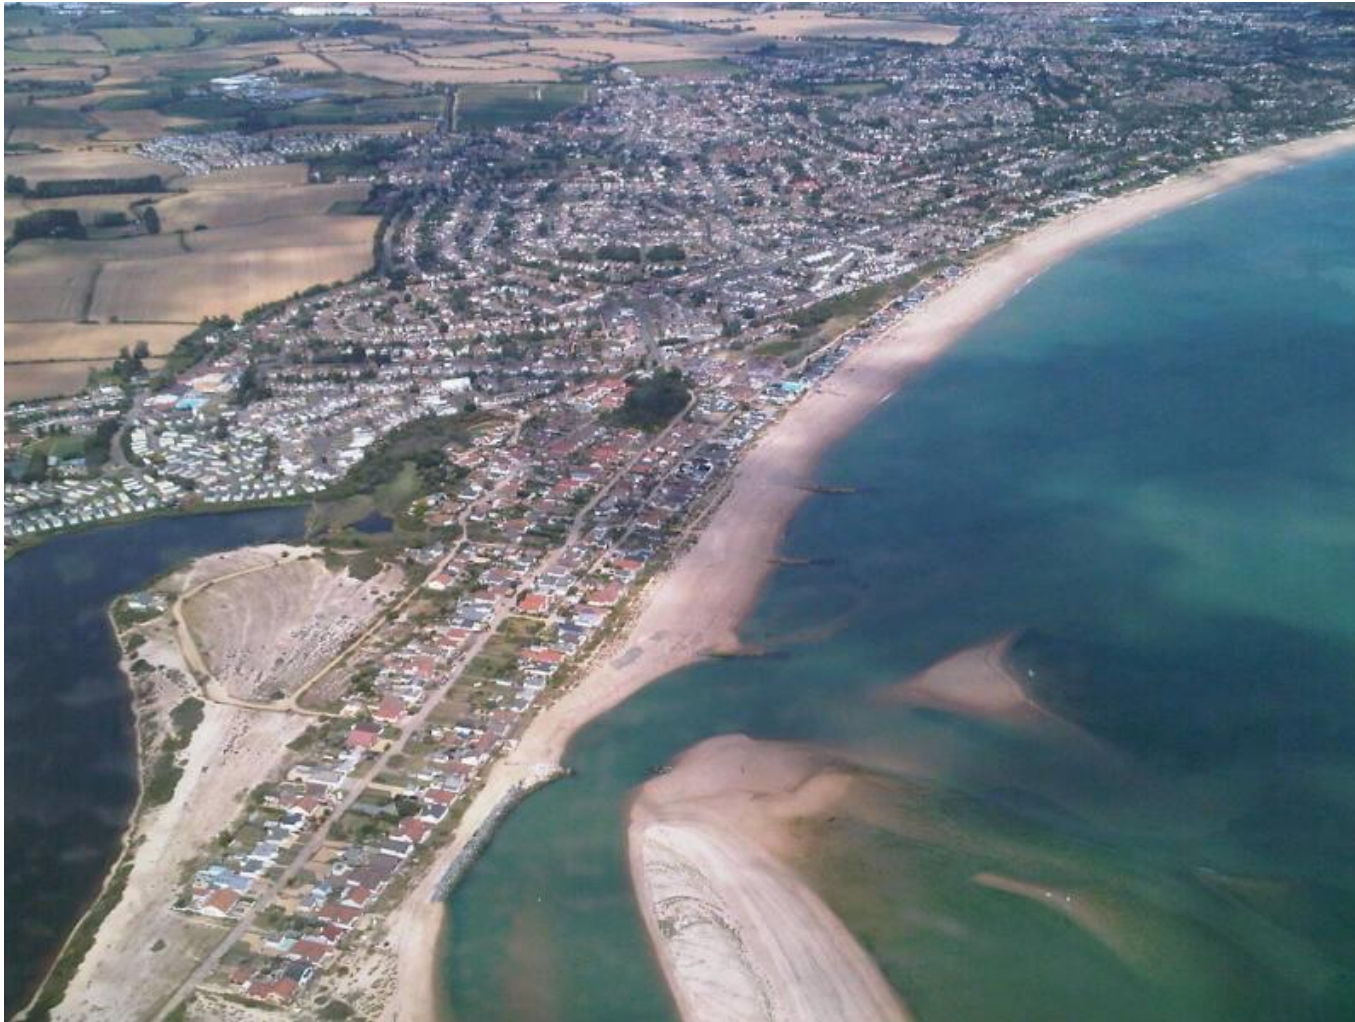
**Photograph 21** – taken 22.08.2014

Further accretion along Pagham Spit. Delta sea bed shaping similar to early 2000's. In this prolonged condition there will be increased tidal energy losses compared to channel outlet conditions in early 2000's affecting tidal exchange with the harbour.

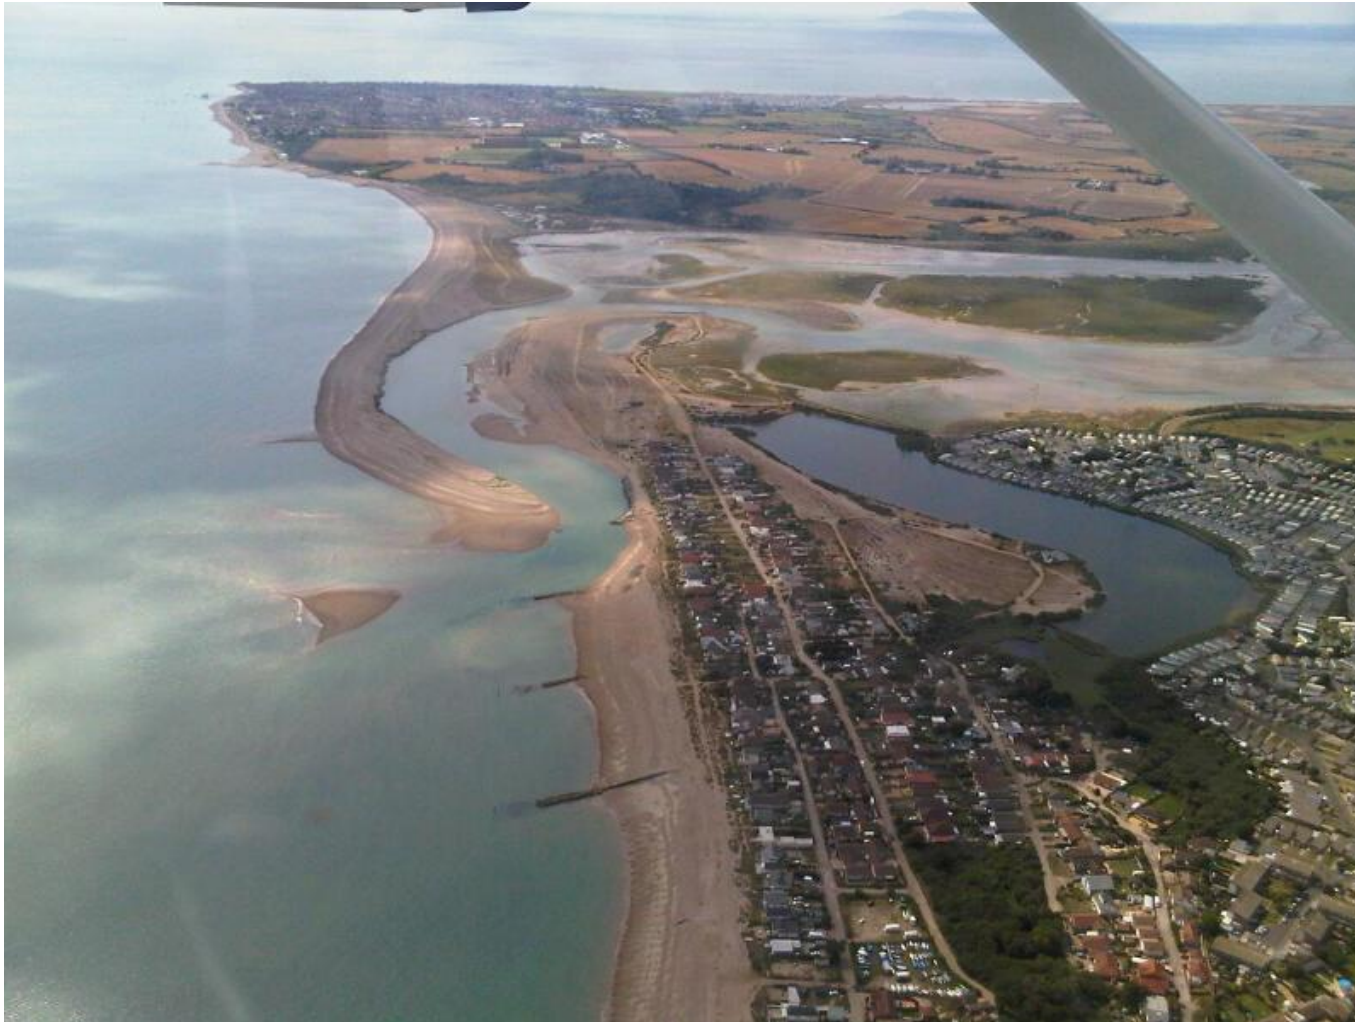
**Photograph 22** – taken September 2014

Further accretion along Pagham Spit. Delta sea bed shaping similar to early 2000's. In this prolonged condition there will be increased tidal energy losses compared to channel outlet conditions in early 2000's affecting tidal exchange with the harbour.

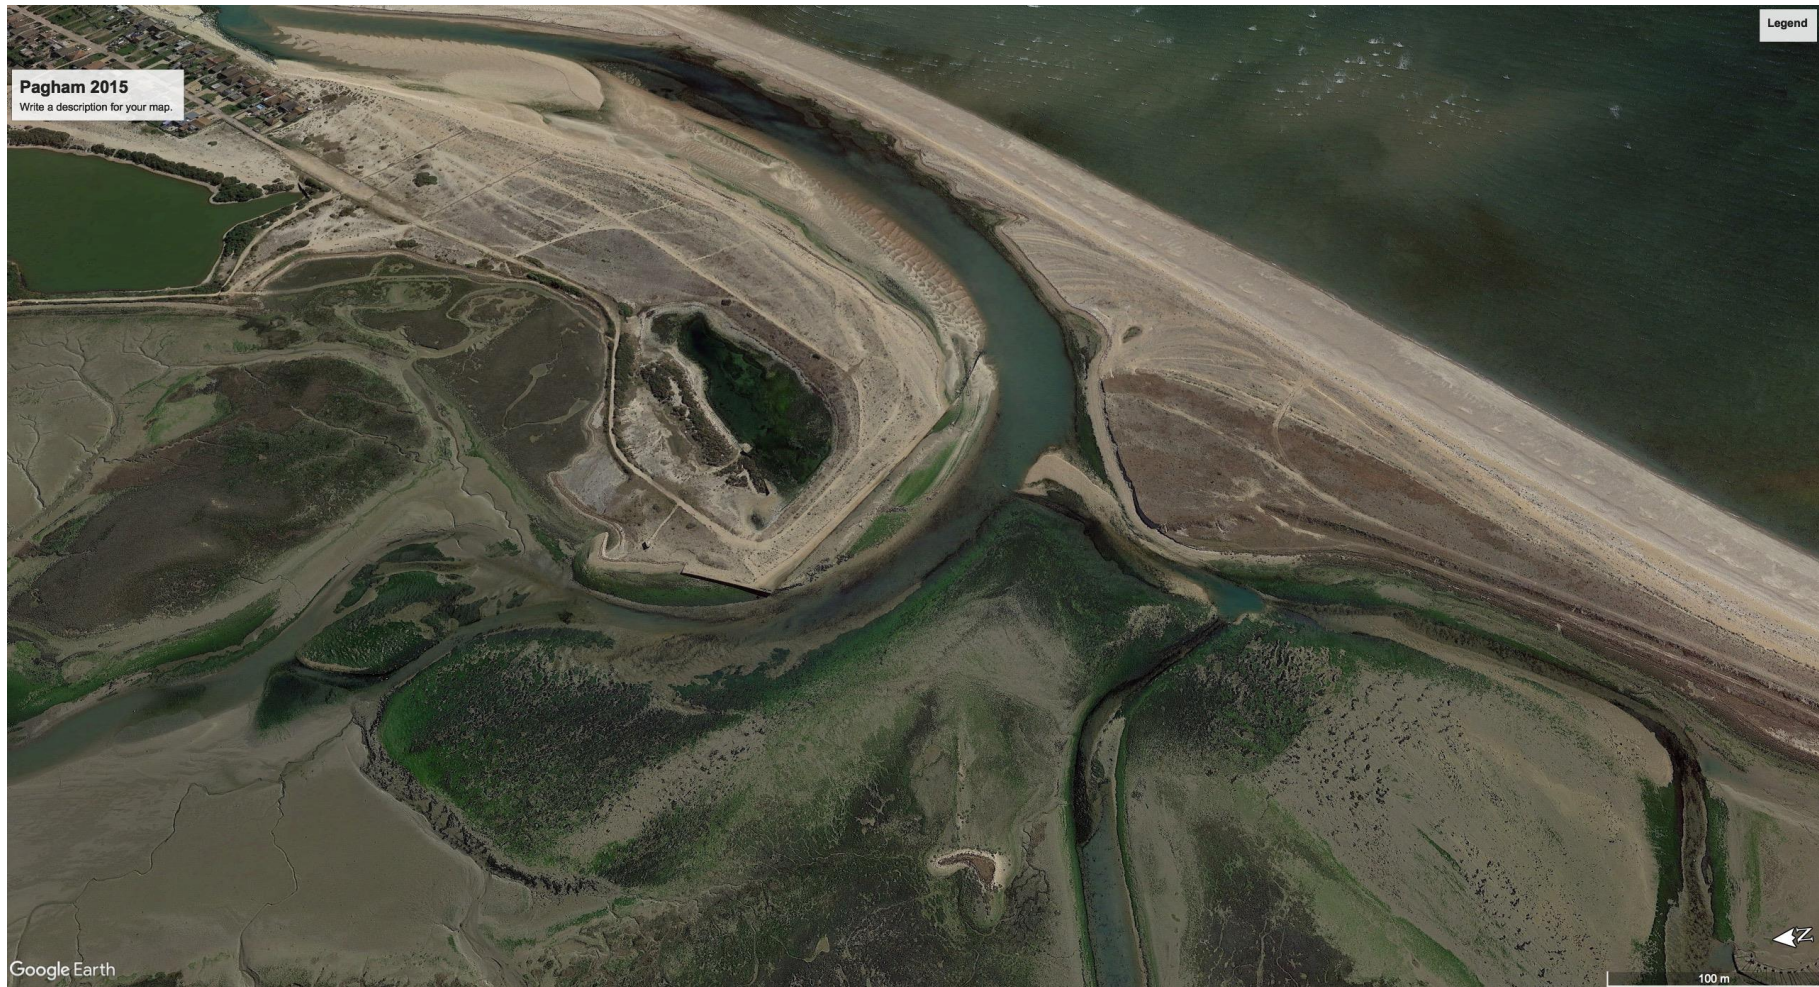
**Photograph 23** – taken April 2015

Harbour outlet channel conditions persist in 2015. Some evidence of a twin channel developing north-east of where CN Spit changes alignment indicating a separation of tidal flood and ebb energies. Delta sea bed shape continues to exhibit similarities with the early 2000's.

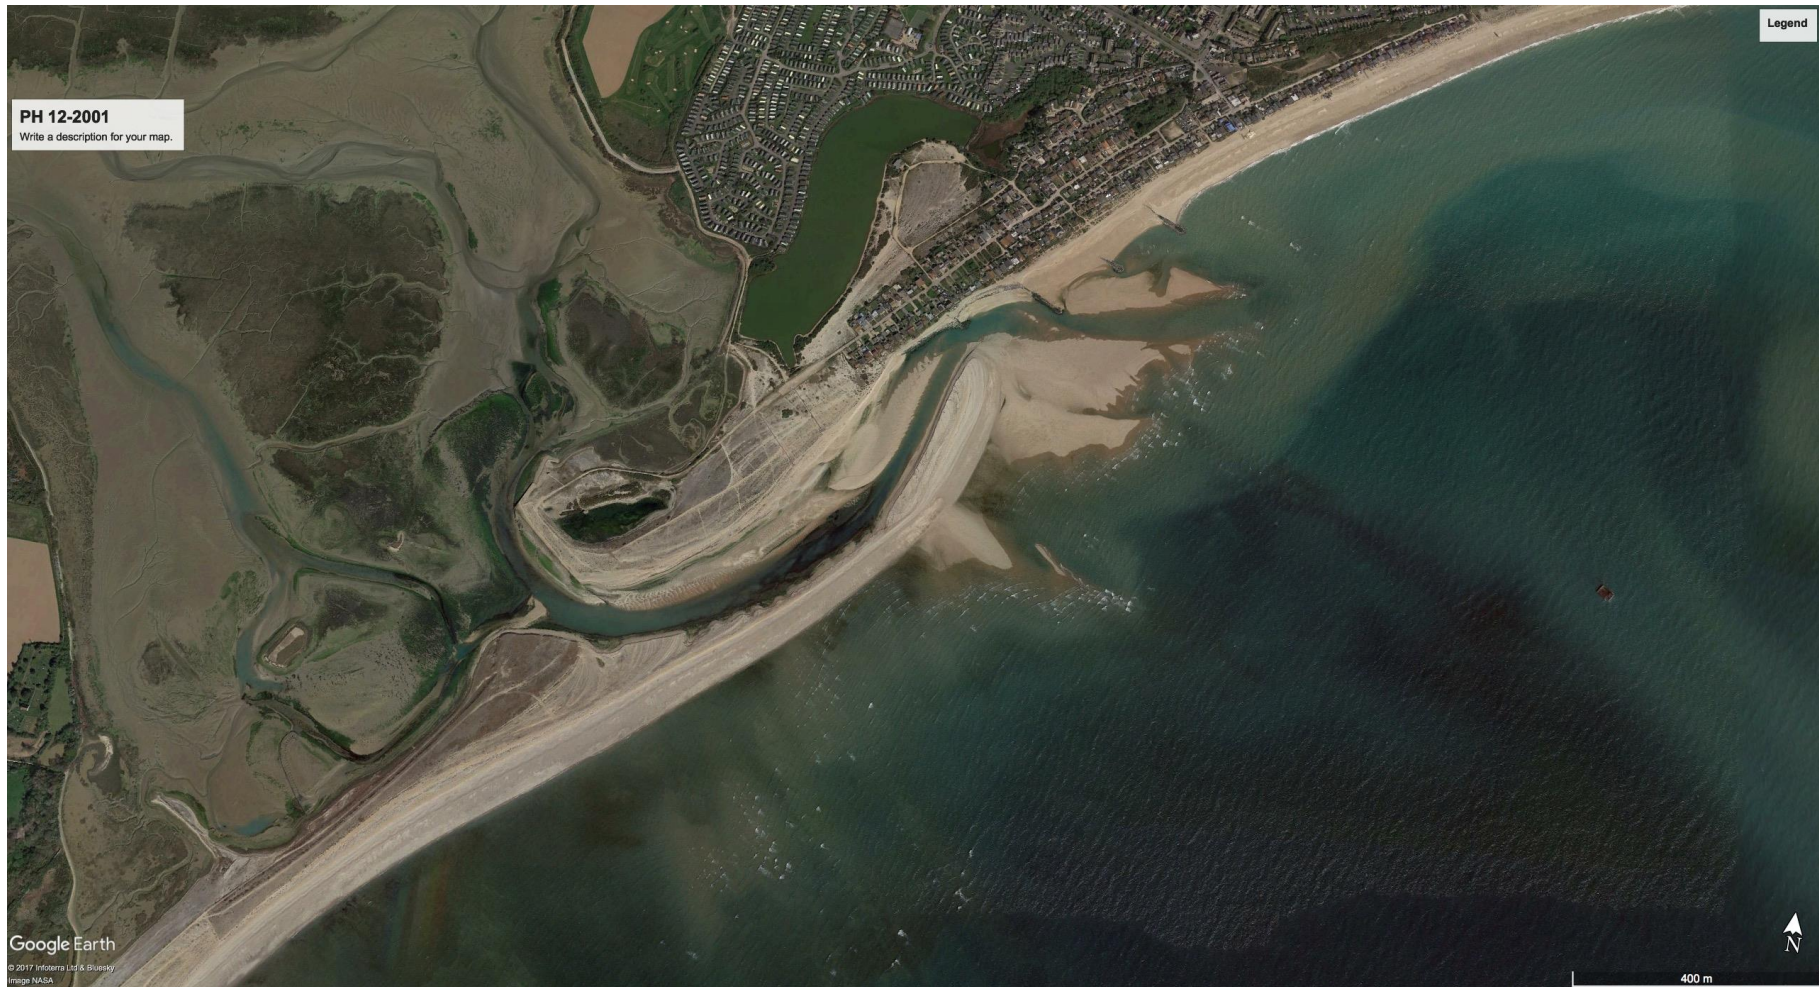
**Photograph 24** – taken April 2015

Harbour outlet channel conditions persist in 2015. Some evidence of a twin channel developing north-east of where CN Spit changes alignment indicating a separation of tidal flood and ebb energies. Delta sea bed shape continues to exhibit similarities with the early 2000's.

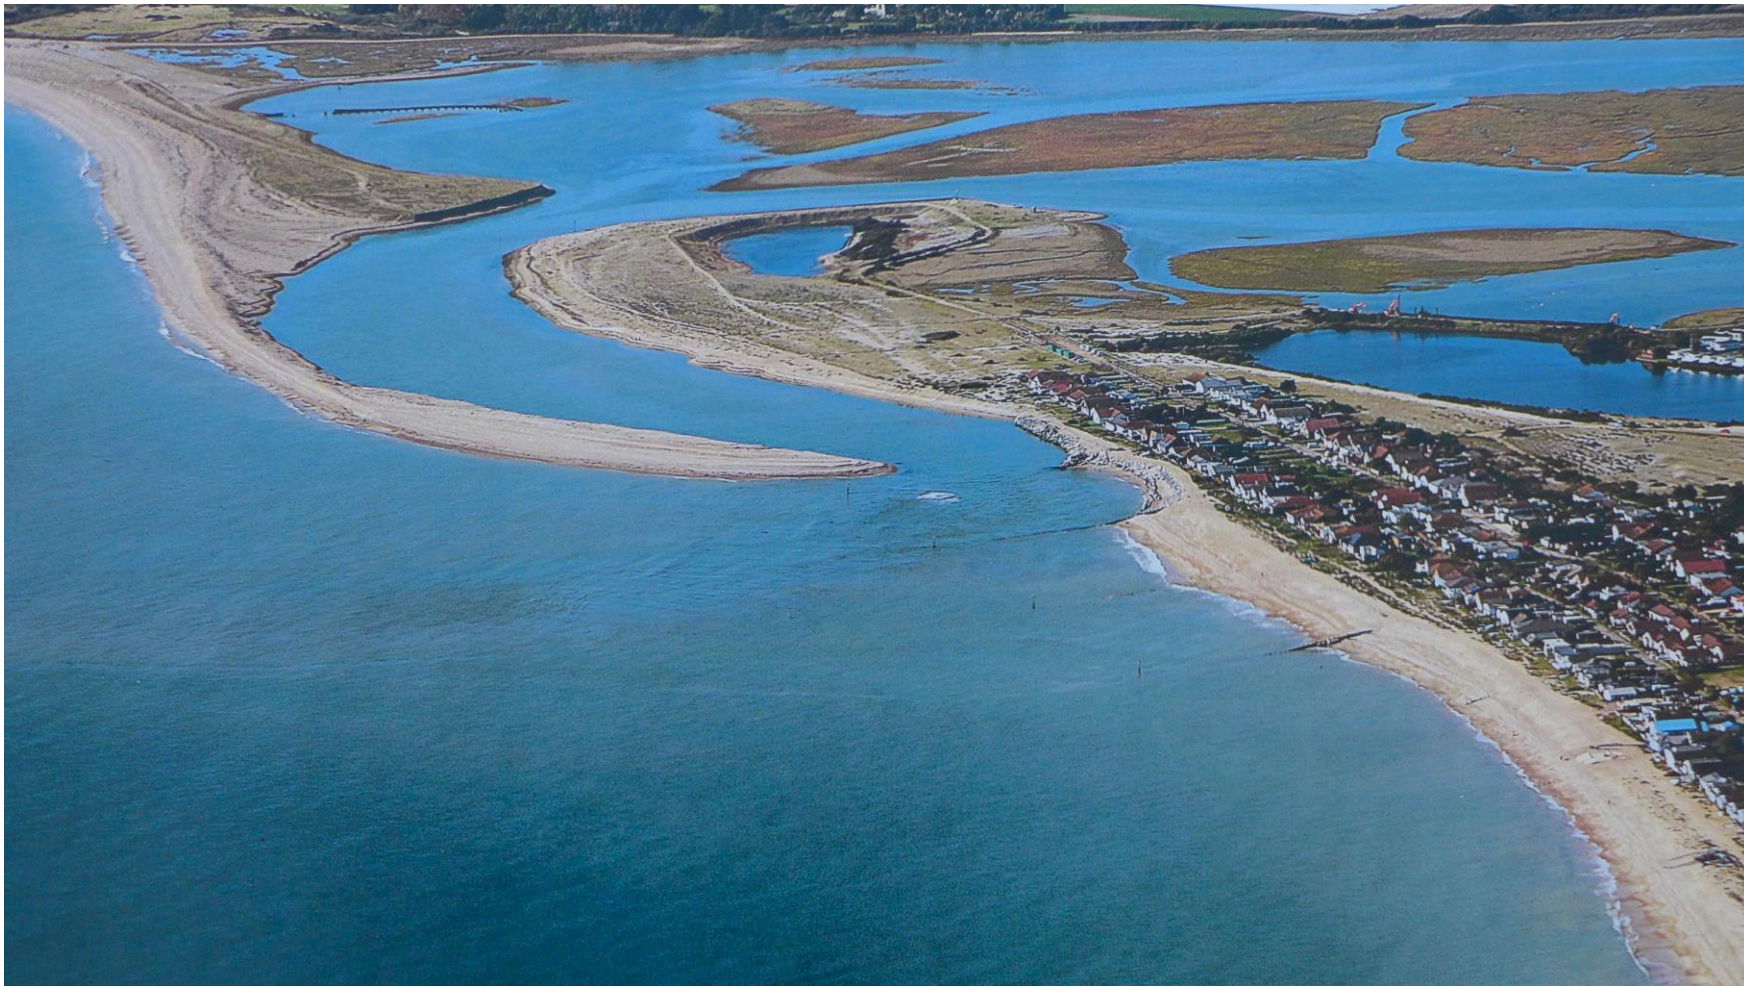
**Photograph 25** – taken 10.03.2016

Immediately prior to the breach of CN Spit (25, 26). Early configuration of breach (27 to 35).

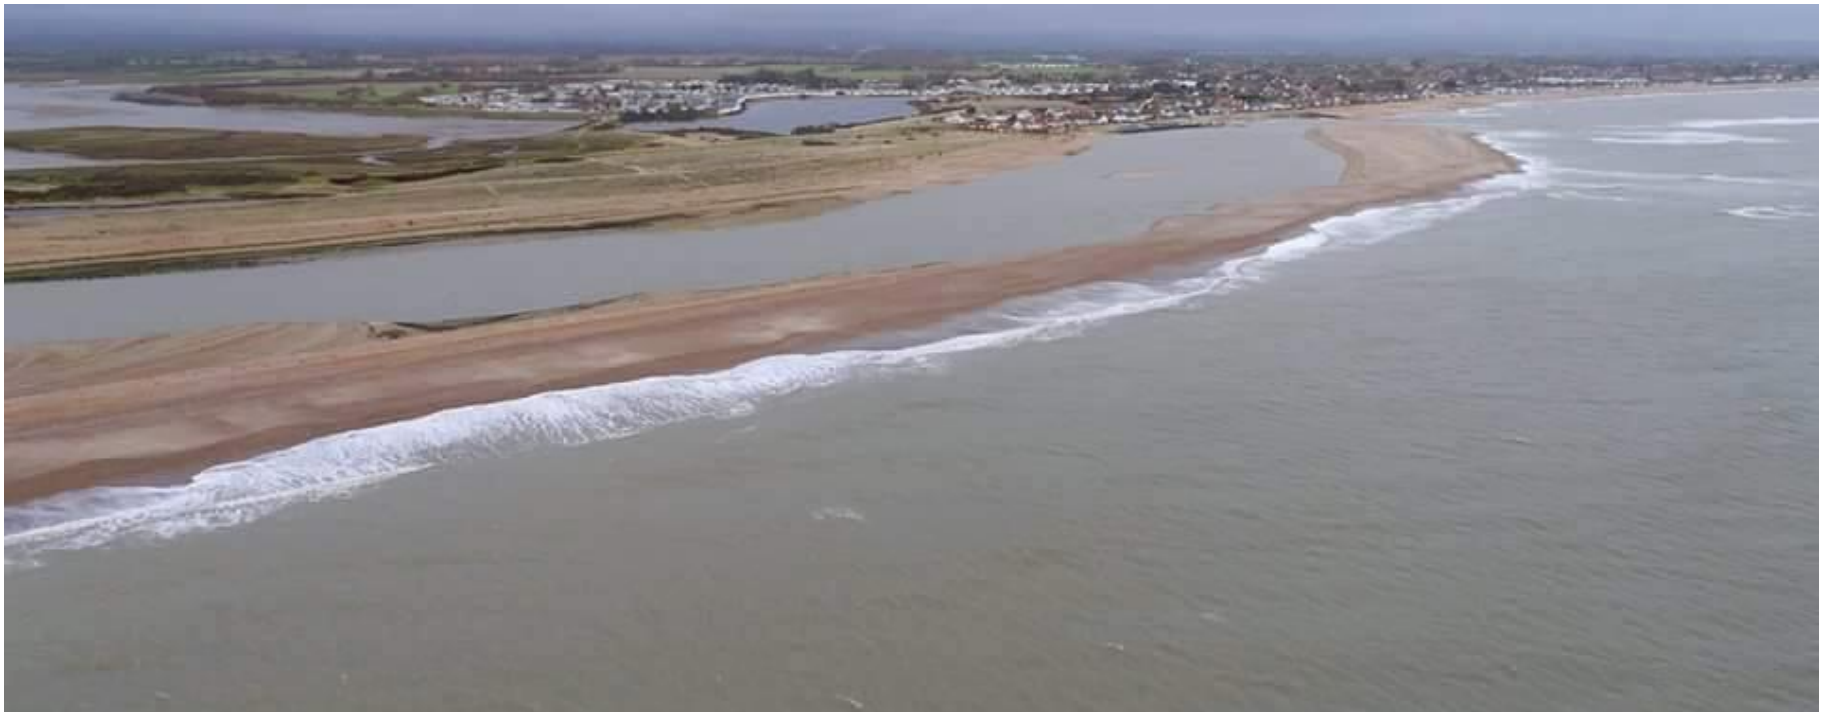
**Photograph 26** – taken 31.01.2016

Immediately prior to the breach of CN Spit (25, 26). Early configuration of breach (27 to 35).

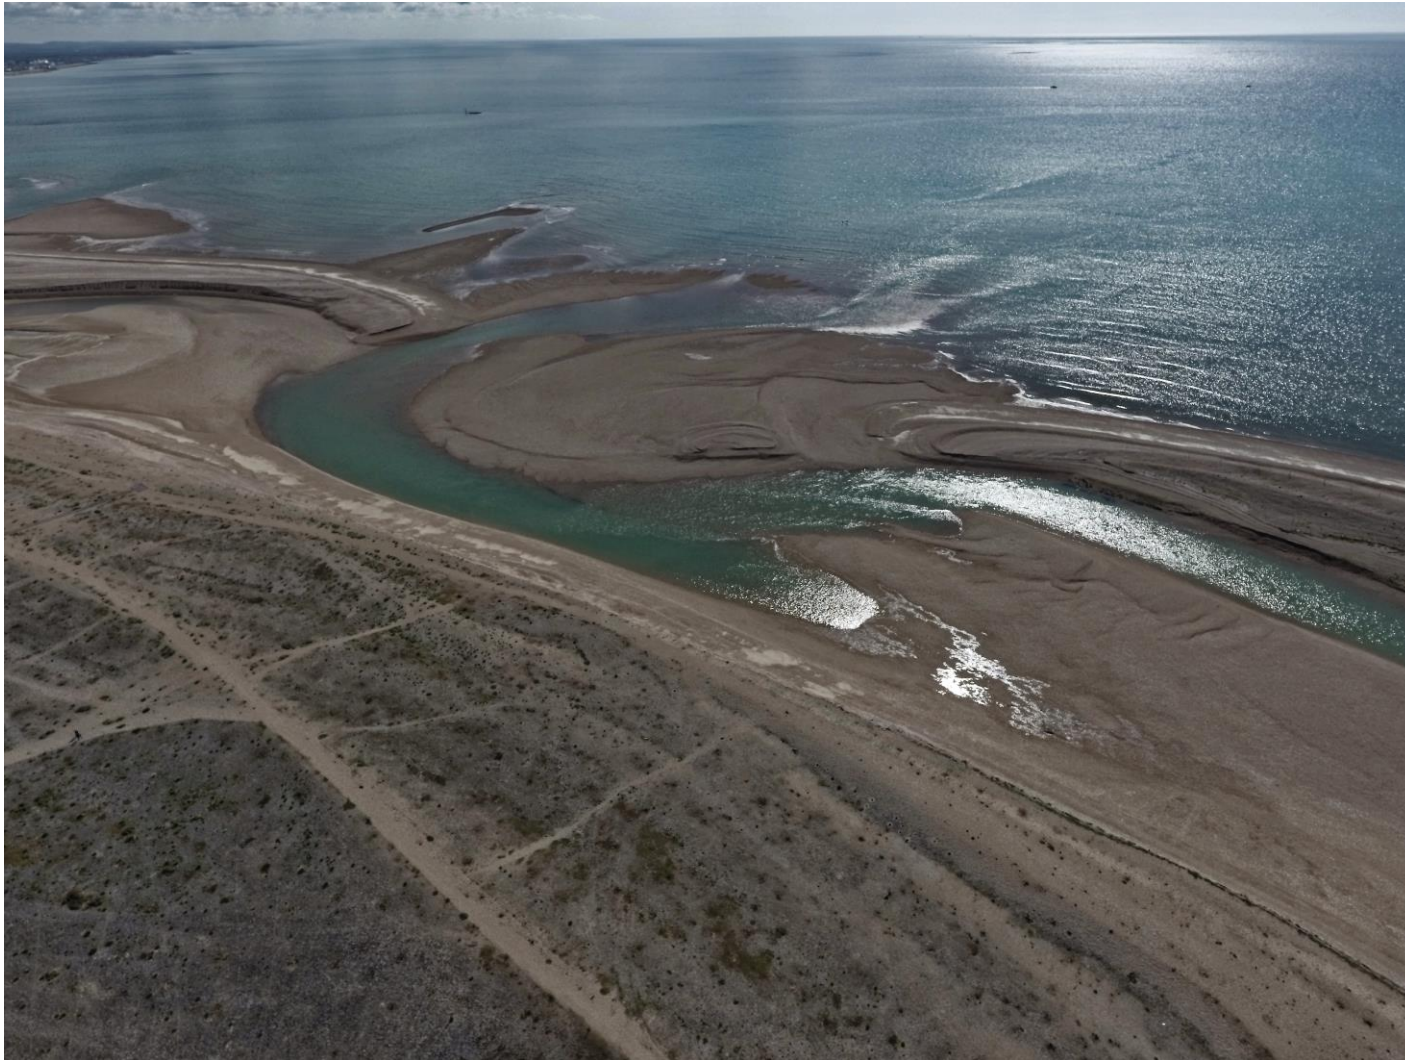
**Photograph 27** – taken April 2016

Immediately prior to the breach of CN Spit (25, 26). Early configuration of breach (27 to 35).

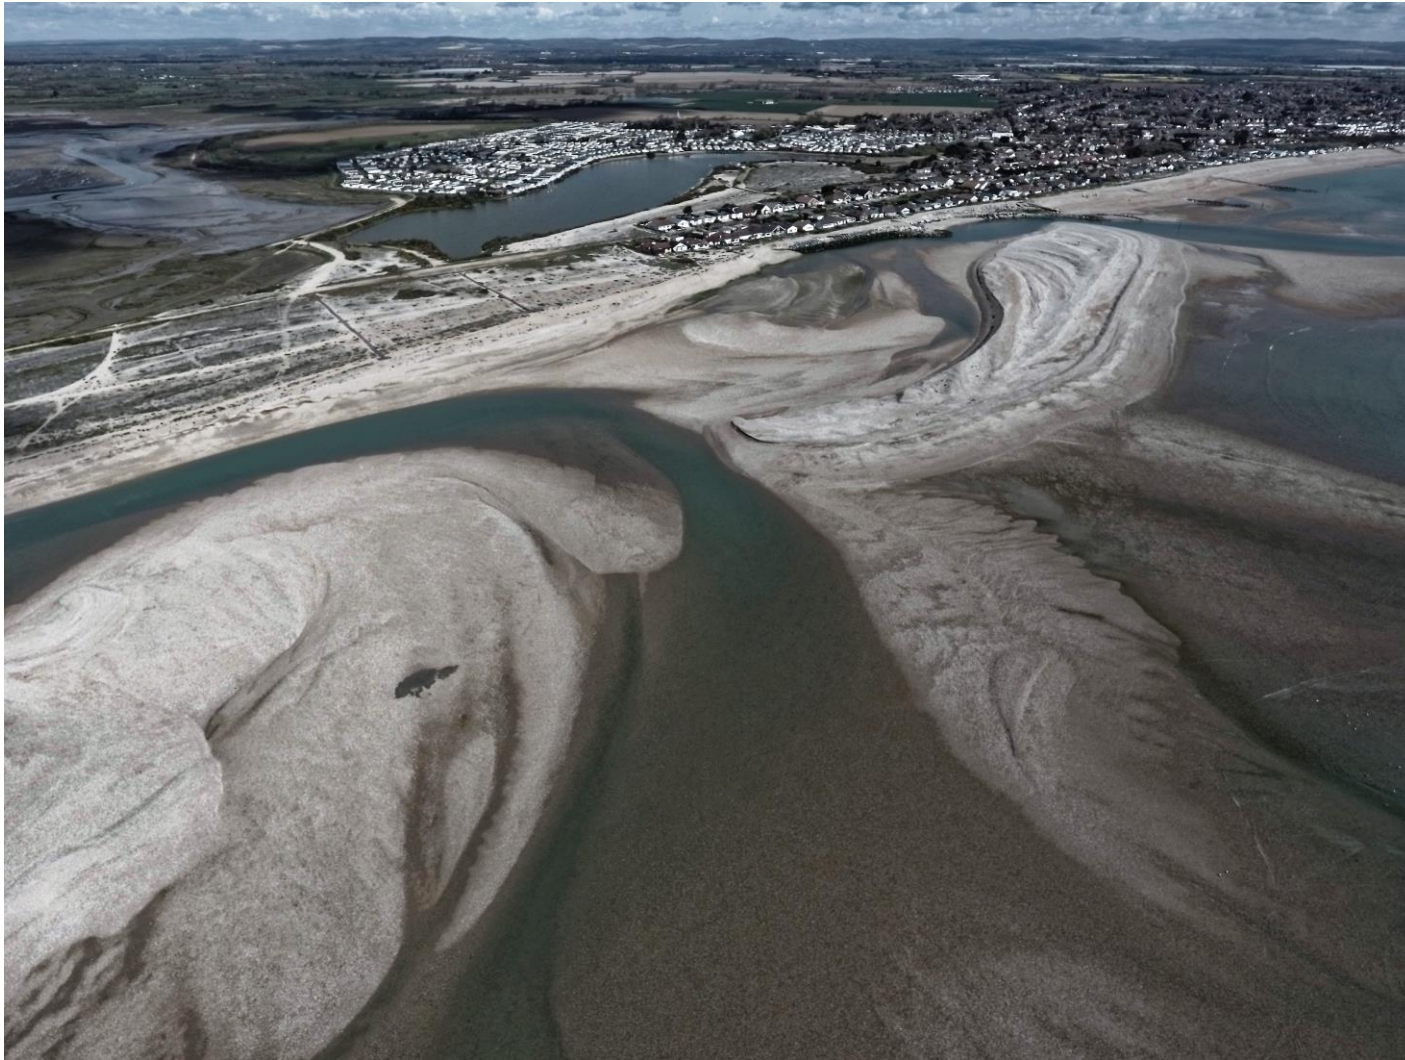
**Photograph 28** – taken April 2016

Immediately prior to the breach of CN Spit (25, 26). Early configuration of breach (27 to 35).

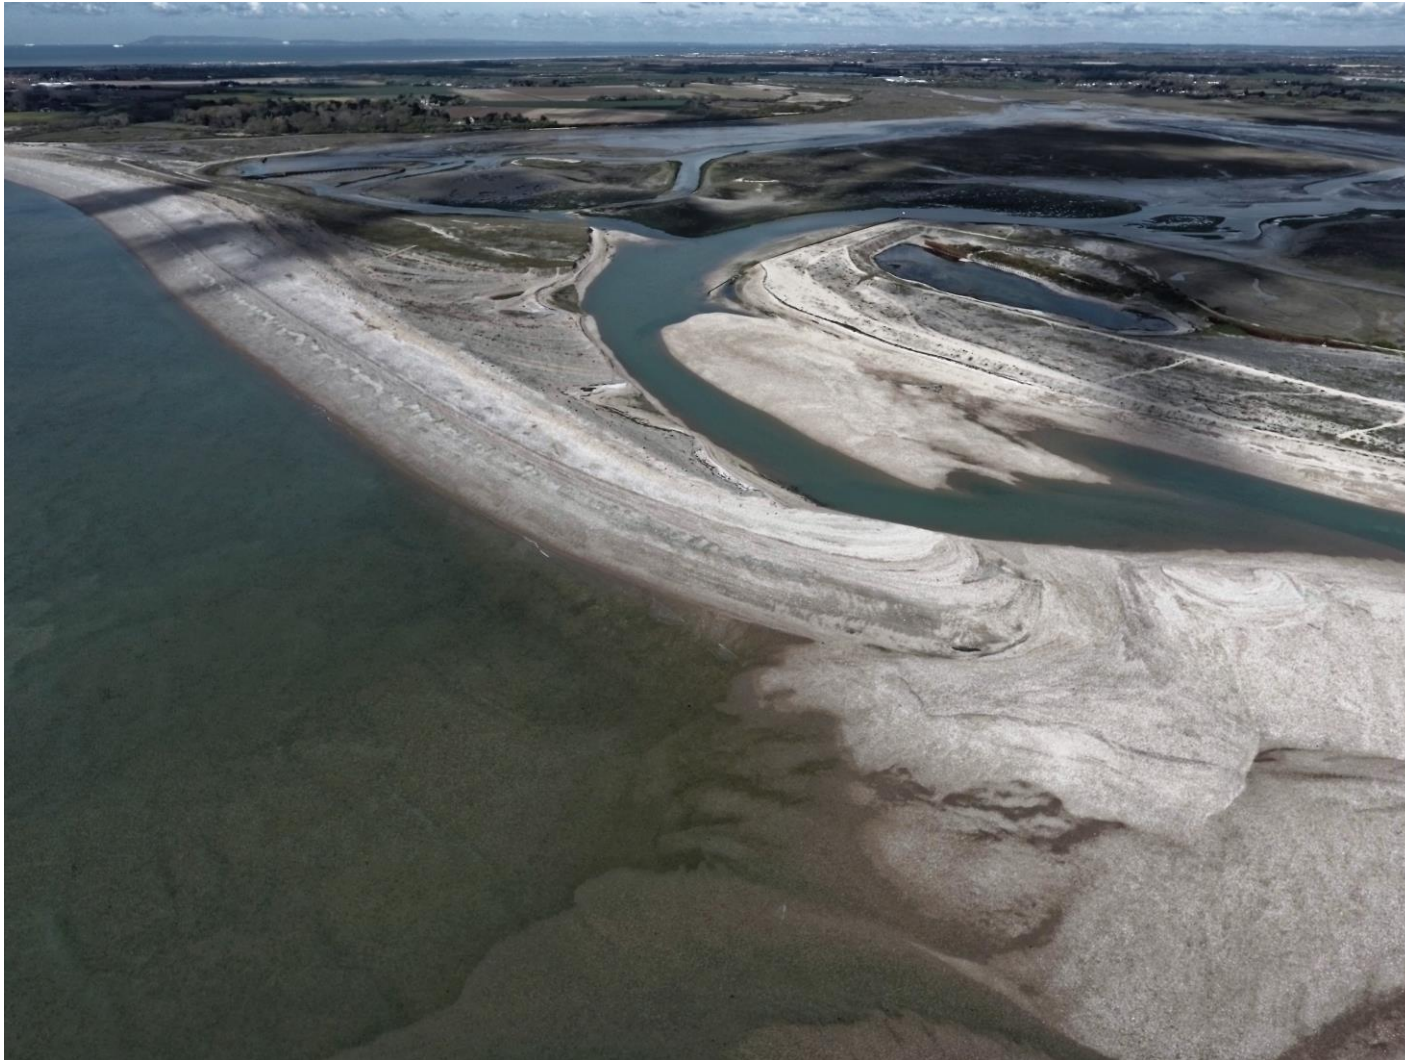
**Photograph 29** – taken April 2016

Immediately prior to the breach of CN Spit (25, 26). Early configuration of breach (27 to 35).
