**Appendix -** (for general location details shown in the photographs, refer to Figures 1 and 3)

## **Pagham Harbour Photographs 2001 to 2019**

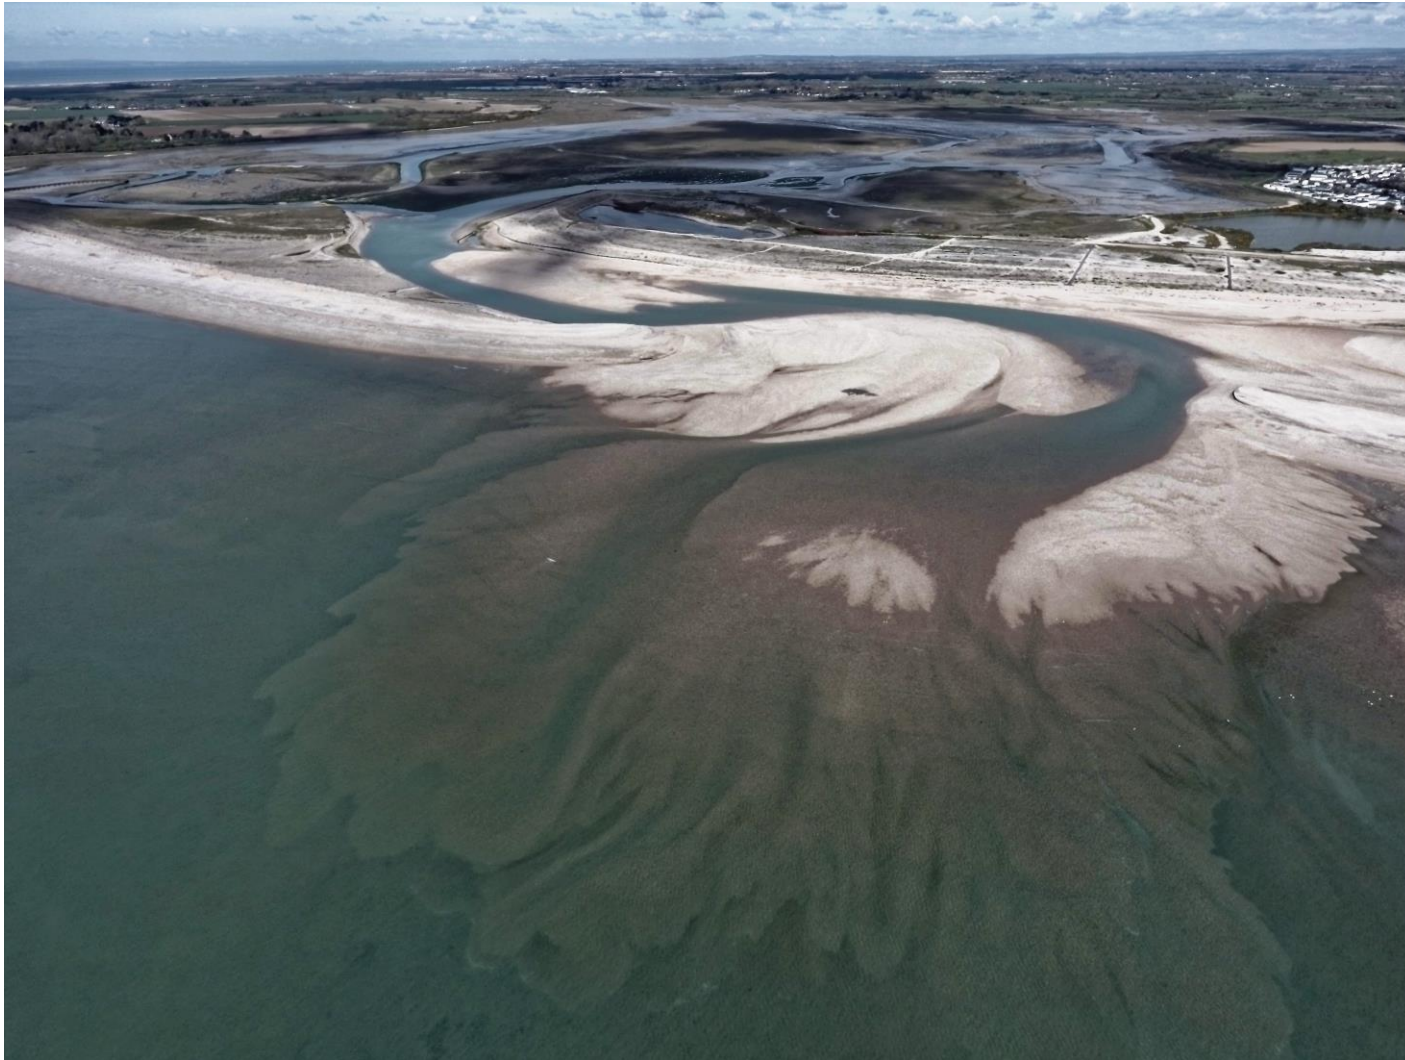
**Photograph 30** – taken April 2016

Immediately prior to the breach of CN Spit (25, 26). Early configuration of breach (27 to 35).

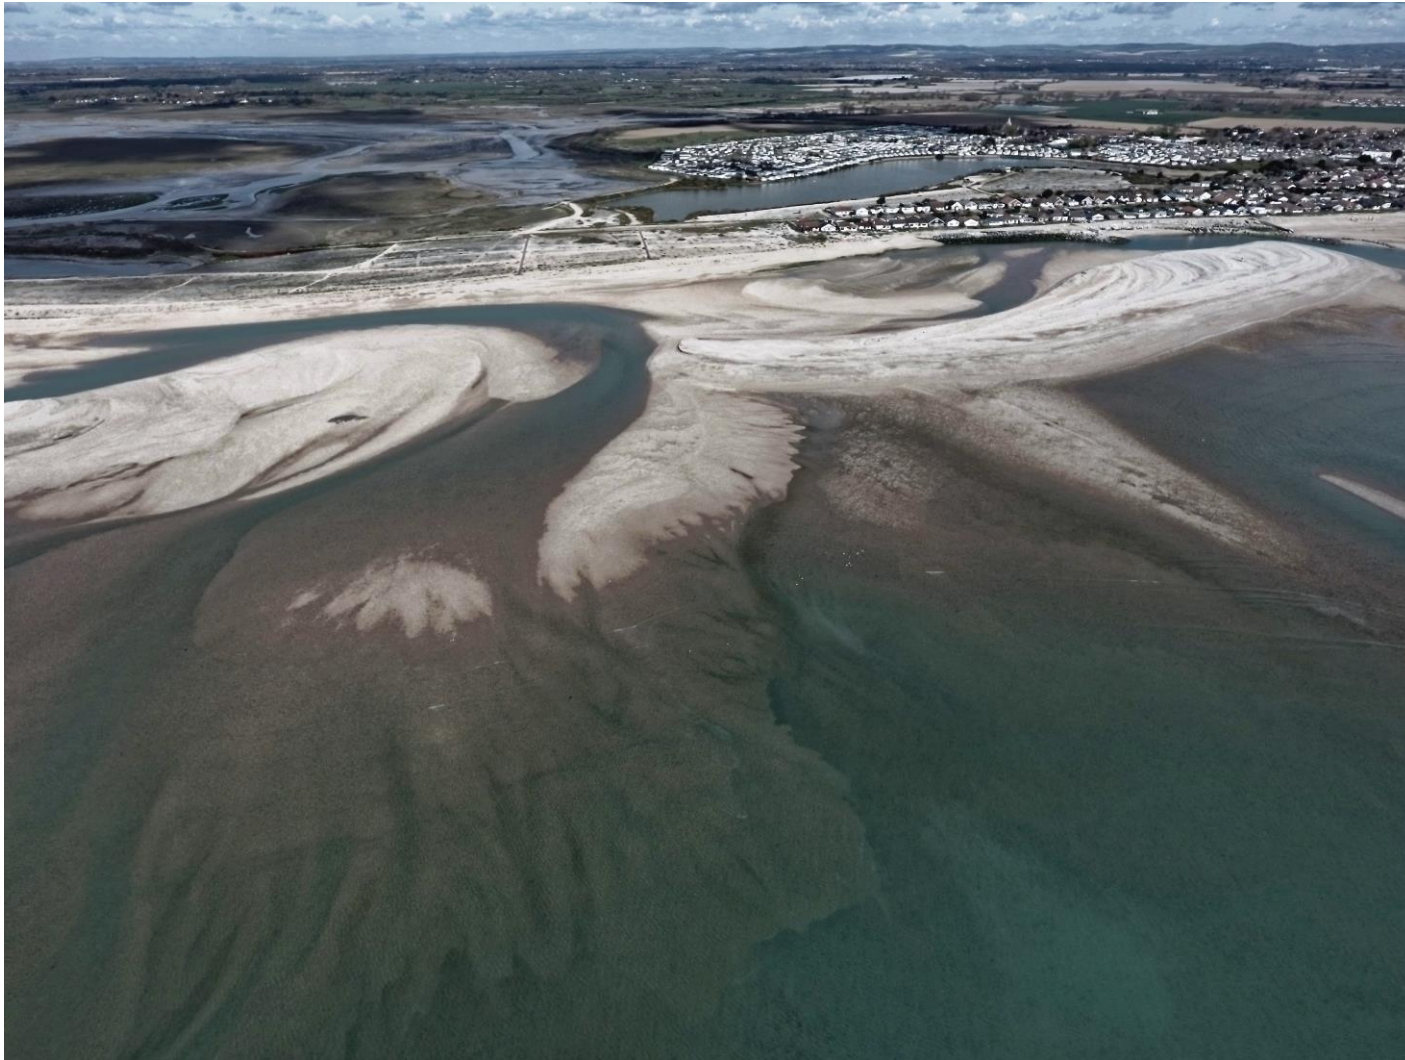
**Photograph 31** – taken April 2016

Immediately prior to the breach of CN Spit (25, 26). Early configuration of breach (27 to 35).

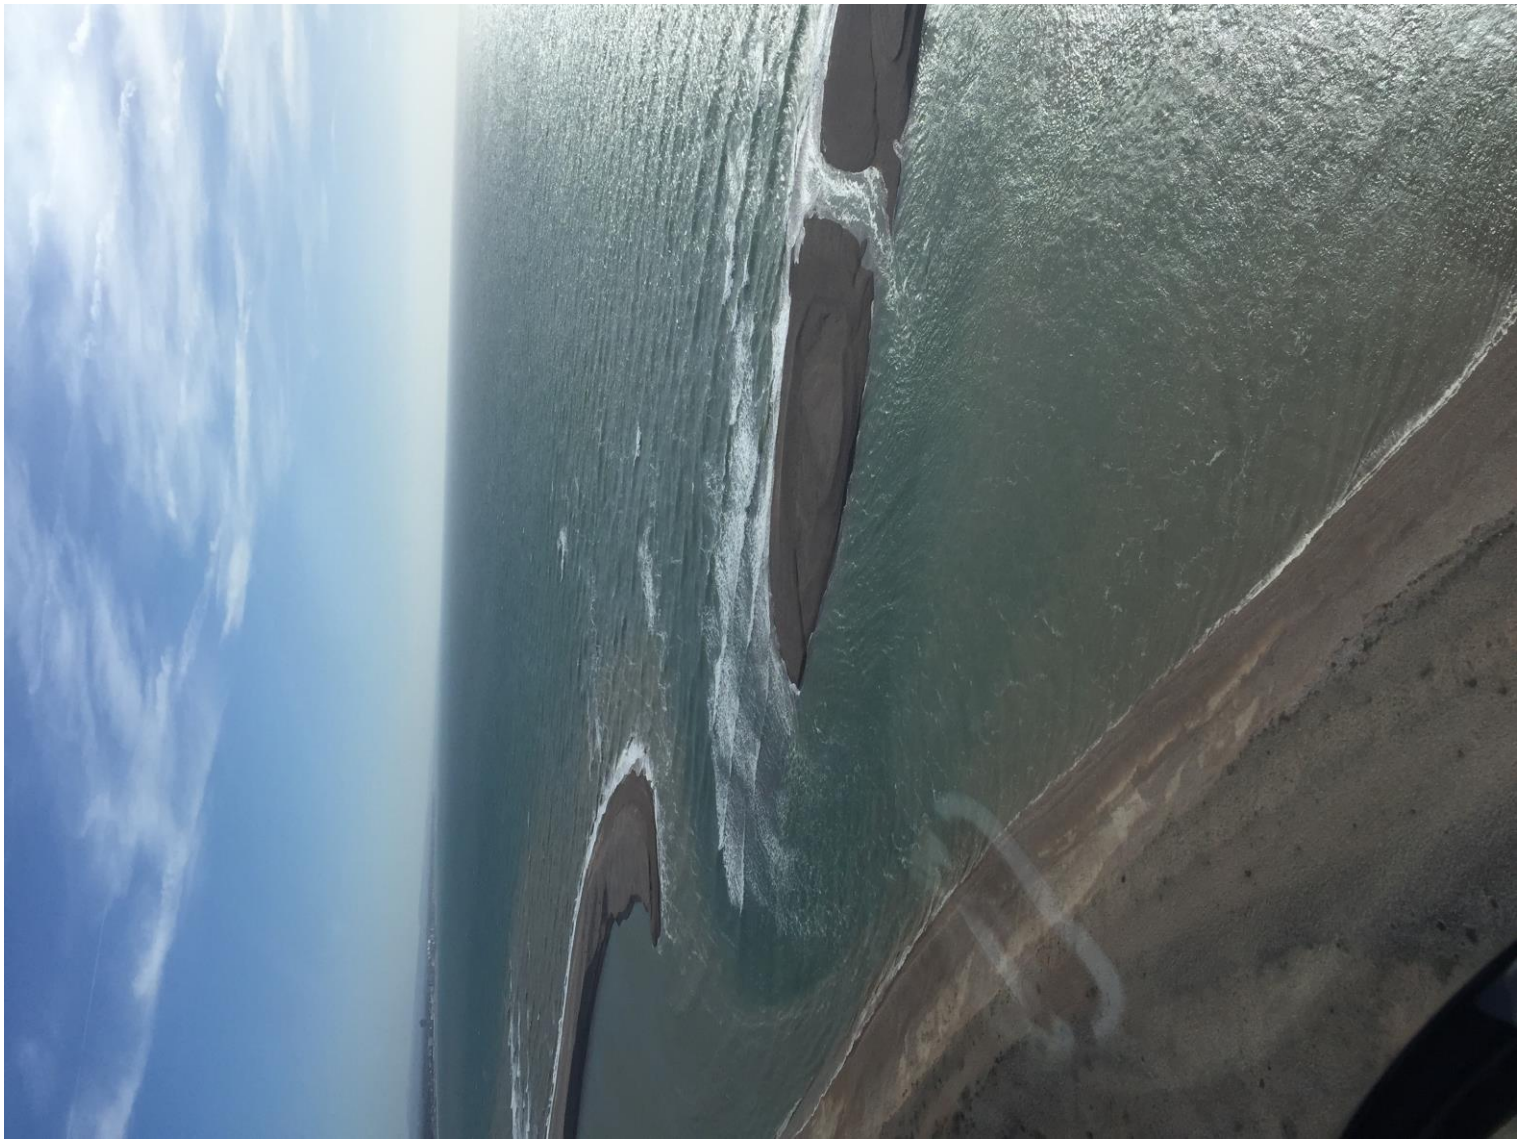
**Photograph 32** – taken April 2016

Immediately prior to the breach of CN Spit (25, 26).  
Early configuration of breach (27 to 35).

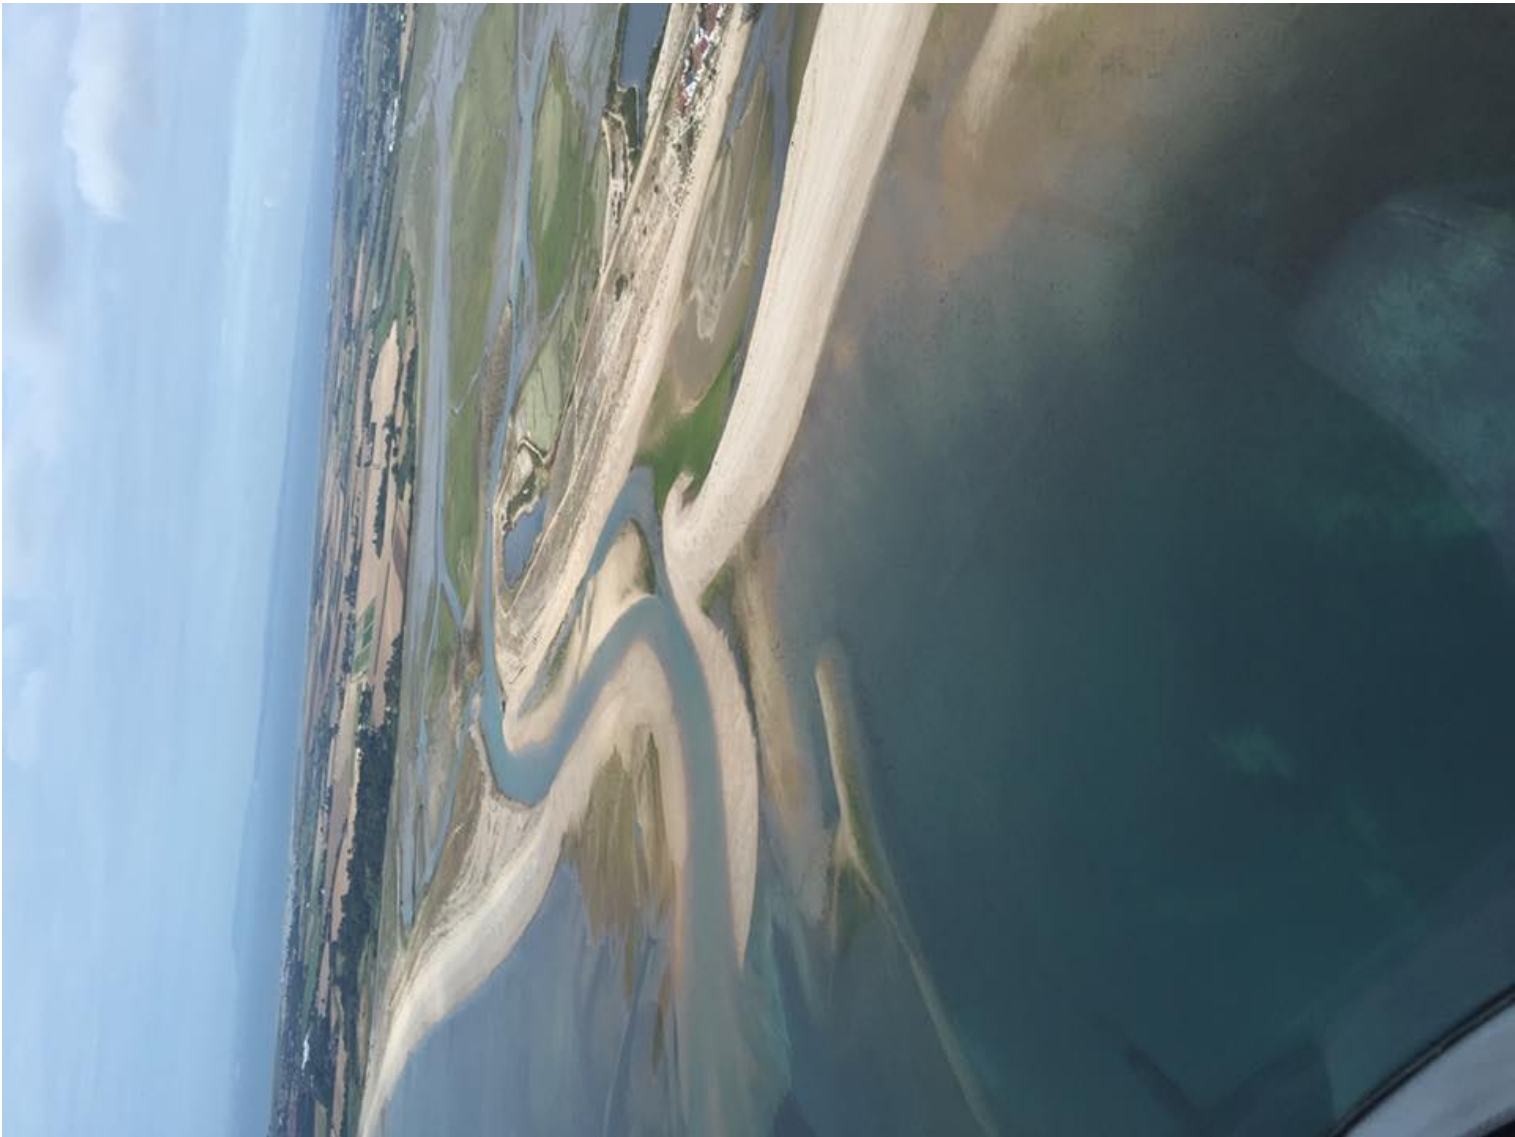
**Photograph 35** – taken August 2016

Immediately prior to the breach of CN Spit (25, 26).  
Early configuration of breach (27 to 35).

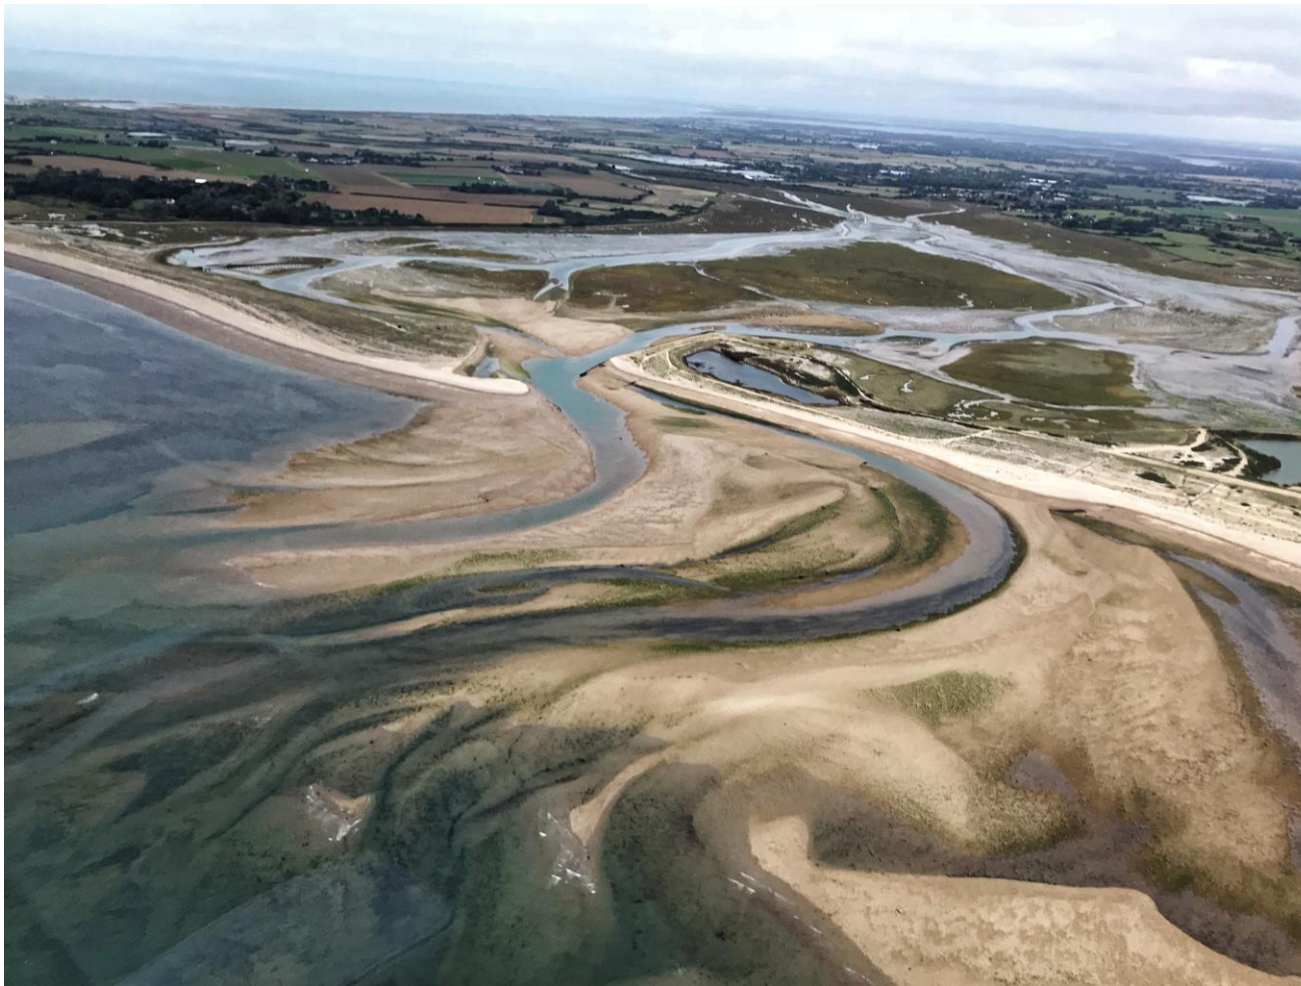
**Photograph 36** – taken February 2017

Breach has expanded back to the south-west, widening to around 350m with two distinct low water channels (36) and a third (probably relic at the time of the photograph) channel (37). Note new CN Spit development (36, 37, 38) further inshore than in the early 2000's. Delta area is now much more extensive (37, 38) alongshore. Breach channels exhibit volatility (39, 40, 41, 42) during 2017.

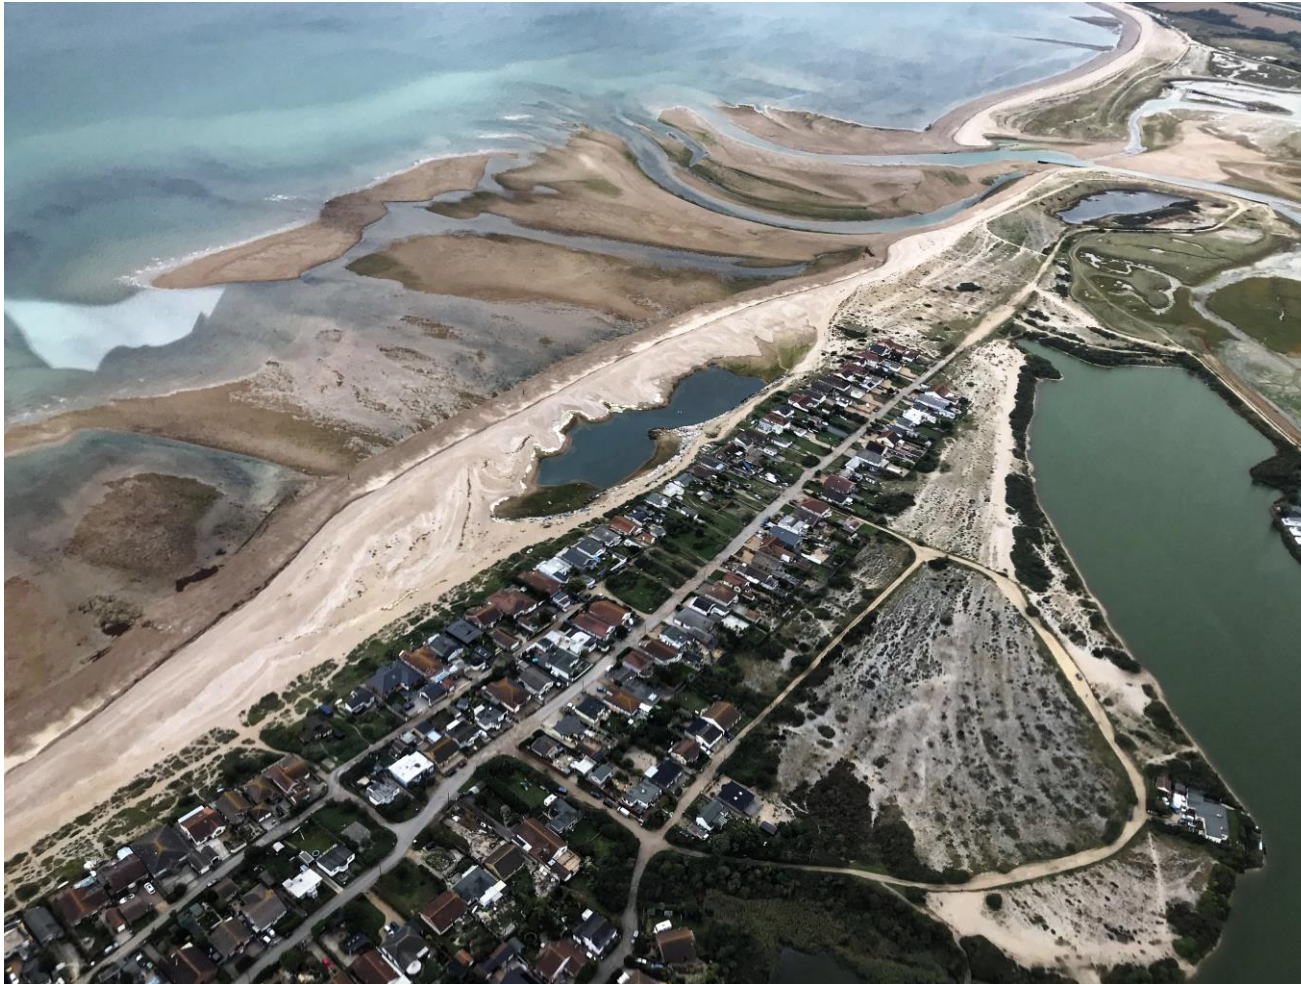
**Photograph 37** – taken February 2017

Breach has expanded back to the south-west, widening to around 350m with two distinct low water channels (36) and a third (probably relic at the time of the photograph) channel (37). Note new CN Spit development (36, 37, 38) further inshore than in the early 2000's. Delta area is now much more extensive (37, 38) alongshore. Breach channels exhibit volatility (39, 40, 41, 42) during 2017.

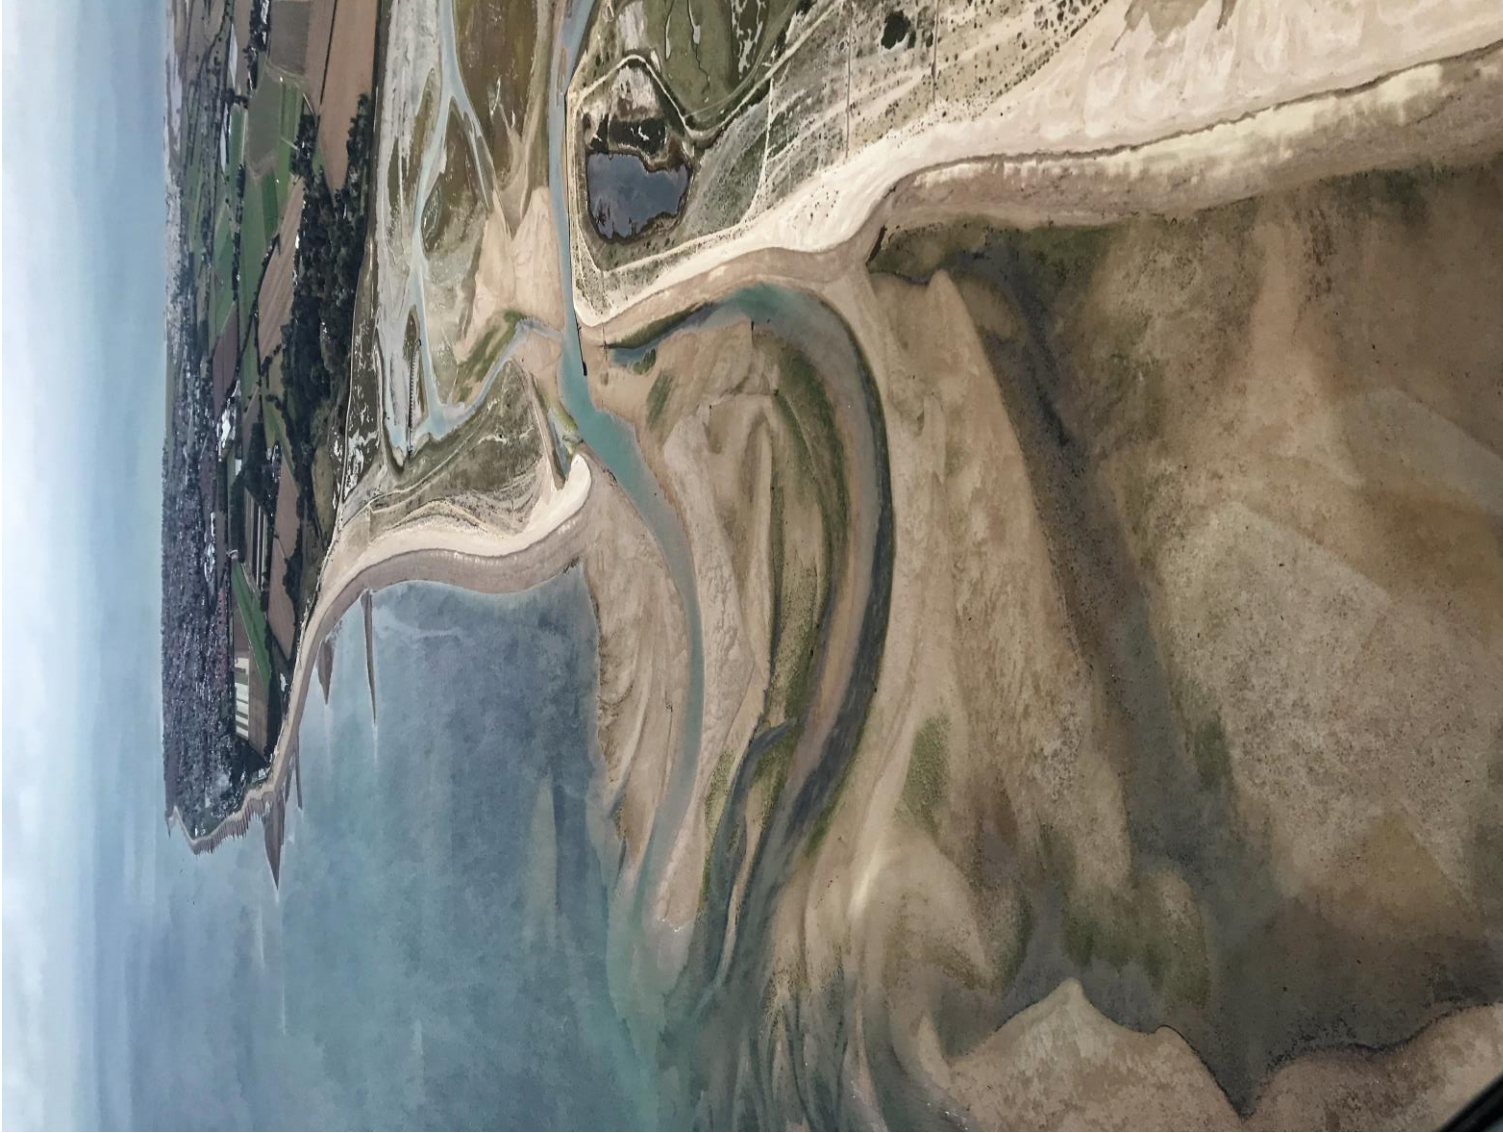
**Photograph 38** – taken February 2017

Breach has expanded back to the south-west, widening to around 350m with two distinct low water channels (36) and a third (probably relic at the time of the photograph) channel (37). Note new CN Spit development (36, 37, 38) further inshore than in the early 2000's. Delta area is now much more extensive (37, 38) alongshore. Breach channels exhibit volatility (39, 40, 41, 42) during 2017.

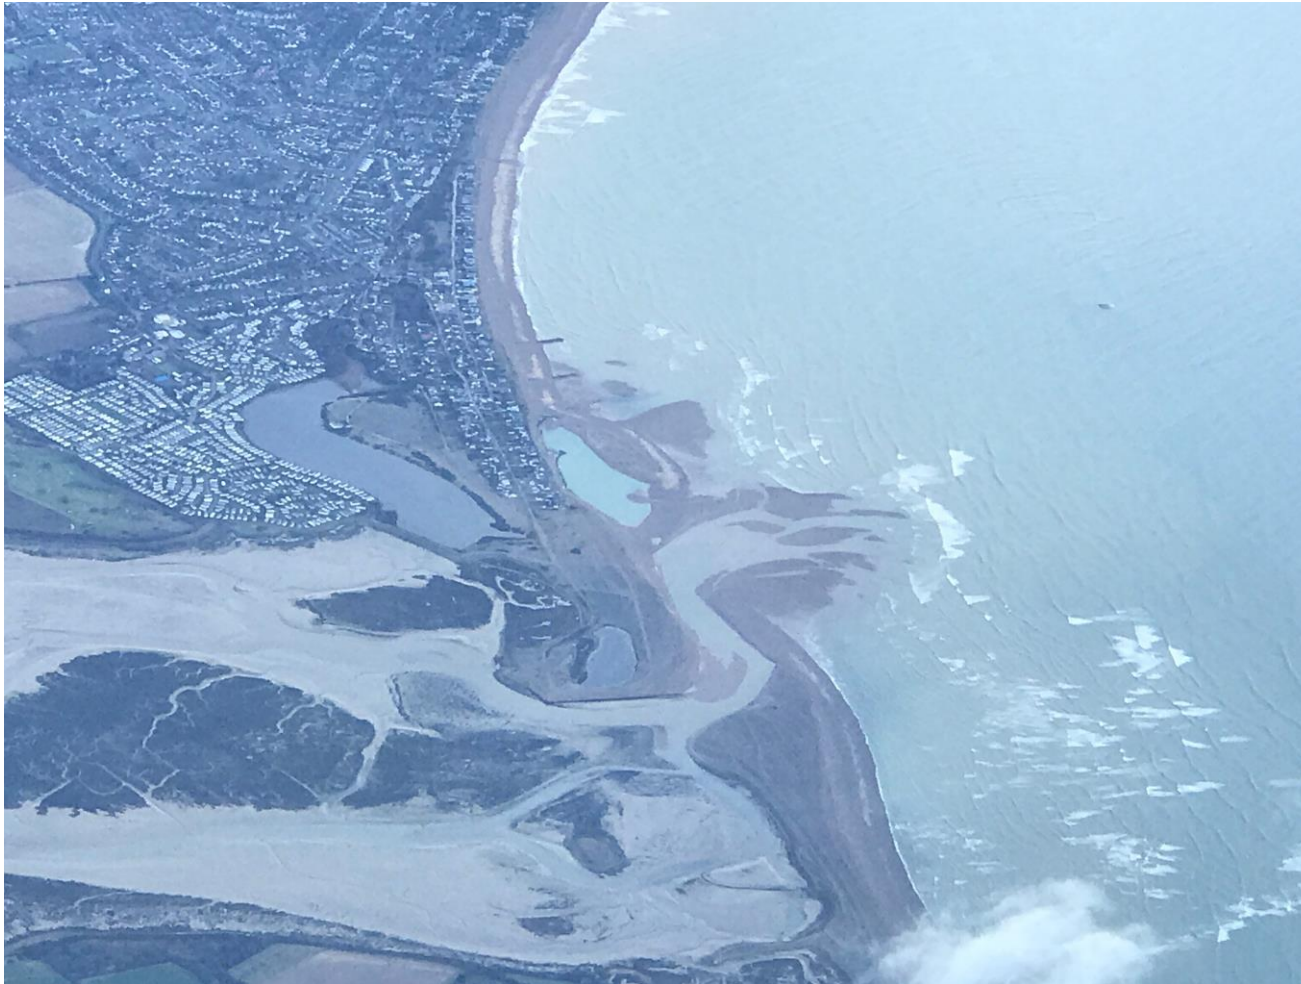
**Photograph 39** – taken February 2017

Breach has expanded back to the south-west, widening to around 350m with two distinct low water channels (36) and a third (probably relic at the time of the photograph) channel (37). Note new CN Spit development (36, 37, 38) further inshore than in the early 2000's. Delta area is now much more extensive (37, 38) alongshore. Breach channels exhibit volatility (39, 40, 41, 42) during 2017.

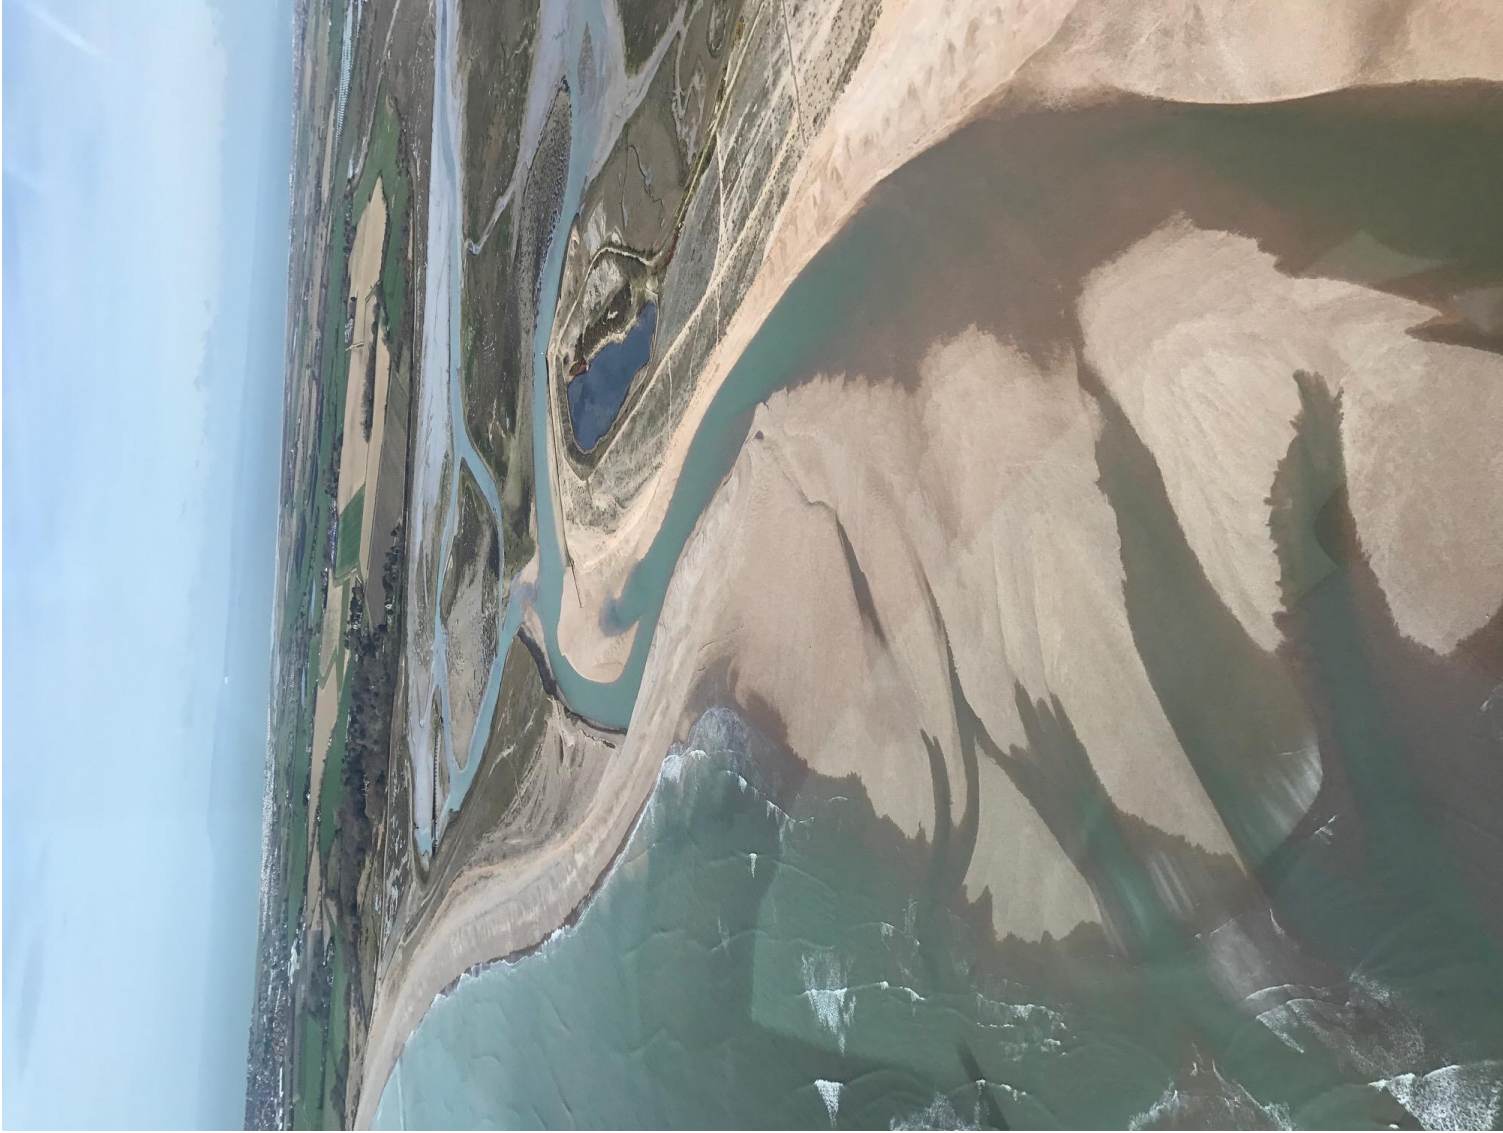
**Photograph 40** – taken March 2017

Breach has expanded back to the south-west, widening to around 350m with two distinct low water channels (36) and a third (probably relic at the time of the photograph) channel (37). Note new CN Spit development (36, 37, 38) further inshore than in the early 2000's. Delta area is now much more extensive (37, 38) alongshore. Breach channels exhibit volatility (39, 40, 41, 42) during 2017.

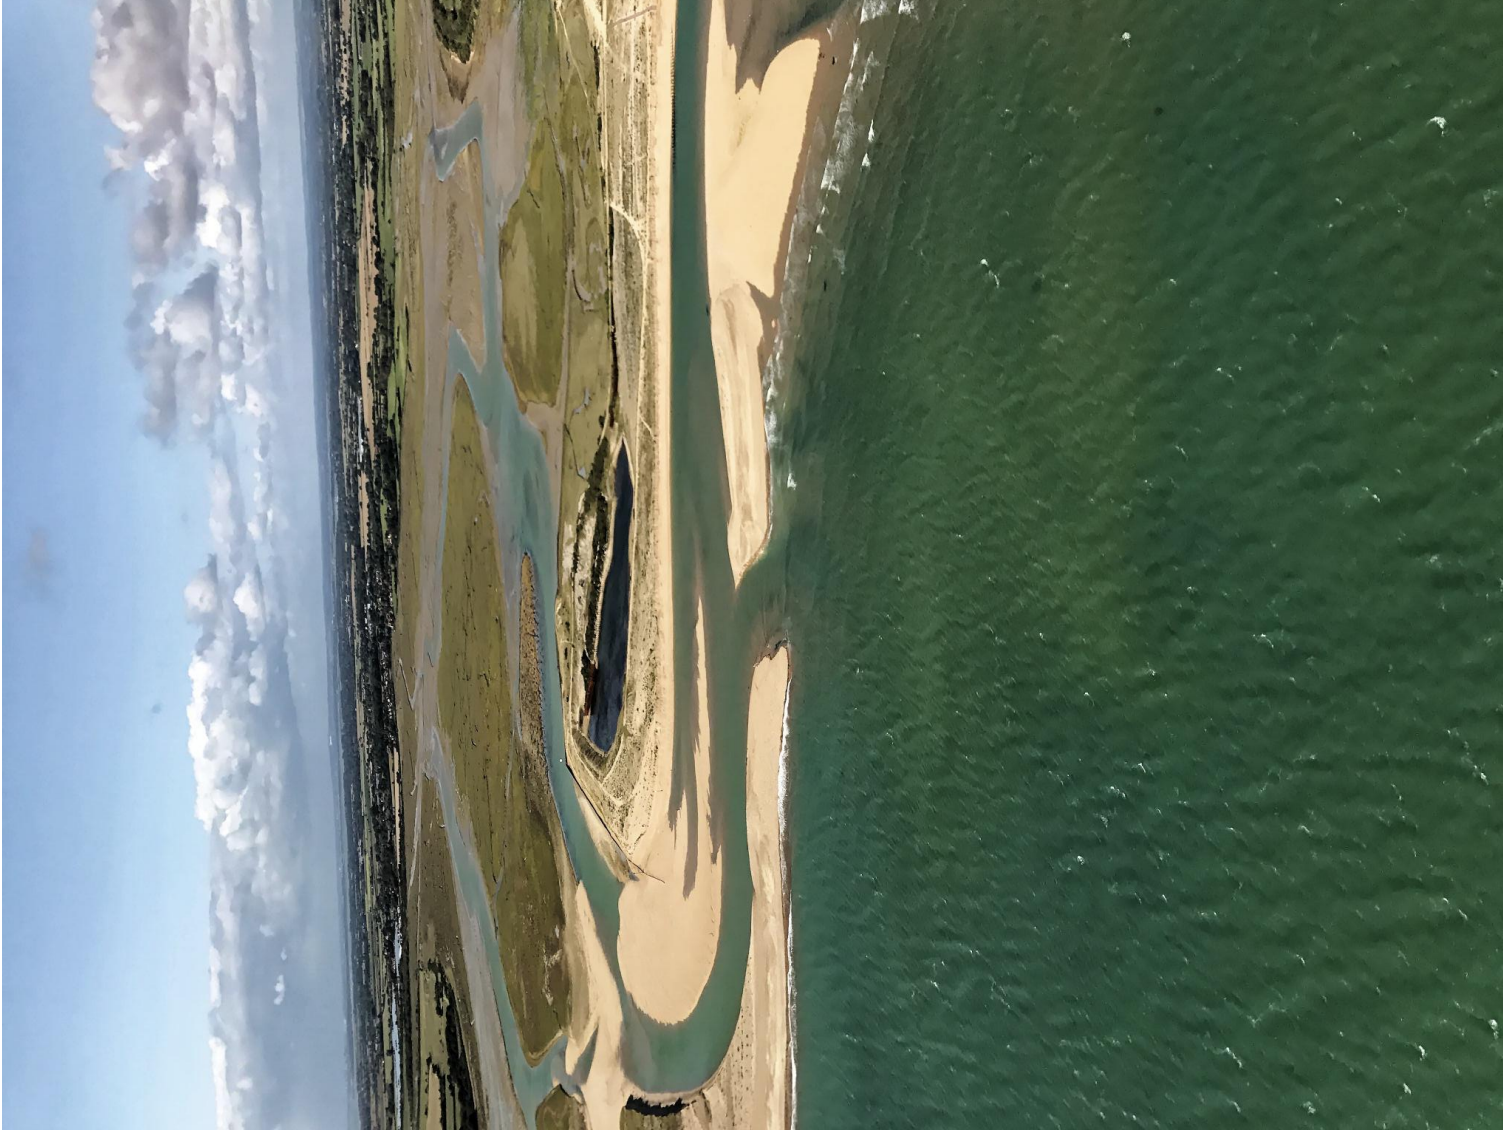
**Photograph 41** – taken September 2017

Breach has expanded back to the south-west, widening to around 350m with two distinct low water channels (36) and a third (probably relic at the time of the photograph) channel (37). Note new CN Spit development (36, 37, 38) further inshore than in the early 2000's. Delta area is now much more extensive (37, 38) alongshore. Breach channels exhibit volatility (39, 40, 41, 42) during 2017.

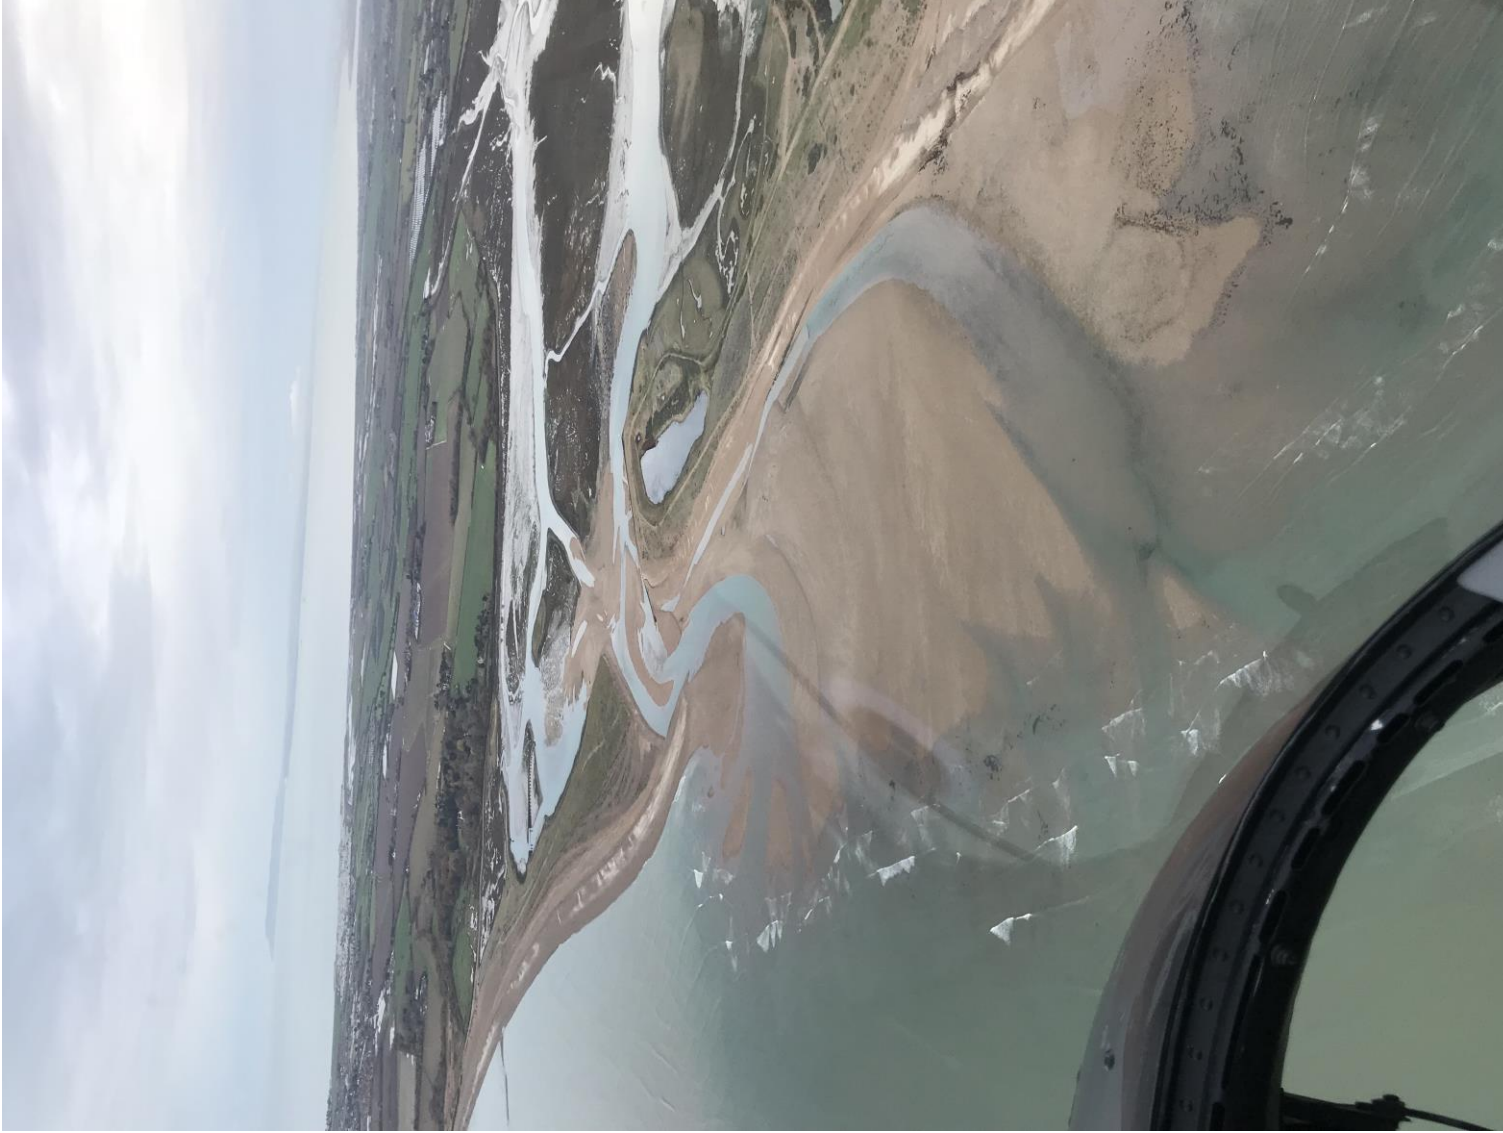
**Photograph 42** – taken November 2017

Breach has expanded back to the south-west, widening to around 350m with two distinct low water channels (36) and a third (probably relic at the time of the photograph) channel (37). Note new CN Spit development (36, 37, 38) further inshore than in the early 2000's. Delta area is now much more extensive (37, 38) alongshore. Breach channels exhibit volatility (39, 40, 41, 42) during 2017.

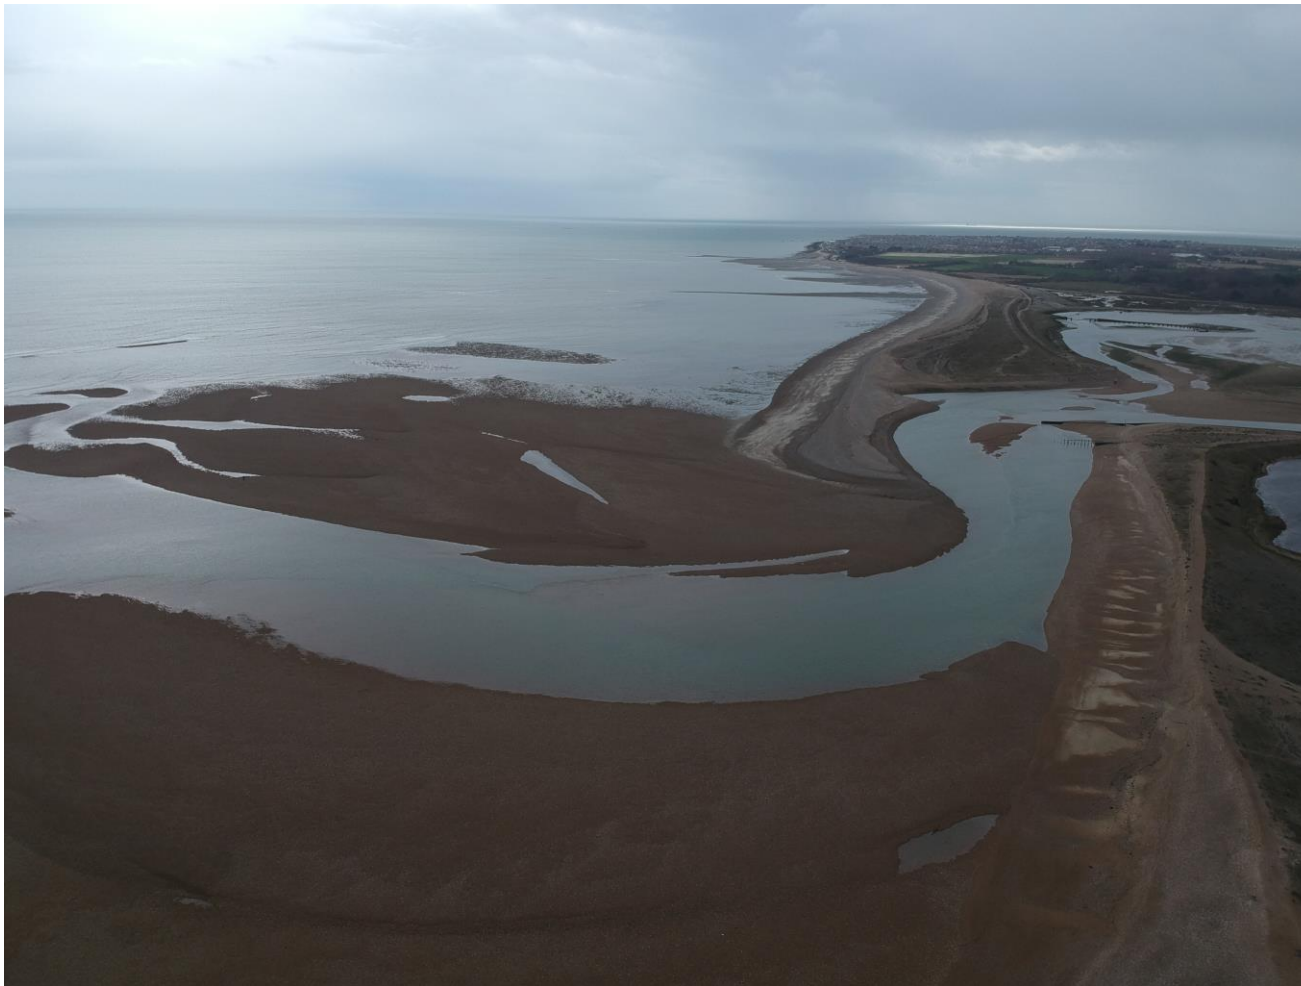
**Photograph 43** – taken March 2019

CN Spit development reaches location for realignment (43) to head towards the shoreline. Harbour outlet channel exhibits bifurcation north-east of training wall, indicating division of tidal flood and ebb flows, (43, 44). Pagham beach has eroded since 2016 as the new spit has developed closer inshore.

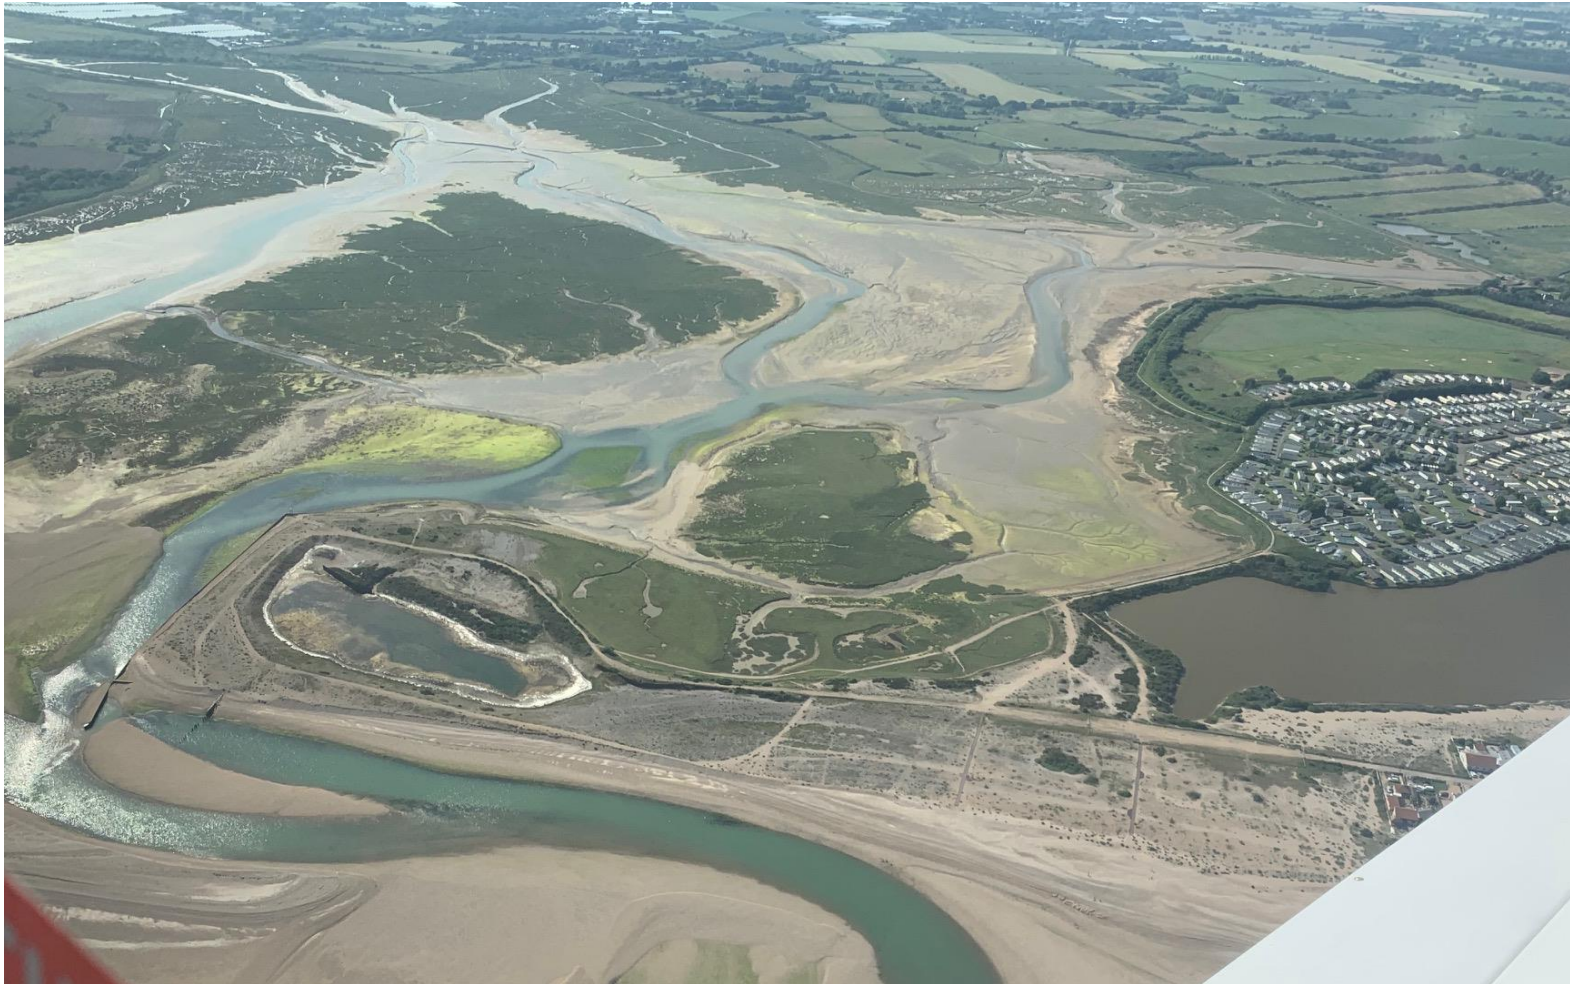
**Photograph 44** – taken July 2019

CN Spit development reaches location for realignment (43) to head towards the shoreline. Harbour outlet channel exhibits bifurcation north-east of training wall, indicating division of tidal flood and ebb flows, (43, 44). Pagham beach has eroded since 2016 as the new spit has developed closer inshore.

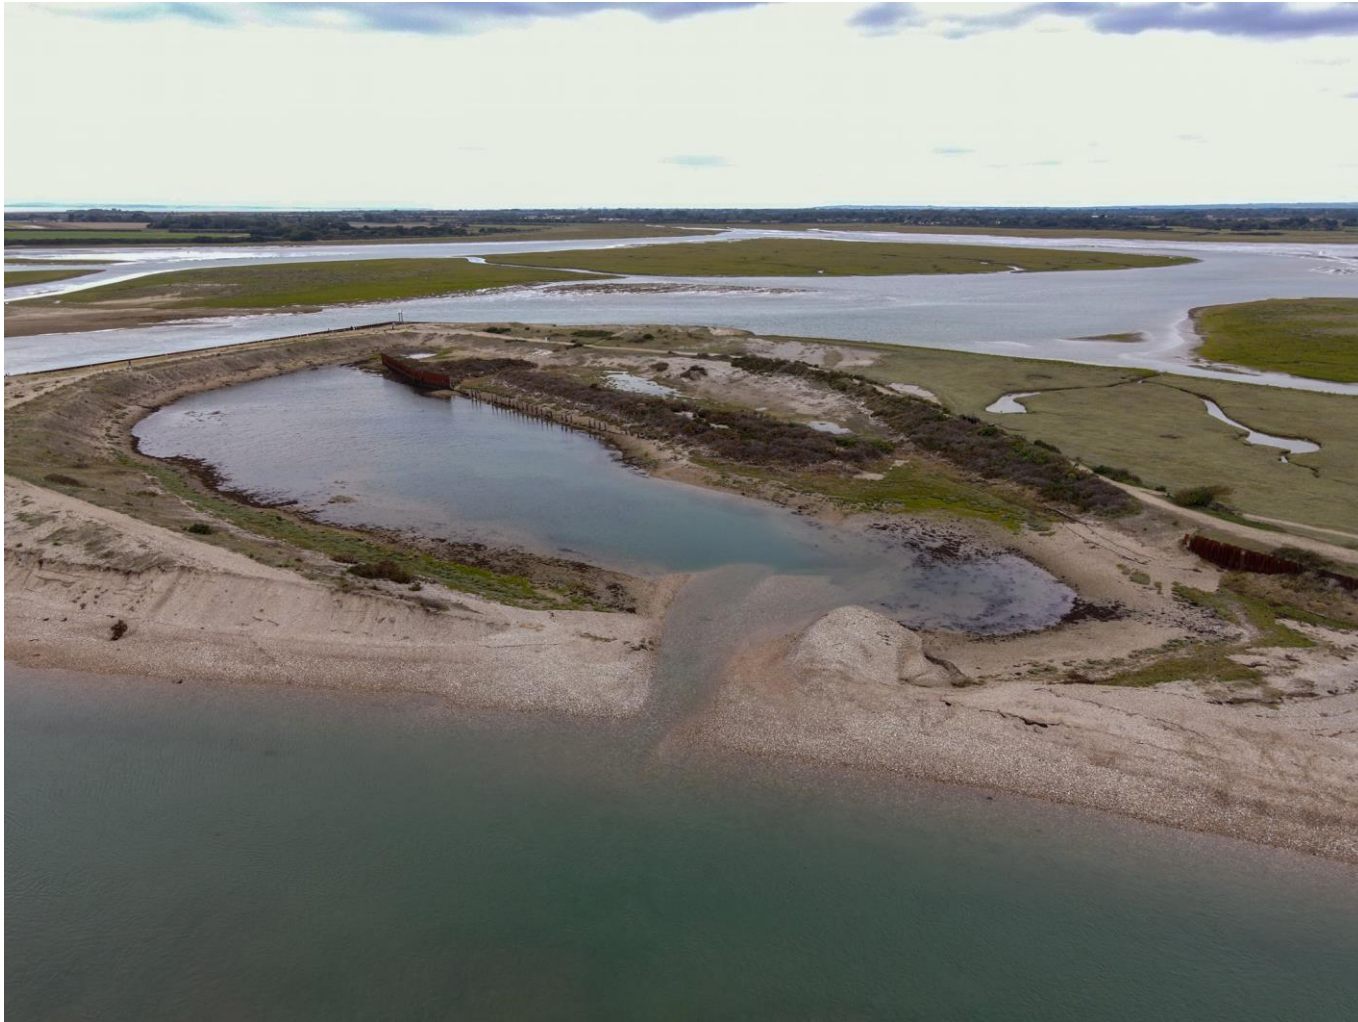
**Photograph 46** – taken 30.08.2020

With CN Spit developing closer inshore since 2016, the Pagham beach frontage has eroded eventually breaking into the Little Lagoon in 2020. (Compare with Pagham beach in front of Little Lagoon in the early 2000's (1 to 6)).
