**Appendix -** (for general location details shown in the photographs, refer to Figures 1 and 3)

## **Pagham Harbour Photographs 2001 to 2019**

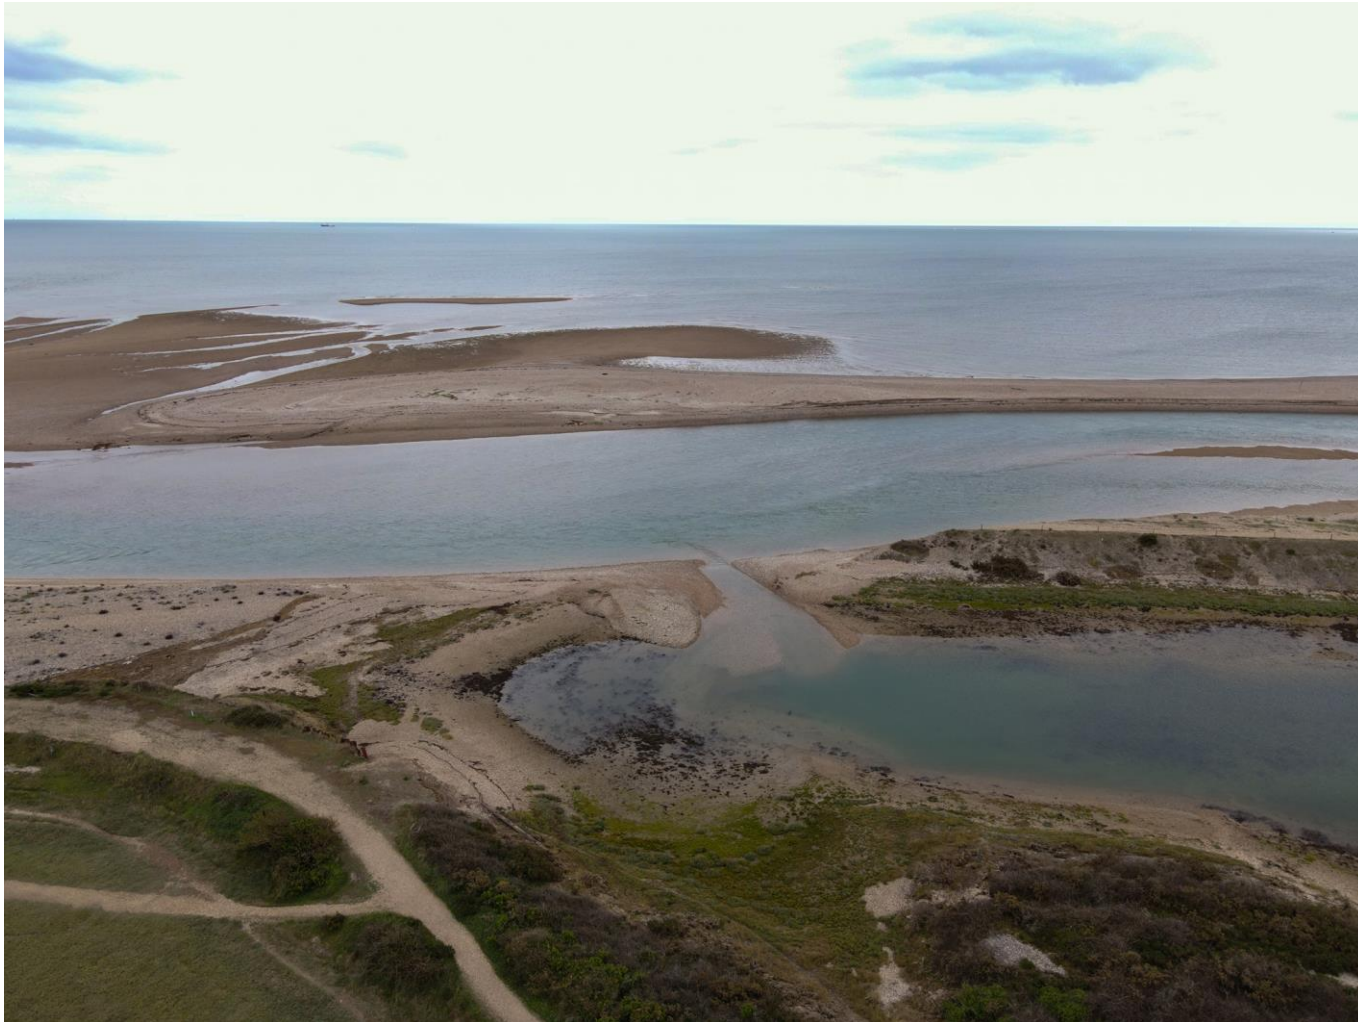
**Photograph 47** – taken 30.08.2020

With CN Spit developing closer inshore since 2016, the Pagham beach frontage has eroded eventually breaking into the Little Lagoon in 2020. (Compare with Pagham beach in front of Little Lagoon in the early 2000's (1 to 6)).
