# Managed Breach of Shingle Spit at Pagham

Further Information for Planning Application  
and Marine Licence

Pagham Parish Council

May 2016

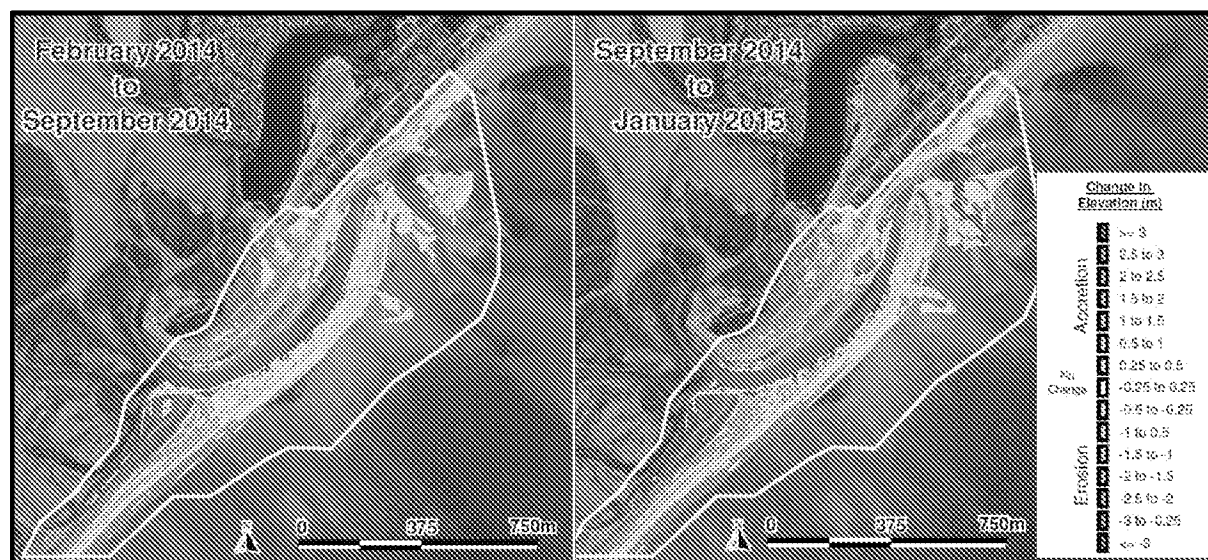
As yet unpublished maps from AWC

For this Further Information Report, additional unpublished data were provided by Adur and Worthing Councils (AWC) (James Bovington, AWC, Pers. Comm.). This data describes the beach volume changes up to 29 January 2016, and includes as yet unpublished spatial maps illustrating these changes up to January last year (2015). The most recently created maps, which describe the beach volume changes for the Pagham Harbour and western beach frontages (Coastal Unit 4dSU23) for the period from February 2014 to the start of last year (January 2015), are shown in Image 1. These maps illustrate how the end of the spit extended in a north east direction from September 2014 to January 2015 while beach material continued to be lost to the east of Groyne 3.

**Image 1. Changes to beach and spit volumes in 2014<sup>4</sup>**

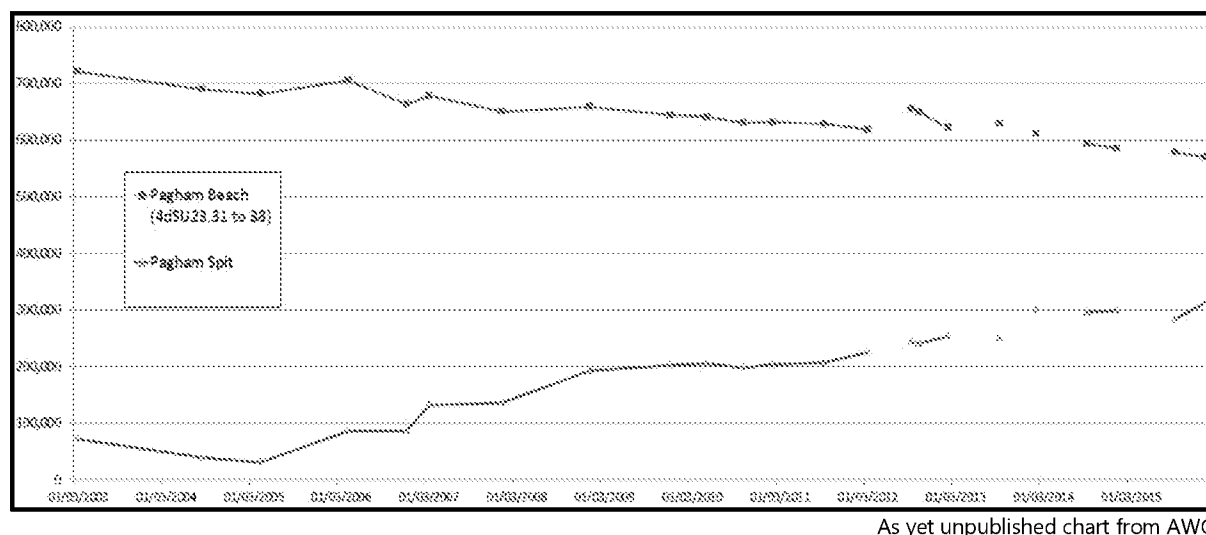
The measured beach volume calculations based on the latest survey on 29 January 2016 also indicated that the spit continued to grow throughout 2015 and that there was continued beach loss along the Pagham Beach frontage. The data shows that since February 2014 the western section of Pagham Beach has lost 40,283 m<sup>3</sup> and the spit has exhibited a net growth of 11,583 m<sup>3</sup>. Over just the last winter alone (September 2015 to January 2016) the beach lost a further 7,438 m<sup>3</sup> and the volume of spit growth was 29,069 m<sup>3</sup>. A chart describing the relative volume changes from 2003 to early 2016 is shown as Image 2.

**Image 2. Changes to Pagham beach and spit volumes (y axis/m<sup>3</sup>) over time (x axis/year)**

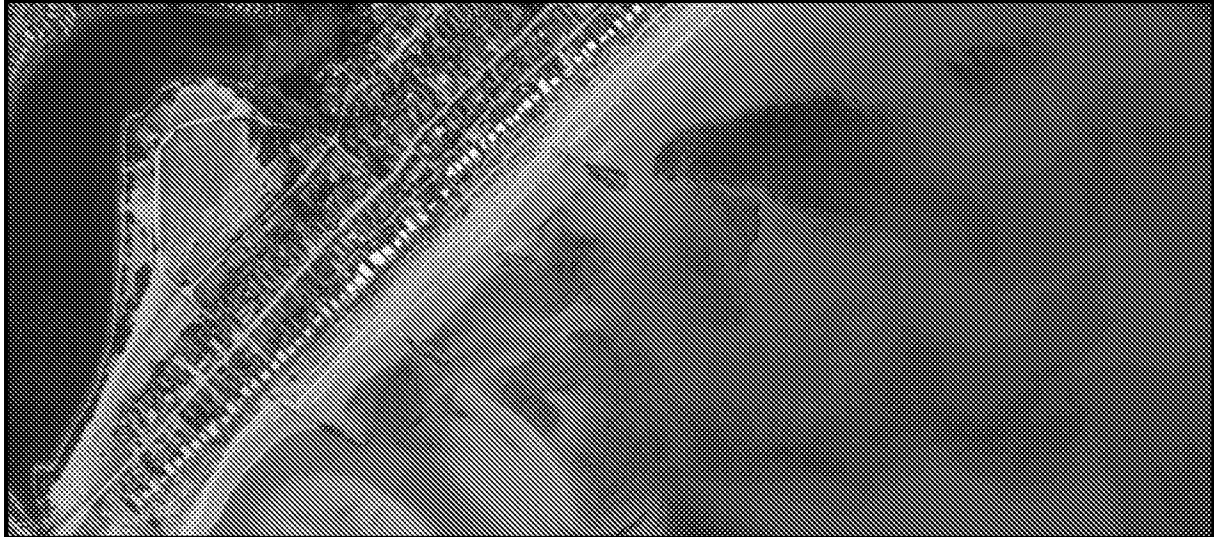
Partial image from Figure 6.6 from ES (ABPmer 2015a)

**Image 3. Location of houses vulnerable to erosion or flooding (West Pagham Beach only)**

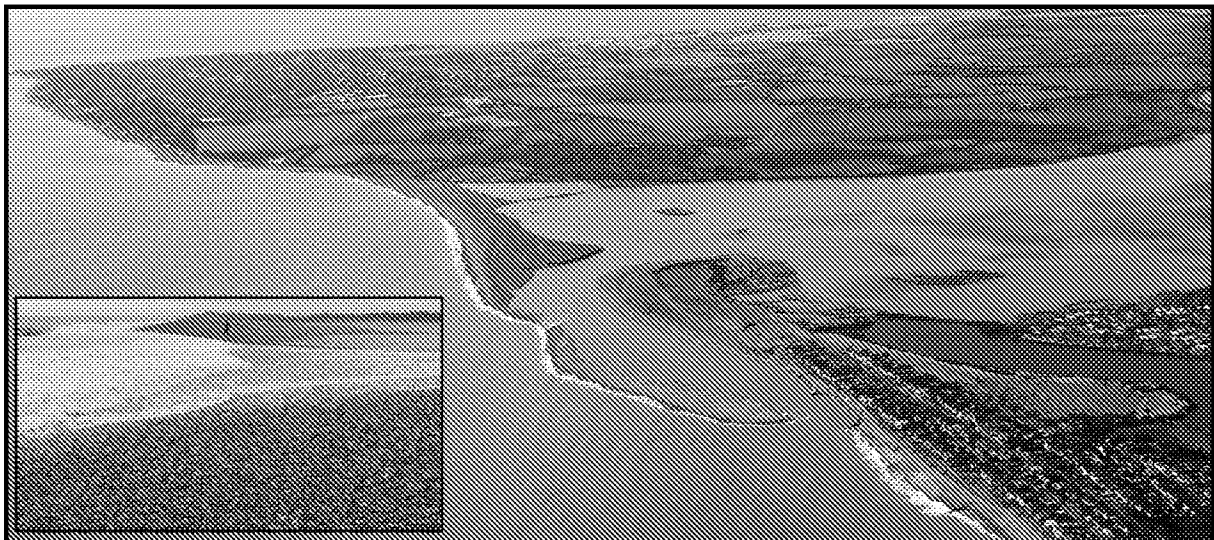
Source: Aerial John Akerman 23 February 2016; inset ABPmer 20 February 2016

Towards the very end of January, there were early signs of a change to the spit morphology with signs of some roll back occurring along a central section. This presaged a process of change which then occurred over the course of February and March. By early February 2016 the central section of the spit 'slumped' along approximately a 90-100 m wide section and high-water exchange began to occur across this section (see Image 4).

**Image 4. View of the spit and high water at Pagham in February 2016**

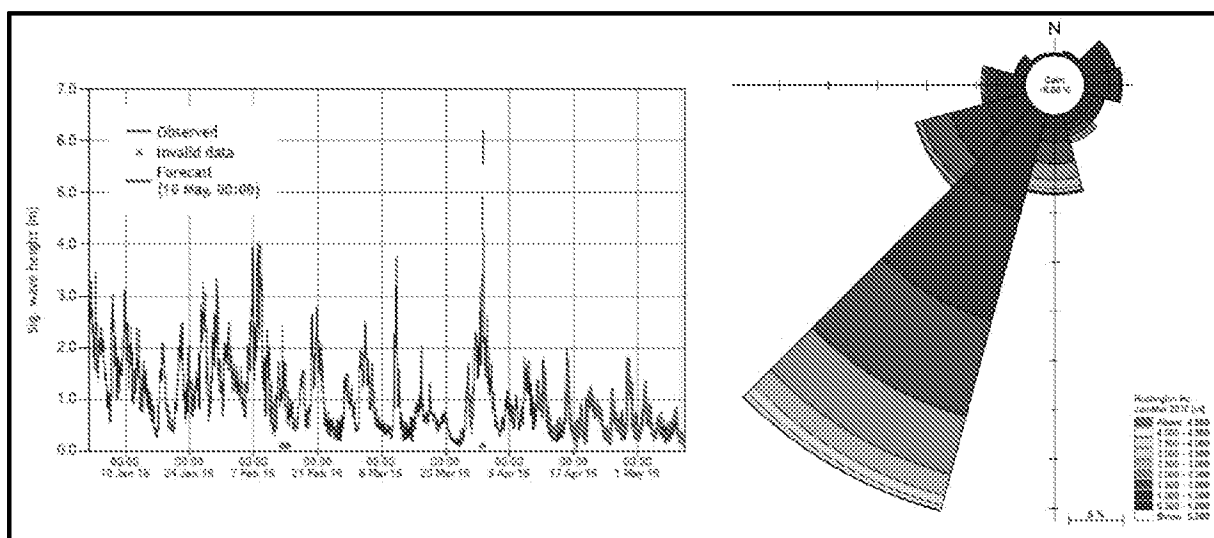
Source: [www.channelcoast.org](http://www.channelcoast.org)

To illustrate the frequency and nature of the storms over this period, significant wave height data from the Rustington buoy is shown in Image 5. This data indicates that while most waves approach from the south west (as is typical) over the last few months, the wave directions have been highly variable during the storms and some of the largest ones (e.g. during Storm Katie) came from the south.

**Image 5. Data from the CCO Rustington Wave Rider (January to May 2016)**

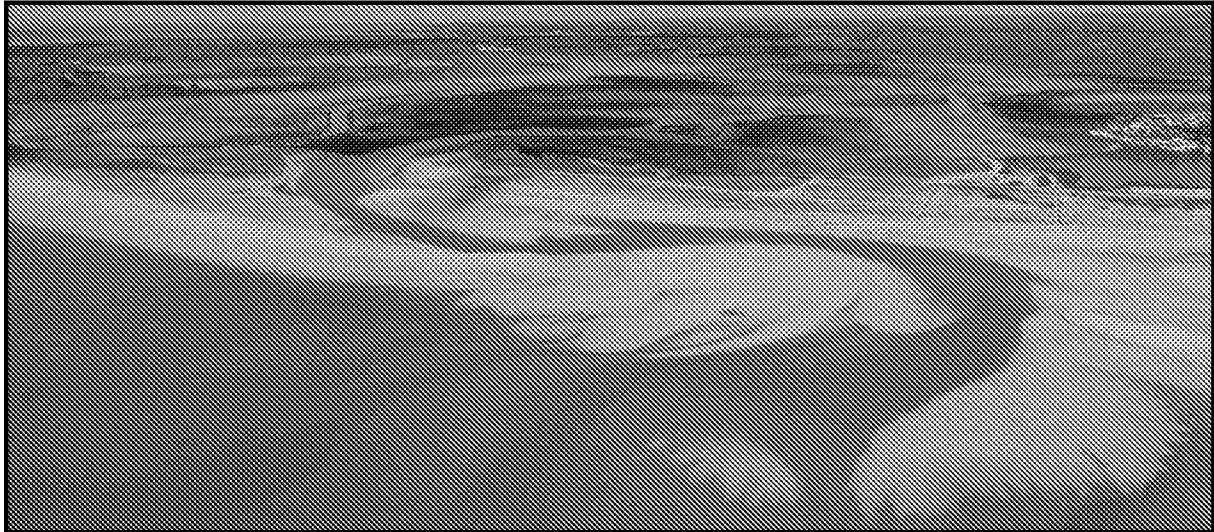
Source: Sussex by Air, 30 April 2016

All potential outcomes are dependent upon factors such as the weather/storm conditions and the supply of shingle. However, as things currently stand in early May 2016, the S-shaped channel is maturing and 'seeking' a more sinusoidal shape. In doing so, this is causing further cliffing and erosion on the Pagham Beach/Spit foreshore and on the spit immediately fronting the training wall and Little Lagoon. This erosion is expected to continue during summer 2016 and possibly much longer depending on the way in which the site develops.

**Image 6. View of the new breach and channel at low water in late April 2016**

This new configuration has created a condition for future shoreline evolution that the proposed managed breach fits even more clearly into. This is because the proposed managed breach will be placed in the area where the channel is now trying to erode the spit (while also shortening the channel directing the flows away from the coast) and in doing so will help to stabilise the morphology.

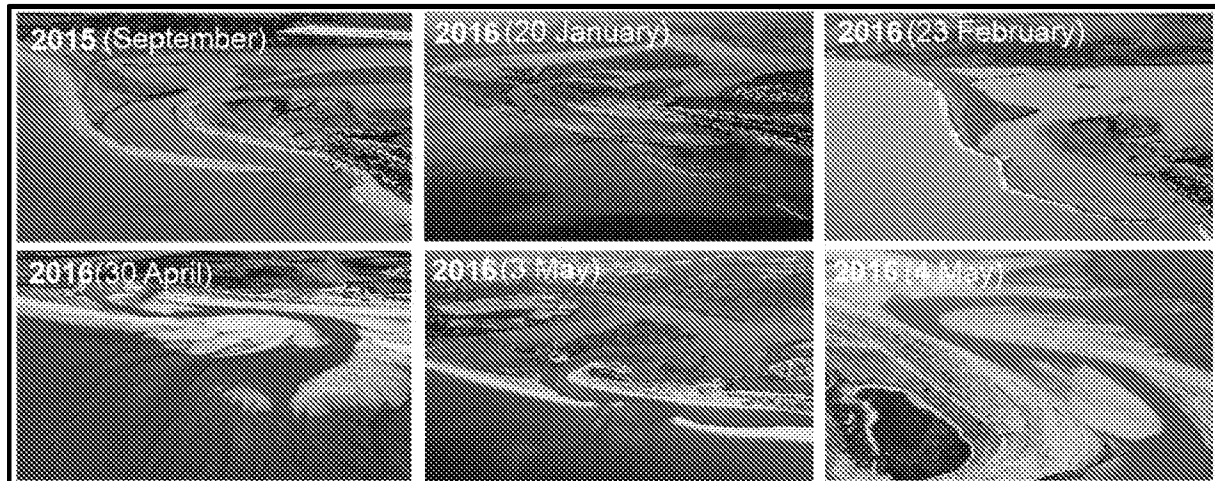
Source: John Akerman; Sussex by Air (30 April 2016); CCO (4 May 2016)

In addition to demonstrating the reason why this work was being promoted in the first place, the changes that have taken place have provided further confidence that such a breach is self-maintaining. What exists on site now is another distinct configuration (in addition to the many that have existed, and been recorded, over the past 400 years<sup>5</sup>) which has not closed up either in this new morphology or in any of the intermediate configurations that took place as it adjusted towards it over the last three months. Instead, throughout this period tidal, exchange between the harbour and coast has been maintained.

**Image 7. Views of the spit and breach over the 2015 to 2016 period**

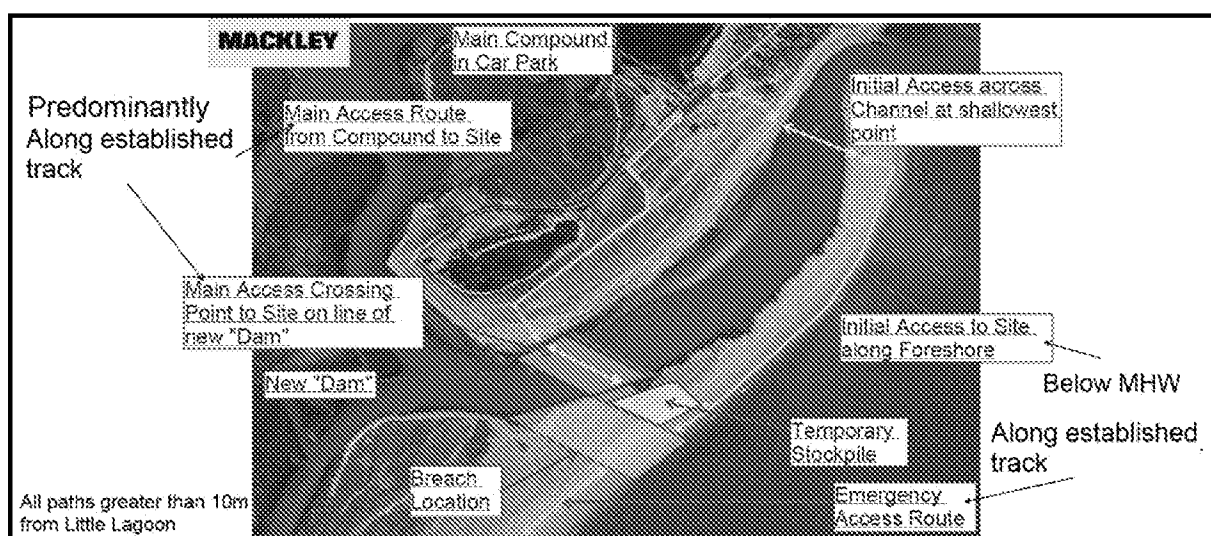
Source: Mackley Construction Proposals, Appendix D, ABPmer 2015a

- » **Plant Routes:** The proposed plant route map shown in Appendix D of the ES is reproduced as Image 8. For this plan the routes were aligned along existing paths or along the un-vegetated sections of the spit below mean high water to ensure that there is minimum damage to areas with vegetation. Adopting this approach will also keep plant away from newly formed shingle ridges (except at the construction areas) which are of geological interest and will keep plant more than 10 m away from the Little Lagoon (see Image 8). This basic plan still applies following the recent physical changes on site. For instance it has been confirmed (following recent advice received from a second expert contractor) that plant access can still be from the distal end of the separated spit and then through the new breach at low water (over the ebb delta). Adoption of this route will avoid damaging vegetated shingle areas and locations of geological interest.

**Image 8. Construction access route map based on site morphology before March 2016**

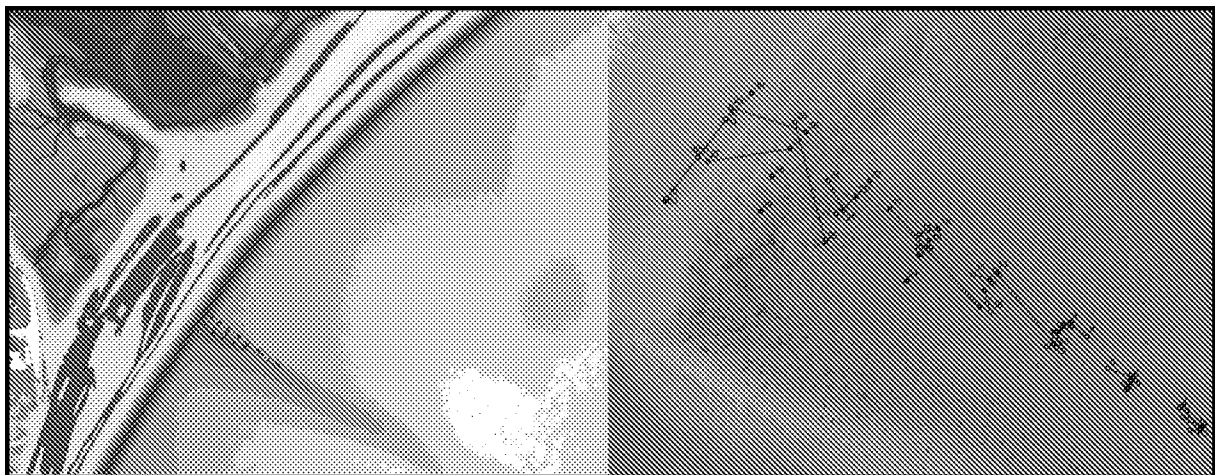
Source: Environment Agency LiDAR 2015 with University of Sussex Shingle tracking data 2016

One example of other research which may provide valuable insights includes a study by the University of Sussex. It is currently conducting shingle/pebble tracking work under a SCOPAC (Standing Conference on Problems Associated with the Coastline) R&D project initiated by the Environment Agency, CDC and ADC. Recent results have shown how rapidly pebbles can move landward (Prof. Cherith Moses, Pers. Comm.). This is illustrated in Image 9, which demonstrates results of a recent (24/25 April 2016) tracking exercise conducted along a spur feature. Hypotheses on the relationships between wave energy conditions, shoreline location and pebble size are being evaluated through this investigation.

**Image 9. Location of shingle tracking work on a shingle 'spur feature'**

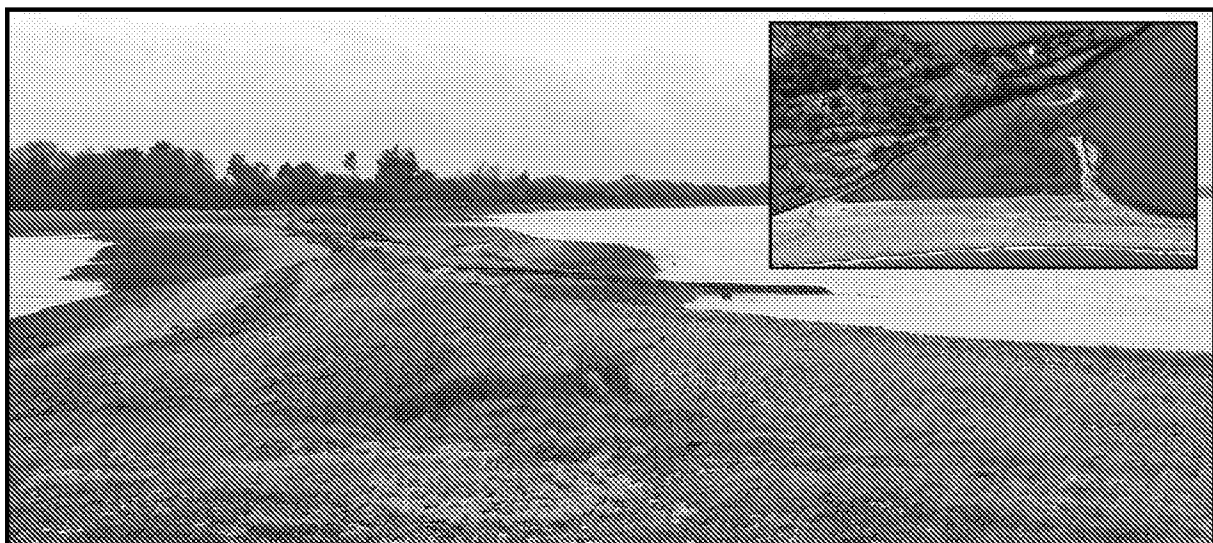
Source: ABPmer 20 February 2016; inset/aerial John Akerman 7 February 2007

In addition ABPmer visited the compensation site with the RSPB on 28 April 2016 to review the conditions and agree the design detail. Following these written exchanges and subsequent discussions, updated scheme designs for this compensation site have been prepared. Illustrations of the design are shown in Figures 3 and 5. Further details about the location in which this work would be carried out and the design are presented below and Images 10 and 11.

**Image 10. View from the south east (seaward) end of the proposed New Tern Island**

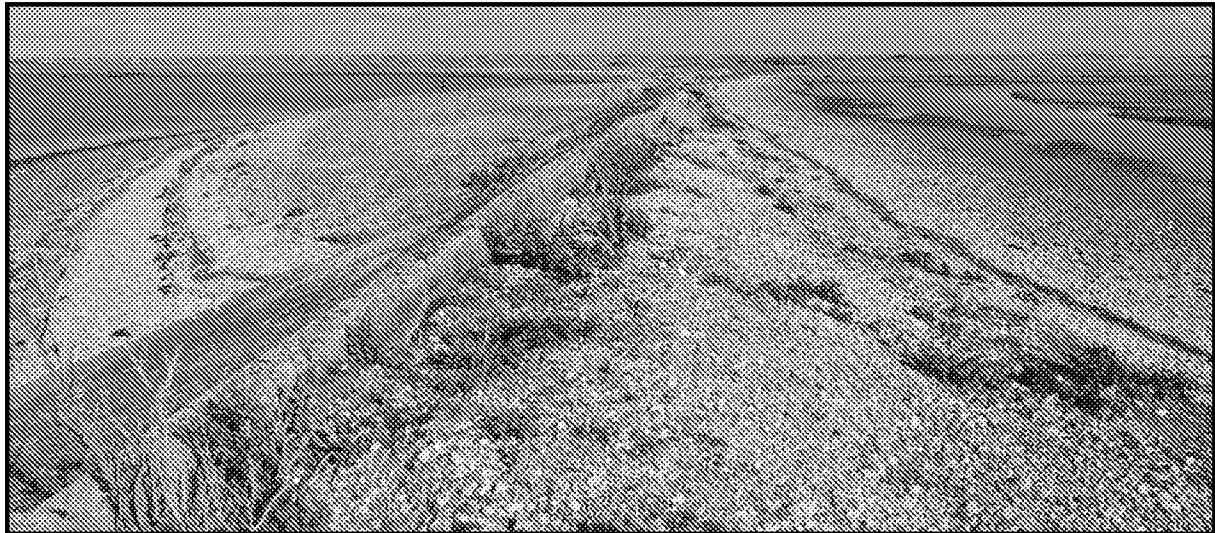
Source: ABPmer 28 April 2016

Natural England has also asked whether the island can be made slightly larger and efforts have been made to do that, although on site there is very little room for horizontal adjustment. To try to achieve this, the channel (to be excavated on the south-east side of the island) has been moved very slightly further to the south-east.

**Image 11. View from the north west (landward) end of the proposed New Tern Island**

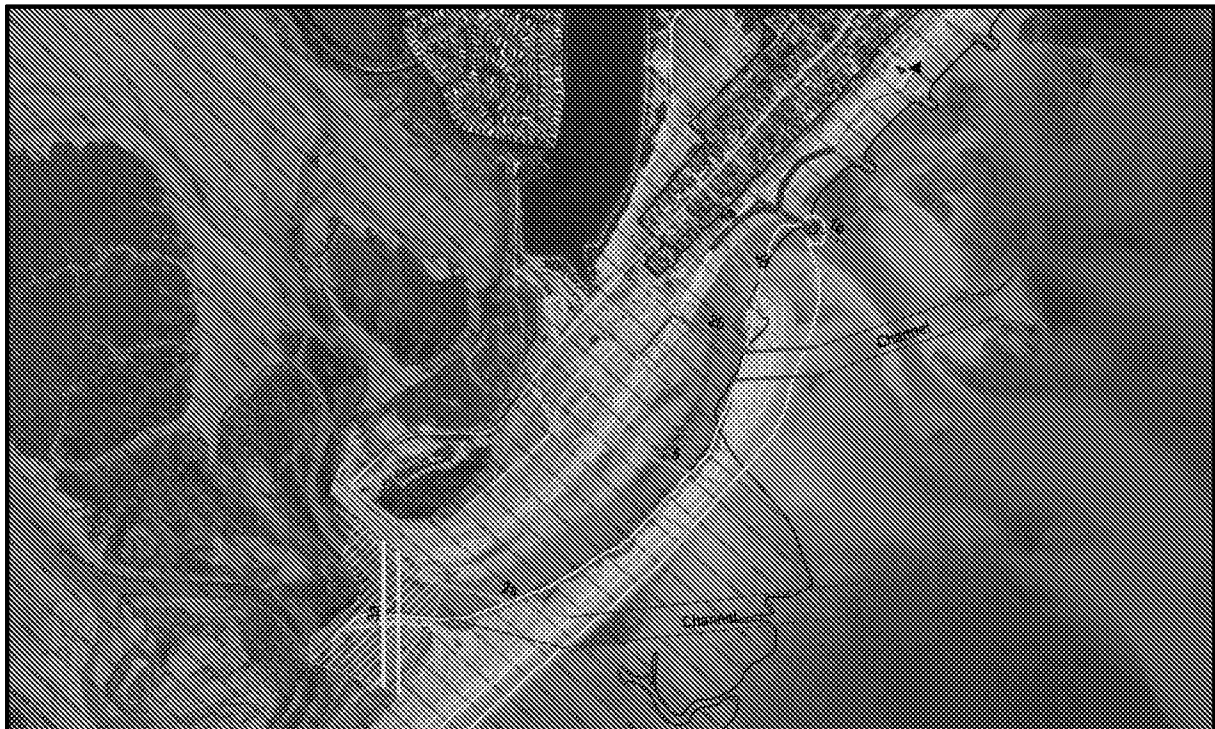
(Source: Aerial Image Channel Coastal Observatory)

2. **Breach and training wall** (not applicable for HRA because more damaging than proposal): As this would involve a managed breach (assumed here to be approximately at the location proposed for the community project (as per Option 2a in Image 12) it would deliver a number of the coastal protection benefits as well as some amenity value by supplying shingle and diverting inlet/outlet flows away from the coastline. However, the introduction of a large training wall to try and pin the breach in place will risk longer term problems along the shoreline and will damage the naturalness and functioning of the European/International Sites. This approach also not achieve the more sustainable multiple benefits approach offered by the community proposal.

**Image 12. Schematic view of alternative options which mainly involving some form of revetment (with published boundary of the SPA/Ramsar as hatched purple)**

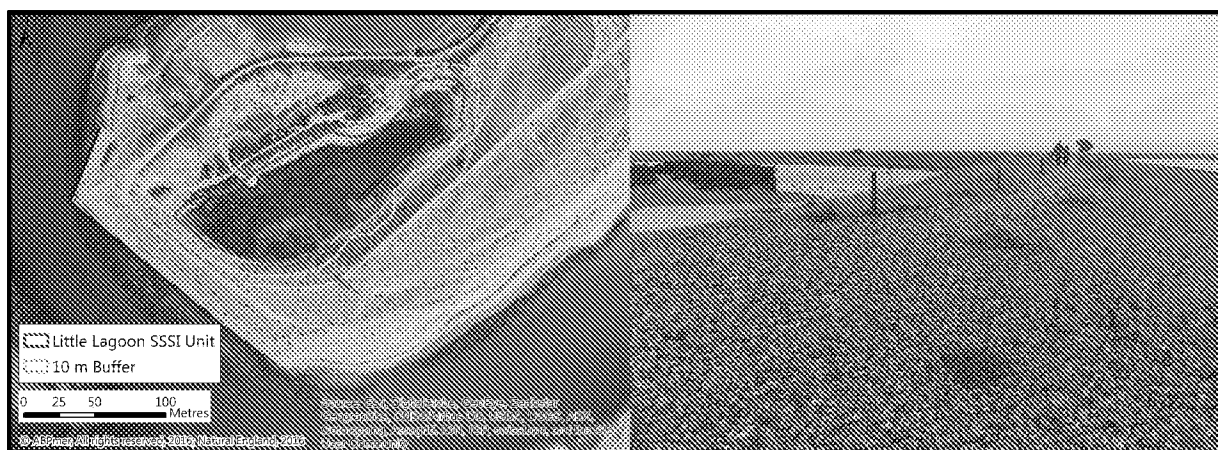
(Source: Photo ABPmer 13 Oct 2014)

In order to mitigate this risk, in its further advice issued on 26 April 2016, Natural England specified that 'this impact could be avoided by having a construction buffer zone of between 5 m to 10 m around Little Lagoon (there is a fence line already in place) and using existing track ways and paths, not turning vehicles on the shingle but reversing back along existing tracks.' The Little Lagoon already has an access exclusion fence around it (some 10-15 m from the lagoon edge) and it can be confirmed that plant will remain at least 15 m way from the Little Lagoon. Image 13 below shows that a minimum 10 m buffer will automatically be observed as all the tracks around the lagoon are at least that distance from the lagoon.

**Image 13. Existing exclusion fencing (right) and 10 m buffer zone around Little Lagoon (left)**

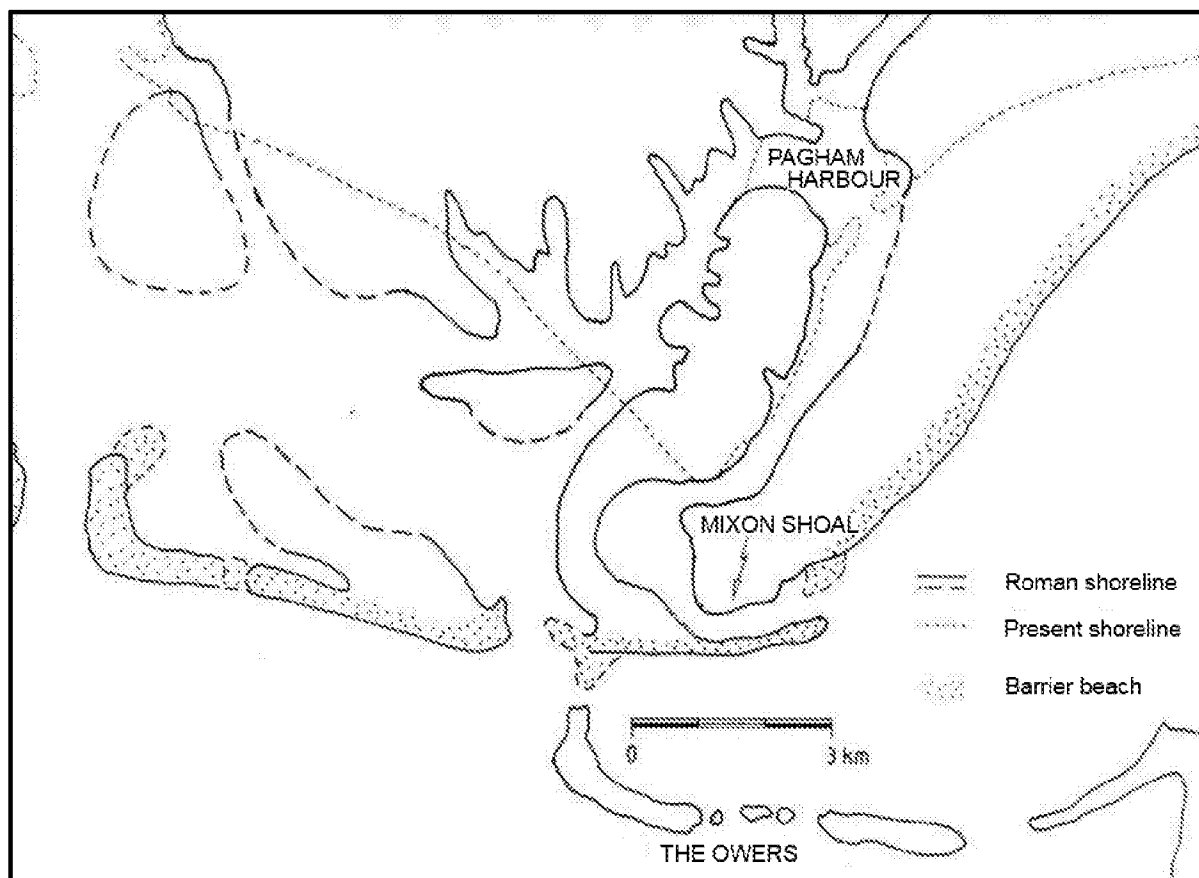
Source: Royal Haskoning, 2009 - after Wallace, 1996

Image 14 presents a probable configuration of the Selsey to Pagham coastline approximately 2,000 years BP, delineated using archaeological information and by tracing a submerged wave cut platform (Wallace, 1990, 1996; quoted by Royal Haskoning, 2009).

**Image 14. Selsey and Pagham coastline 2000 years BP**

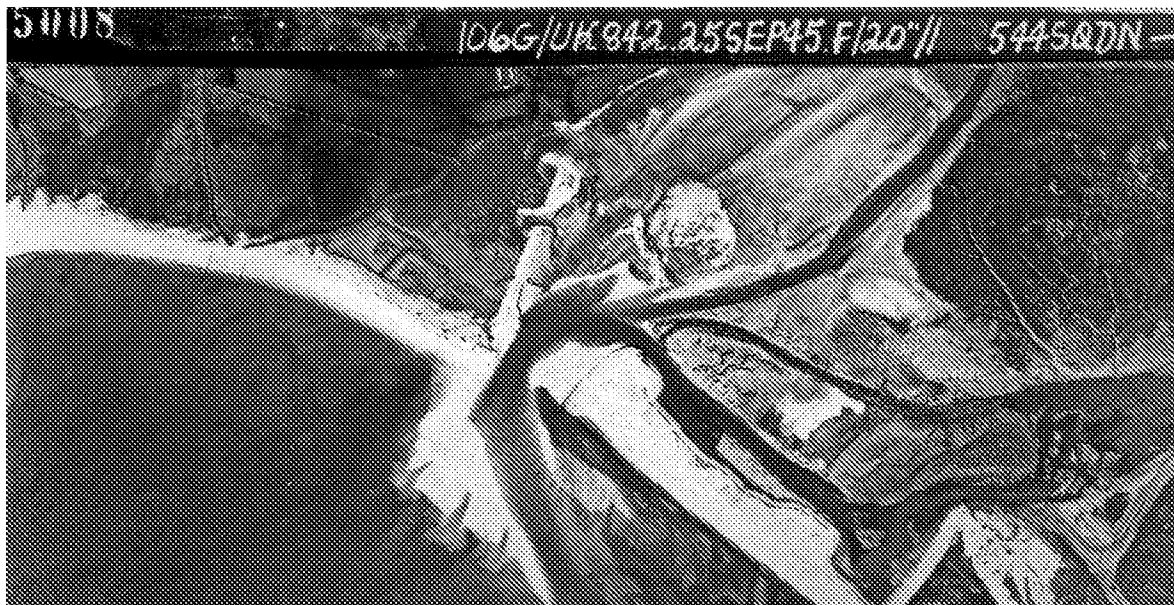
In 1876, the inlet was artificially closed and the mudflats within the harbour claimed for pasture land (Robinson and Williams, 1983). In 1910, the shingle ridge was breached by a large storm towards the southern Church Norton side of the harbour (see Figure 6.2 of the ES). In the years since then, the position and size of the inlet continued to change greatly in response to anthropogenic and natural factors (see Figures 6.2 and 6.3 of the ES). In 1937, a new breach entrance in the south, near Church Norton, was created (see Image 15). This was supported by two training walls on either side of the new breach. In the mid-1950s, the spit was breached and the inlet subsequently migrated by 900 m to the north. In 1963, a training wall was introduced at the new location to stabilise the entrance; this situation was largely maintained subsequently (Bray *et al.*, 2004). Over the period from 1969 to 1997 the area generally remained relatively 'stable', aided by regular reshaping by the flood risk authority (up to 2004) (Royal Haskoning, 2009; Dornbusch, 2014; Bray *et al.*, 2004).

**Image 15**      **The southern entrance in 1945**

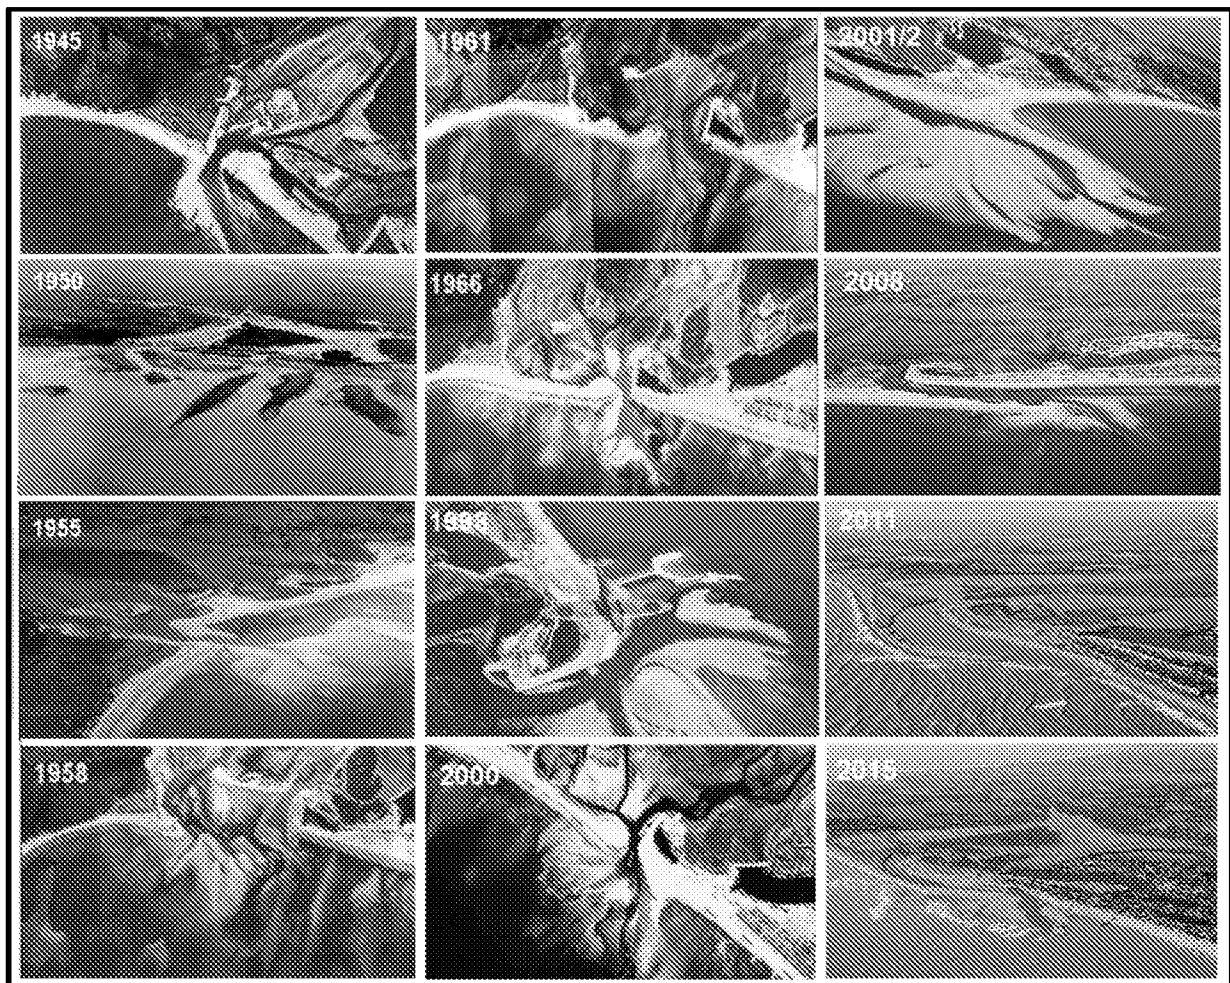
**Image 17. Changing configurations of the spit, inlet and delta complex**

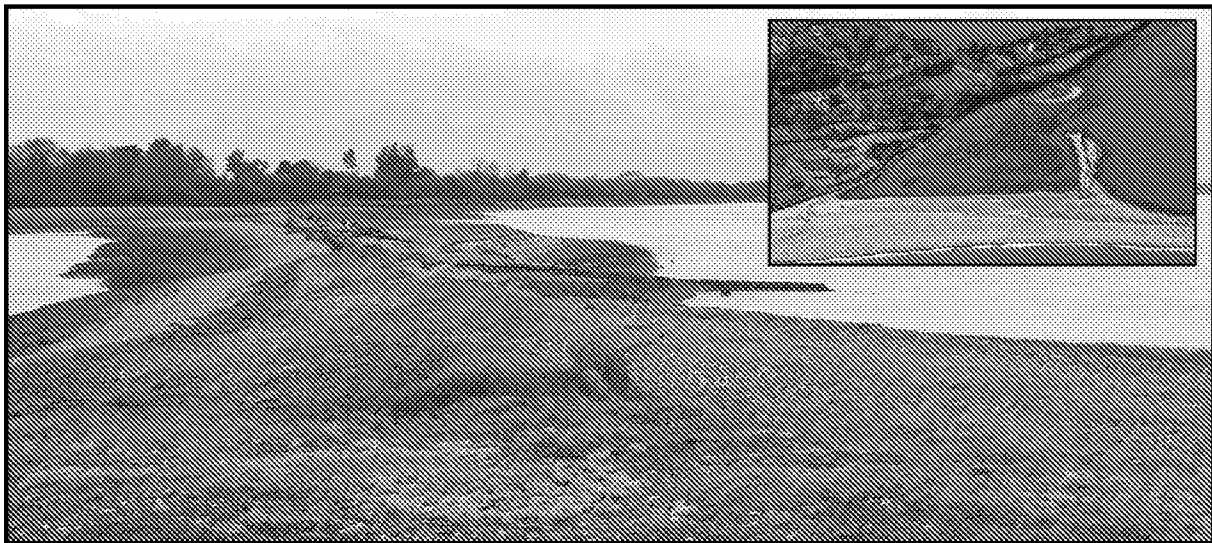
Source: ABPmer 20 February 2016; inset/aerial John Akerman 7 February 2007

In order to provide compensation for the potential reduction in Little Tern breeding habitat, the creation of an additional breeding island in the harbour is proposed. The design for this island is described in additional detail in Section 1.5.6. This is to involve covering the remnants of the westerly 1937 training wall shown in Image 18 with gravel (approximately 1 m on average, and up to 1.5 m), and cutting a 20 m-wide channel between this island and the Church Norton Spit to a depth of -0.5 mODN. This would involve excavations of around 3.5 m in depth, as can be seen in the profiles provided in Figure 5 of this further information document. The top layer measuring some 1.7 m in thickness would consist of shingle thought to have largely been deposited around the time of the training wall construction, and below this would be estuarine mud.

**Image 18.** View from the south east (seaward) end of the proposed New Tern Island

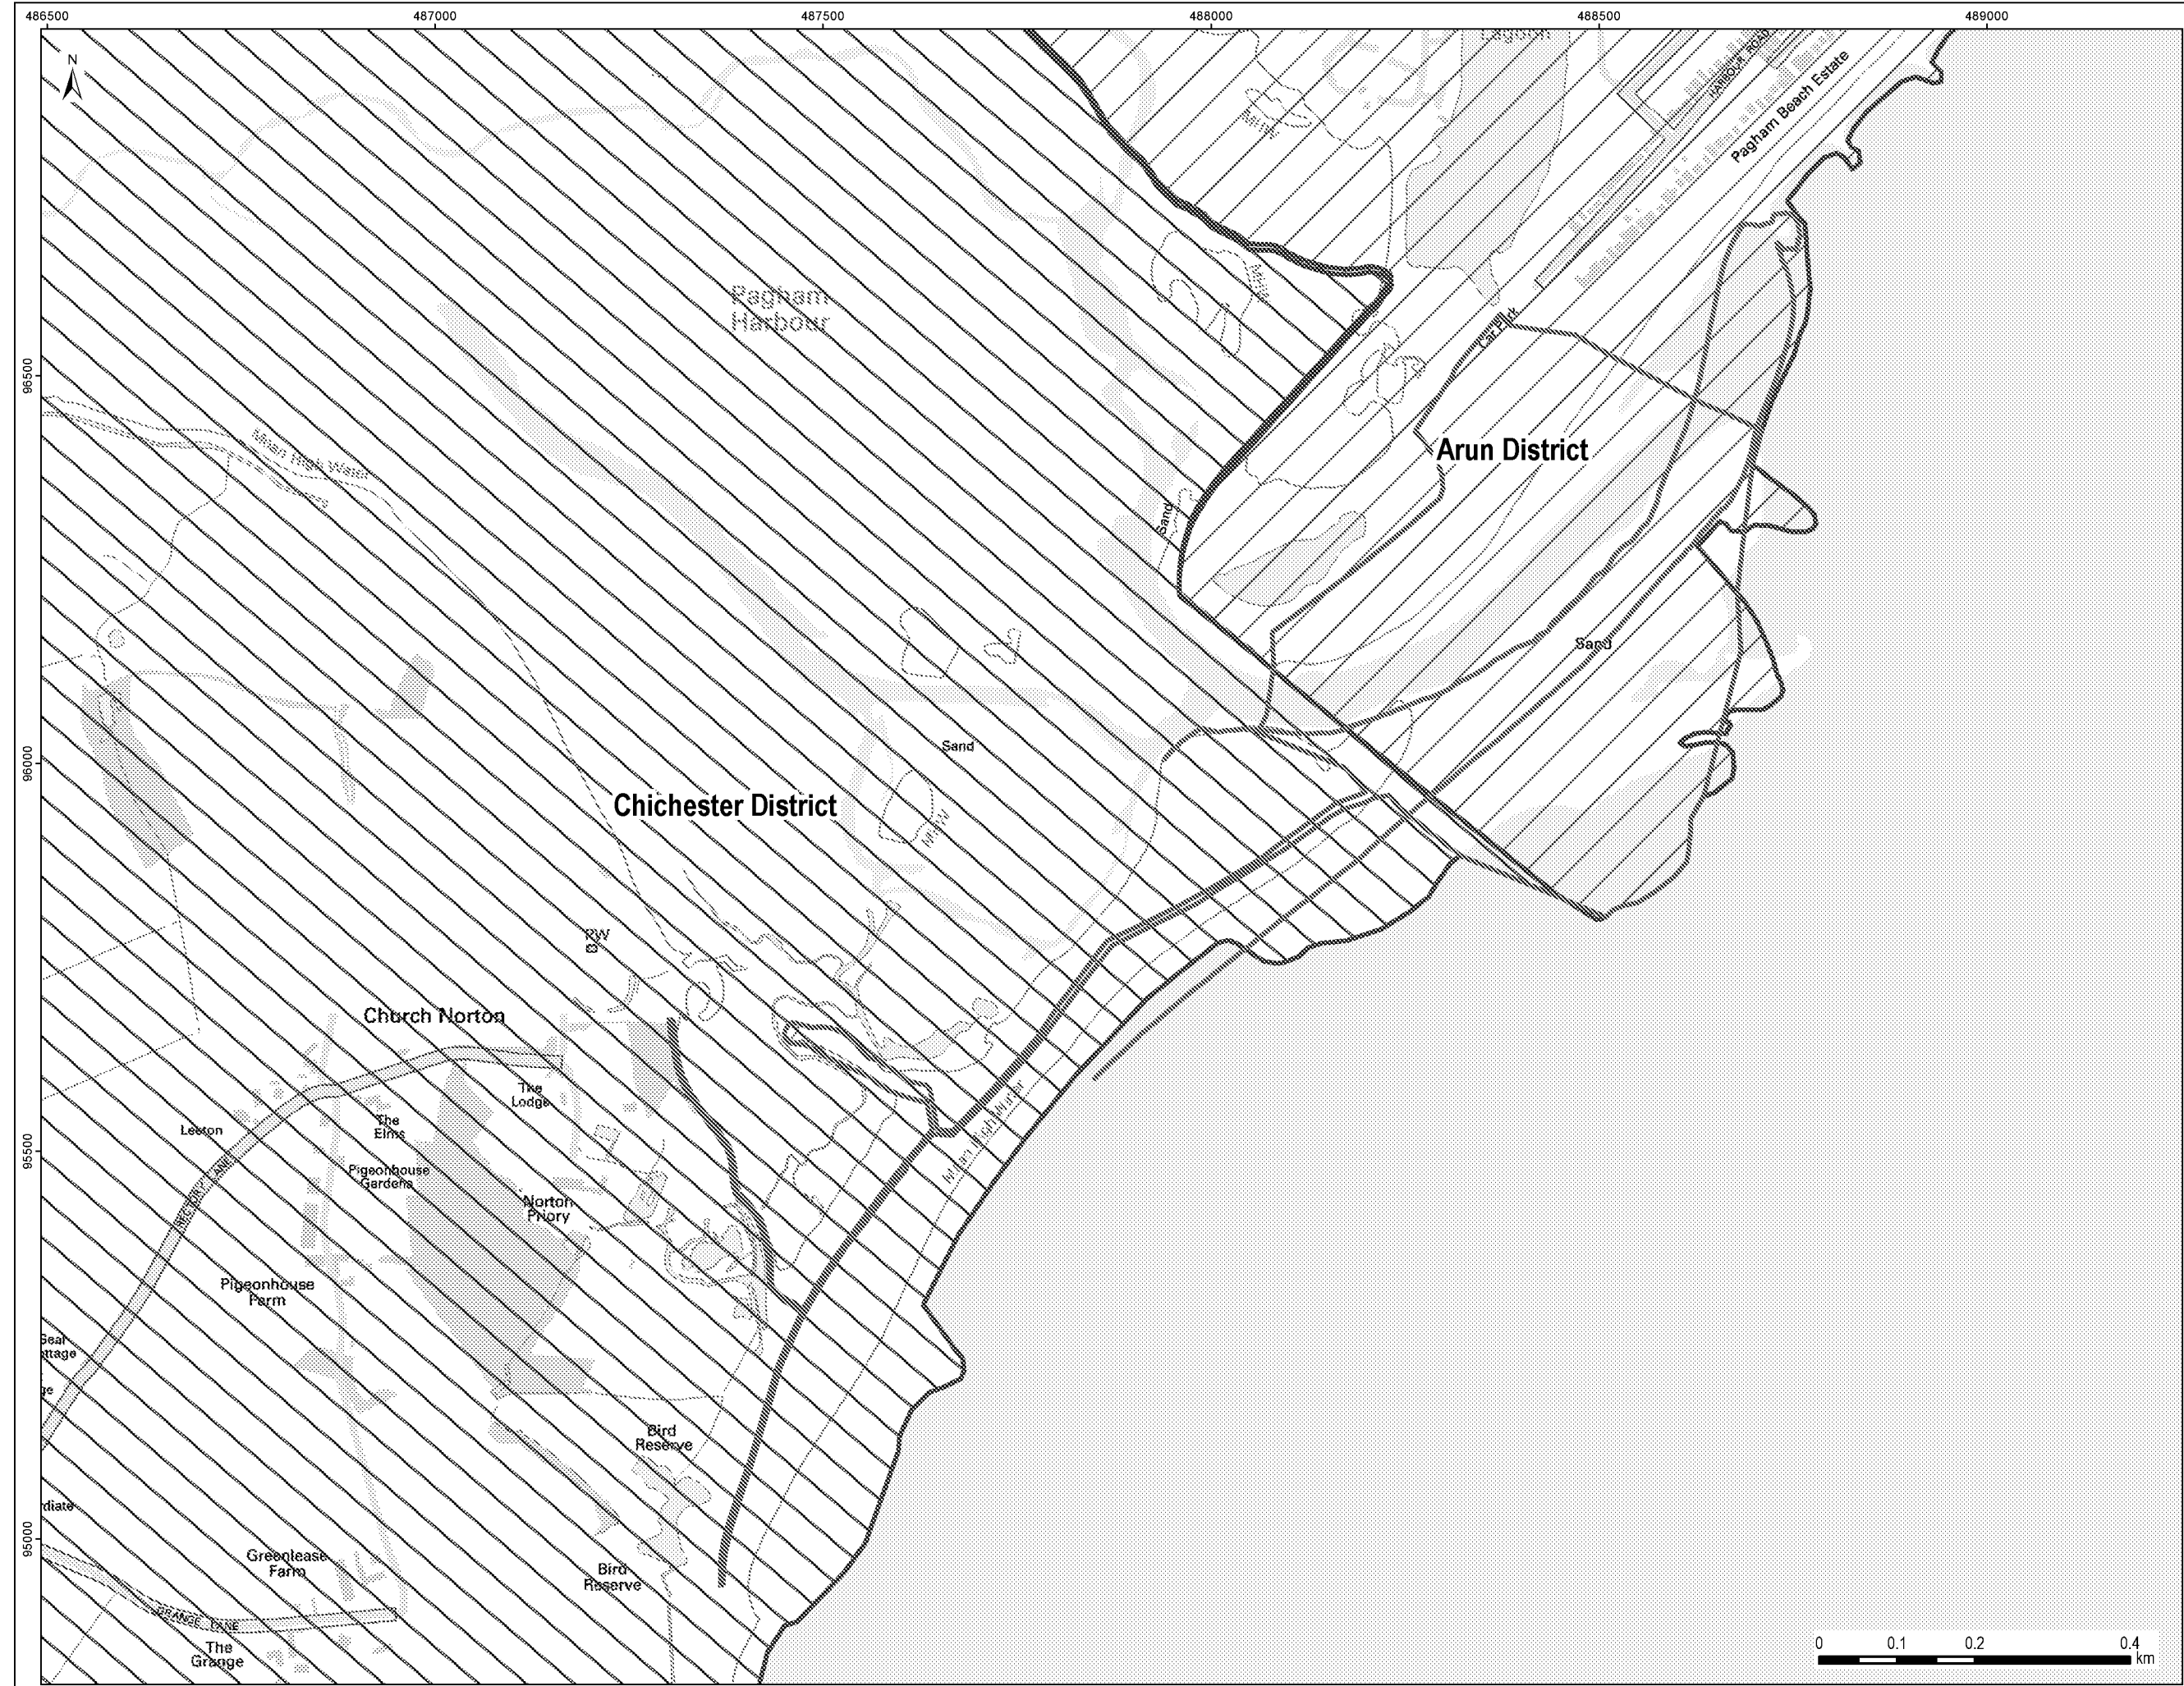
Figure 1

- Application Site
- Extent of Church Norton Spit in January 2015
- Arun District
- Chichester District

Access tracks for plant machinery will use existing paths

As requested by ADC, further clarifying details about the cut and fill volumes and the design of the proposed infill are provided here. Updated plans of the design are also included as Figures 1 to 5. These plans update and replace the plans that were presented in Figures 1 to 4 of the DAS report (ABPmer 2015d). They also include an extra plan (Figure 5) which describes the shape and design of the New Tern Island compensation site.
