# Managed Breach of Shingle Spit at Pagham

Further Information for Planning Application  
and Marine Licence

Pagham Parish Council

May 2016

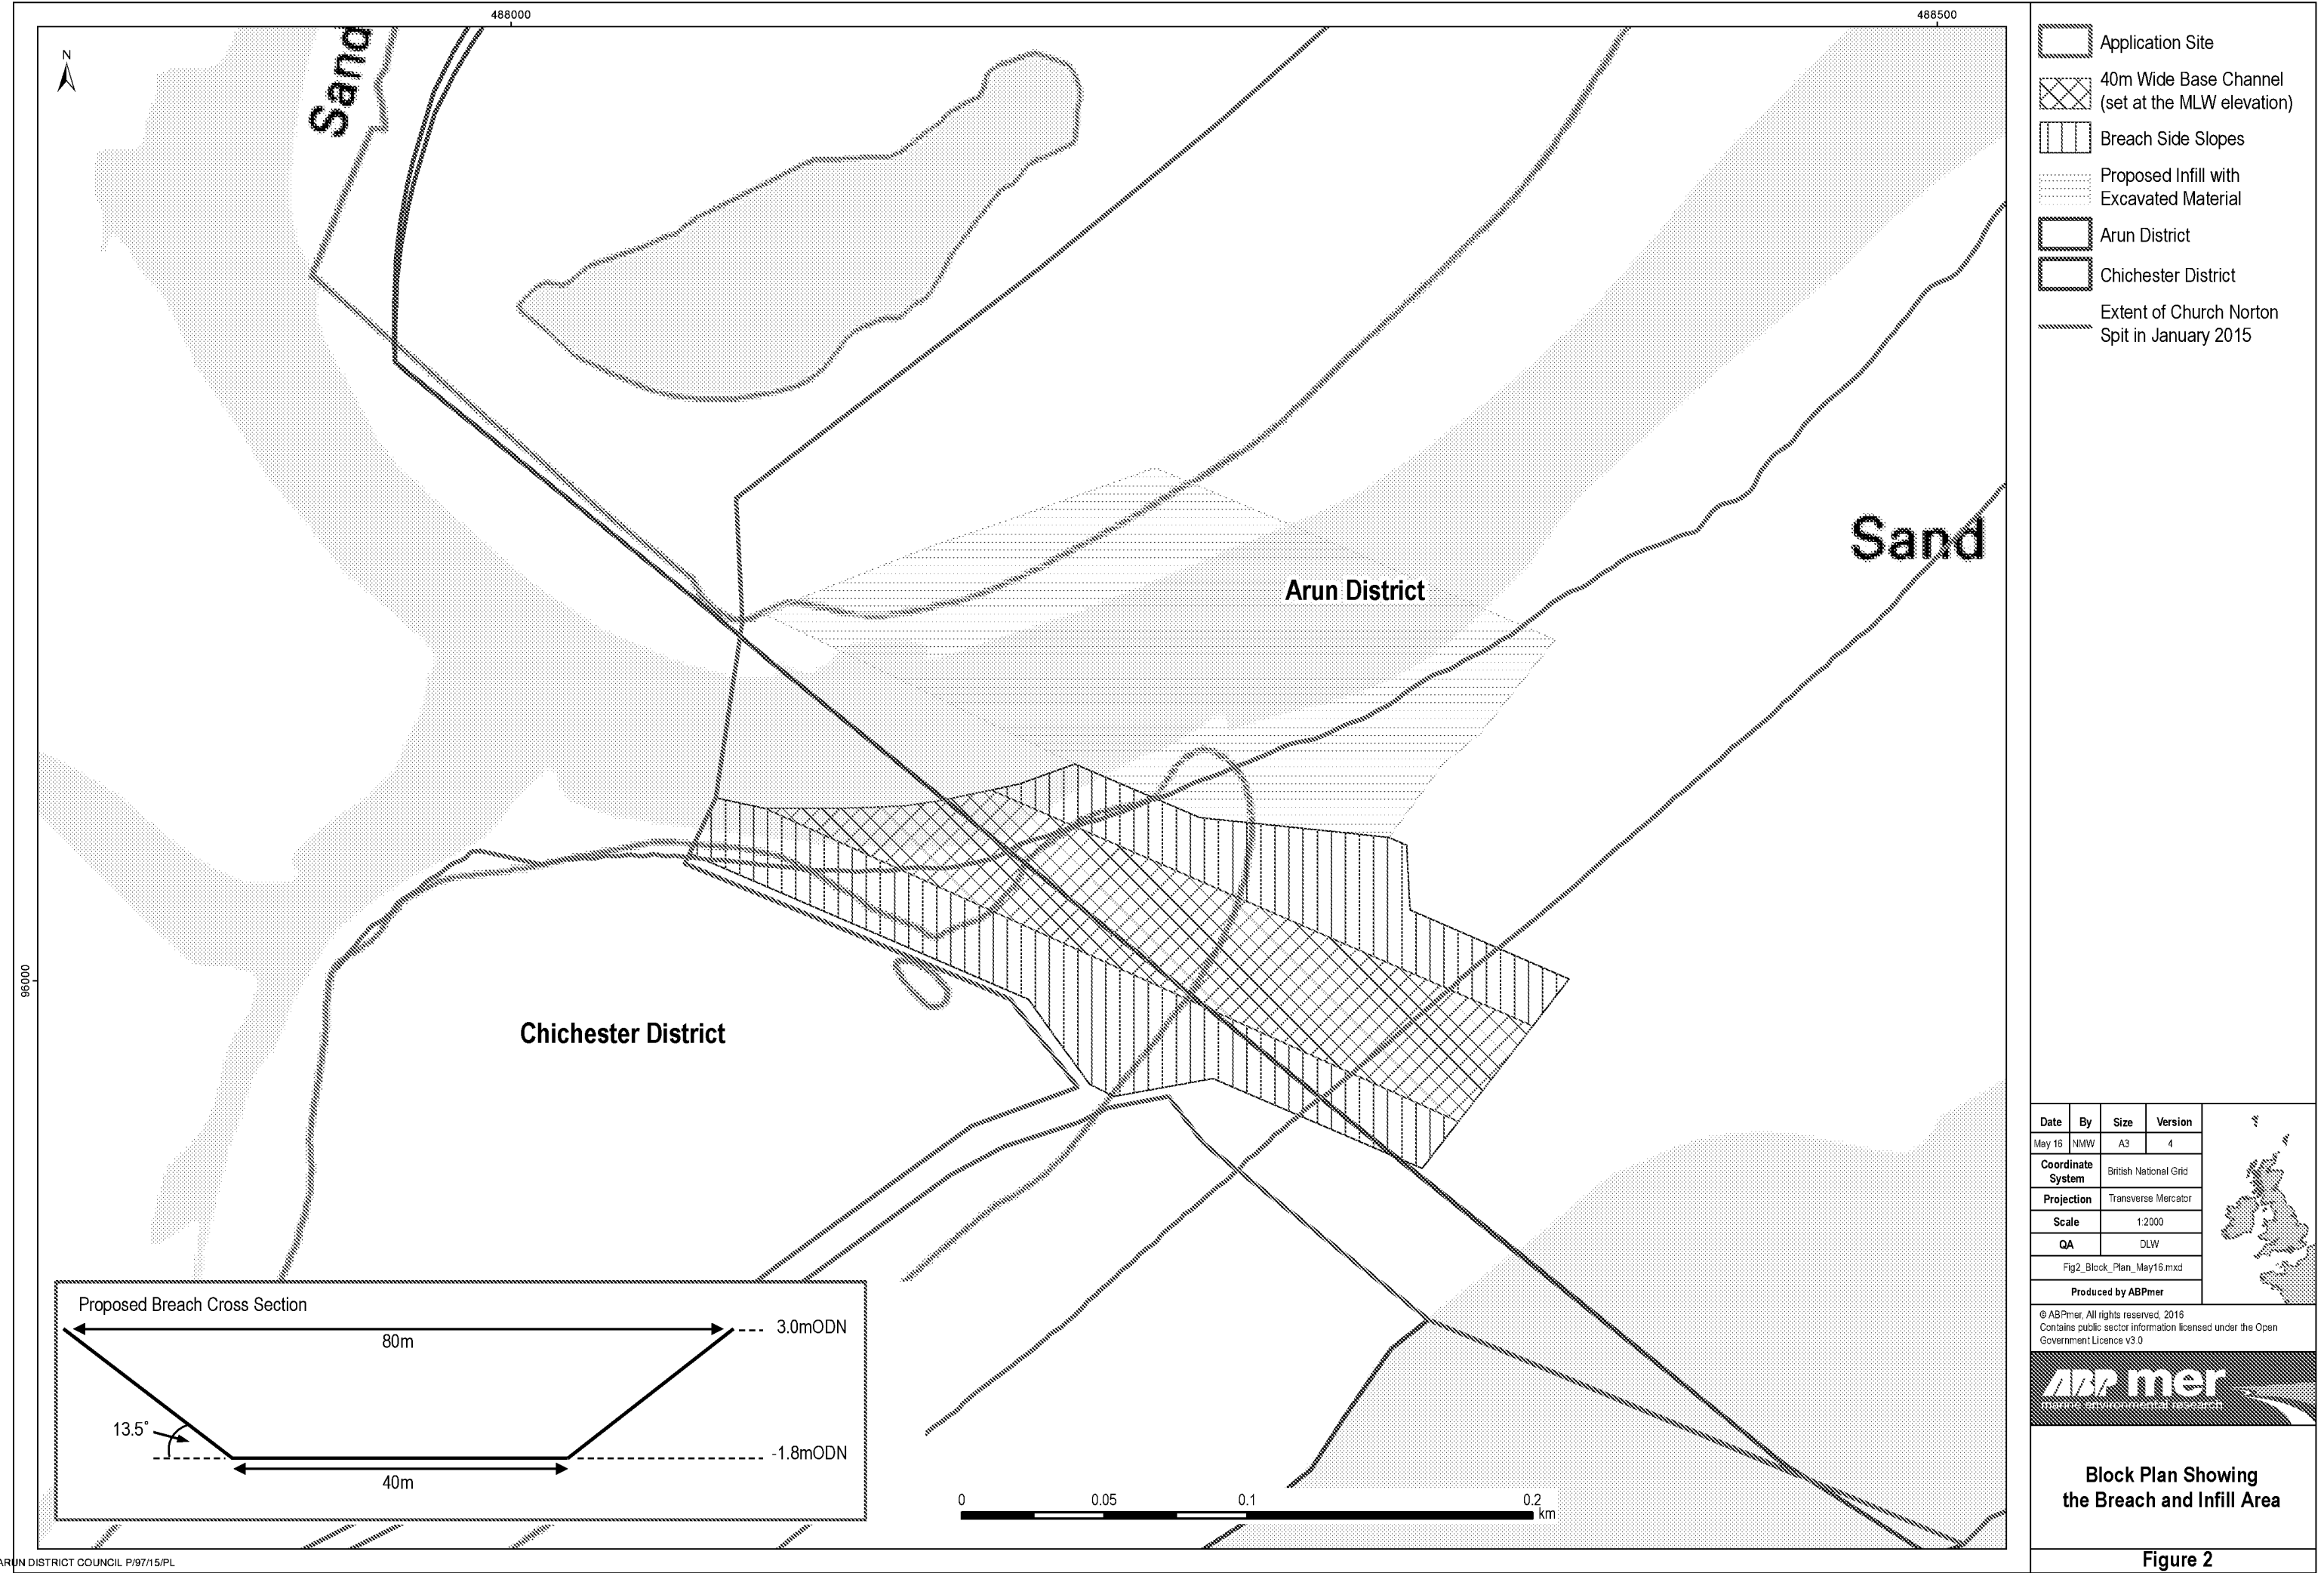
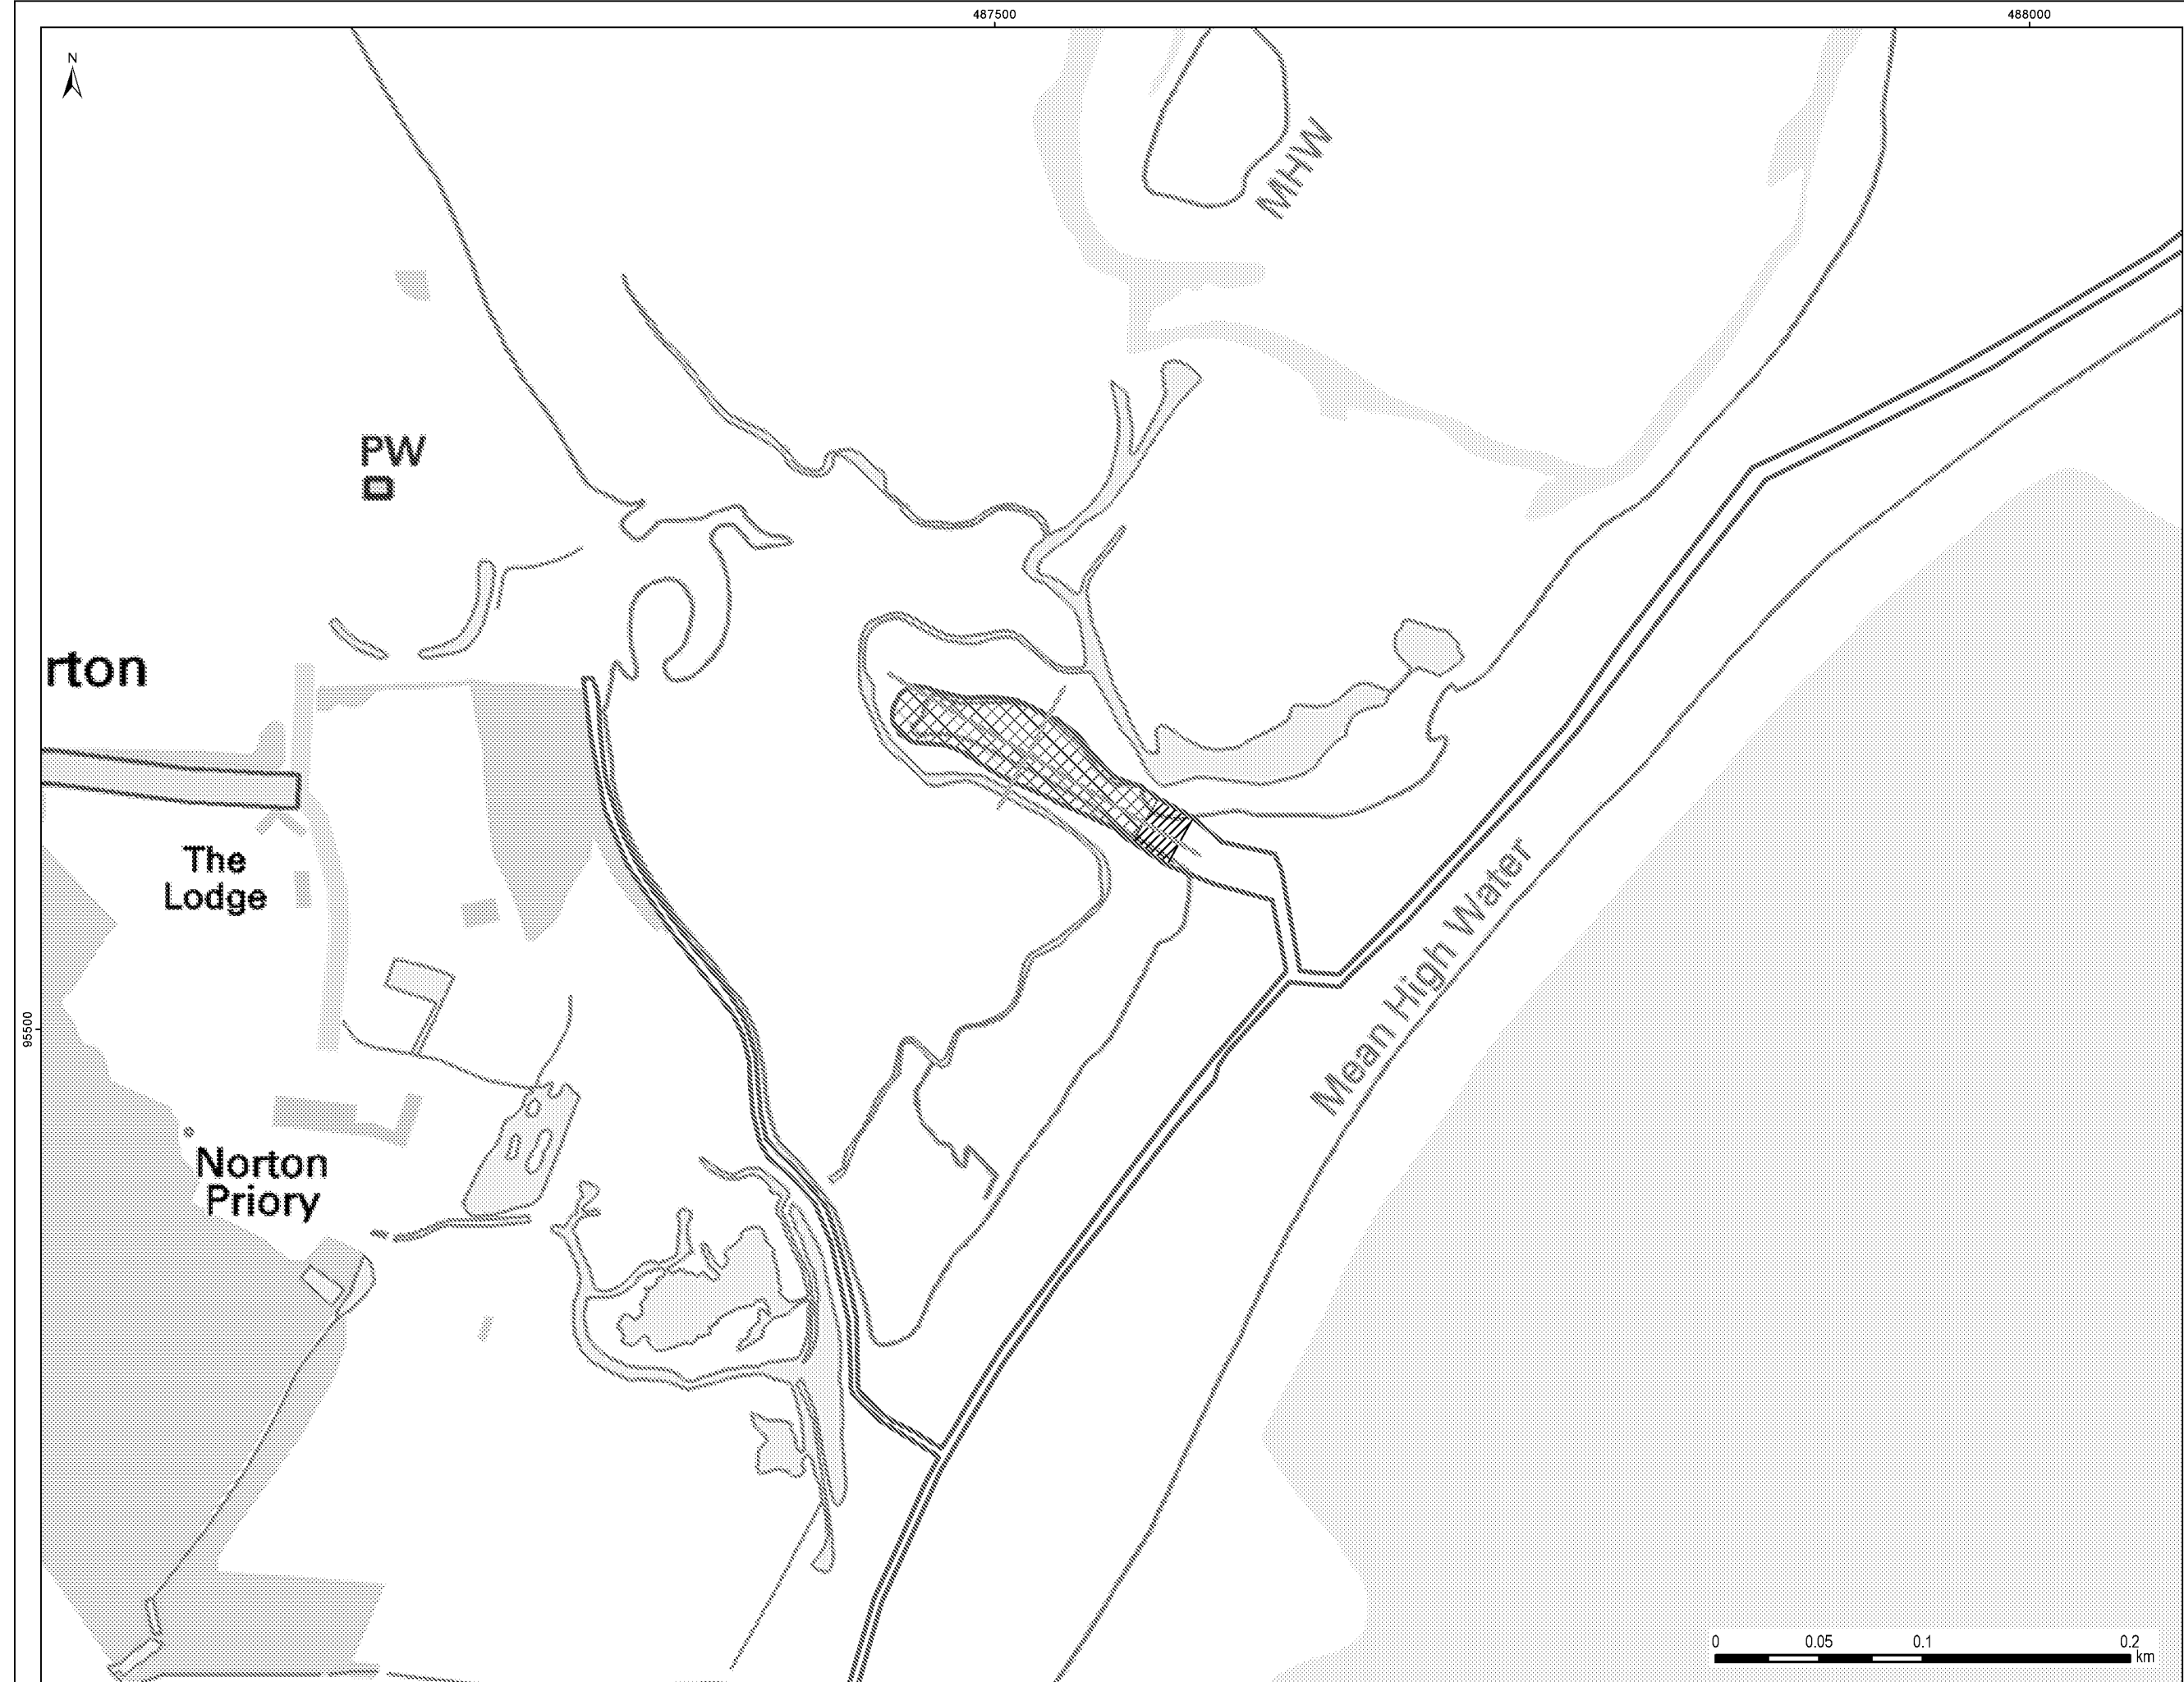
Figure 3

- Application Site
- Proposed Location of a New Tern Island
- Excavation to Create Isolated Island
- Profile D
- Profile E

As requested by ADC, further clarifying details about the cut and fill volumes and the design of the proposed infill are provided here. Updated plans of the design are also included as Figures 1 to 5. These plans update and replace the plans that were presented in Figures 1 to 4 of the DAS report (ABPmer 2015d). They also include an extra plan (Figure 5) which describes the shape and design of the New Tern Island compensation site.

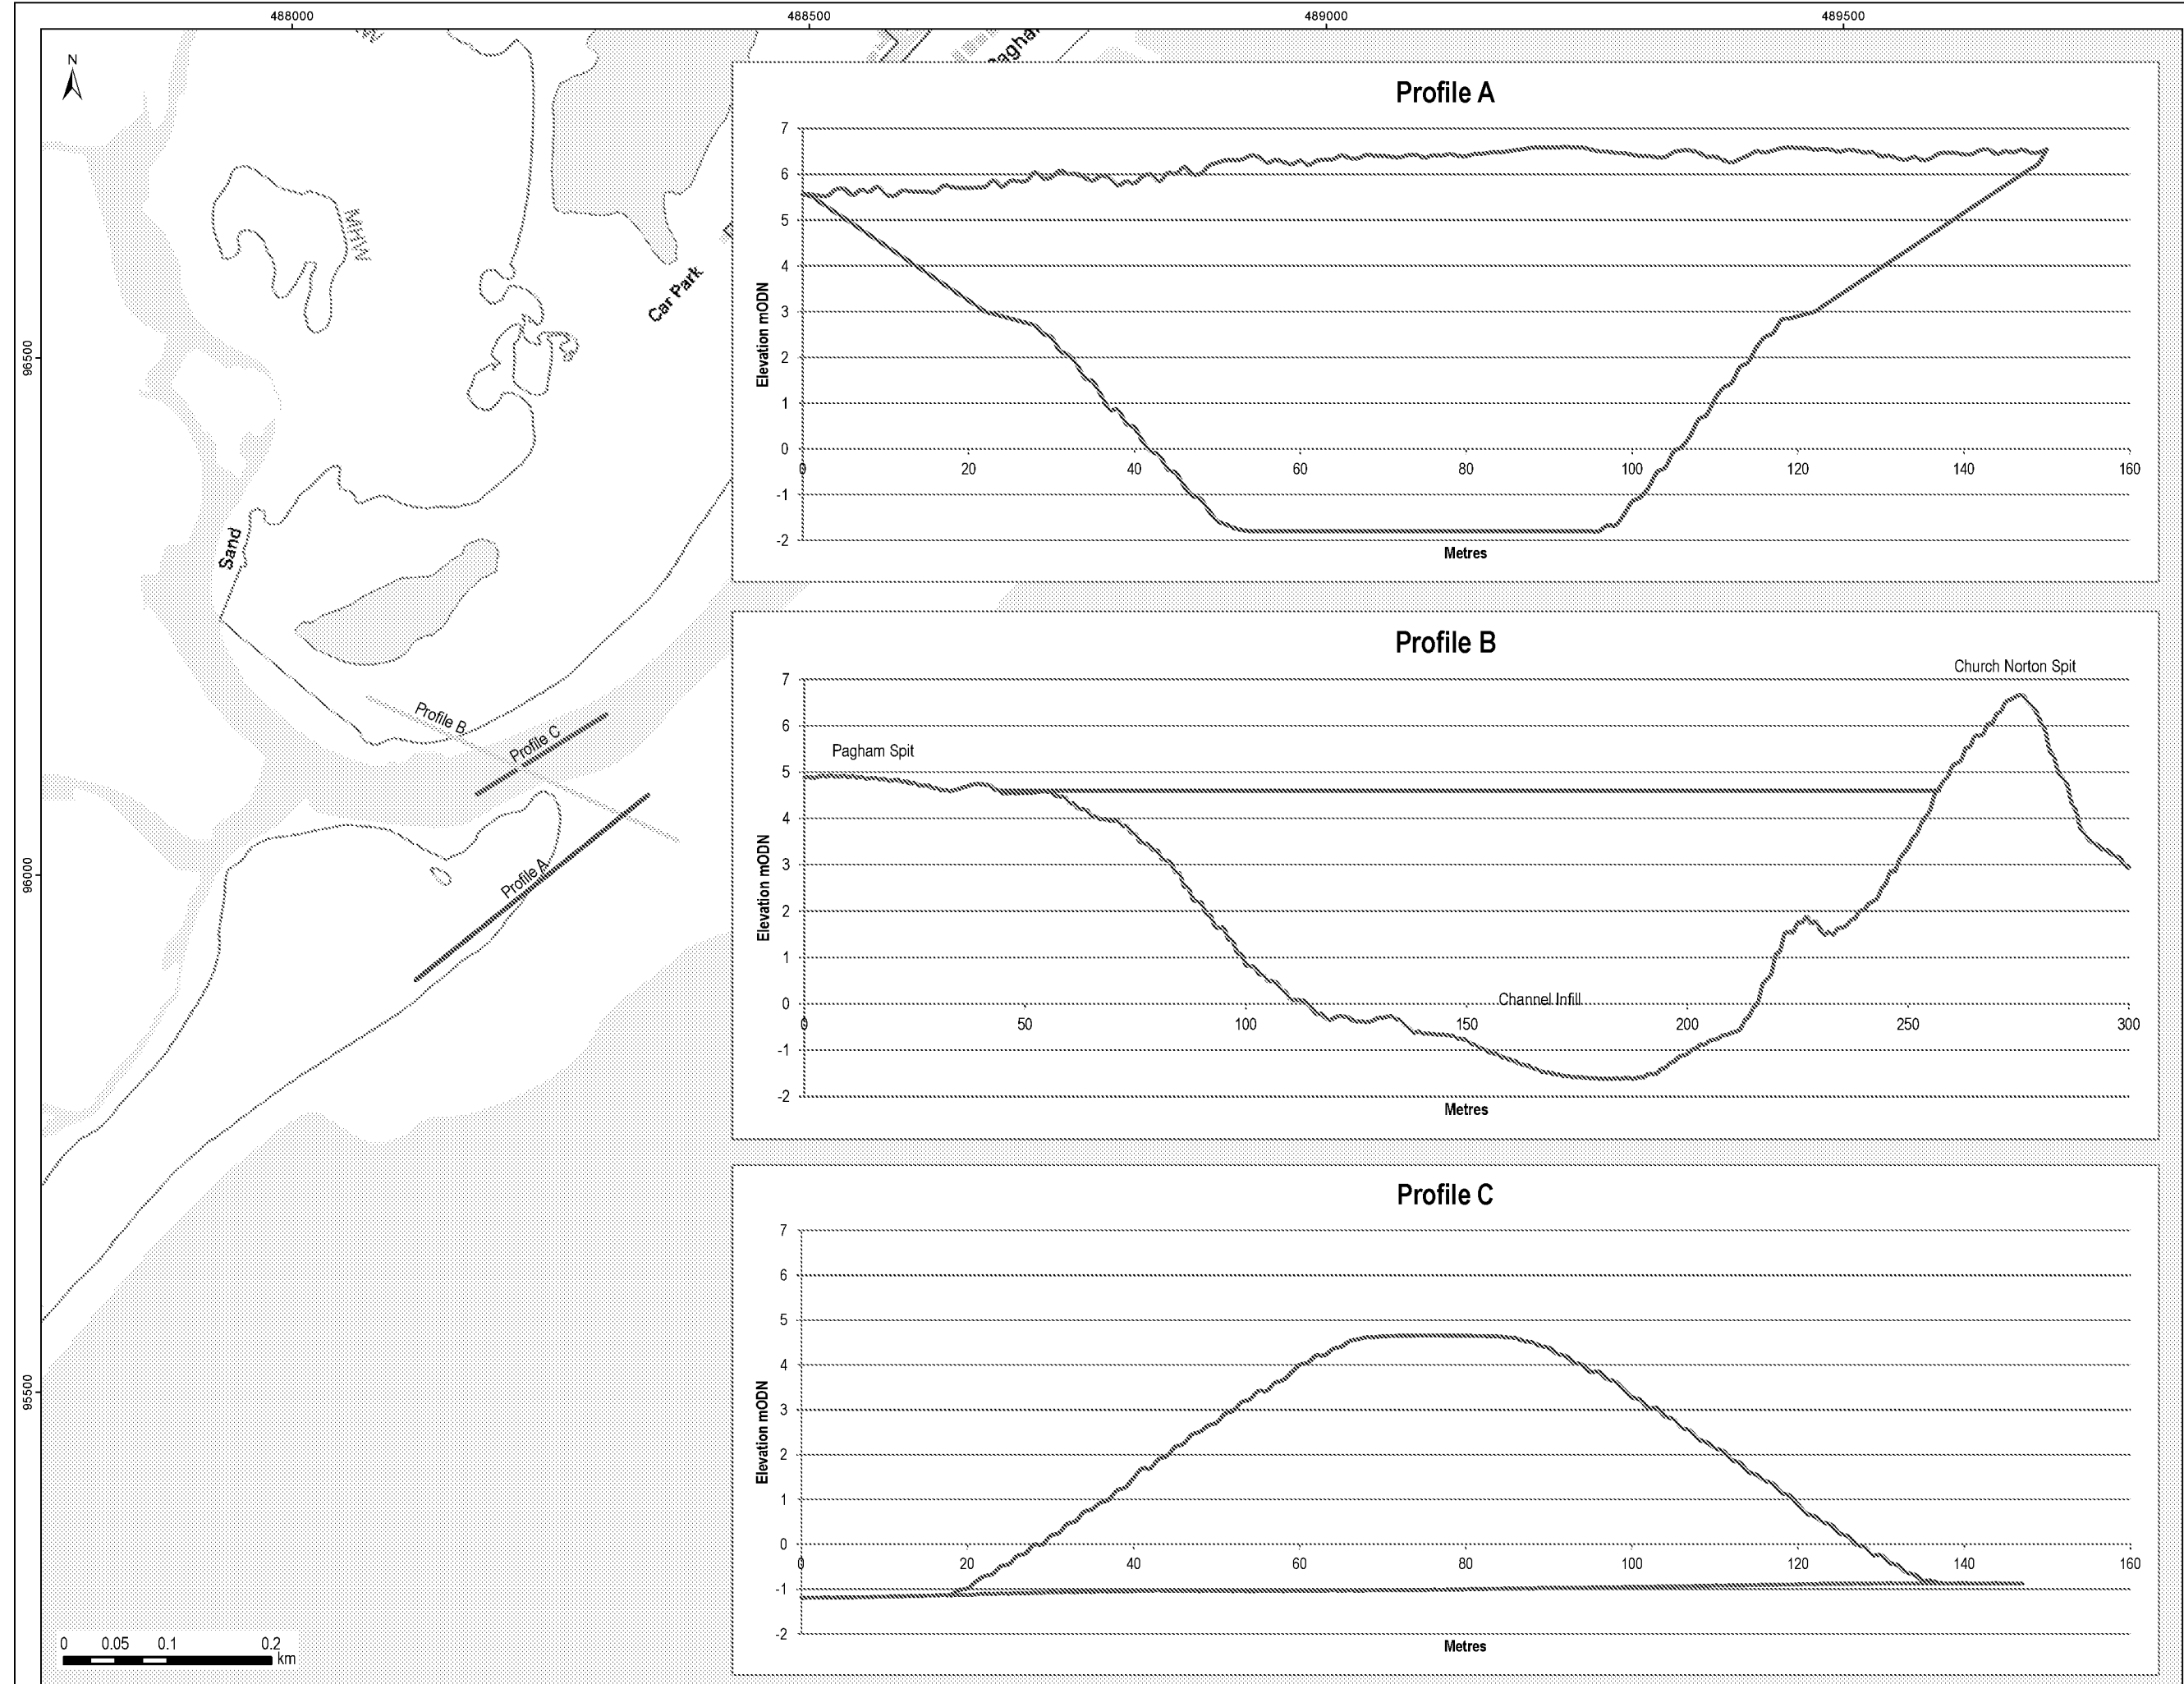
Figure 4

Current Elevation  
Proposed Elevation

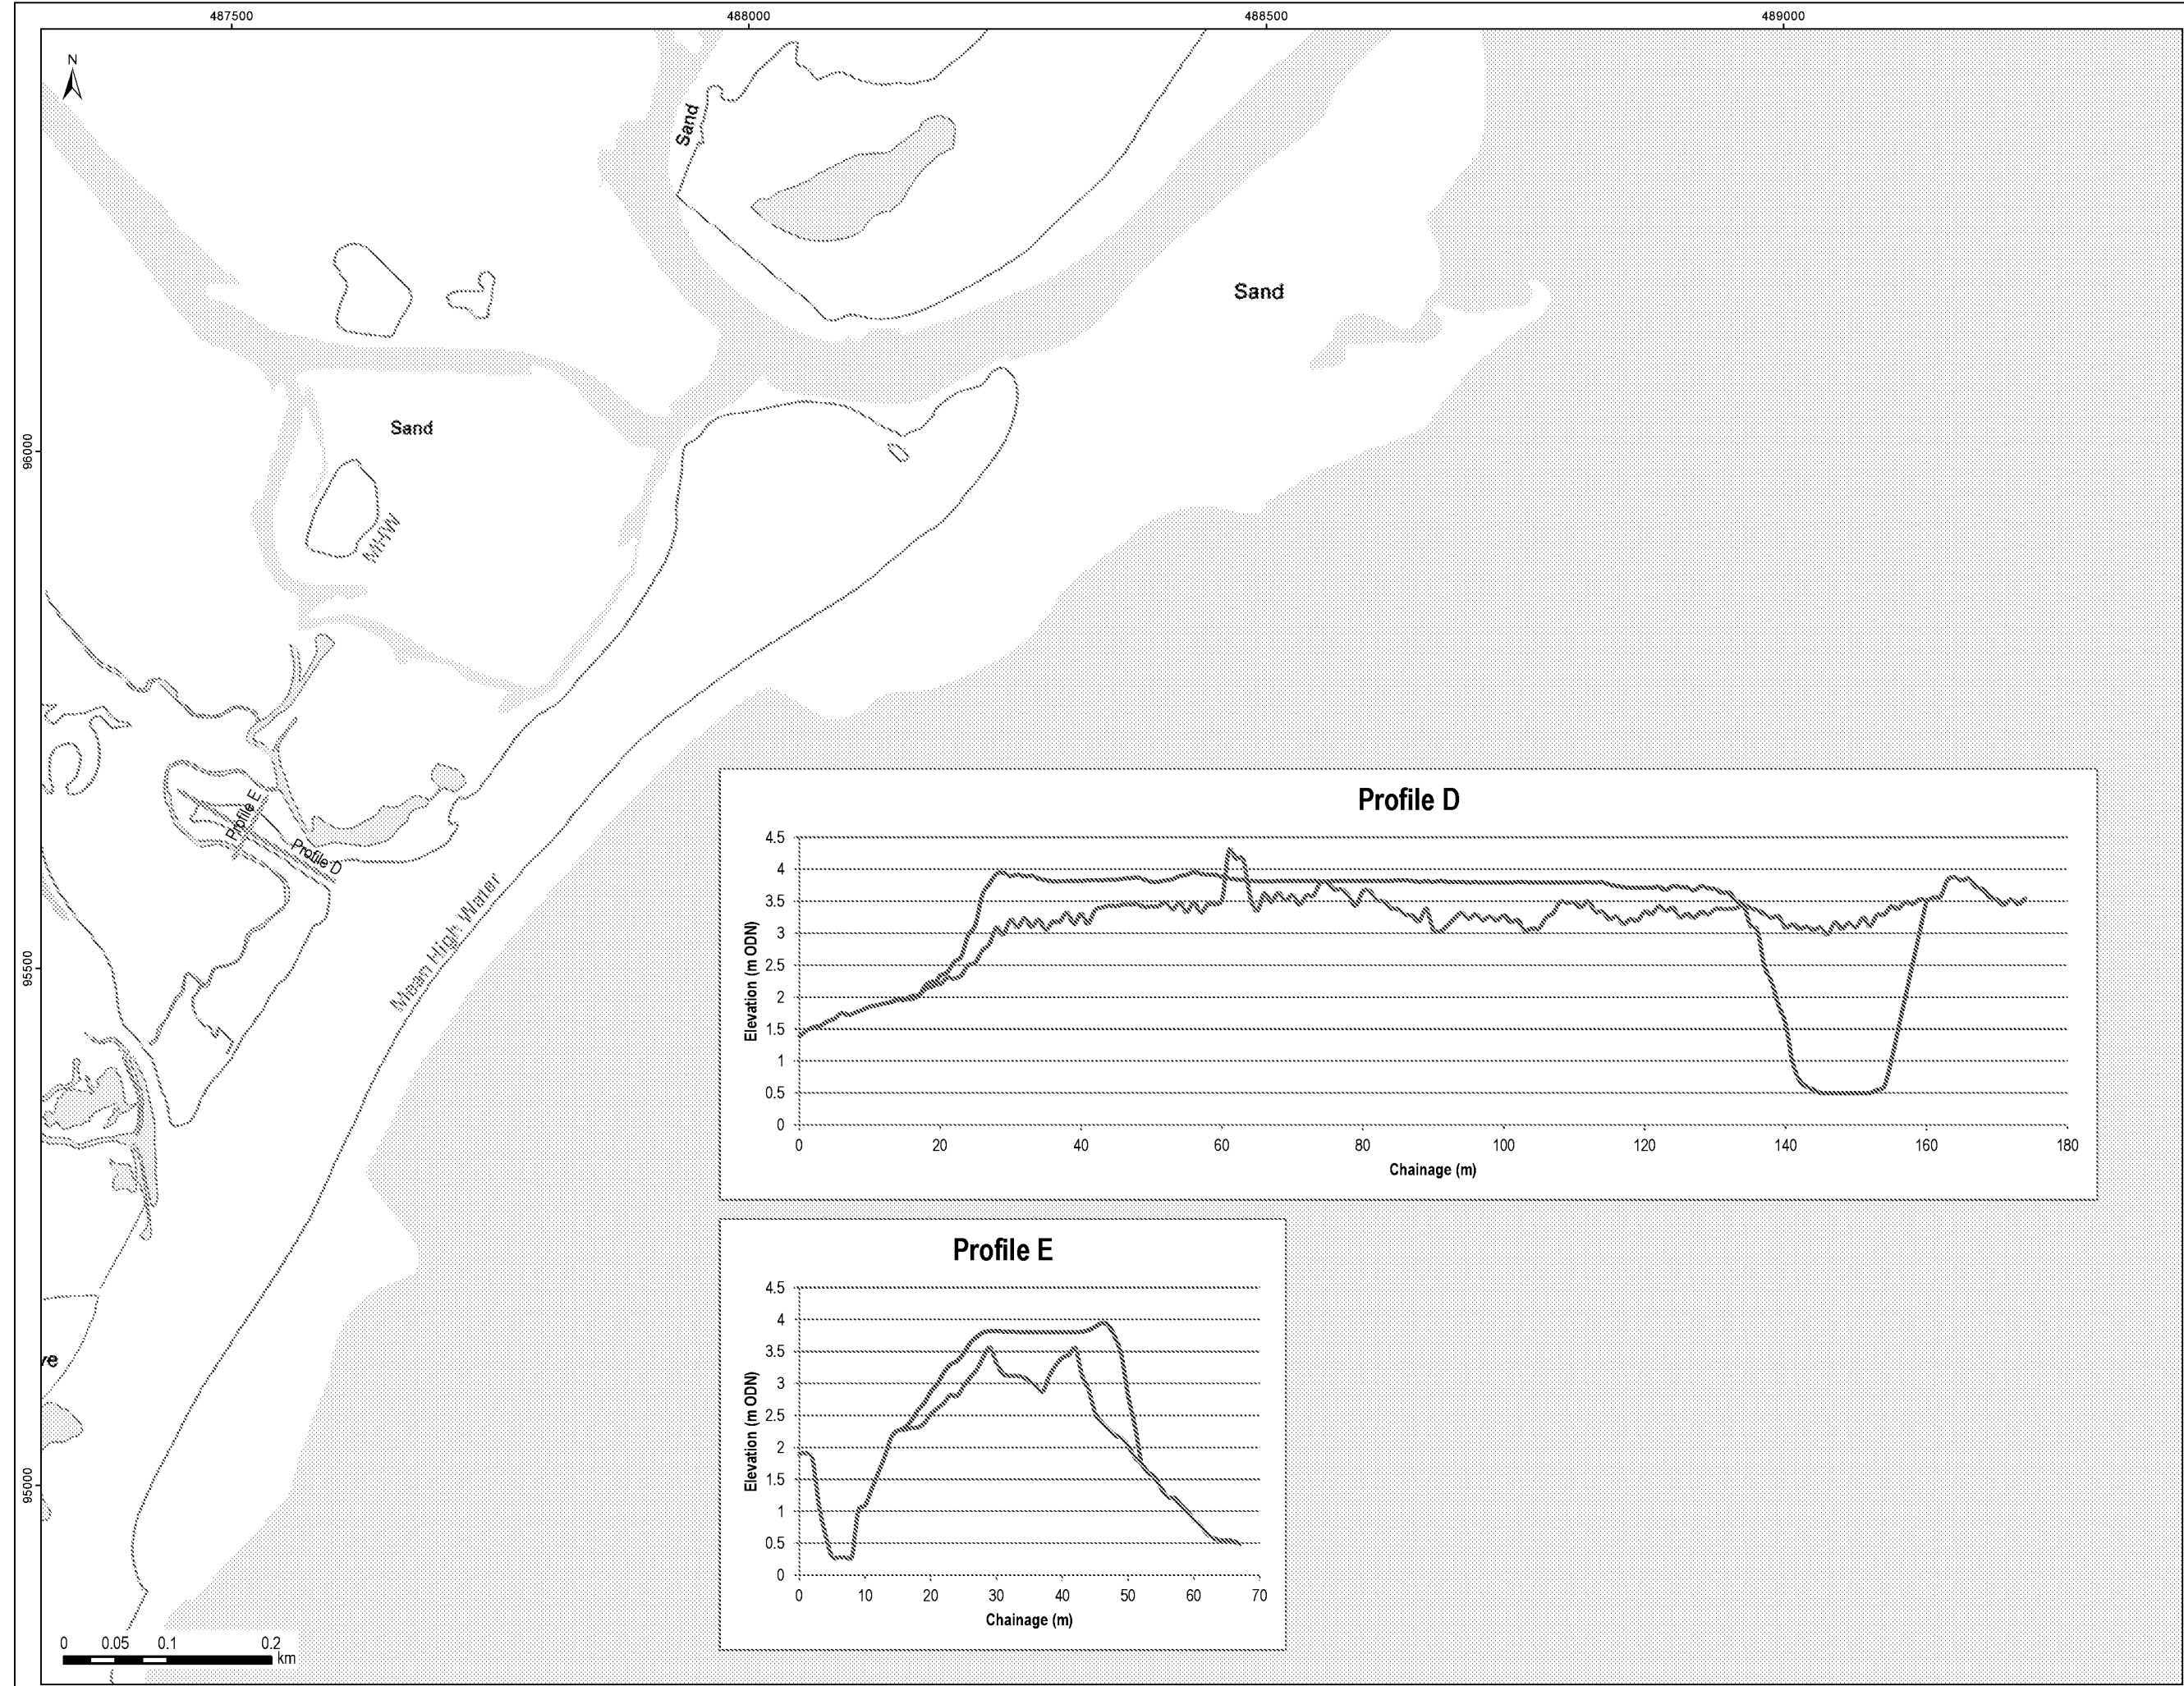
Current Elevation  
Proposed Elevation

Breach side slopes to be determined  
based on safe plant machinery removal

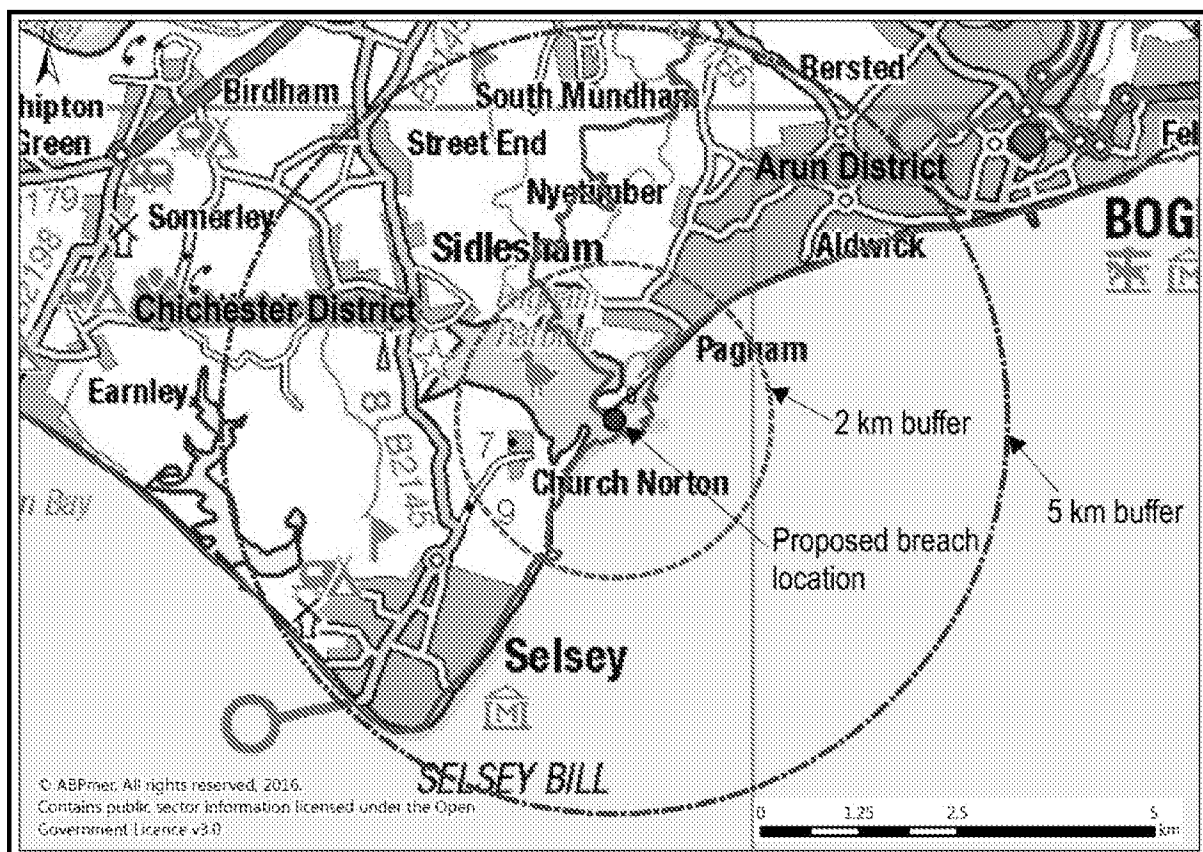
**Image B1.** Location of proposed breach and study buffer areas (immediate buffer within 2 km, wider buffer within 5 km)

The location of the proposed breach point is shown in Image B1 below.

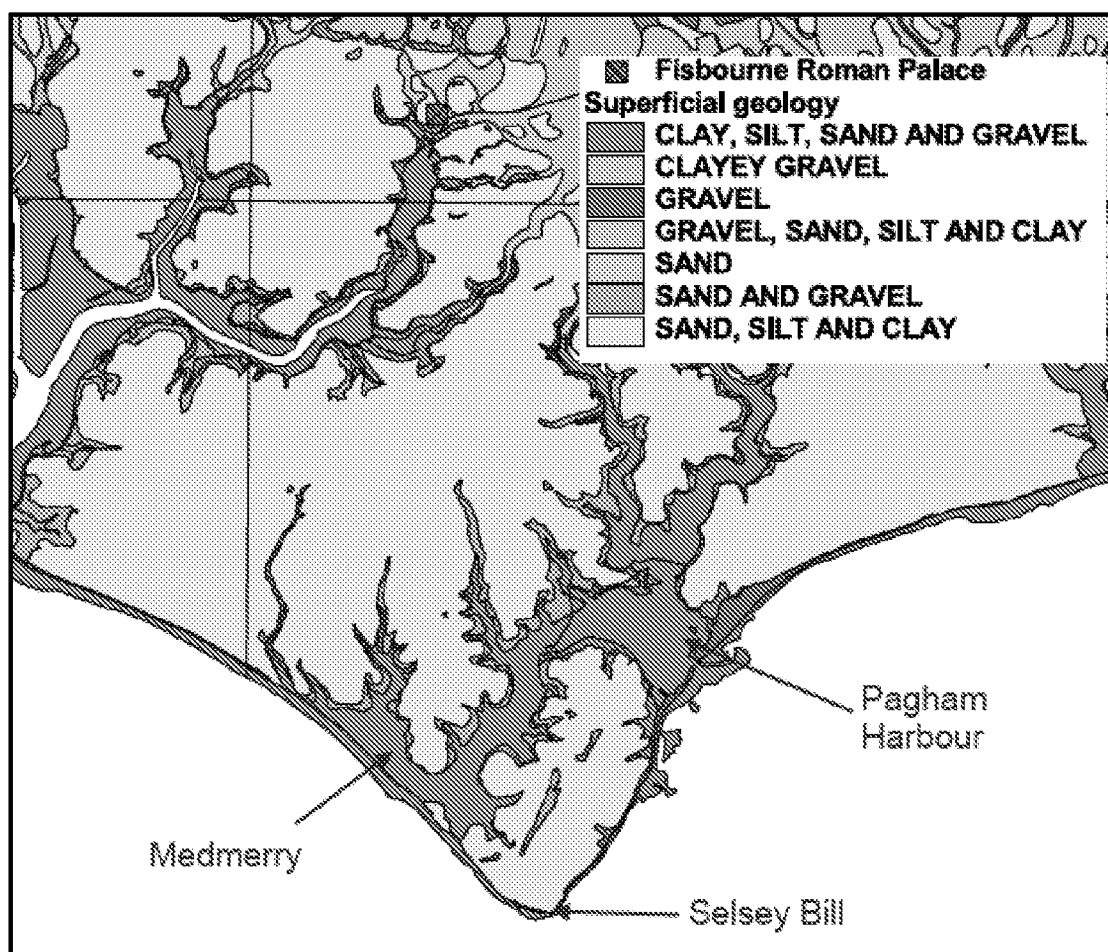
Source: Manley, 2008; place annotations by ABPmer

The superficial geology of Pagham Harbour and surroundings is shown in Image B2. Royal Haskoning (2009) reports that most of the surficial geology within the study area is of Pleistocene or recent origin with only a few occurrences of older Eocene strata. At the base of the geological sequence lies the London Clay above which lie the Bracklesham Beds, a dark green medium to fine glauconite sand, which dip gently to the south and are up to 100 m in thickness. These Eocene formations are in turn unconformably overlain by Pleistocene deposits.

**Image B2. Superficial geology of Pagham Harbour and its surroundings**

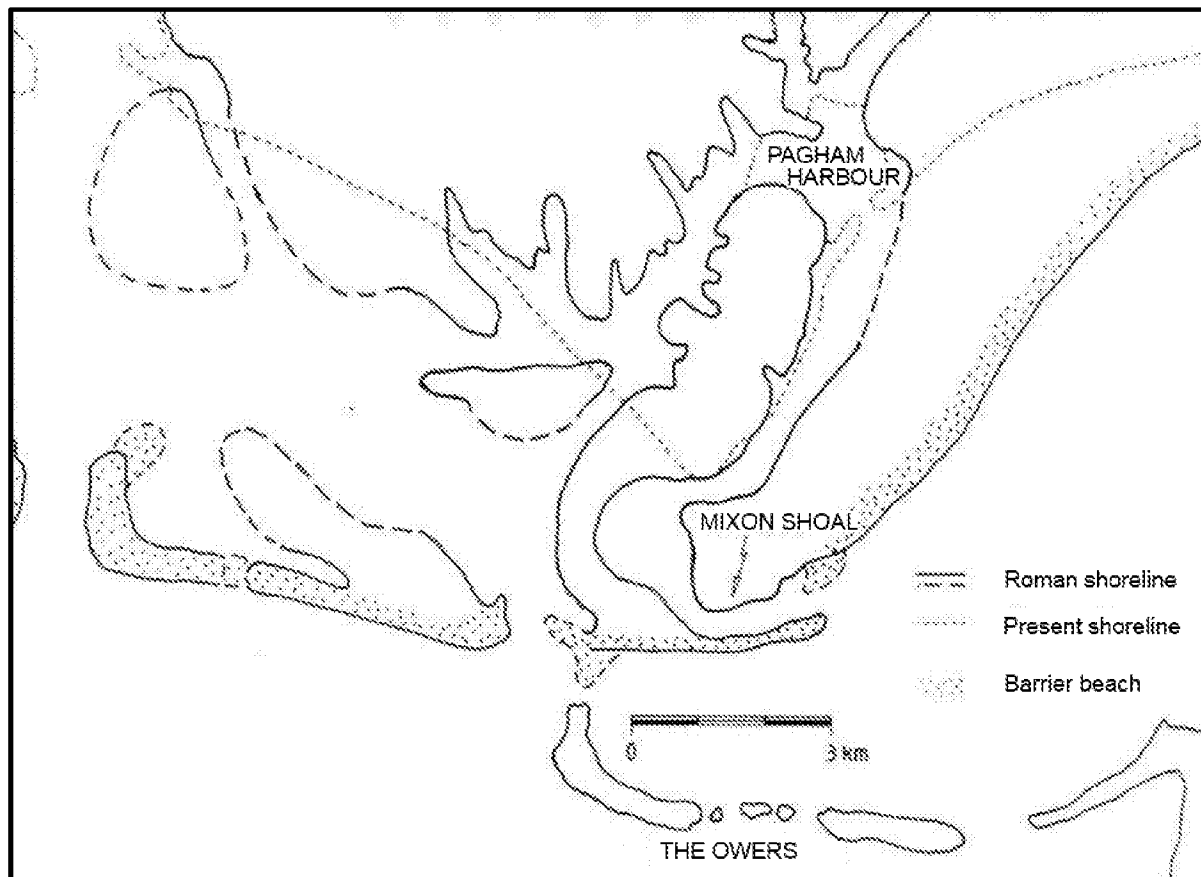
Source: Royal Haskoning, 2009 - after Wallace, 1996

**Image B3. Selsey and Pagham coastline 2000 years BP**

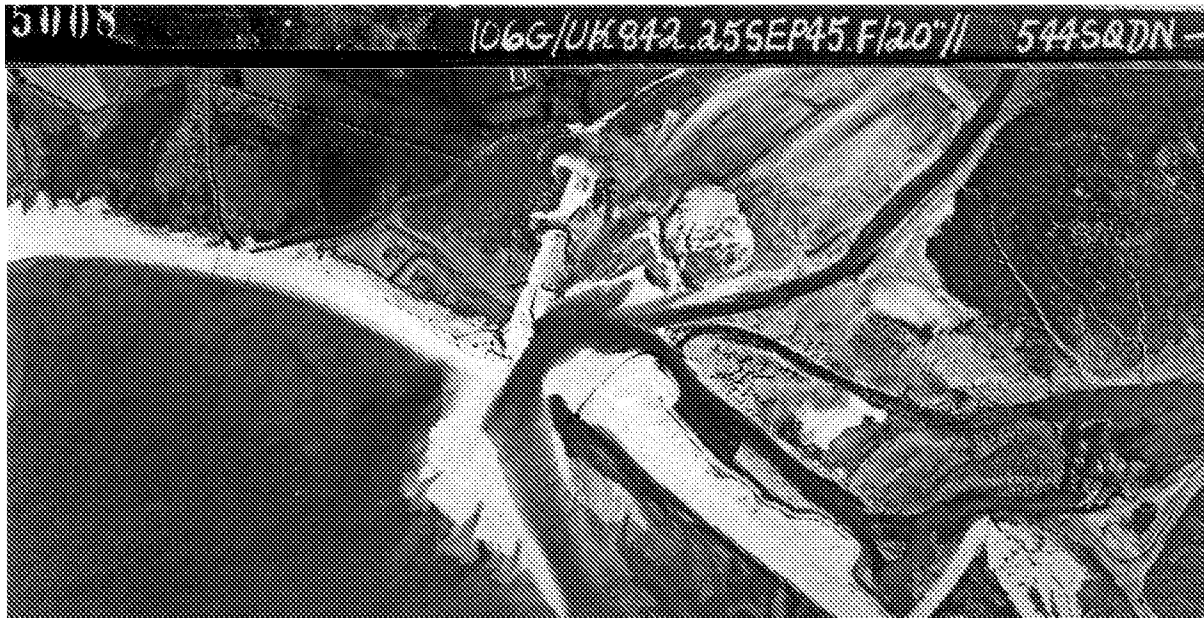
its major collapse (Bray *et al.*, 2004). Over the period from 1969 to 1997 the area generally remained relatively 'stable' when compared to past conditions (Royal Haskoning, 2009; Dornbusch, 2014). Through the 1990s and up to 2004, the Church Norton Spit and ebb delta were subject to regular annual intervention by the National Rivers Authority (NRA) until 1996 and then the Environment Agency. This involved taking approximately 15,000 m<sup>3</sup>/year sediment on average from the harbour mouth nearshore banks and ebb delta and then using it to rebuild and reshape the beach fronting the Church Norton spit following winter storms (Bray *et al.*, 2004).

**Image B4**      **The southern entrance in 1945**

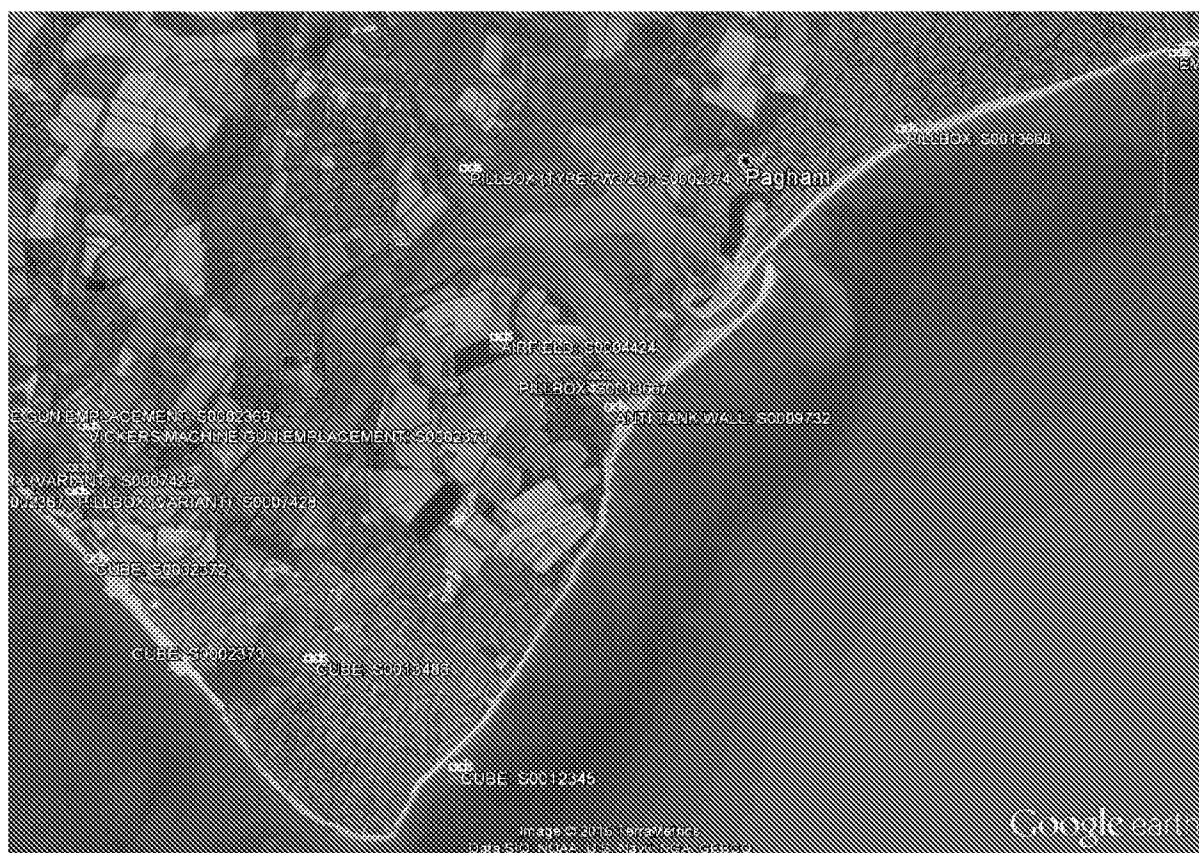
**Image B6.** Defence of Britain records within 5 km of the proposed breach

The defences around the harbour formed part of the Sussex coast defences; which ran from north of Pagham harbour to West Wittering. For a brief period in 1944/45 the harbour was used as an aerial gunnery practice range for Spitfire and Hurricane fighter planes (Sidlesham Parish Council, 2007). Remnants of Mulberry Harbours can be found in the subtidal fronting Pagham harbour. These were temporary portable harbours developed by the British during World War II to facilitate the rapid offloading of cargo. One Mulberry Harbour caisson (originally stored offshore prior to D-Day) can still be seen from Pagham Beach at low tide; this is located some 1.9 km from the proposed breach point. With regard to further defence records, the 'Defence of Britain' project's database (2002/06), which holds records of the 20th century militarised landscape of the United Kingdom, shows five such assets around the harbour itself, including two pill boxes, an anti-tank wall, an airfield and a 'flame fougasse' (see Image B6).

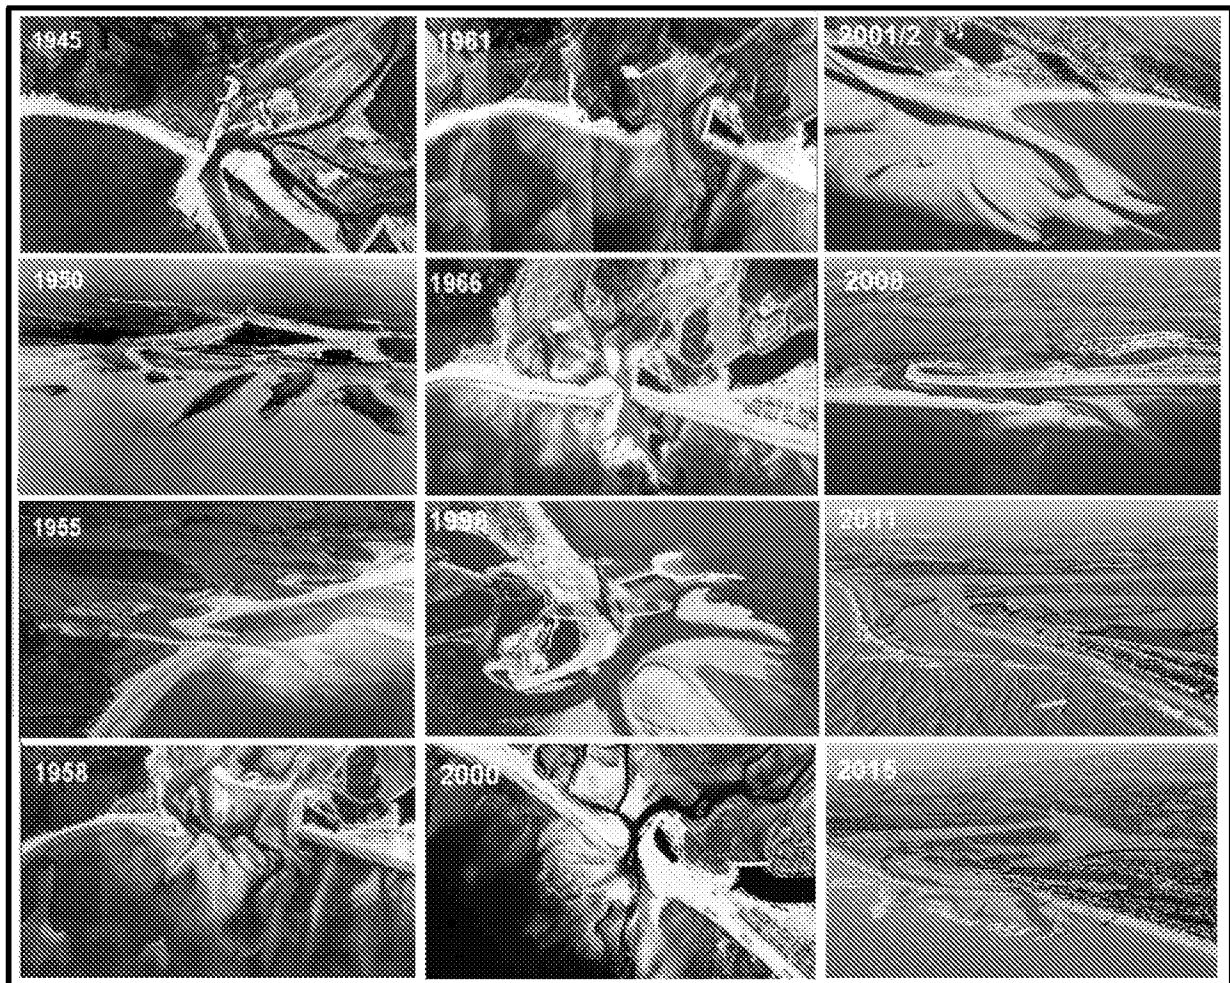
Image B7. Changing configurations of the spit, inlet and delta complex

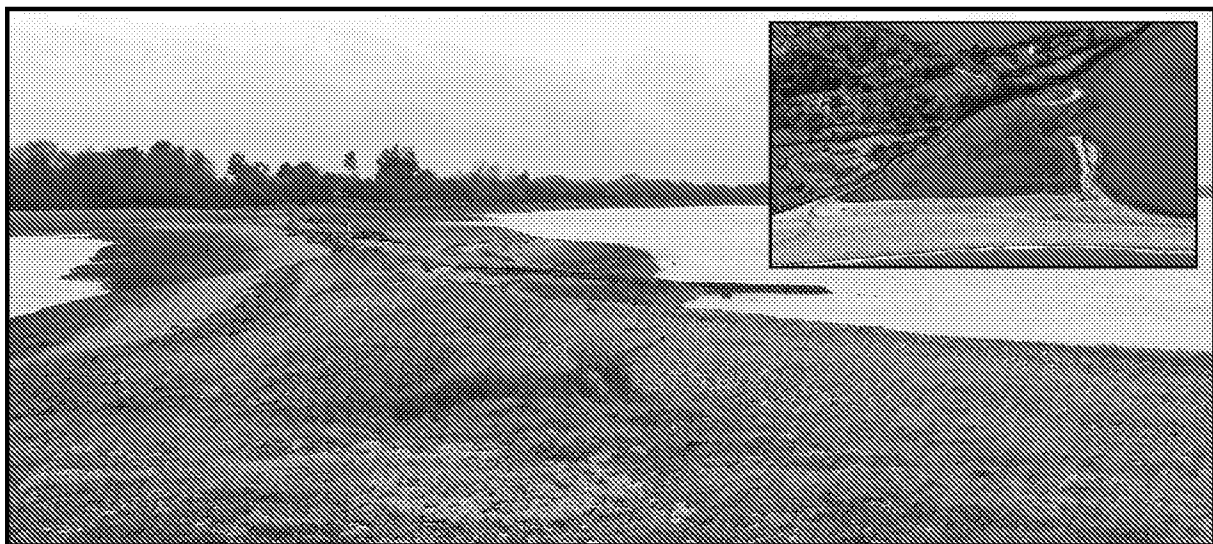
Source: ABPmer 20 February 2016; inset/aerial John Akerman 7 February 2007

The cutting of the channel at the end of the proposed new island to a depth of -0.5 mODN would affect estuarine mud and shingle mostly accreted and deposited between 1910 and 1937, as described above. Thus excavating the channel would not be expected to yield any significant archaeology or the concrete structures. The exposure to change is thus considered negligible, and the impact assessed as **not significant**.

**Image B8.** View from the south east (seaward) end of the proposed New Tern Island
