Land adjacent to Tiled Barn

**Extended Phase 1 Habitat Survey**

**Internal and External Bat Survey**

**November 2014**

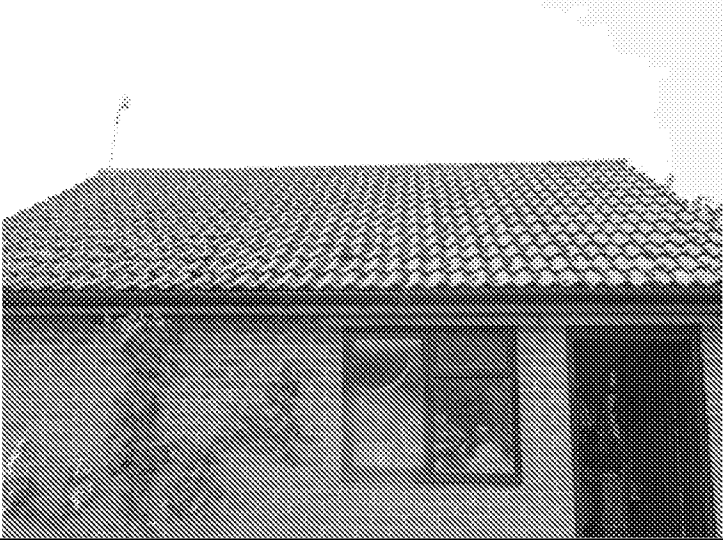
- 3.9 This garage was located within the south west corner of site. The garage building was brick built with a pitched fitted tile roof. The building was well maintained and considered to be in a good condition. Internally the building was subject to high levels of natural light through windows present in the elevations. The garage is used regularly as a workshop and to store a car and is subject to high levels of disturbance. The internal roof space was not enclosed into a void and was open to the rest of the building. The tiles were lined internally with bitumen felt and no potential access points for bats were observed. Externally the roof was considered to be in good condition, with no slipped or missing tiles present. The roof was tiled with fitted curved concrete tiles, which fit together tightly and offer less opportunity for crevice dwelling bat species than traditional

clay tiles. No bats or evidence of bats was recorded internally or externally. It is understood that this building will be removed under proposals.

| <p><b>Photograph<br/>1: Building<br/>1</b></p> | A black and white photograph of a single-story building with a tiled roof. The building has a large window on the right side and a dark door. The roof is covered in tiles, and there is a small chimney or vent pipe on the left side of the roof. |

- 4.3 Building 1 was considered to be in good condition and is regularly used to store a car and as a workshop. Regular disturbance is likely to significantly reduce the likelihood of the presence of bats. Although the garage had a pitched tiled roof, no slipped, lifted or missing tiles were observed on the roof, which may provide opportunities for crevice dwelling bats. The roofing tiles were curved style fitted tiles, which prevented very little opportunity for roosting as the tiles lay on roof flush with no potential entrance points for bats observed. The building had no internal roof void and was considered to have very limited opportunities for roosting bats. It is not considered that building 1 is used by roosting bats or has the potential to support roosting bats. No further surveys are recommended and the building is not considered to be constrained by bats.

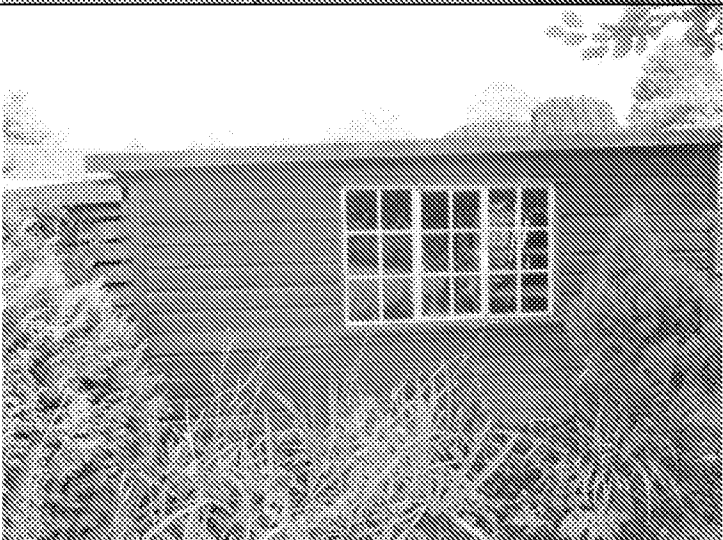
- 3.10 Building 2 was a smaller garage than building 1 and was constructed of wooden weatherboarding and was used to store some household belongings. The weatherboarding walls did not contain a void, or contain back panelling, presenting limited opportunity for crevice dwelling bats. Internally the building was light, due to the presence of three windows and a window within the door. There was no internal roof void and a lack of suitable roosting features. Externally the roof was covered with bitumen felt and was very slightly sloping. A small open log store was present on the western elevation. No evidence of bats was recorded internally or externally within building 2. It is understood that building 2 will be removed under proposals.

| <p><b>Photograph<br/>3: Building<br/>2</b></p> | A black and white photograph of a building, likely a shed or outbuilding, with a corrugated metal roof. The building has a large window with multiple panes. The building is surrounded by tall grass and some trees in the background. |

- 4.4 Building 2 was a small wooden garage with a very gentle sloping felt roof. The weatherboarding on the walls were tight with no gaps observed and the wall had no cavity which bats maybe able to exploit as roosting space. The internal environment was subject to natural light from windows. It is not considered that building 2 is used by roosting bats or has the potential to support roosting bats. No further surveys are recommended and the building is not considered to be constrained by bats.

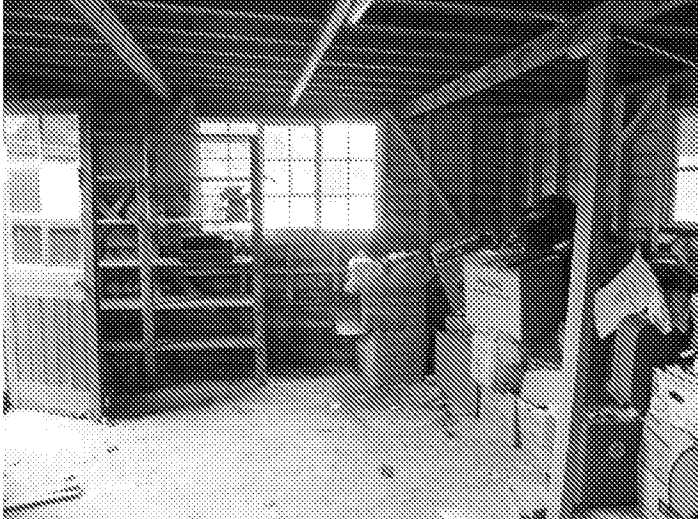
| <b>Photograph 4:</b> Inside building 2 | |

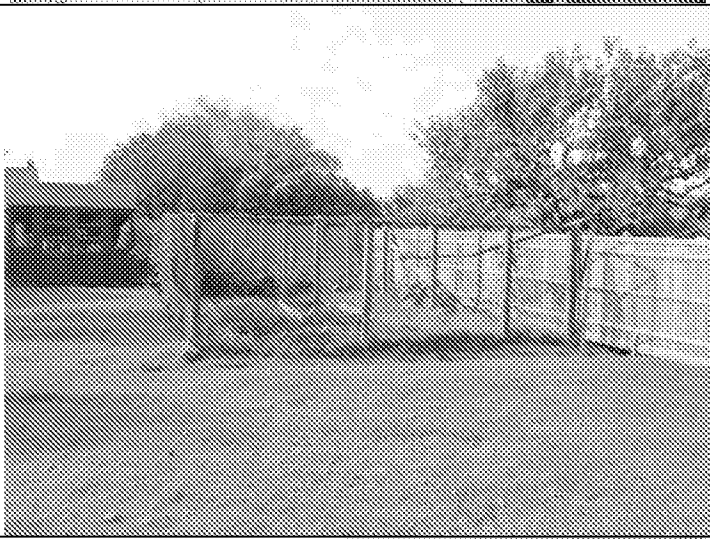
- 3.11 Building 3 was a small summer house situated to the north of building 1 close to the western boundary of the site. The building was largely built of tight wooden weatherboarding, with a large amount of windows. No evidence of bats was recorded within the building and the building was considered to have limited potential, with a lack of suitable features for roosting. This building will also be removed under proposals.

| <b>Photograph 5:</b> Old Veg patch and building 3 | |

- 4.5 Building 3 was a small summer house style building. Again the internal environment was subject to high light levels of natural light from windows and contained no internal roof void. The building lacked external features which bats could exploit, with tight weatherboarding and small pitched roof with tight felt style tiles. No evidence of bats was recorded within building 3 and it was considered that the building lacked any potential to support roosting bats. No further surveys are recommended and the building is not considered to be constrained by bats.
