# **Drainage Statement**

**Site: Booker Hall, Rustington Hall  
Nursing Home, Station Road,  
Rustington, BN16 3AY**

**Proposal: Demolition of existing community hall  
and associated storage buildings, and  
construction of replacement  
community hall.**

# FACTUAL SITE INVESTIGATION REPORT

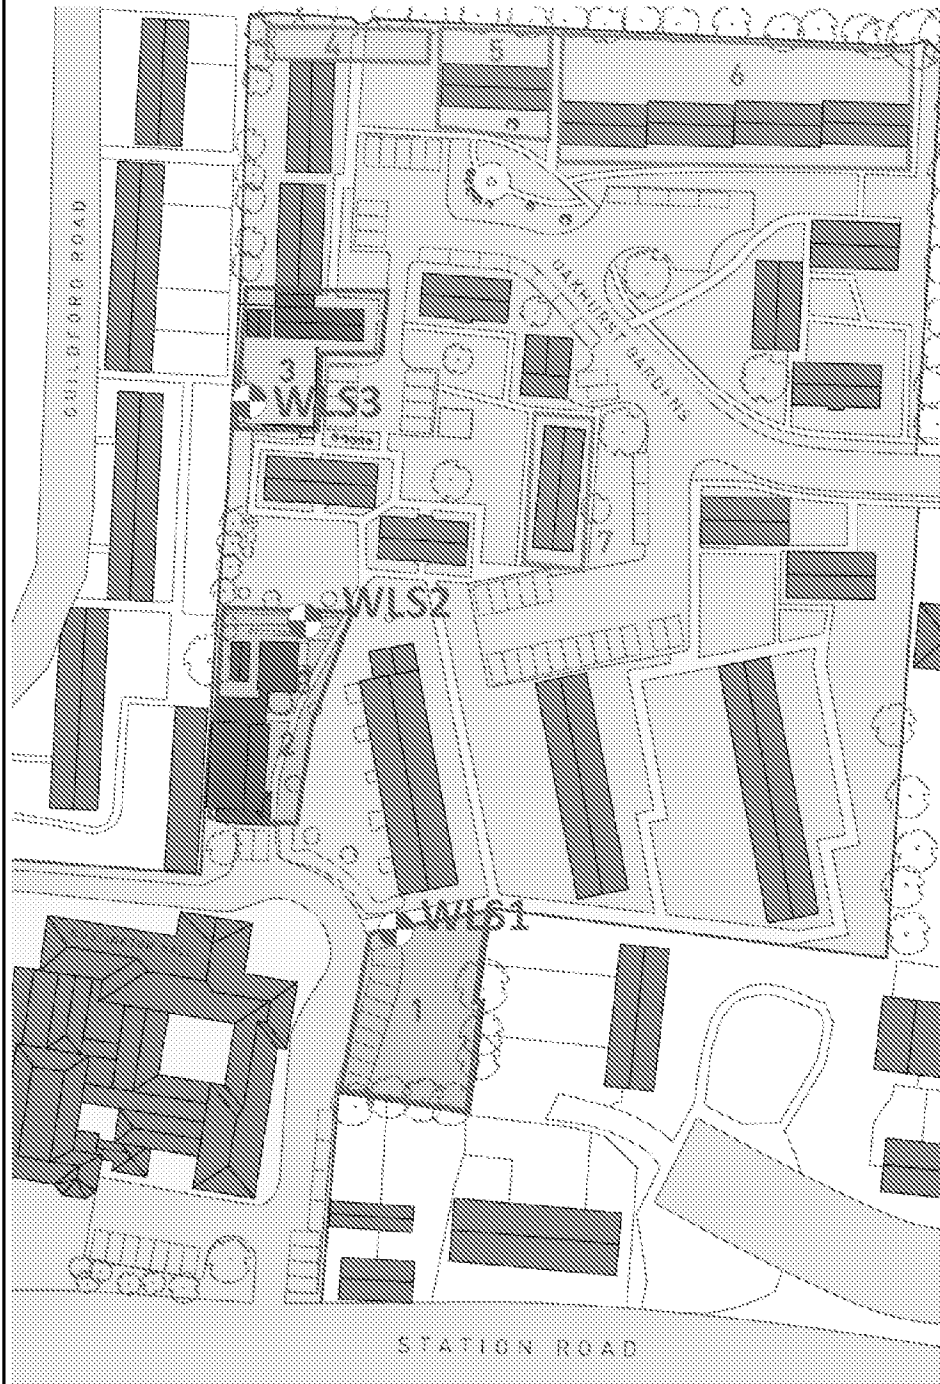
Figure 2: Site  
Investigation Plan

The Site Investigation Plan showing the final exploratory positions is provided in **Figure 2**.

WLS

Borehole

Development  
Areas

- 3no. windowless sampler boreholes (WLS1-WLS3) to a maximum depth of 6mbgl;
- 3no. groundwater standpipe installations to a maximum depth of 5.55mbgl.

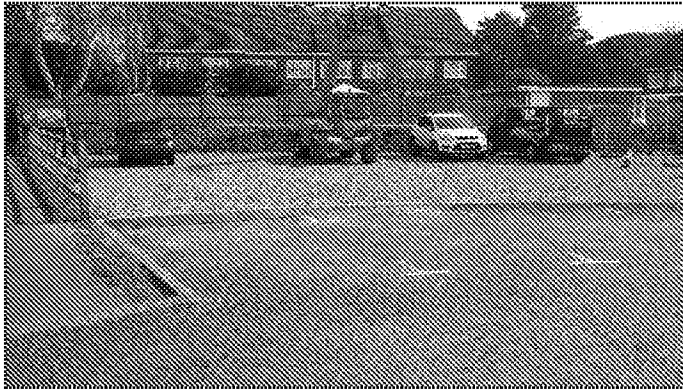
1.

- 1) WLS1 general area
- 2) WLS1 reinstatement
- 3) WLS2 reinstatement
- 4) WLS2 general area

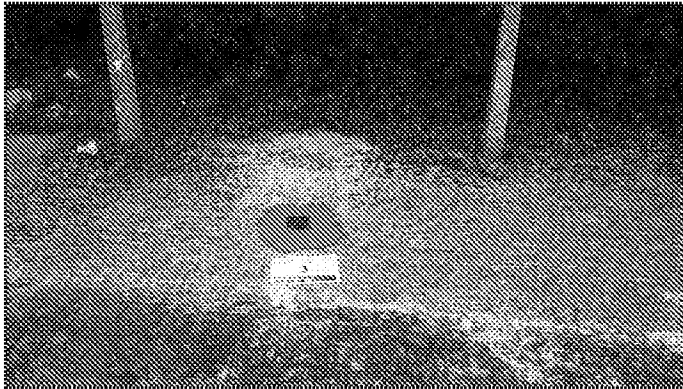
5.

- 5) WLS3 reinstatement
- 6) WLS3 general area
