| Surface Water Drainage Technical Note | | |
| Project Name & Number: | Condair, Brookside Avenue | D2287 |
| Client: | Condair Ltd | |
| Planning Reference: | R/239/24/PL | |

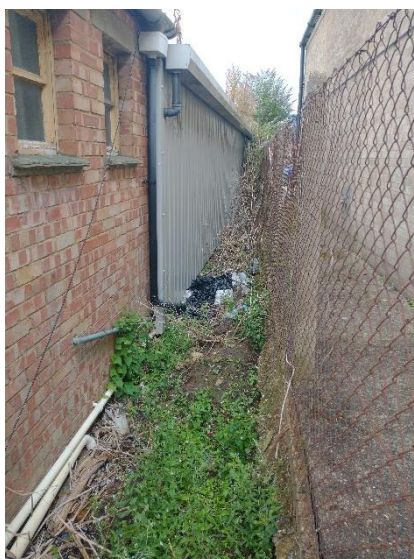
Figure 3. Photograph depicting the strip of unkept land between the existing building and the neighbouring site to the south

In respect of Arun District Council's comment on surface water flood risk, Flood Maps for Planning identifies extents at the southern boundary between the existing building and the neighbouring building to the south as being at 'Low' risk of surface water flooding (1 in 1000). This 'corridor' is an unkept strip of land (see Figure 3) which is lower-lying than the adjacent site's concrete slab levels, as demonstrated by the site topographic survey. This represents a localised low-point in topography.

The proposed development will introduce soft landscaping in addition to the hard landscaping (permeable paving) along the southern boundary of the site, with edgings and/or kerbs introducing an upstand. The proposed development will therefore 'design out' this localised low point, and it is not considered that this represents a risk of surface water flooding on site, or that there will be any detriment to the operation of the surface water drainage system. It is also not considered that the extents identified represent a significant catchment and/or represent a surface water flow path. The site is in a flat, low lying setting.
