# Design Statement

29 Frobisher Way  
Rustington

The property is located within Frobisher Way. The proposal is for loft conversion, rear extension and remodelling to front elevation.

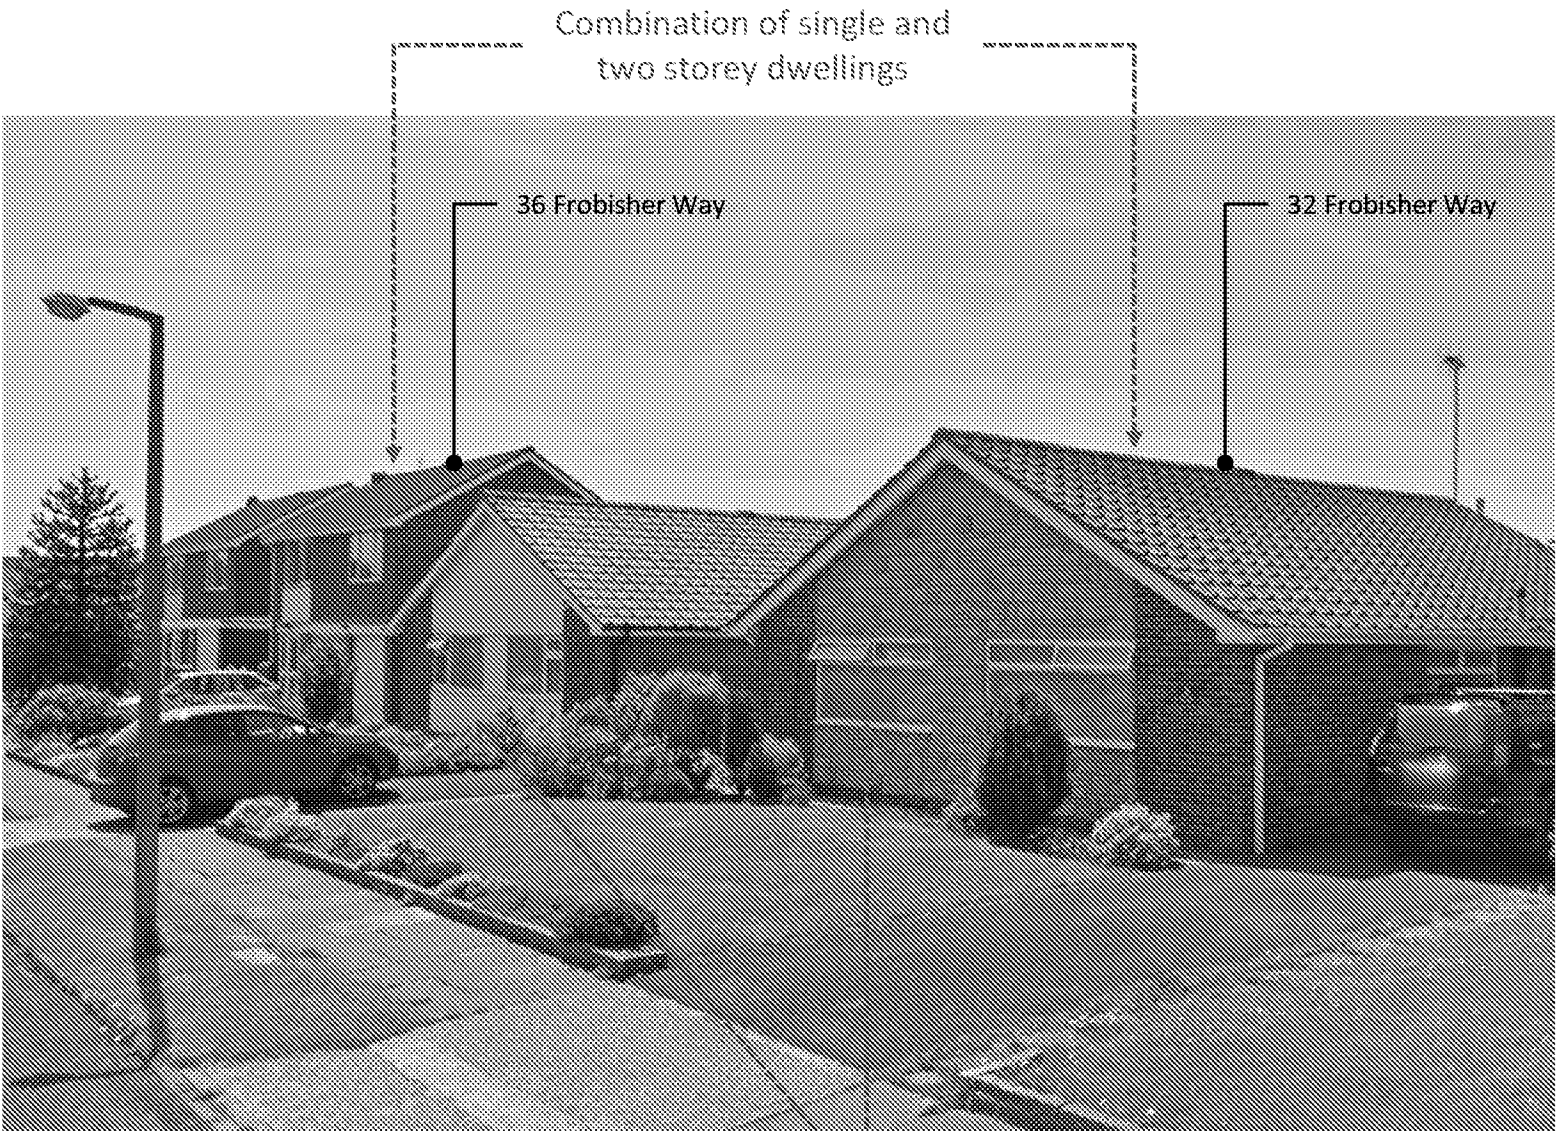
To the south end of Frobisher Way there are further examples of varying scales of dwelling. In addition, the dwellings to right identify a combination of different cladding to the front gable of the properties. This is consistent throughout the street.

Ceramic tile and weather  
boarding cladding examples

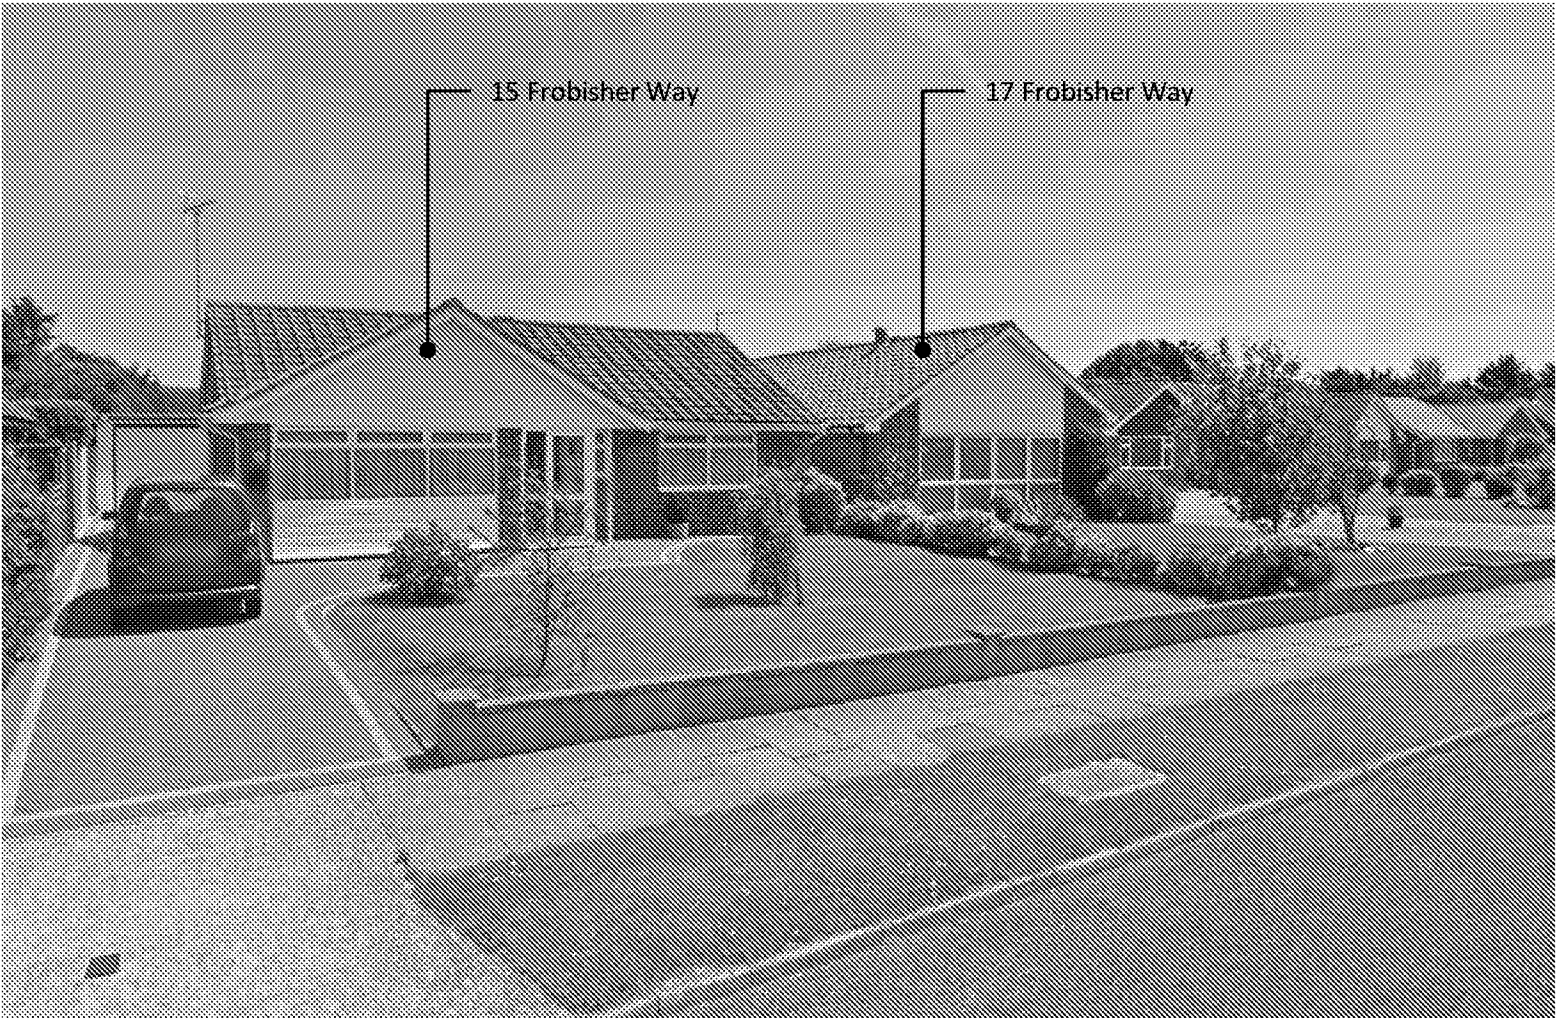
The street view to the right demonstrate two further examples north of 29 Frobisher Way which feature weather board cladding to gables.

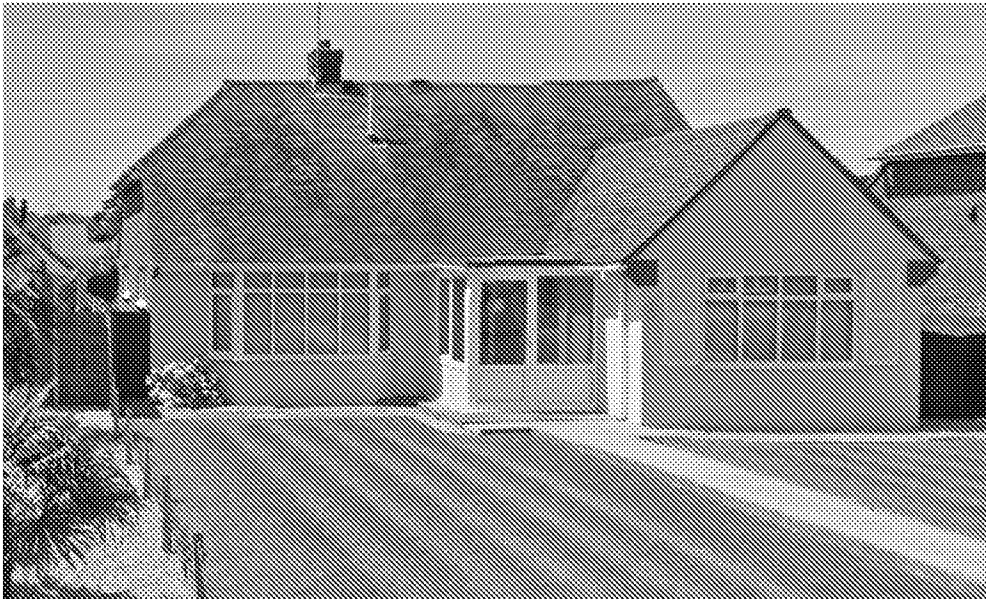
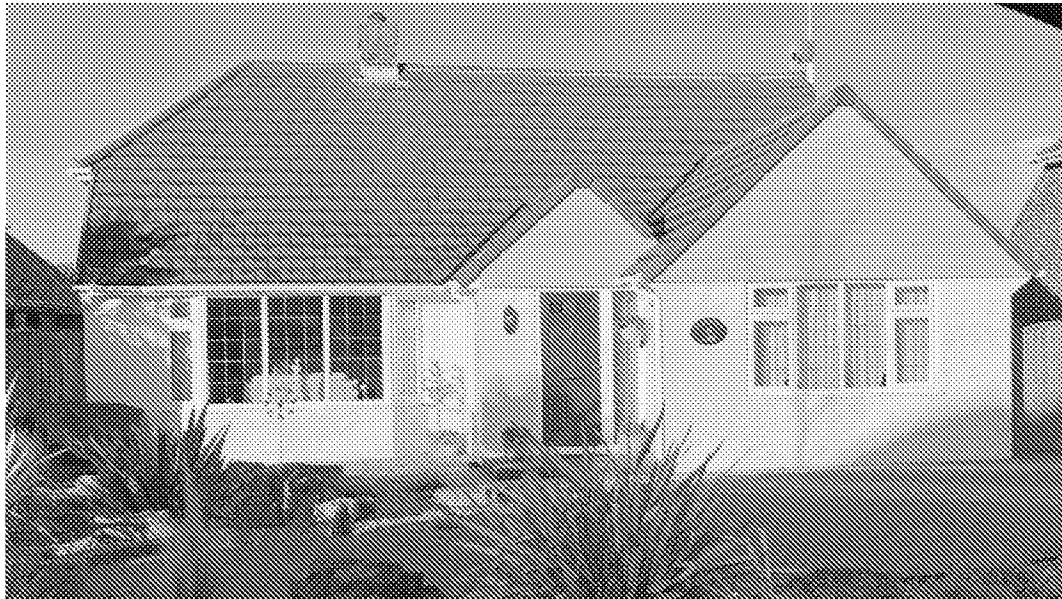
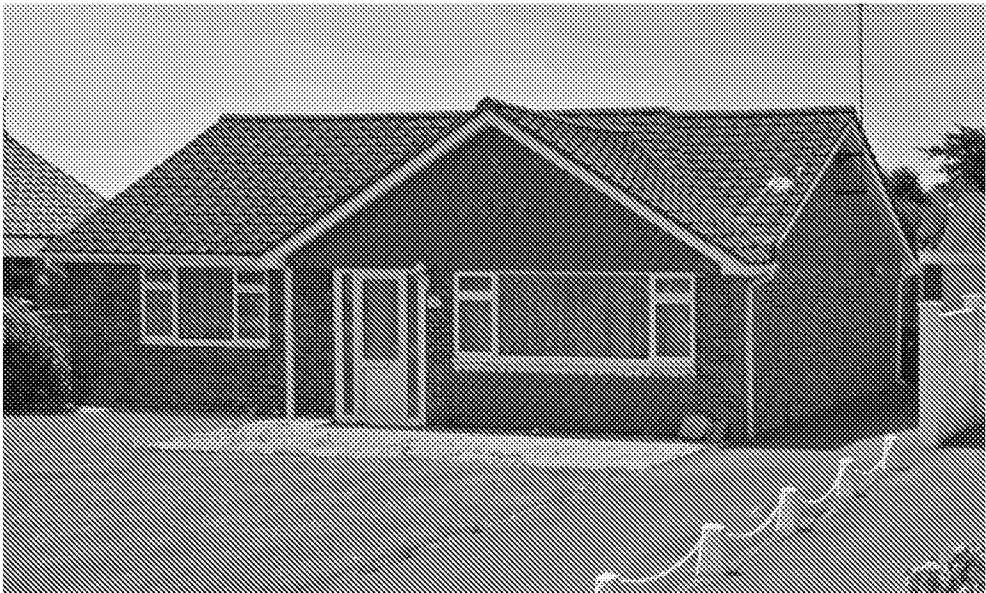
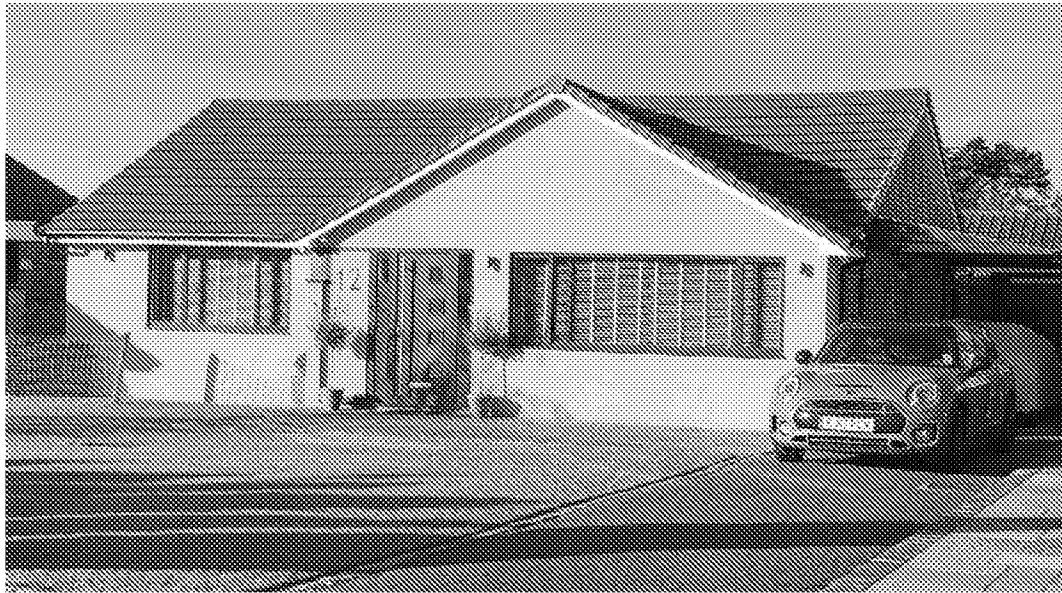
The images above are precedents of other bungalows in Frobisher Way that have recently been refurbished with weather boarding and slate effect cement tiles.

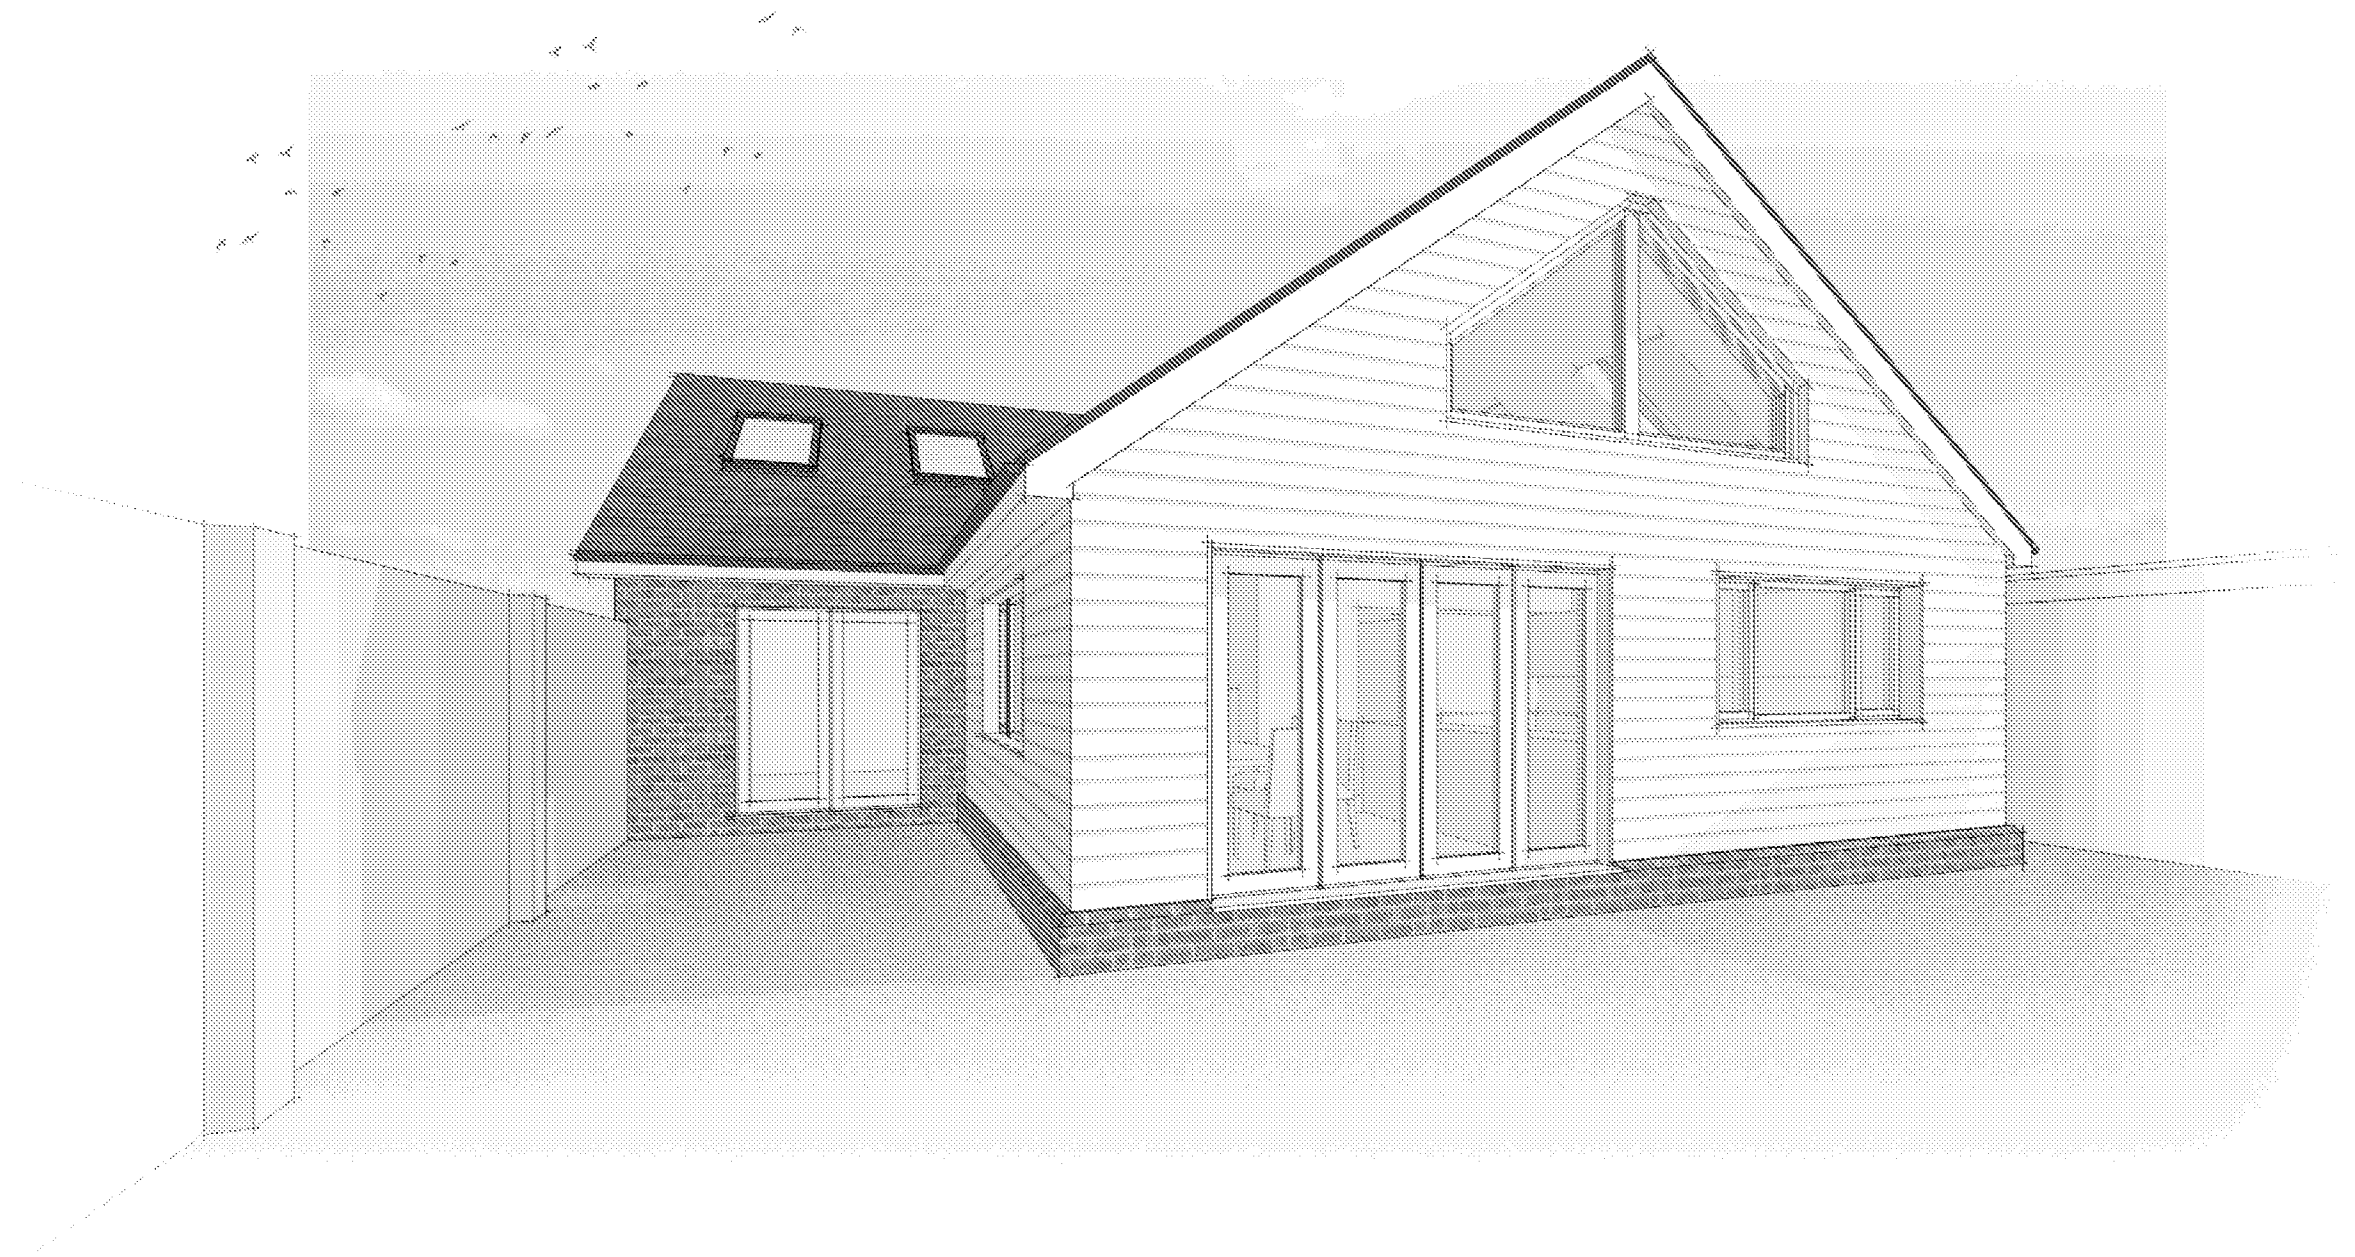
3D view of rear elevation

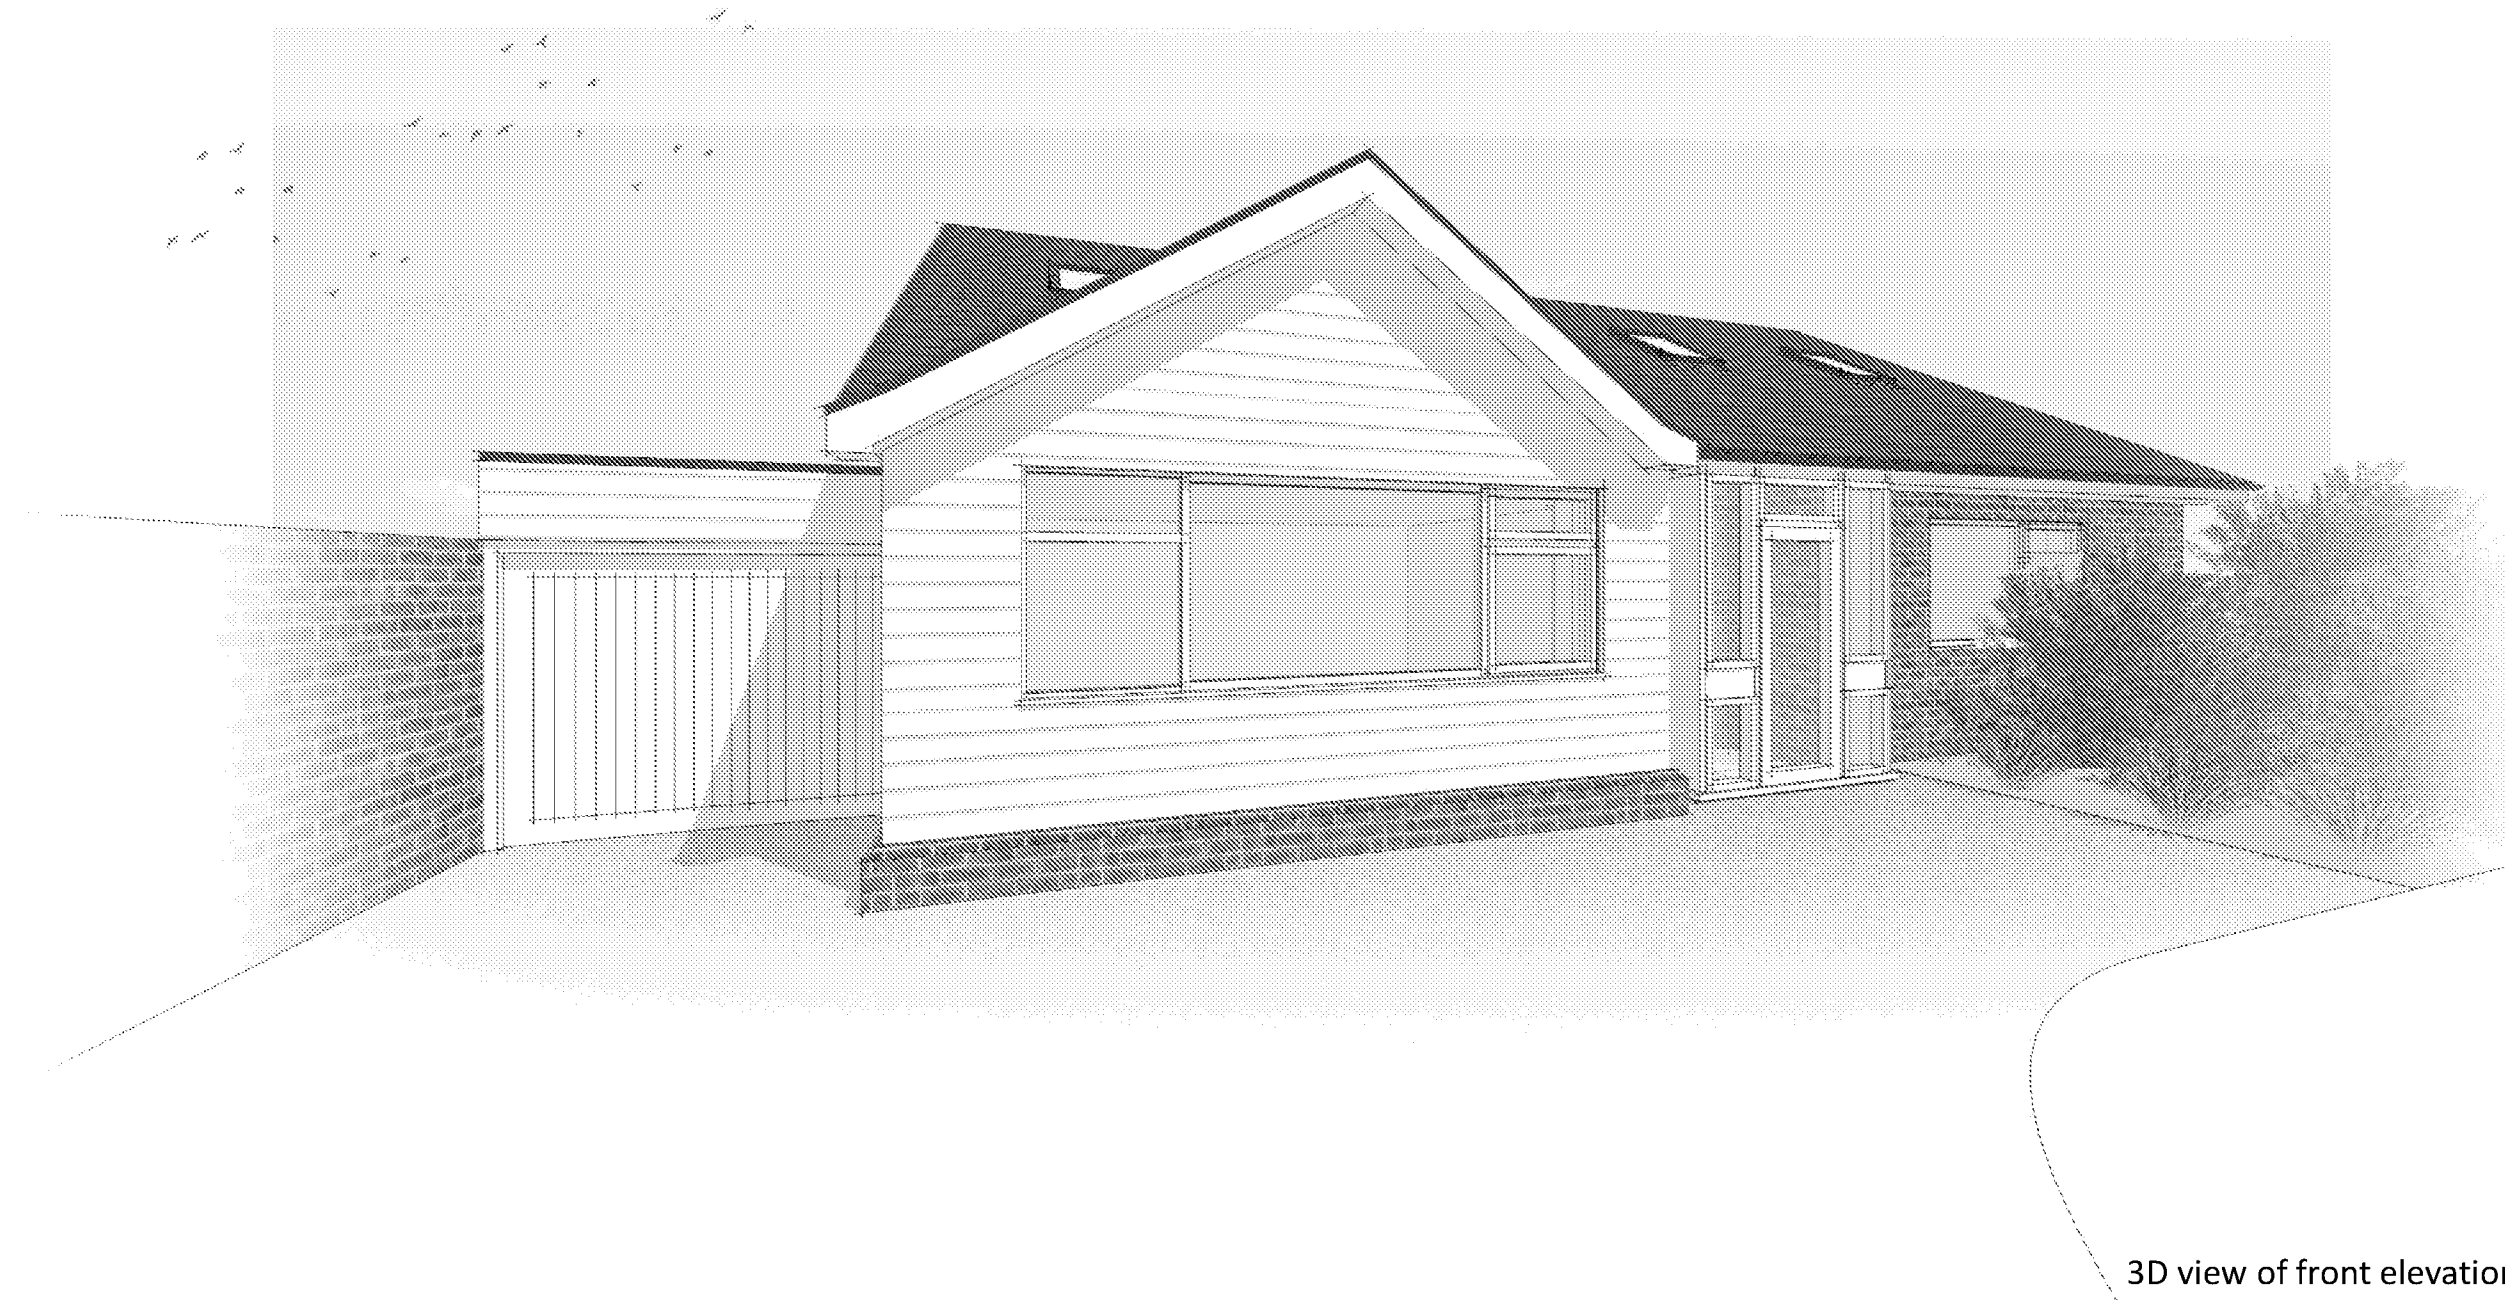
3D view of front elevation
