## Preliminary Ecological Appraisal

6 Manor Road

Rustington, West Sussex

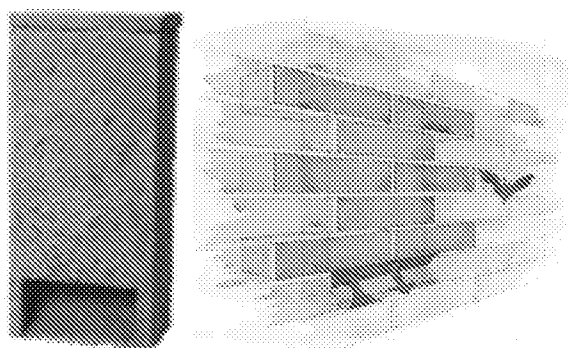
*Figure 3: Schwegler 2FR tube (left) and Habibat 003 Bat Box (right)*

- 4.9 New roosting opportunities can be created by integrating bat boxes/tubes in the new dwelling (Figure 3). These provide good opportunities for crevice-dwelling species such as pipistrelles. The opening of the bat box/tube will be the only section visible and they are designed so that they require no maintenance. The bat tubes will be installed as high as possible, will not be situated above a window to avoid cat predation and will not be illuminated by artificial lighting. Schwegler or Habibat tubes should be used (Figure 4). A booklet should be created for future home owners informing them of the tubes' purpose and the legal protection surrounding bat roosting sites.

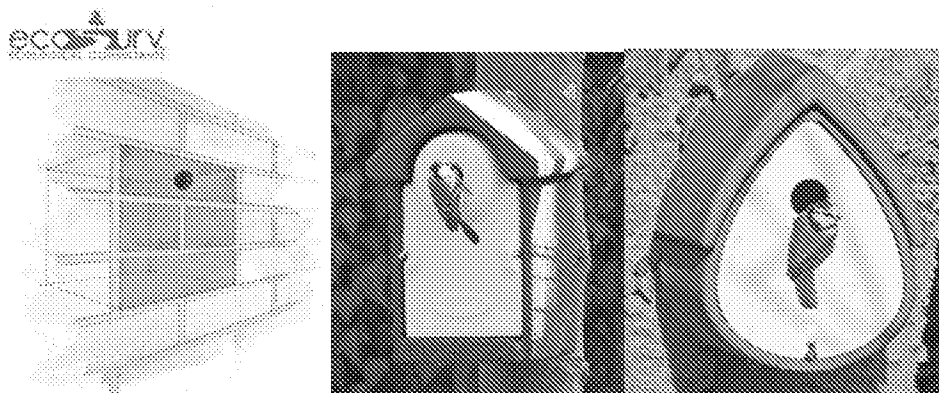
*Figure 4: Integrated starling/sparrow box (left), Vivara box (centre) and Schwegler box (right)*

- 4.14 New nesting opportunities should be provided by installing bird boxes on site. An integrated bird box for sparrows or starlings can be installed in the new dwelling. Some boxes are designed to match the brickwork, such as those by Ecosurv (Figure 4). Boxes could also be installed on fences within a green wall or on the side of the new garage. Examples include the Vivara Pro Seville woodstone nest box and the Schwegler 1MR avianex box, both of which are long-lasting (Figure 4).

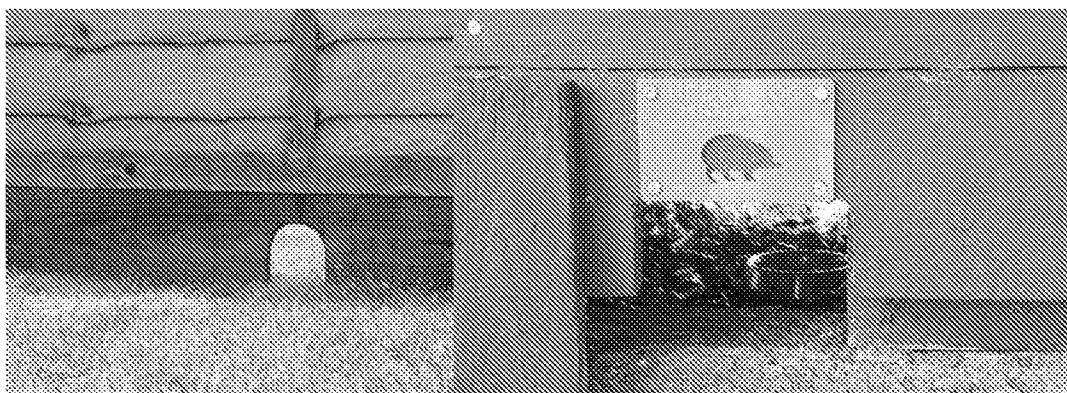
*Figure 5: Hedgehog-friendly fencing and 'highway' signage (hedgehogstreet.org)*

- 4.15 Where possible, fencing will be made hedgehog-friendly on site by creating a 13cm x 13cm hole at the base. This species is declining, in part, due to isolation of habitats and a local of connectivity. As such, these holes provide passageways for hedgehogs to travel between gardens. To ensure that new residents do not block these, small signs will be painted or erected above the hole, such as those produced by the People's Trust for Endangered Species, informing them of their purpose (Figure 5).

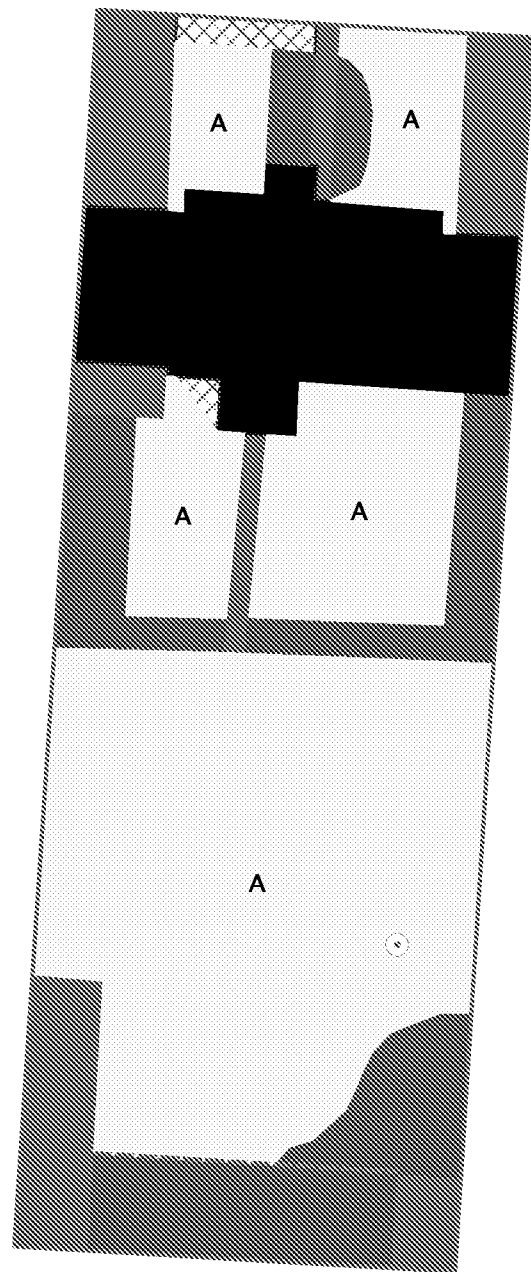
## Appendix 1: Habitat Map (Illustrative only)

- Site boundary
- Building
- ▨ Bare earth
- A Amenity grassland
- ▩ Hardstanding
- ▤ Introduced shrub
- Brick wall
- ⊙ Target note: Mammal holes

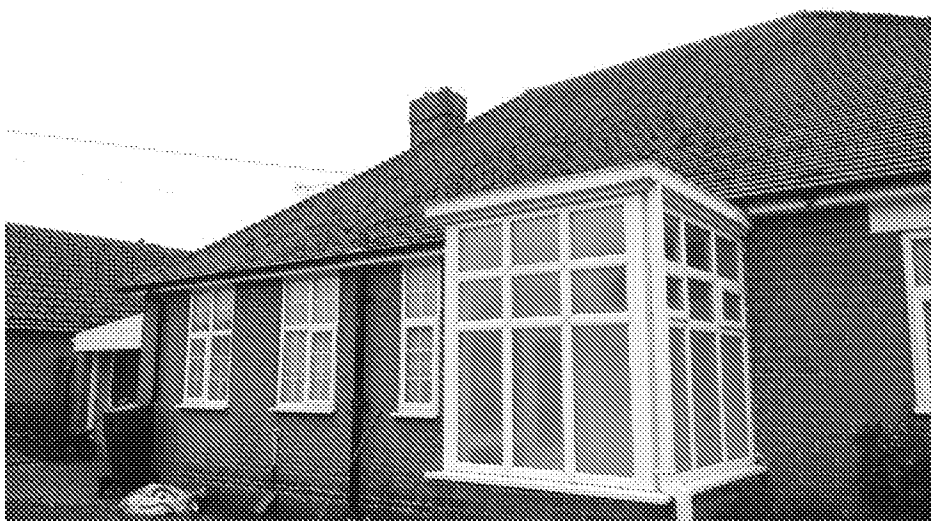
- 3.8 The main dwelling was a brick building with a clay-tiled roof. Multiple gaps were noted under the roof tiles which could offer opportunities for crevice-dwelling bats. This building is to remain in situ and will not be significantly altered as part of the proposals. As such, an internal survey of the house was not carried out.
- 3.9 Two garages were present on either side of the dwelling (eastern and western aspects). The garage on the western aspect is to be dismantled to provide an access route to the new dwelling at the rear. Both garages had low-angled felt-lined rooves with intact soffit and barge boarding. They were also well-sealed with south-facing windows and no potential crevices suitable for roosting bats. No evidence of bats was found in either garage. As such, both structures were considered to have negligible roosting bat potential.

| <p><b>Photograph 1:</b><br/>Front of dwelling at 6 Manor Road.</p> | A black and white photograph showing the front of a two-story brick house. The house has a dark roof, a chimney on the left, and a large white-framed bay window on the right. Several other windows are visible on the front facade. |

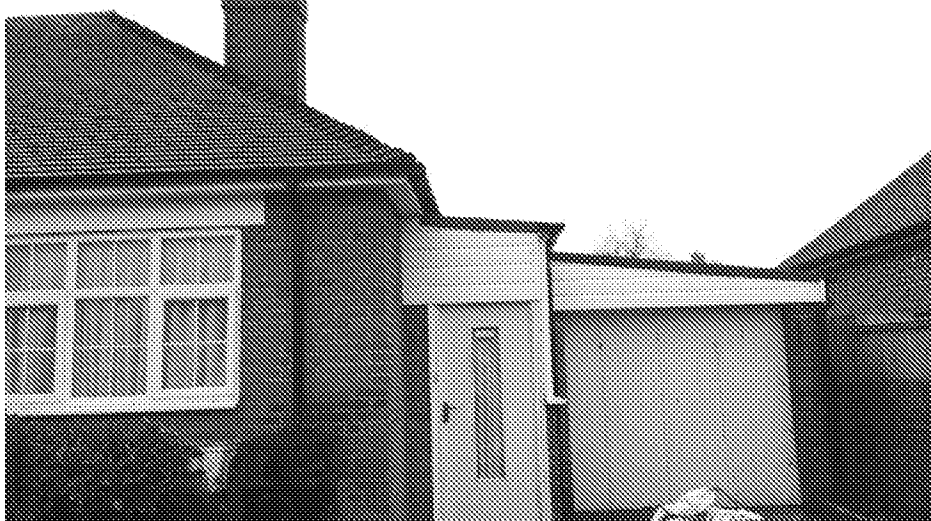
| <p><b>Photograph 2:</b><br/>Western garage on side of dwelling to be removed to create new access.</p> | A black and white photograph showing the side of the house. A white-framed window is on the left. To the right is a small white door leading to a garage. The garage has a white door and a flat roof. The area to be removed is indicated by the caption. |

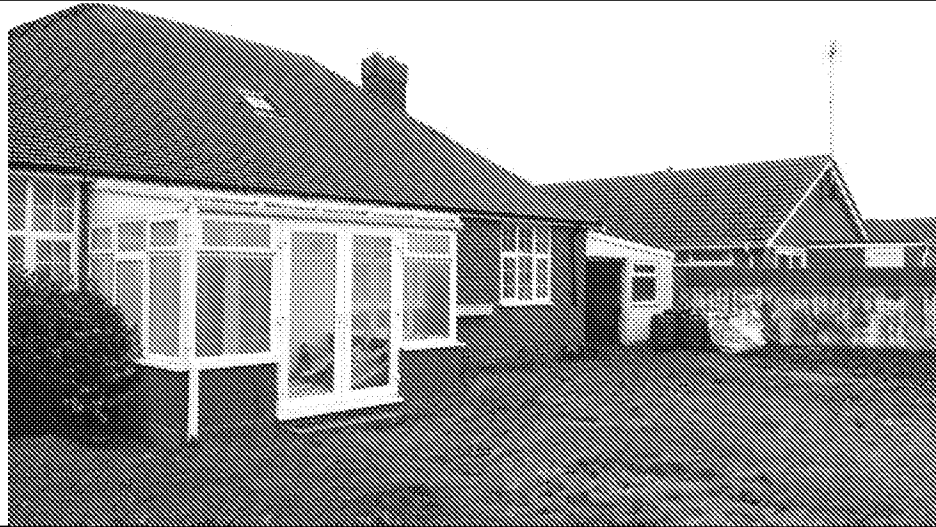
**Photograph 4:**

Rear of main dwelling and view of eastern garage.

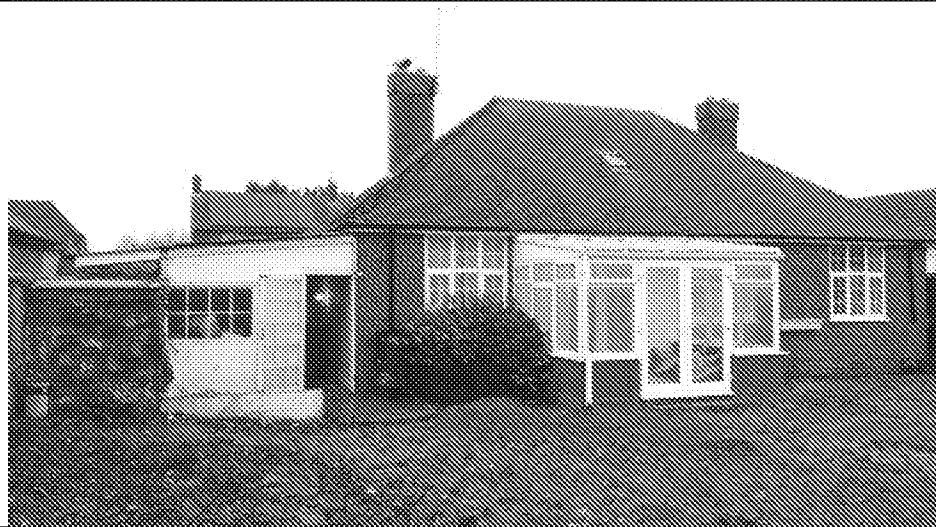
**Photograph 5:**

Rear of main dwelling and western garage.

- 4.4 The garages had negligible roosting bat potential. As such, the western garage can be dismantled without further consideration for bats. However, care should be taken to ensure the house and its roof are not damaged during demolition.

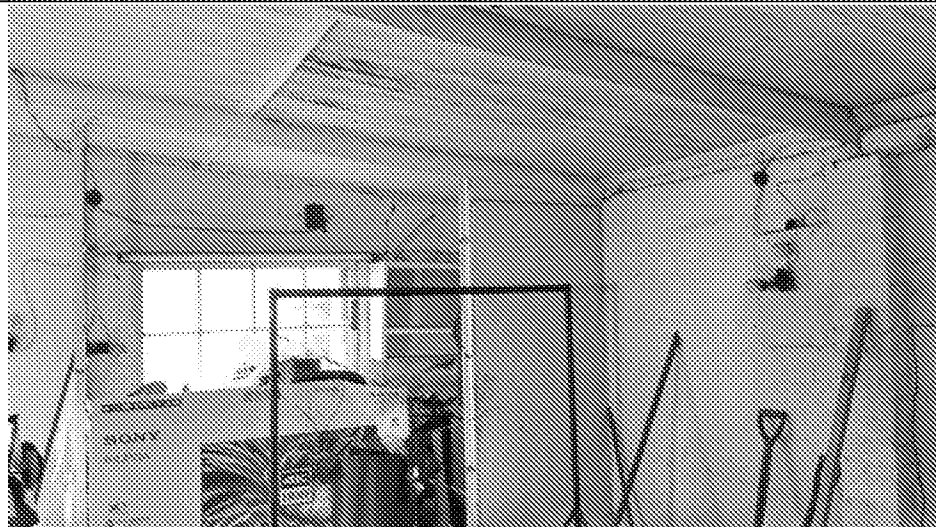
**Photograph 6:**

Inside the western garage – light from window and no crevice suitable for roosting bats.

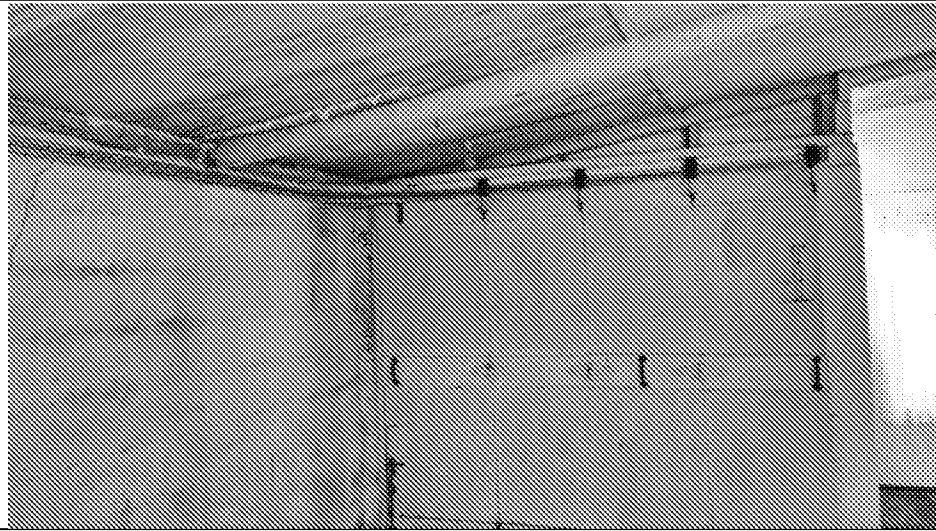
**Photograph 7:**  
Inside western  
garage – well  
sealed.

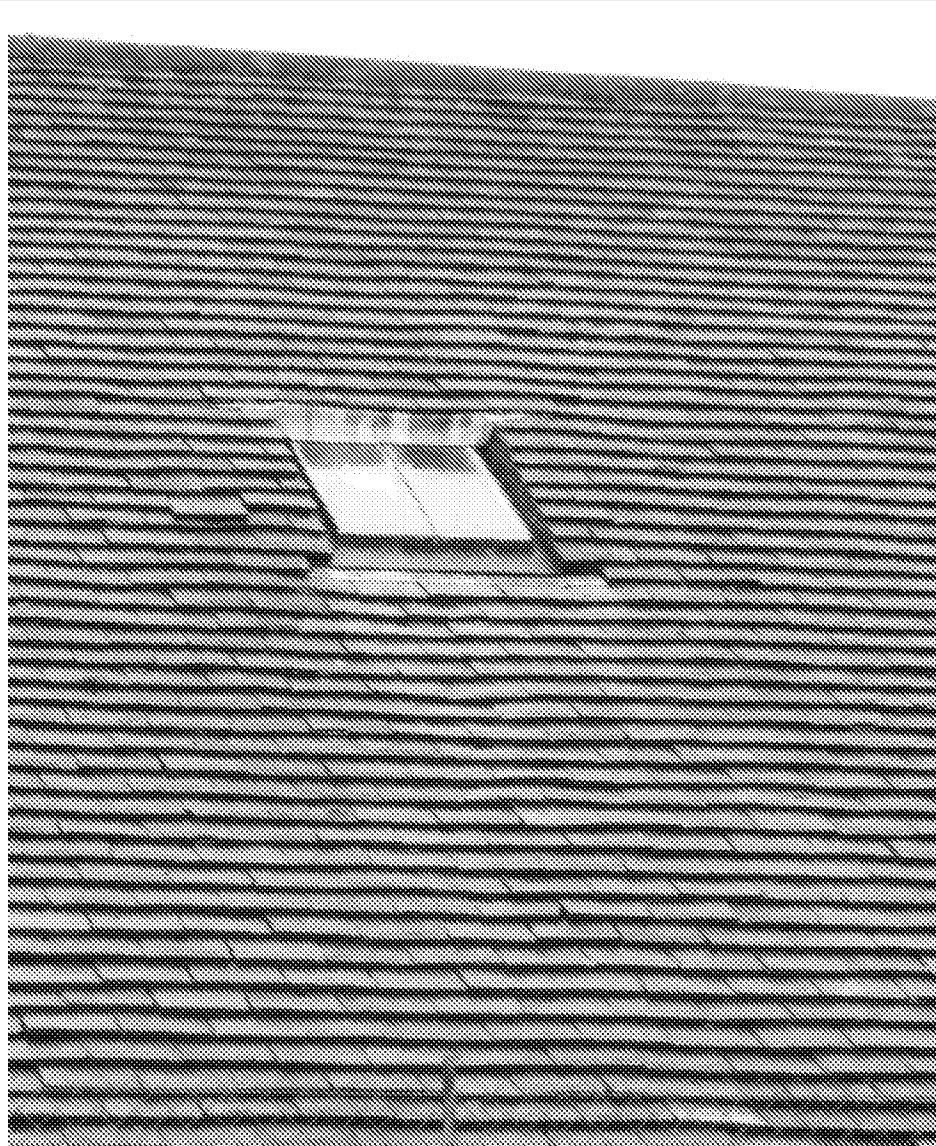
**Photograph 8:**  
Gaps under  
roof tiles on  
southern  
aspect of roof  
of main house.

- 4.5 The house could only be assessed externally and the gaps under the roof tiles mean it has roosting bat potential. The proposals will not impact the roof or the internal void. However, any refurbishment works in the future which could impact the void or the roof will require an internal inspection and further bat surveys.

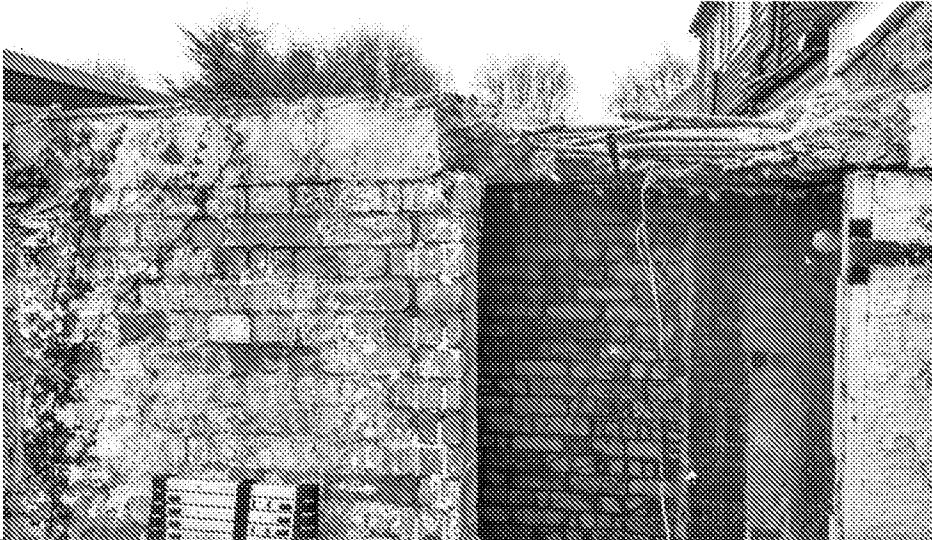
| <p><b>Photograph 9:</b><br/>Brick storage area to the south of the garage – no roosting bat potential.</p> | A black and white photograph showing a brick storage area. On the left is a wall made of large, light-colored rectangular bricks. To the right of this wall is a dark, recessed area that appears to be the entrance to a garage or a storage shed. The ground in front of the wall is covered with some debris and what looks like a small pile of bricks or rubble. |

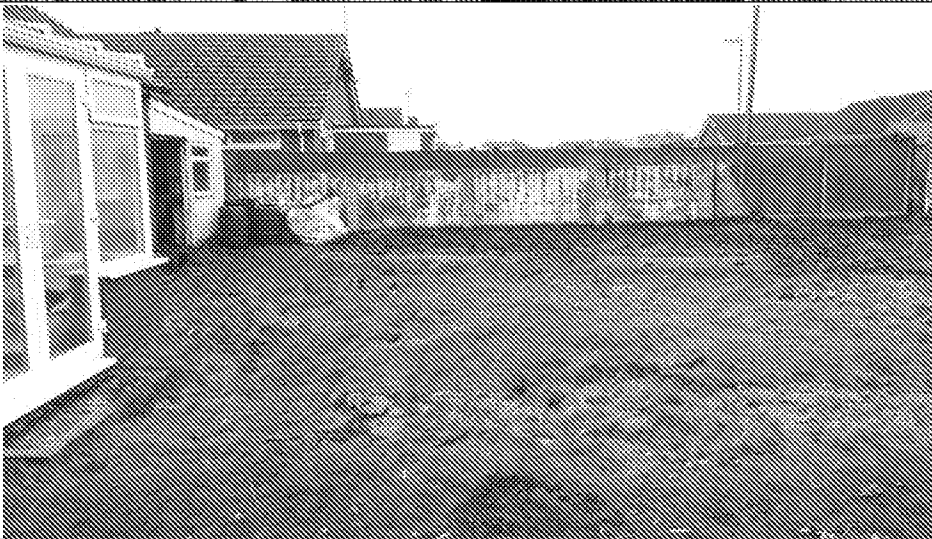
| <p><b>Photograph 10:</b> Rear garden dominated by amenity grassland and bare earth patches.</p> | A black and white photograph of a rear garden. On the left side, there is a white-painted structure, possibly a conservatory or a small extension of the house, with large glass windows. The rest of the garden is a flat, open area with a mix of grass and patches of bare earth. In the background, there is a wooden fence and the roof of a neighboring house. |

- 4.12 The grassland will be enhanced by increasing its species richness with an appropriate seed mix and areas of bare earth will be sown with the same mix. This will include species tolerant to regular mowing as found in the EL1 flowering lawn mixture from Emorsgate Seeds. Species include lady's bedstraw (*Galium verum*), bird's-foot trefoil (*Lotus corniculatus*), meadow buttercup (*Ranunculus acris*), common bent (*Agrostis capillaris*) and crested dogtail (*Cynosurus cristatus*).

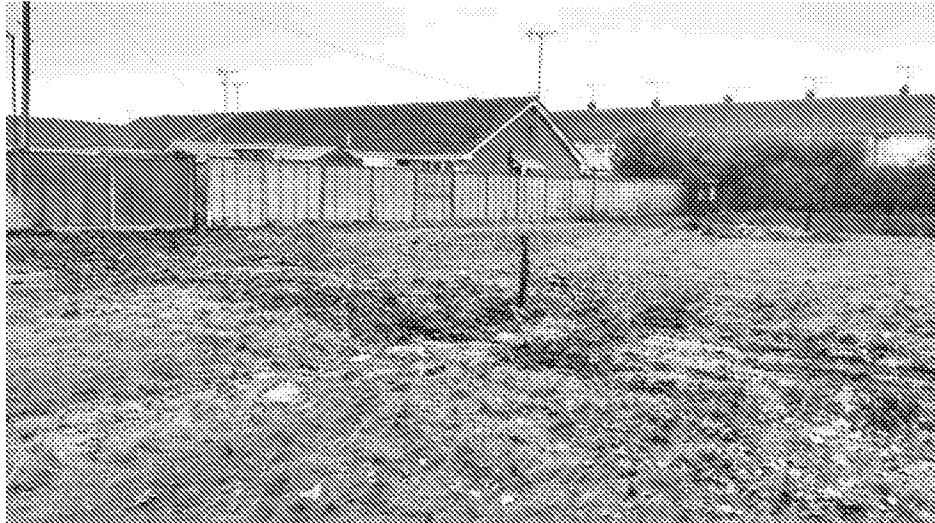
| <p><b>Photograph</b><br/><b>12:</b> Rear garden dominated by short amenity grassland.</p> | A black and white photograph showing a large, open rear garden. The foreground is covered in short, uneven grass. In the background, there is a wooden fence and a row of residential houses with gabled roofs under a clear sky. |

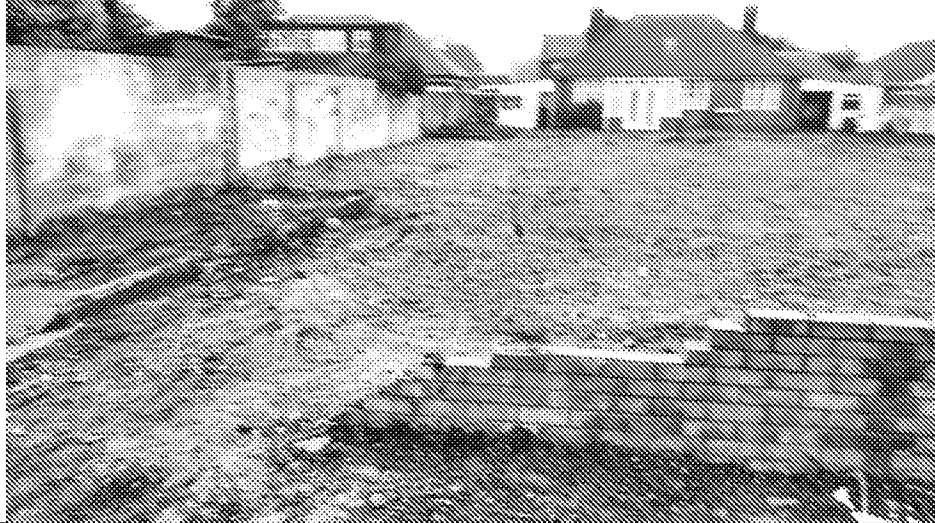
| <p><b>Photograph</b><br/><b>13:</b> Rear garden as seen from southern boundary.</p> | A black and white photograph taken from the southern boundary of the rear garden. It shows a grassy area with a brick wall in the immediate foreground. In the background, a white fence runs along the garden's edge, with houses visible beyond it. |

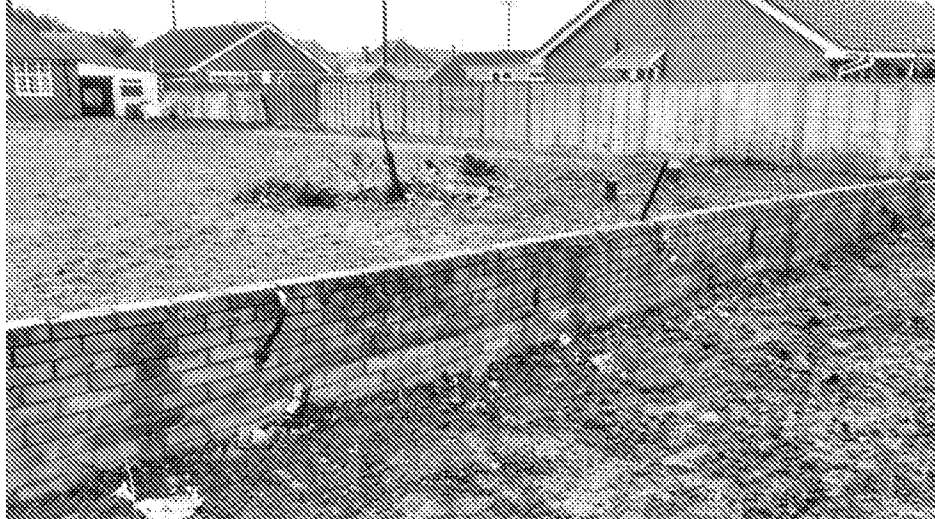
| <p><b>Photograph</b><br/><b>14:</b> Rear garden looking towards eastern boundary.</p> | A black and white photograph looking towards the eastern boundary of the rear garden. A brick wall is in the foreground, and a wooden fence runs across the middle ground. Houses are visible in the background behind the fence. |

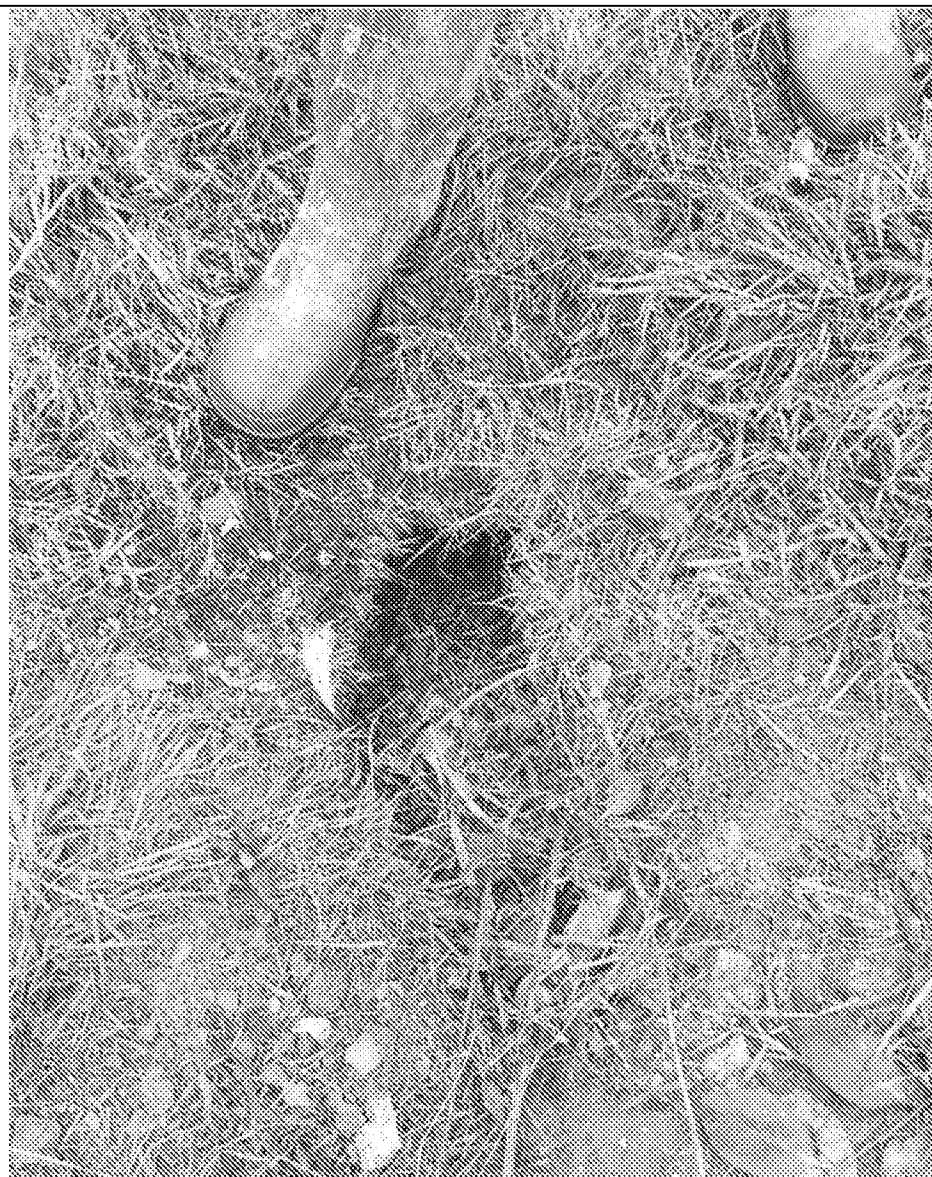
**Photograph**

**15:** One of a handful of small mammal holes found in rear garden.

- 4.7 Mammal burrows were found in the rear garden. These should be excavated sensitively using hand tools to prevent harm to any animals that may be inside. Under the Wild

- 5.6 Small mammal burrows are present in the rear garden. Any mammals which may be present within the burrows are protected under the the Wild Mammals (Protection) Act 1996 from crushing or asphyxiation. This burrows will be excavated sensitively using hand tools to prevent any harm. As long as this method is followed, no residual effects ae predicted.
