**Preliminary Ecological Appraisal and Building Inspection - Rustington Convalescent Home,  
Rustington, West Sussex**

## Rustington Convalescent Home Appendix 1: Site Photographs

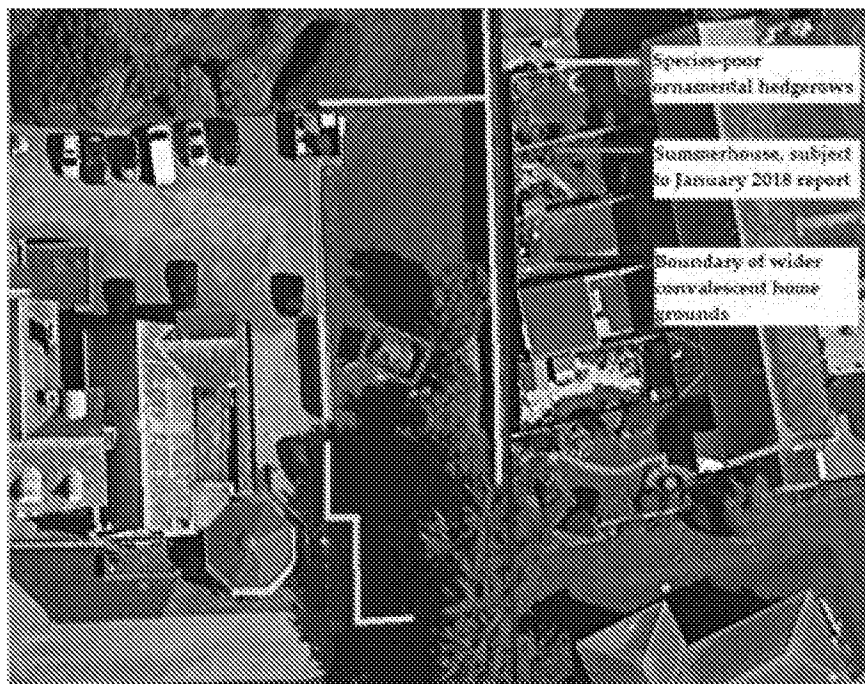
Hedgerows in the immediate vicinity of the summerhouse (see Figure 2) range from 2.5m to 1m in height with all hedgerows measuring approximately 0.5m in width. The dominant species present within the hedgerows comprised Escallonia (*Escallonia* sp) with evergreen spindle (*Euonymus japonicus*), ivy (*Hedera helix*) and bramble (*Rubus fruticosus* agg) present in the hedgerow extending to the east of the summerhouse. Hedgerows present immediately adjacent to the summerhouse are shown in Figure 2 below.

**Figure 2: Location of hedgerows immediately surrounding summerhouse**

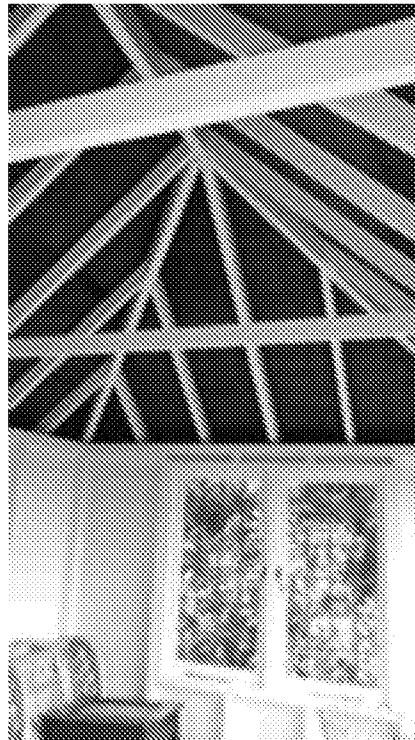
The summerhouse comprised a small timber building with a pitched and bitumen tiled roof set on a concrete slab platform. Internally, bitumen roofing felt is present between the external bitumen tiles and interior roof rafters. The internal bitumen roof lining was in a reasonable condition with few rips/holes noted; however, areas of the roof lining were noted to be damp, particularly above the eaves with patches of mould also observed. Externally, the roof tiles appeared to be well sealed with few narrow gaps noted in places beneath the ridge. The narrow gaps were not sufficient to provide opportunities for crevice dwelling bat species. It was observed that the capping on the hipped end terminal ridge tiles were missing, creating a small opening at the end of the ridge. No bats or evidence of bats, such as droppings or staining was identified within the summerhouse and no external evidence of bats was found.

No bats or evidence of bats, such as droppings or staining was identified within the summerhouse and no evidence was found externally on sections of the summerhouse able to be viewed from ground level. Although some small gaps were present at the gable ends of the structure under the ridge tiles, the gap was considered to have negligible suitability for roosting bats. It is considered that the exposed nature of the site and lack and fragmentation of any suitable foraging and commuting habitat in the local area further reduce the sites suitability to support roosting bats. No further surveys are recommended and the removal of the building is not considered to be constrained by the presence of roosting bats.

**Photo 3:** Internal view of summerhouse

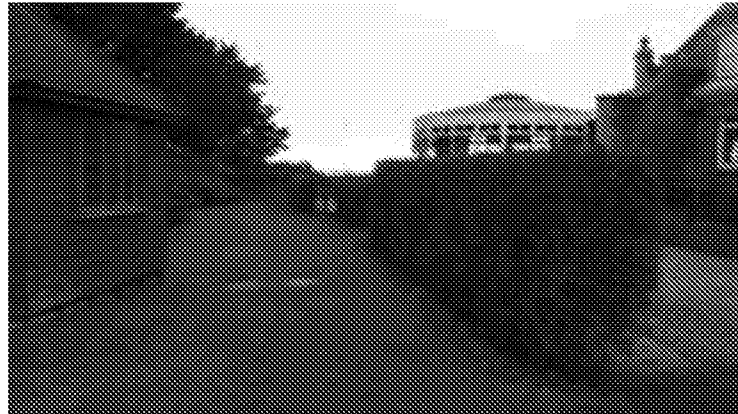
Areas of short mown amenity grassland surround the summerhouse, where typical species included cocksfoot (*Dactylis glomerata*), Yorkshire-fog (*Holcus lanatus*) and annual meadowgrass (*Poa annua*) with daisy (*Bellis pernnis*), dandelion (*Taraxacum officinale* agg), white clover (*Trifolium repens*), ribwort plantain (*Plantago lanceolata*) and yarrow (*Achillia millifolium*).

**Photo 4:** Grassland and hedgerows to the west of the summerhouse

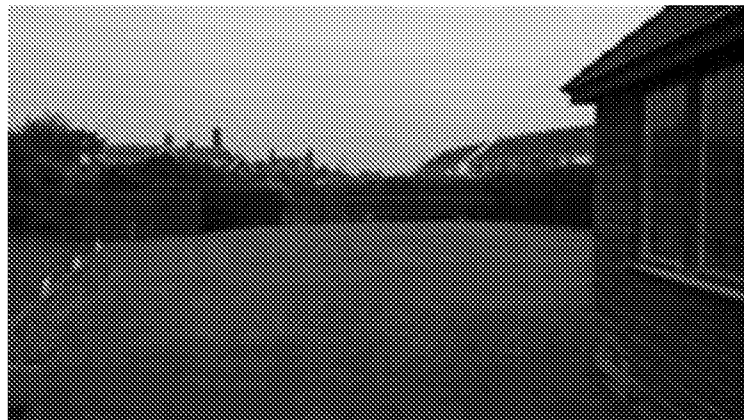
Several lengths of low, well maintained ornamental hedgerows surround the summerhouse, which have been assessed for their species richness and other ecological features. It is noted that hedgerows associated with domestic gardens are not protected under The Hedgerow Regulations, 1997 (as amended).

**Photo 5:** Grassland and hedgerows to the north of the summerhouse

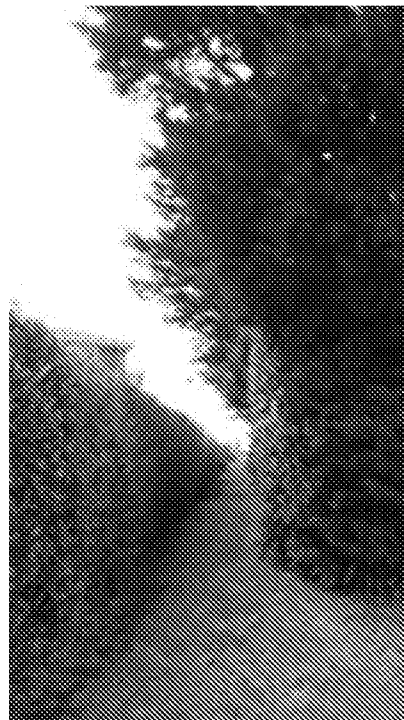
Immediately to the south-east of the summerhouse is a young cherry (*Prunus* sp) tree, beyond which lies an extensive strip of ornamental planting with mature and semi-mature coniferous trees. Additional

Although several mature and semi-mature coniferous trees are located within an area of ornamental planting immediately to the east of the building, these trees were considered to have negligible potential to support bats, owing to a lack of suitable features for roosting, such as cracks, rot holes, woodpecker holes and/or dense ivy cover.

**Photo 6:** Hedgerow and ornamental planting to the east of the summerhouse
