01. Tree Removals Plan Scale 1:500

Location  
Client  
Littlehampton, West Sussex  
The Carpenters' Company

Rustington Convalescent Home  
Tree Protection and Removals Plan  
494-CLA-XX-0F-DR-L-0700

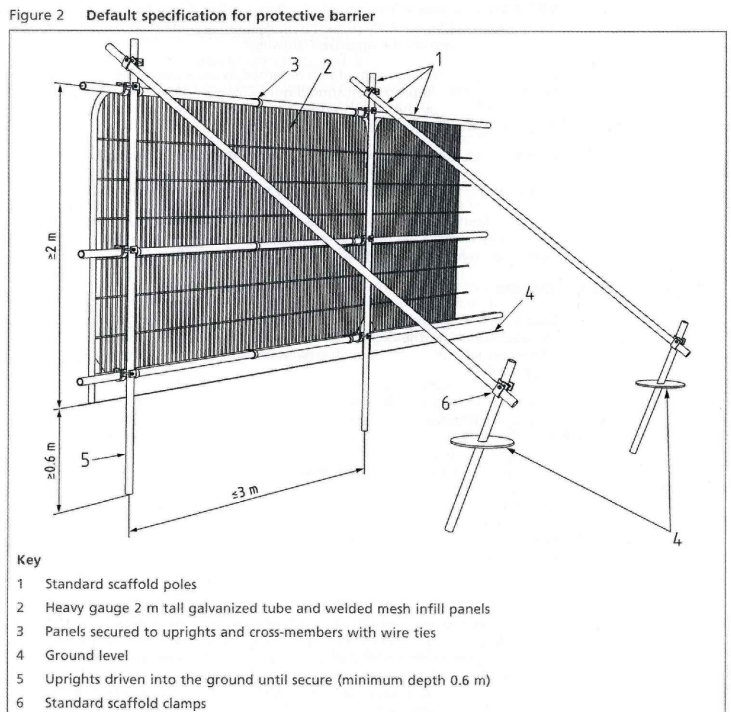
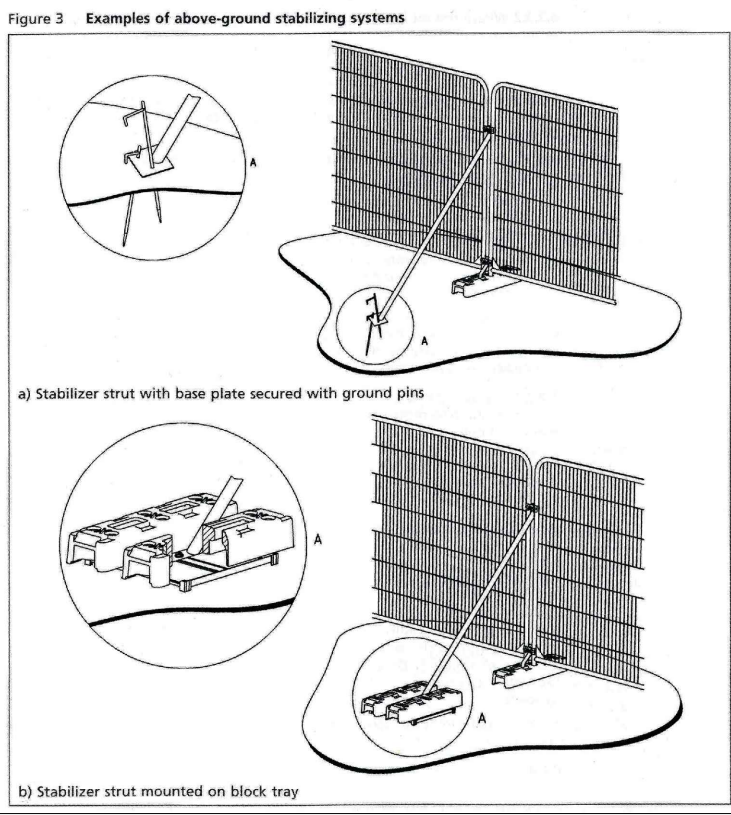
Protective fencing as specified by BS 5837-2012 is to be used for tree protection, see BS diagrams below.
