# **CONTAMINATION ASSESSMENT**

**Fircroft Crescent, Rustington  
West Sussex**

**December 2025**

A site visit was undertaken on 24<sup>th</sup> November 2025 and the area was inspected. The yard was in a derelict state and had not been used for a number of years. The open areas of the yard were surfaced with concrete and there was a container parked adjacent to a building. Where exposed, the concrete was clean with no evidence of staining by oil.

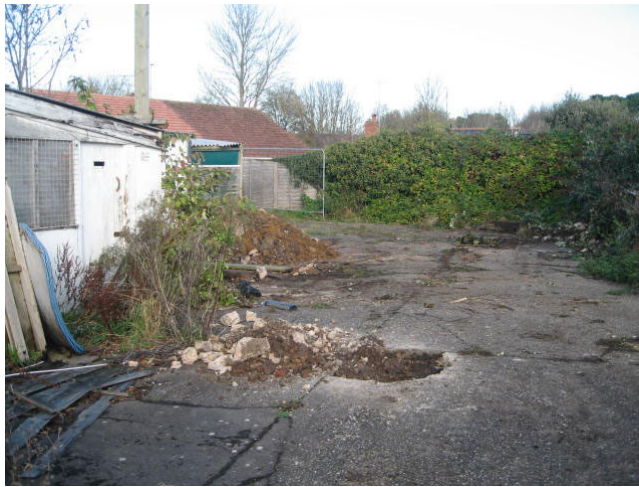
Photograph 1

Photograph 1: A general view looking north to the existing access.

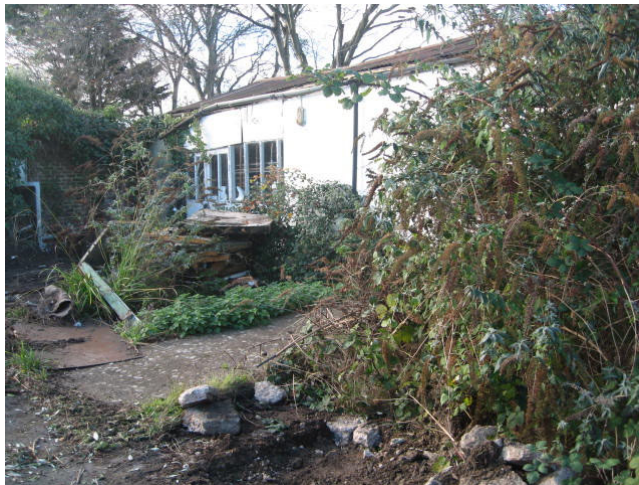
Photograph 2

Photograph 2: South west corner showing a building used as an office and for storage.

Overgrown builders' debris and a steel plate on the concrete.

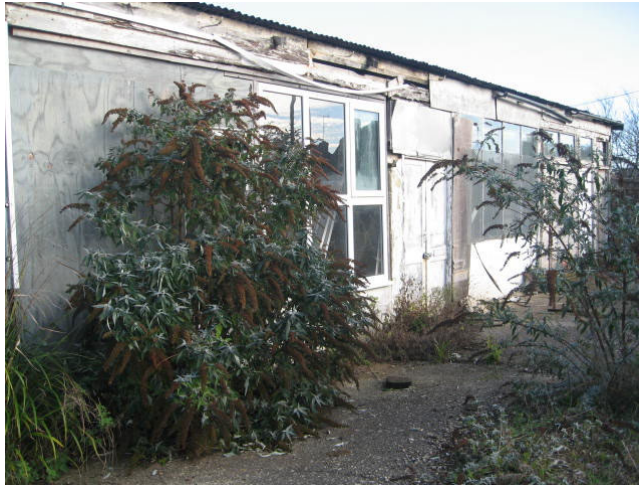
Photograph 3

Photograph 3: Carpentry workshop on the north side of the yard.

Generally, there were piles of inert material, including hardcore in the yard. The carpenters building contained building materials, wood, cans of paint etc and the electricians building contained unused fittings and coils of wire. The remaining buildings were either empty or full of general rubbish. The container was not

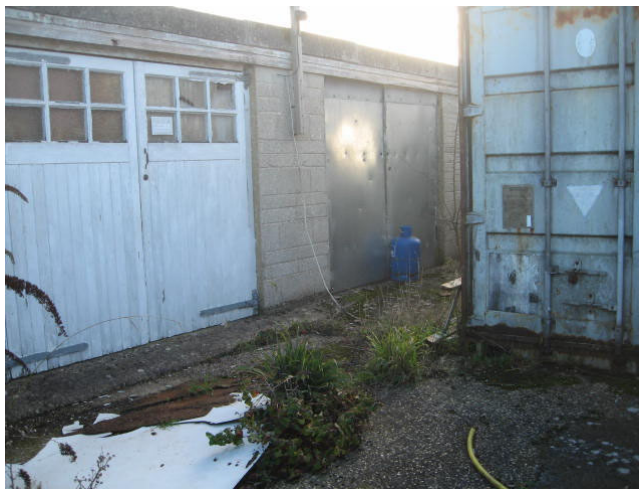
Photograph 4

Photograph 4: Building on the east side of the yard used by an electrician, also part of the container.
