Our ref: GE16334/JT01/180228

### **Rustington Convalescent Home – Soakage Testing**

Further to your instruction, we write to report on the BRE365 trial pit soakage testing undertaken on the above named site on 15/02/18.

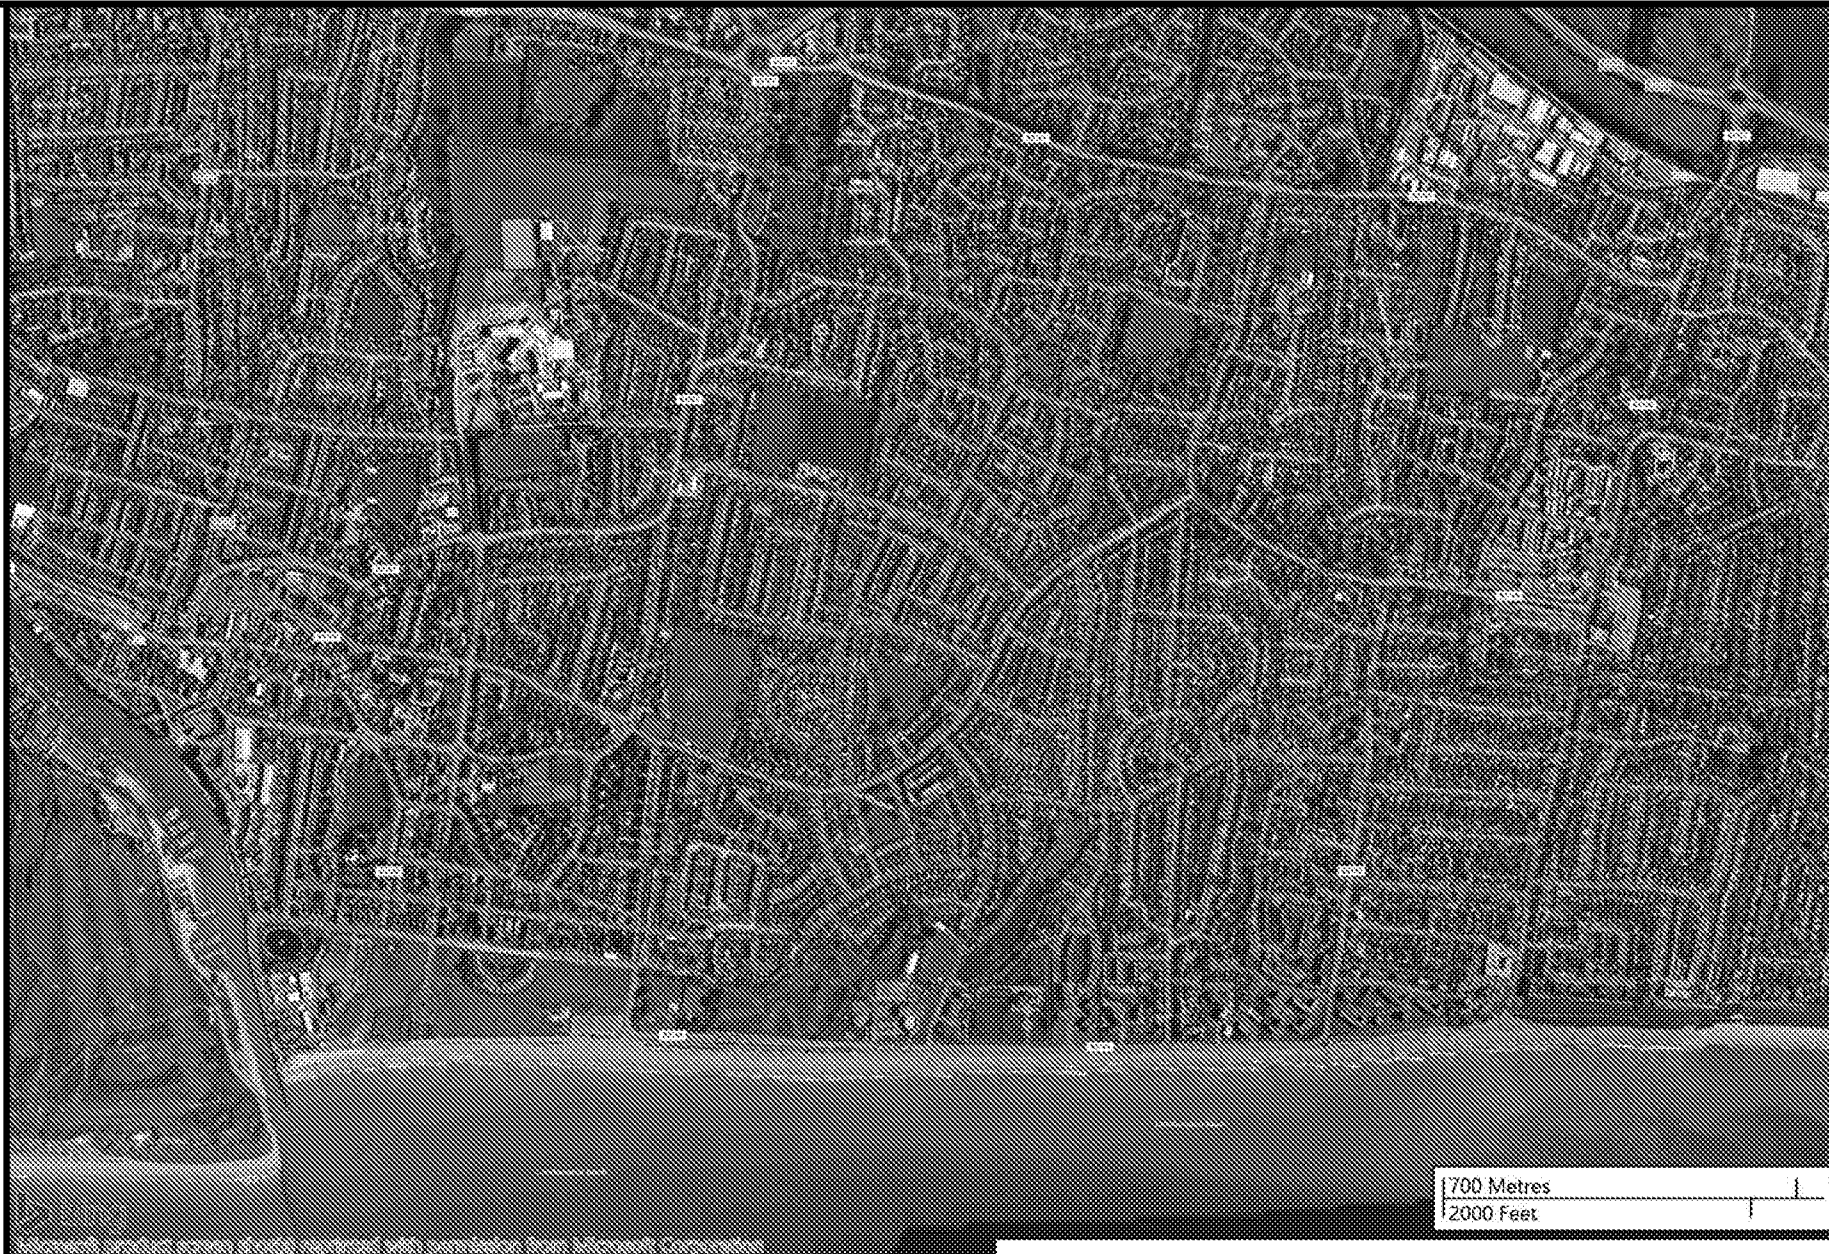
**Title :** Figure 2 - Exploratory Hole Location Plan  
**Scale:** 1:2000  
**Engineer:** DW

The ground conditions recorded within the trial pit comprised turf and Topsoil overlying River Terrace Deposits. The River Terrace Deposits were described variously as silty gravelly CLAY and slightly gravelly clayey SAND and was encountered to depths of between 2.10mbgl and 2.90mbgl. The River Terrace Deposits were in turn underlain by structureless CHALK. The trial pits each terminated in the White Chalk Subgroup at depths of between 3.00mbgl-3.10mbgl. For further details of the ground conditions encountered and trial pit location plan, please refer to the engineer's trial pit logs and plan appended.
