# Preliminary Bat Roost and Ecological Appraisal

Goose Green, Binsted

Document Reference: GS040.GooseGreenBinsted.PEA.v1

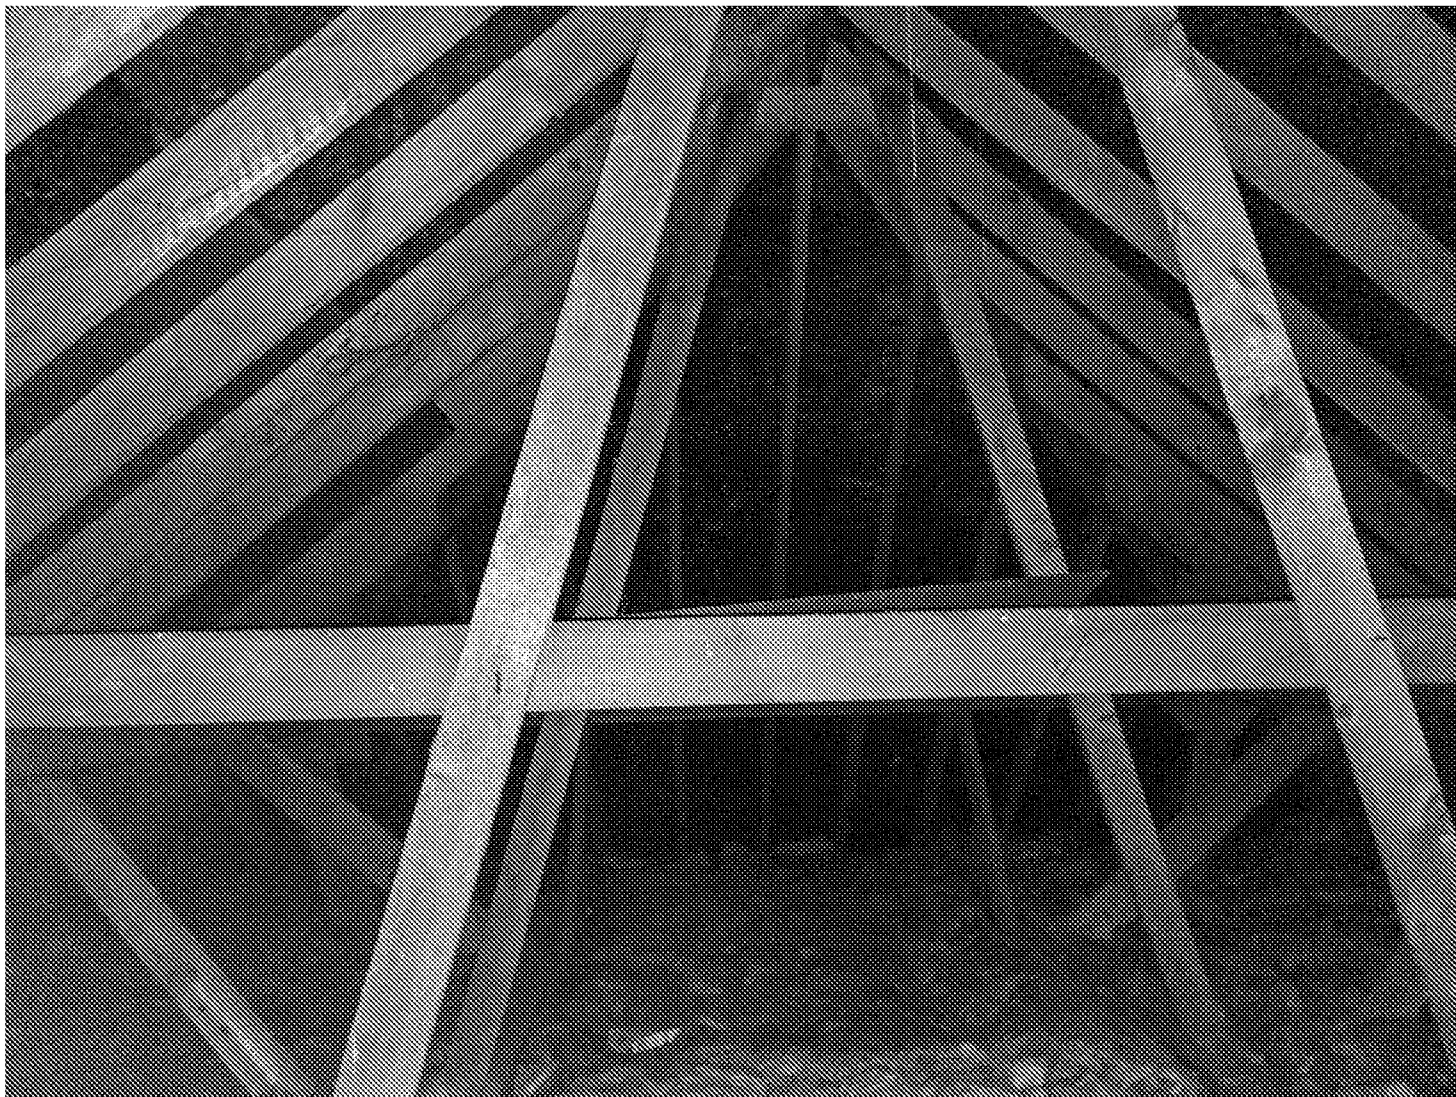
| <i>Building Descriptor</i> | <i>Description</i> | <i>Bat Roost Potential</i> |
|---|---|---|
| <i>B1 - Dwelling</i> | <i>A large detached house, believed to date from the 1930s. The building has been extended several times, most recently with a large flat roofed extension to the east. The building exhibits a complex tiled roof, with several dormer windows with small areas of hanging tiles. A number of tiles were noted to have slipped resulting in potential access points. Internally, the loft was lined with a combination of felt in more modern sections, and timber sarking in older sections. Access into the two modern loft sections was not full possible due to the size of the opening, but inspection with high powered torch did not reveal any obvious large accumulations of droppings. The main loft contained a reasonable scattering (c.50) of bat droppings, likely to be either Myotis sp. or long-eared bat.</i> | <i>High / Confirmed Roost</i> |

Photo 3 – View of the loft of B1.

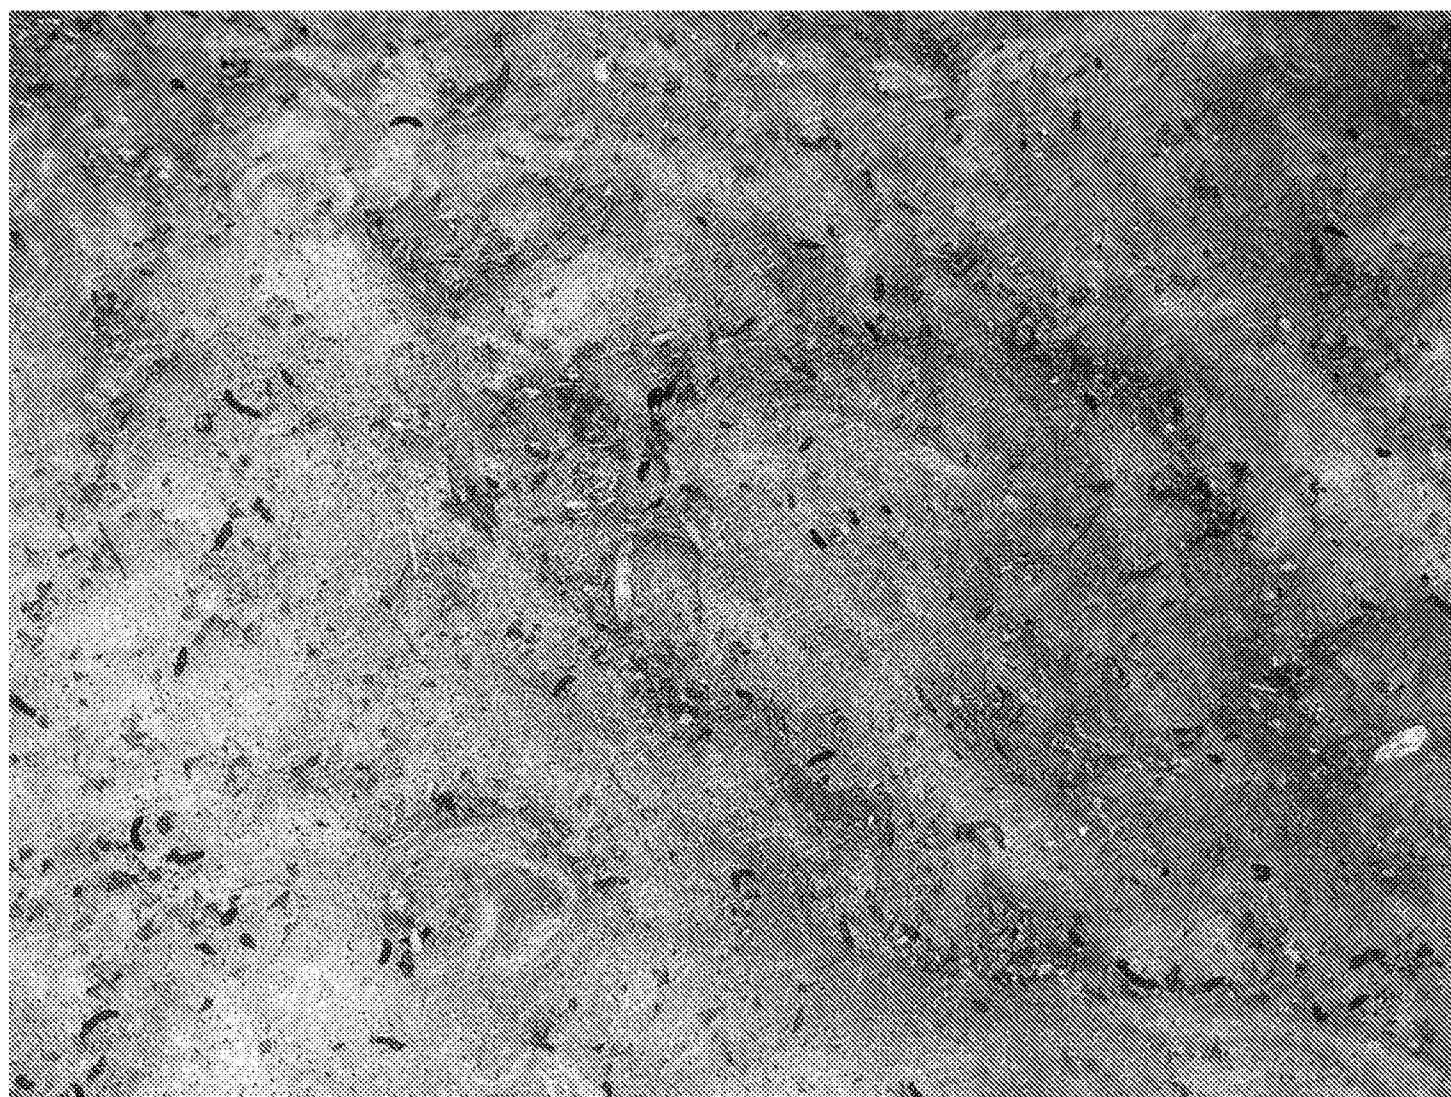
Photo 4 – View of bat and mouse droppings within the loft of B1.

9.2 There is potential for protected species of bats to be present within the buildings, which require further survey effort to determine the type of roosts present and mitigation and licencing required. Hypothetical mitigation (subject to surveys) is provided above to ensure that bats are not harmed and roosts are not damaged. There is potential for nesting birds, hedgehogs, and very minor potential for GCN, water voles and reptiles to be disturbed by the proposals. Mitigation has been proposed which would avoid this disturbance.

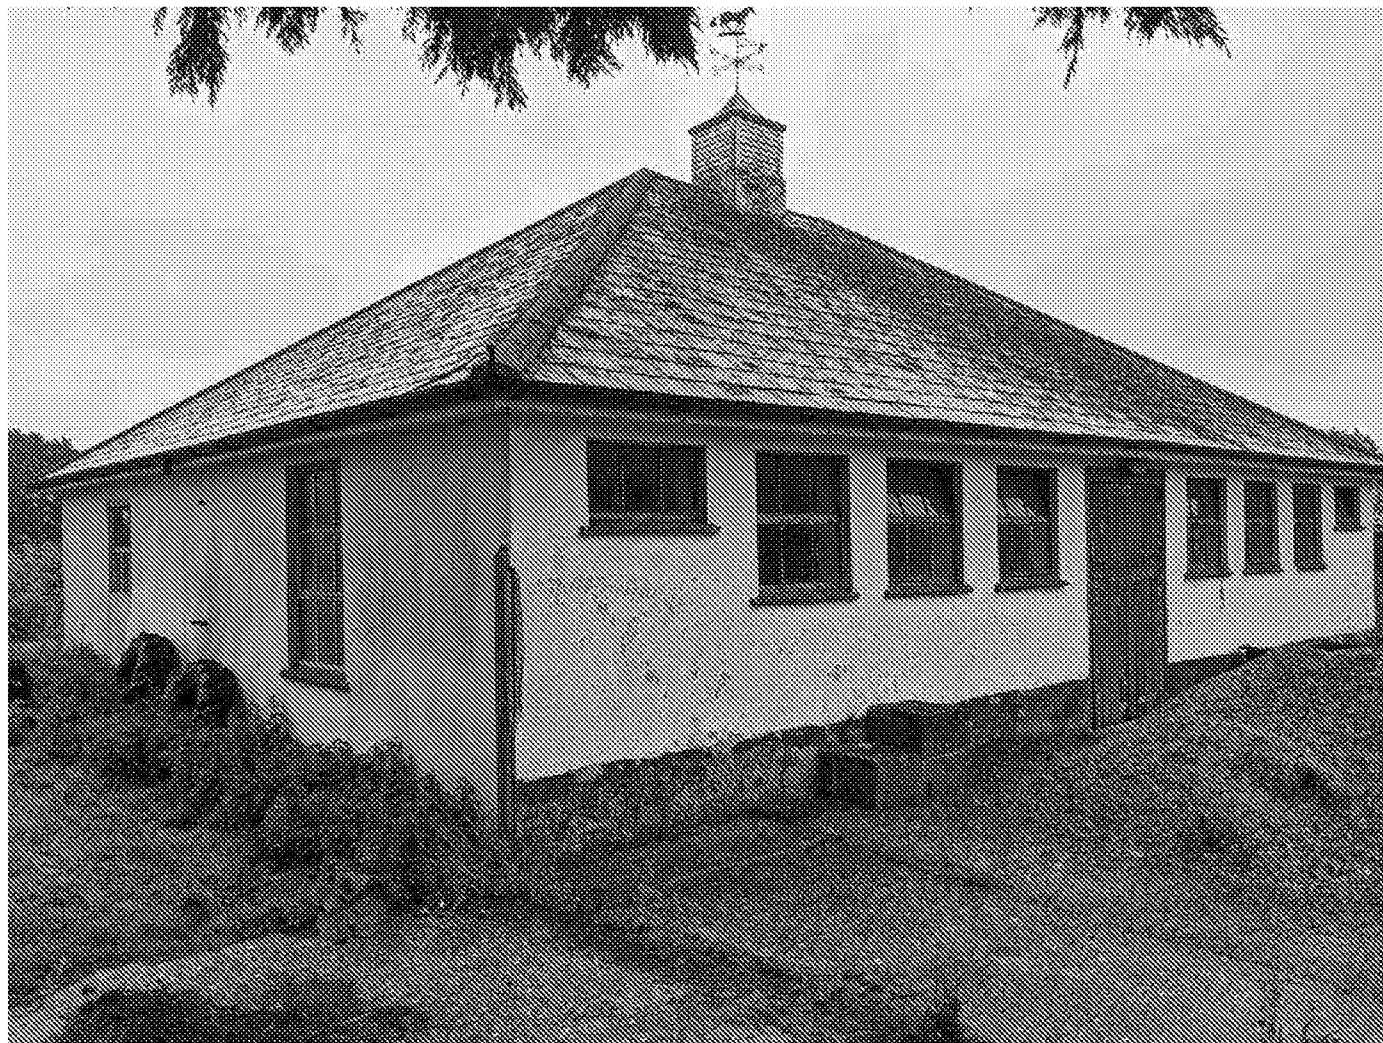
| <i>Building Descriptor</i> | <i>Description</i> | <i>Bat Roost Potential</i> |
|---|---|---|
| <i>B2 - Stable</i> | <i>A rendered brick single storey-stable, with a hipped slate roof. Externally the building is well-sealed, with only one access point noted to the corner of a soffit. Internally the roof is felted and open to the roof. No bat droppings or feeding remains were found inside. It is unlikely the building is used by bats, but the single access point may allow bats access to the soffit box.</i> | <i>Low</i> |

Photo 6 - The building B2, viewed from the north-west.

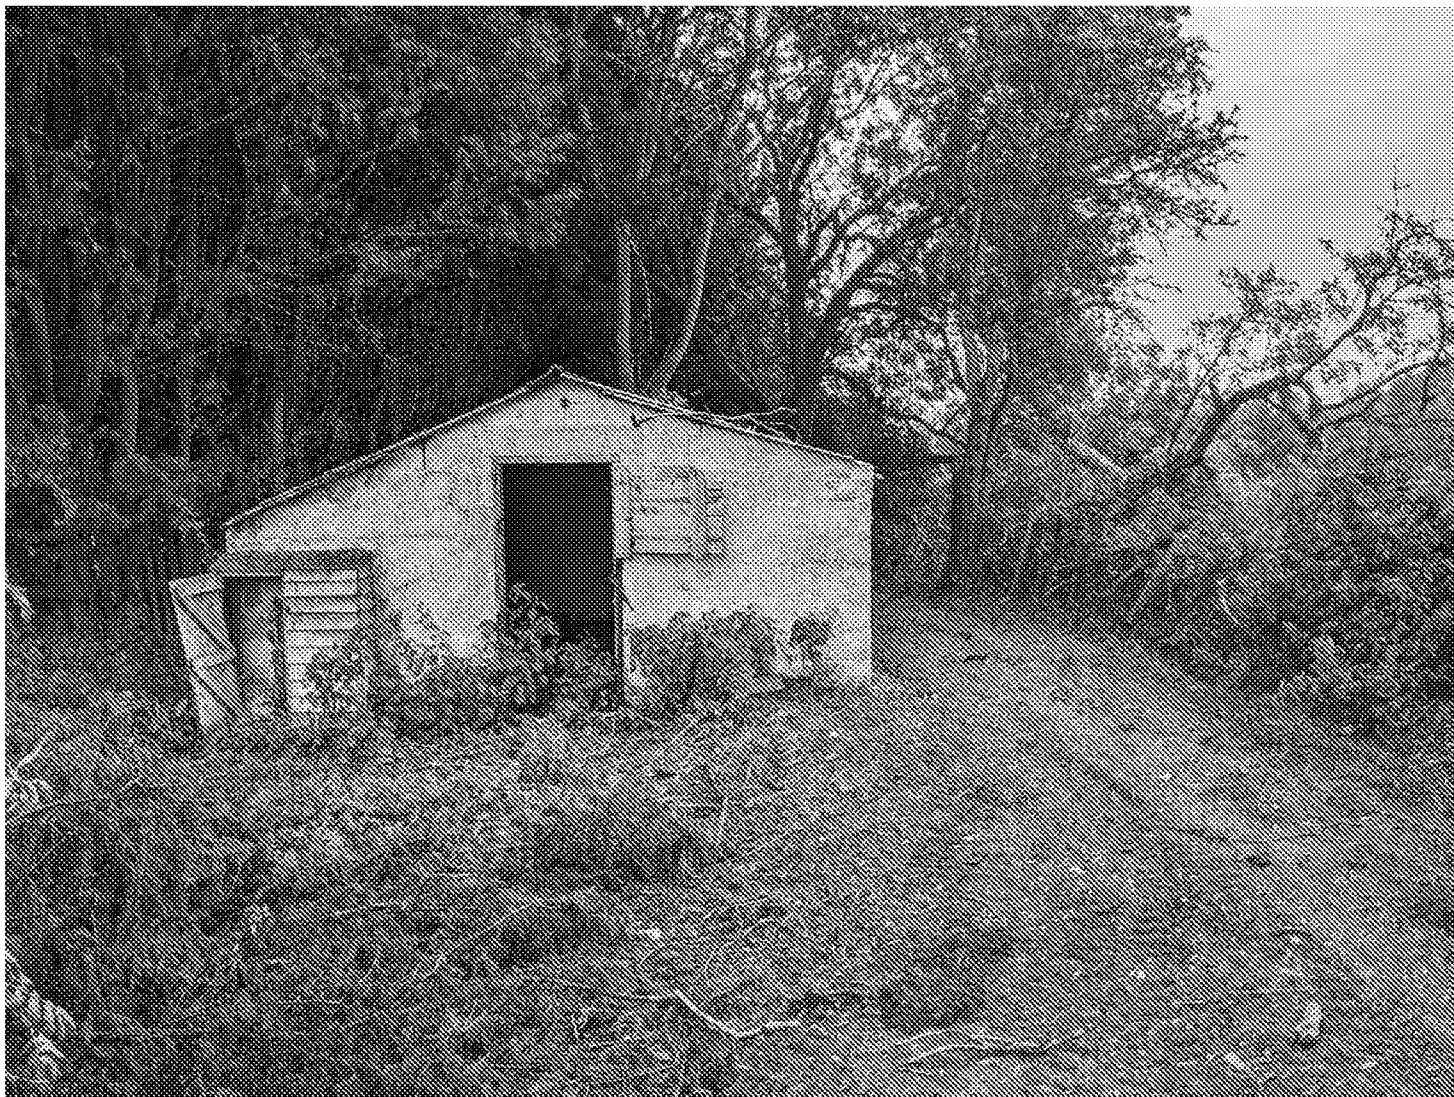
| <i>Building Descriptor</i> | <i>Description</i> | <i>Bat Roost Potential</i> |
|---|---|---|
| <i>B4 - Blockwork Outbuilding</i> | <i>Derelict blockwork barn, with a corrugated panel roof. Several skylights and lack of a door make the building bright internally. No evidence of bats was recorded.</i> | <i>Negligible</i> |

Photo 8 – View of B4.

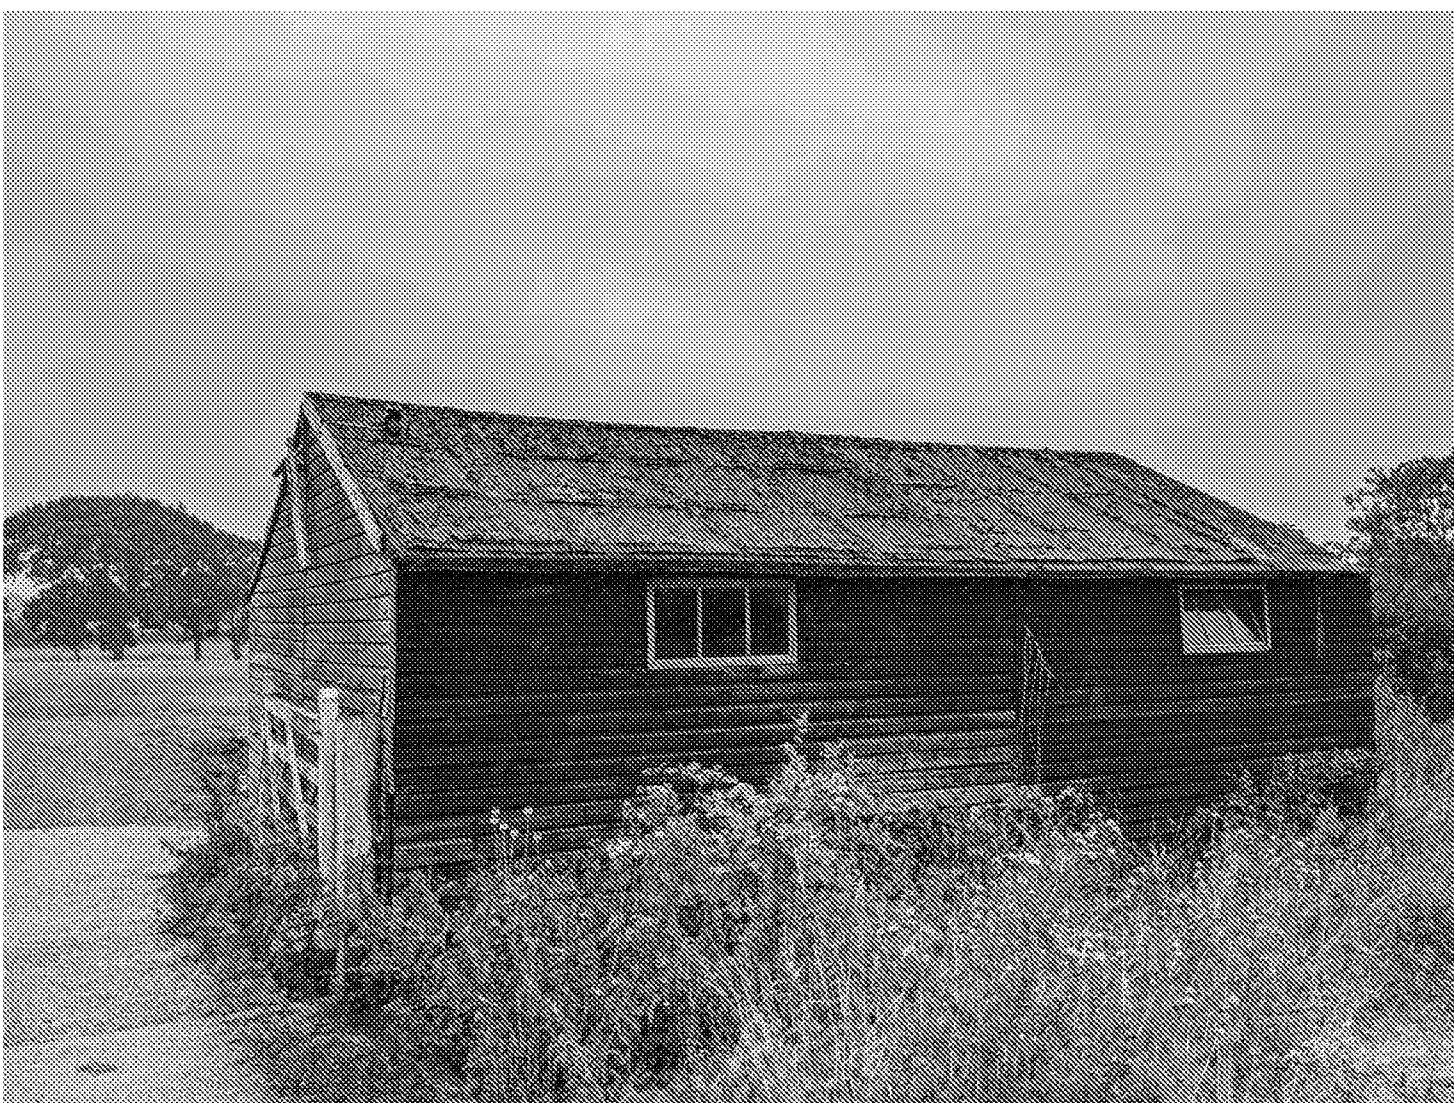
| <i>Building Descriptor</i> | <i>Description</i> | <i>Bat Roost Potential</i> |
|---|---|---|
| <i>B5 - Timber stables</i> | <i>Several timber stables with half-open stable doors. Internally the buildings are relatively bright and damp. A little owl family were found to move between the buildings. Within one stable were several droppings and moth wings, indicative of an occasional feeding perch, likely for long-eared bat</i> | <i>Low (likely feeding perch)</i> |

Photo 9 – View of B5.

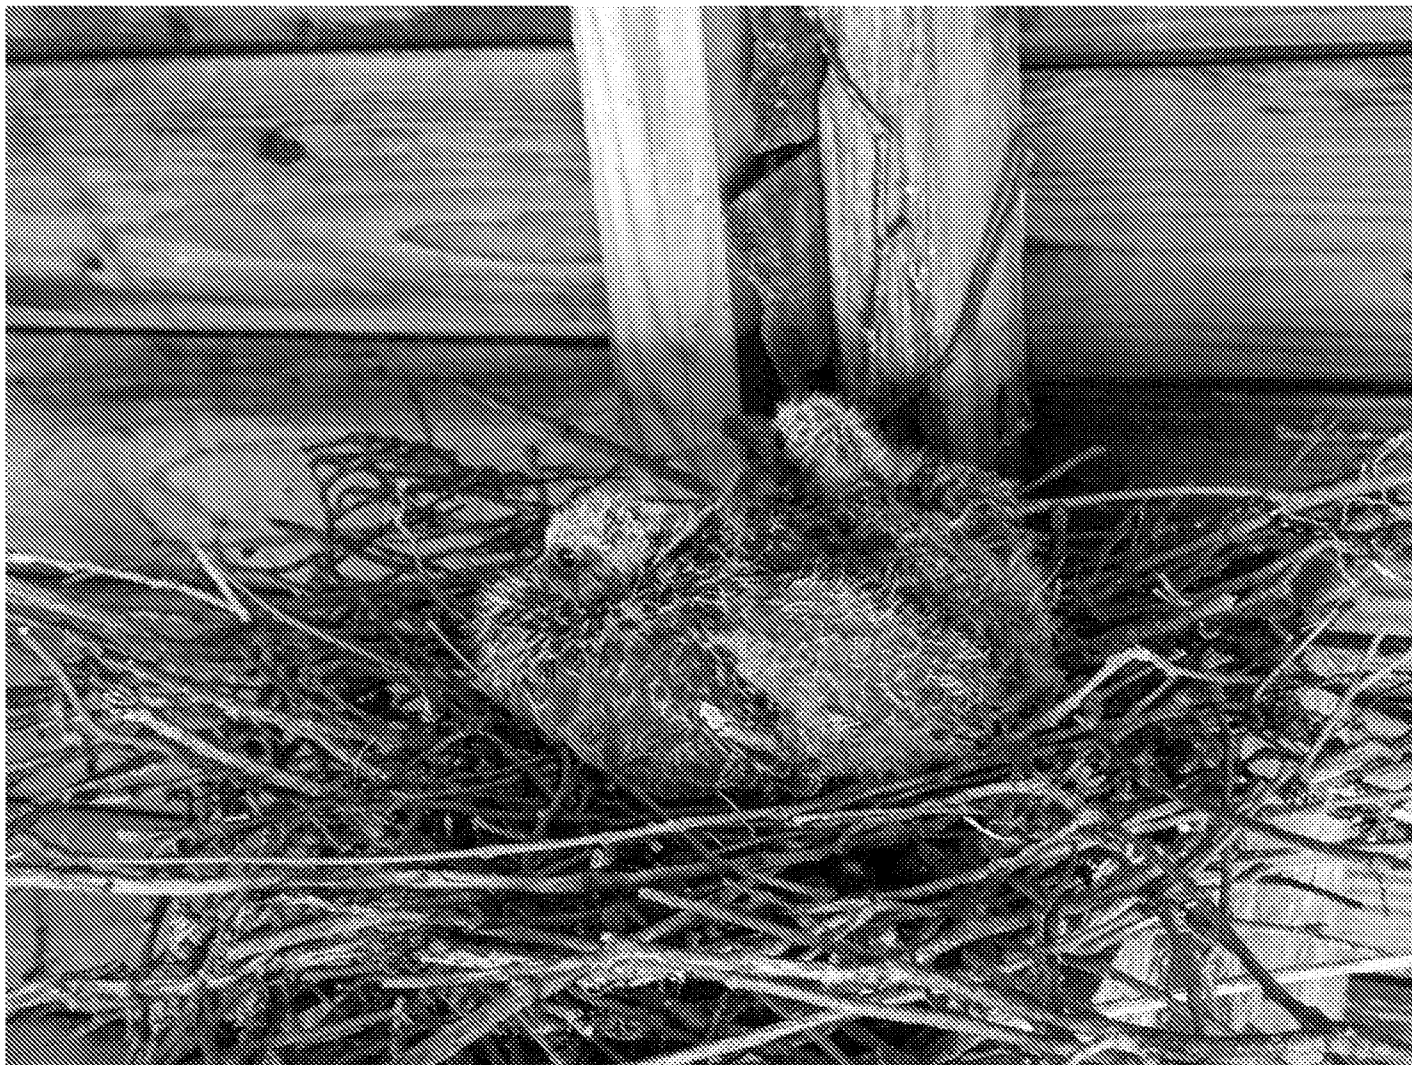
- 6.4 Several birds' nests were noted in B2, B4 and B5 indicative of swallows, which were noted foraging over the grassland. An active pigeon nest with squabs was noted within B5. A family of little owl (*Athene noctule*) were recorded using B3 and B5 with numerous pellets noted and the birds recorded flying between the two.
- 6.5 The improved grassland offers 'low' potential for ground nesting birds, due to frequent mowing, with the marshy grassland offering 'moderate' potential. The trees, woodland and treelines offer 'high' potential for nesting birds. The off-site reedbeds offer 'high' potential for water birds such as moorhen (*Gallinula chloropus*).

Photo 10 – Pigeon nest with squabs in B5.

- 7.11 The above mitigation required for bats would adequately protect nesting birds within the building, providing the works avoid the nesting season (March-August inclusive). Any nests found must be removed when out of use.
- 7.12 Compensation should be provided for the little owl family which inhabit the various outbuildings. A roost feature could either be installed freestanding, within a new building or to a tree within the woodland or treeline.
- 7.13 Compensatory nesting provision for the swallows on-site shall be provided within the enlarged stable building, in the form of swallow nesting cups, and access points into the roof.
- 7.14 Any trees and scrub proposed for removal must be removed outside of said nesting season or checked by a suitably-qualified ecologist prior to removal.
- 7.15 All other suitable habitat should be retained and enhanced through new planting.

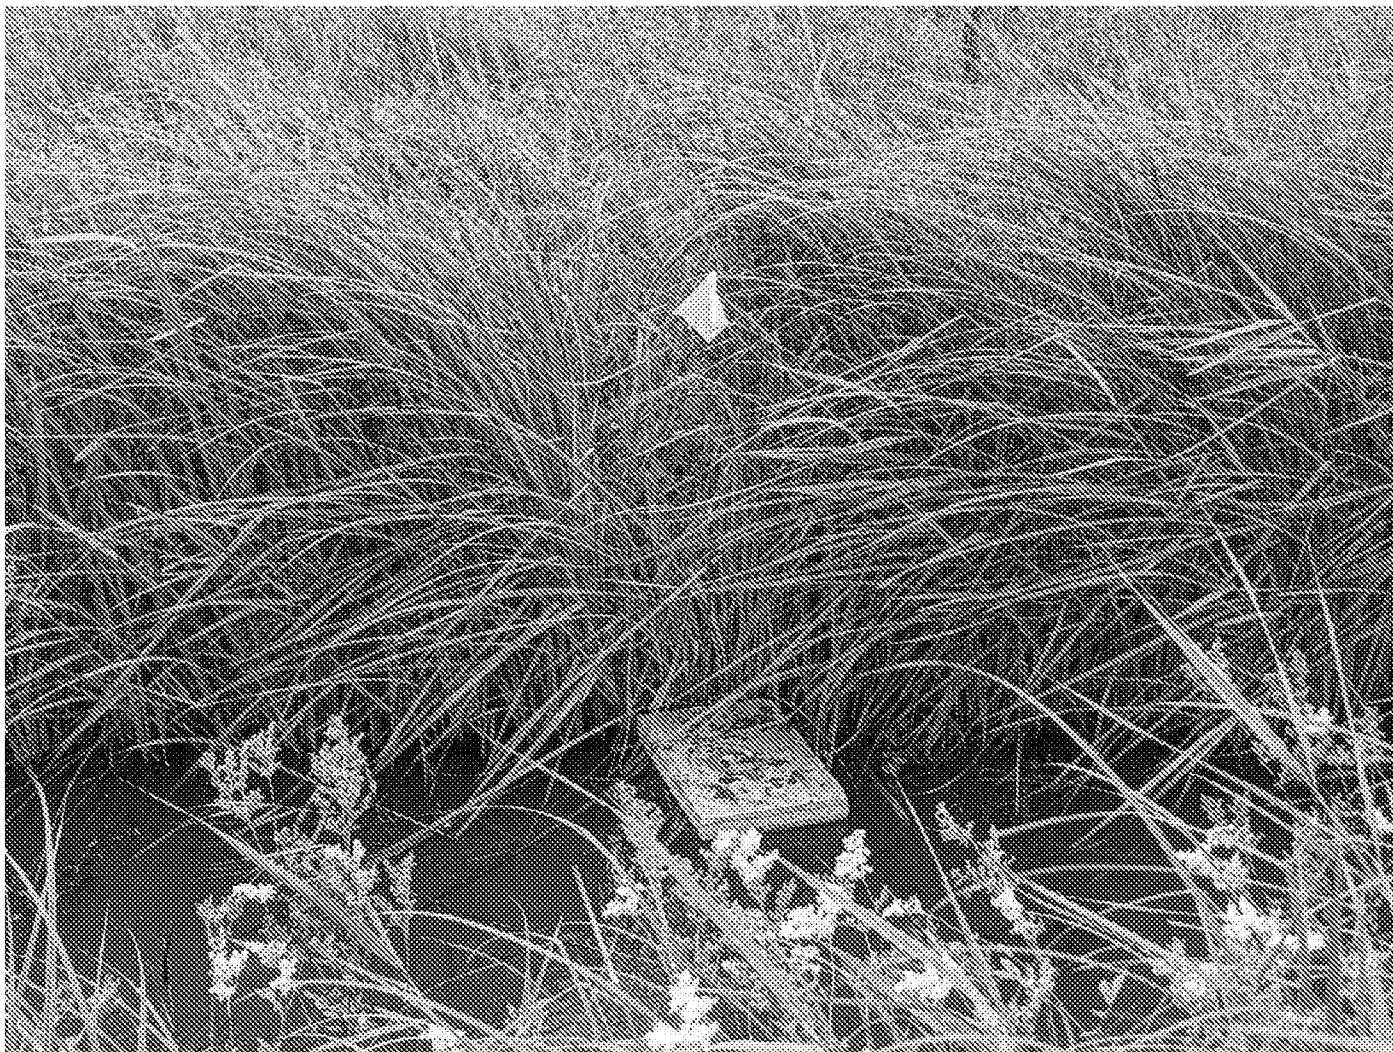
- 5.12 Lining the north-eastern, eastern and south-eastern boundaries are small ditches and a stream. These appear in good condition with a thin reedbed habitat, formed of reedmace (*Typha latifolia*), common reed (*Phragmites australis*), and wetland forbs such as purple loosestrife (*Lythrum salicaria*). As reedbeds these areas are priority habitats, albeit relatively small ones of limited connectivity. The habitat is of moderate ecological value at the local level.

- 6.15 The site is largely unsuitable for water vole. The nearby ditches were considered highly suitable for water voles, with abundant suitable vegetation. A water vole survey in the form of an insulation sheet pontoon was noted to the east, which appeared to display water vole droppings. The standing water in the site is stagnant, shallow and exposed with no marginal vegetation, and as such is unsuitable for water vole.

Photo 12 - The eastern ditch/reedbed off-site with water vole survey.

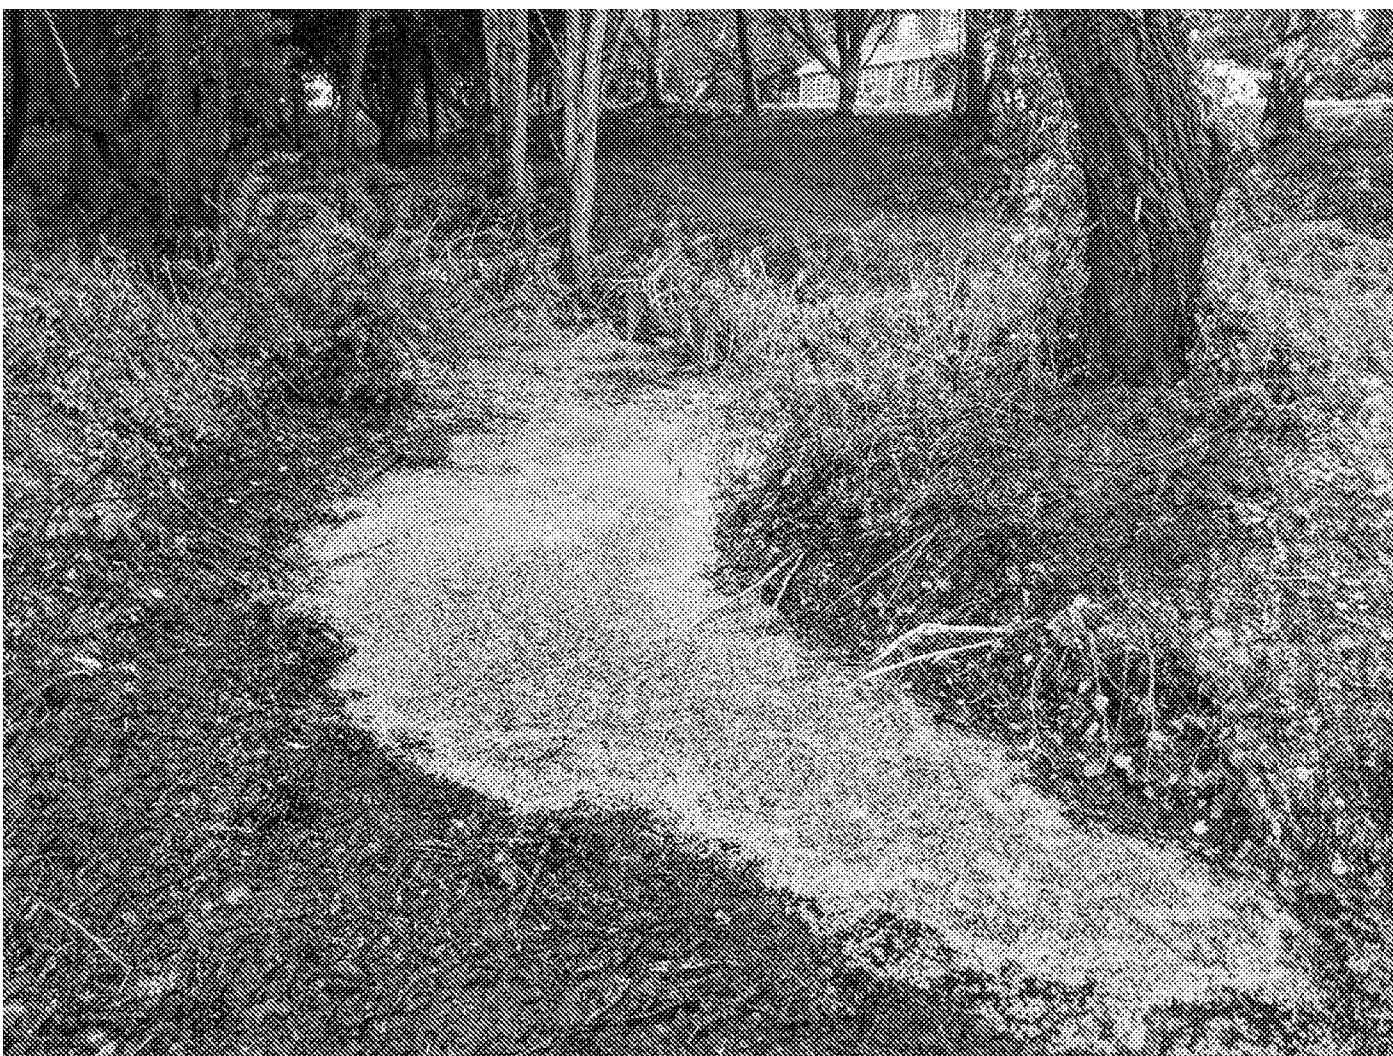
- 5.18 Within the above woodland is a small patch of standing water, of c.4sqm. The water was covered in duckweed and appeared stagnant. The water was likely covered in scrub until recent landscaping works revealed it. The water is not considered a priority habitat pond, but offers 'high' potential for enhancement.

Photo 13 - standing water in the woodland offers 'negligible' potential for water voles and GCN

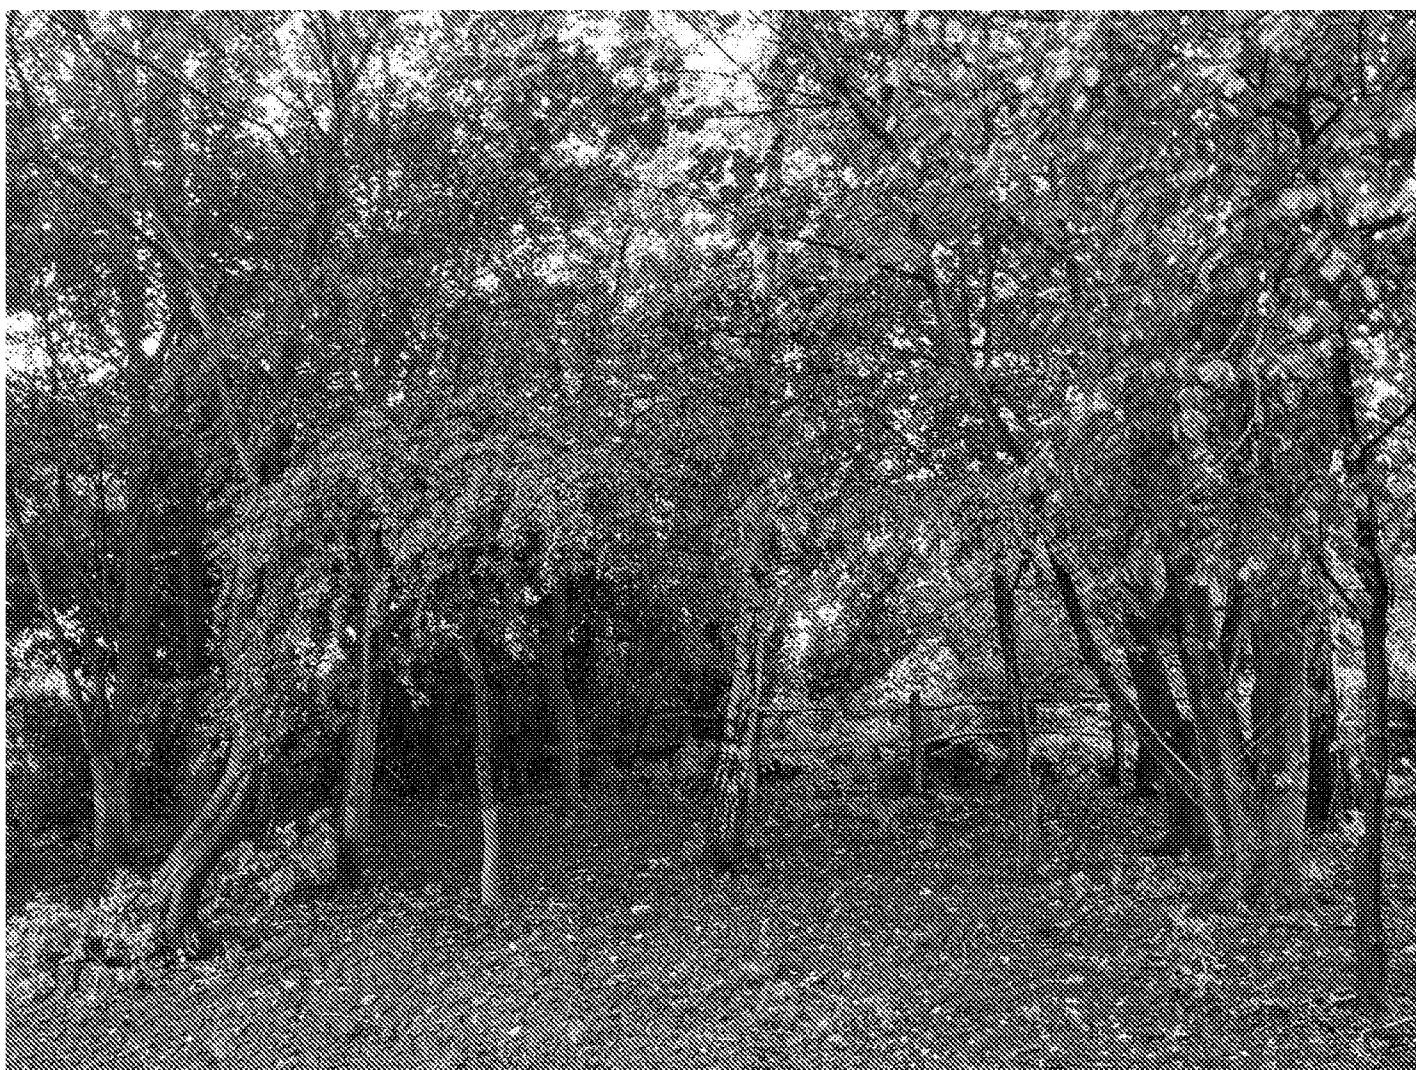
- 5.17 The southern section of the site lies in a small depression, around and within which a number of trees have self-seeded or been planted. The dominant trees are willows (*Salix sp.*) with several silver birch (*Betula pendula*), horse chestnut (*Aesculus hippocastanum*), ash and more rarely oak. The understorey is mostly bare, with some landscaping works having been recently undertaken to remove scrub. Several hawthorn (*Crataegus monogyna*), hazel (*Corylus avellana*) and cherry laurel (*Prunus laurocerasus*) shrubs are present. A small area of standing water and a dry ditch are present within the woodland. The trees are generally of poor form and the area is of low ecological value at the site level only.

Photo 14 – the broadleaf, plantation woodland, currently lacking understorey and groundcover.

- 7.1 The proposals would remove small areas of habitat of generally low value. Trees of better condition should be retained where possible.
- 7.2 The marshy grassland, ditches, hedges and woodland shall require strict protection in accordance with BS5837:2012 and BS42020:2013.
- 7.3 Any trees or areas of habitat removed should be replaced with new native planting of greater value.
- 7.4 The proposals provide an opportunity to enhance habitats including the hedges (infill planting) pond (desilting, planting and enlarging) and the woodland (understorey and groundcover planting).

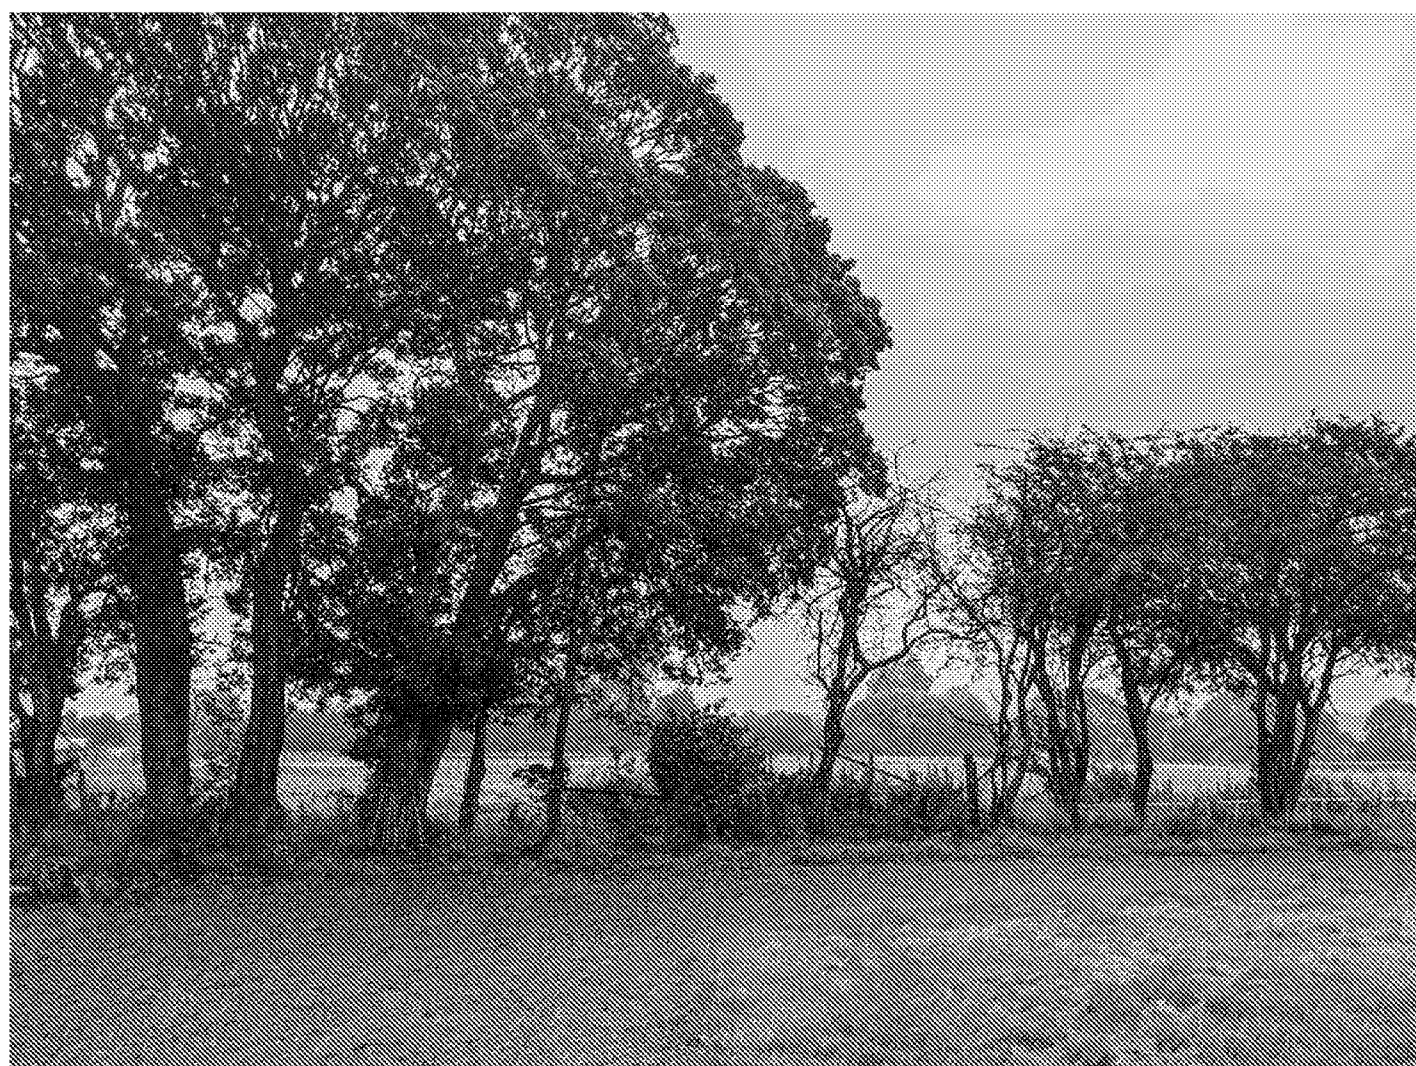
- 5.19 The north-eastern boundary is lined with an old hawthorn hedge, now formed of sparse scattered trees. This boundary has recently been replanted with new hedging whips, yet to establish. The south-eastern boundary and south western boundary are lined in places with a defunct hedge, now generally formed of individual hazel stools. The hedges are old but offer limited habitat and poor connectivity and are too gappy to be considered a priority habitat. The hedges are of low value at the site level, with good potential for enhancement through gapping-up and connecting to other habitats.

Photo 15 – Defunct hedges suitable for infill planting

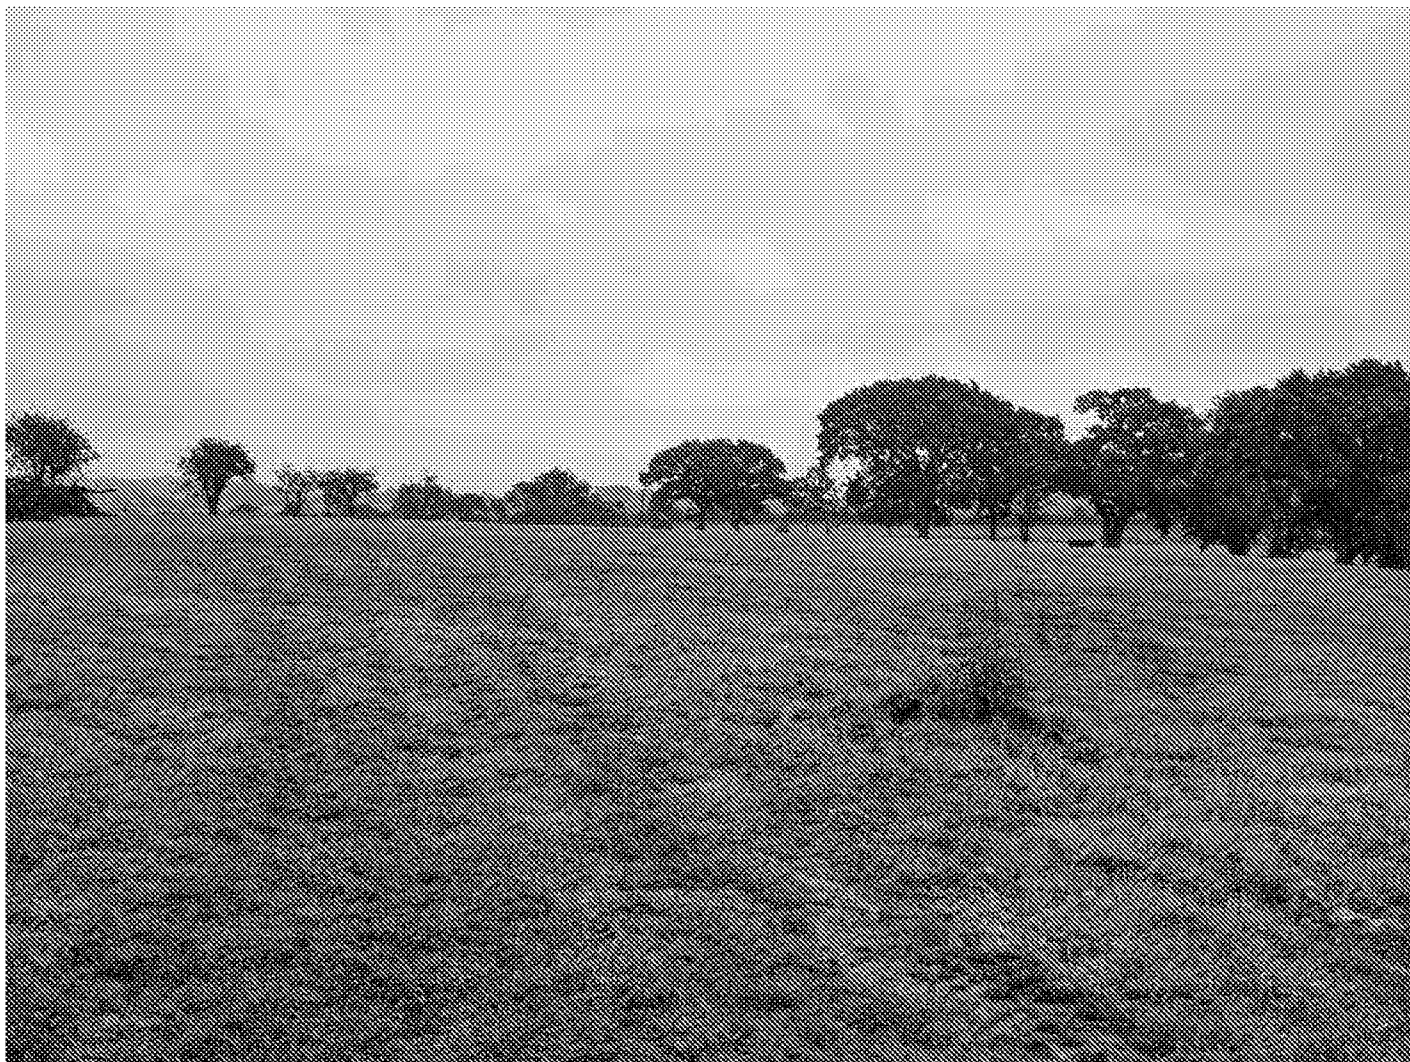
- 5.10 To the east the land is dominated by relatively coarse, improved grassland. The vegetation appears regularly mown with a sward height of c.10cm currently. The sward is dominated by coarse and common grasses including Yorkshire fog (*Holcus lanatus*), red fescue (*Festuca rubra*) and patches of perennial ryegrass (*Lolium perenne*) and meadow fescue (*Schedonorus pratensis*). Common forbs include abundant creeping buttercup (*Ranunculus repens*), frequent white clover (*Trifolium repens*) and yarrow (*Achillea millefolium*). The habitat is of low ecological value at the site level only.

Photo 16 – Improved grassland forming much of the site.

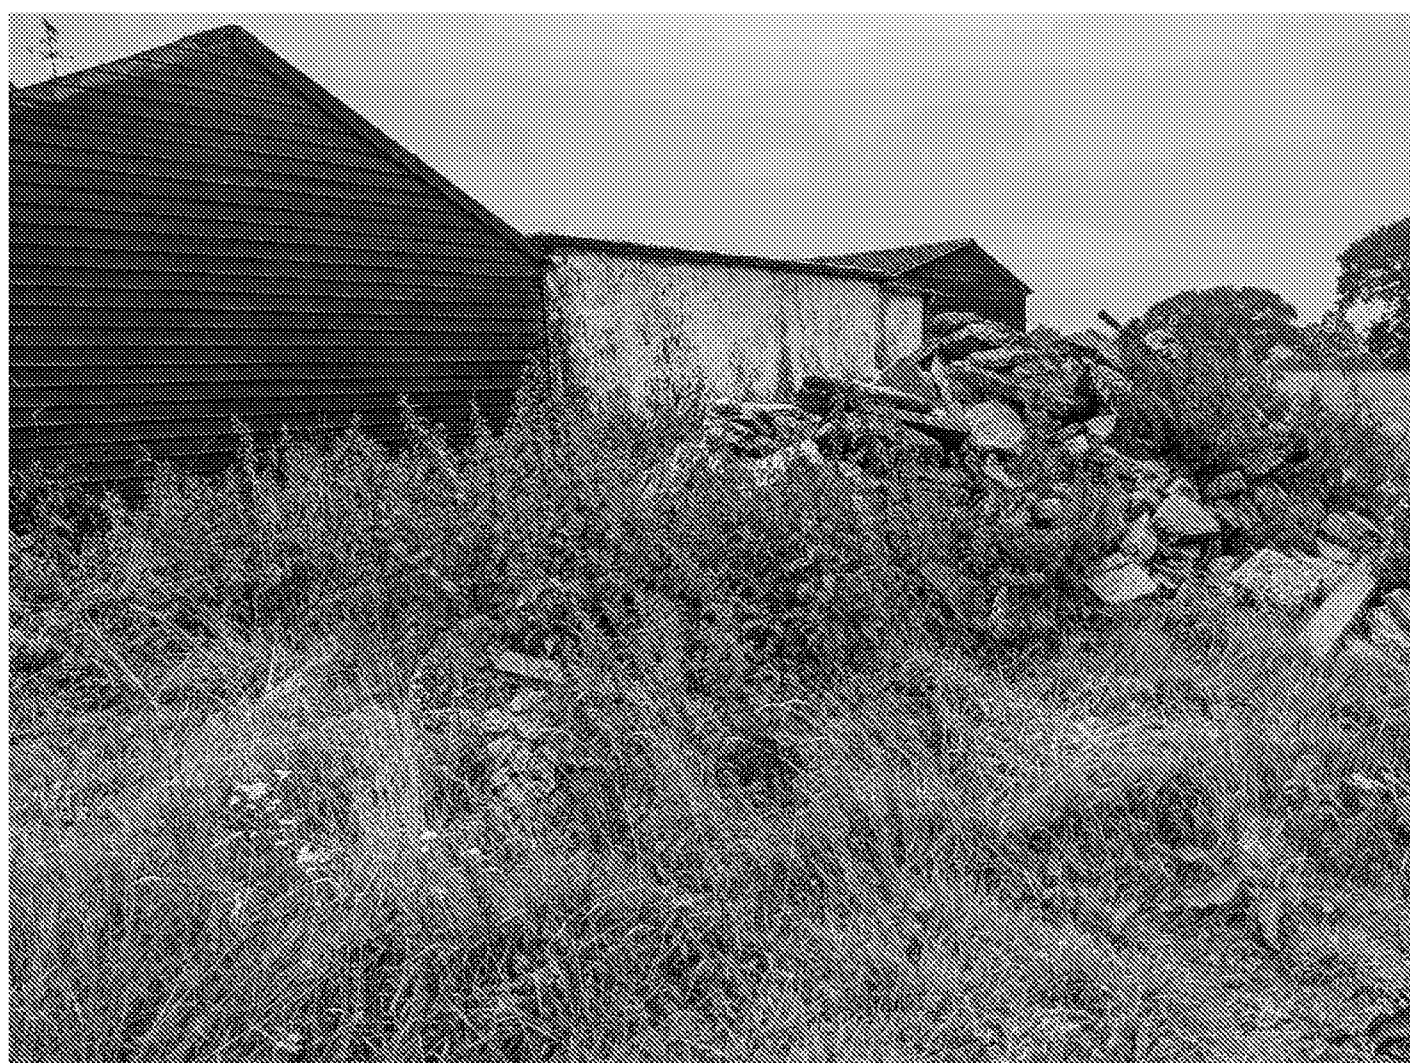
- 5.13 A main access track is lined with mixed tall ruderal vegetation, consisting of common species such as nettle (*Urtica dioica*). A patch of ground to the east of the buildings is overgrown almost entirely with burdock (*Arctium minus*). The habitat is of low ecological value at the site level only.

Photo 17 – patches of tall ruderal and log/debris piles offer limited suitability for reptiles in small areas.

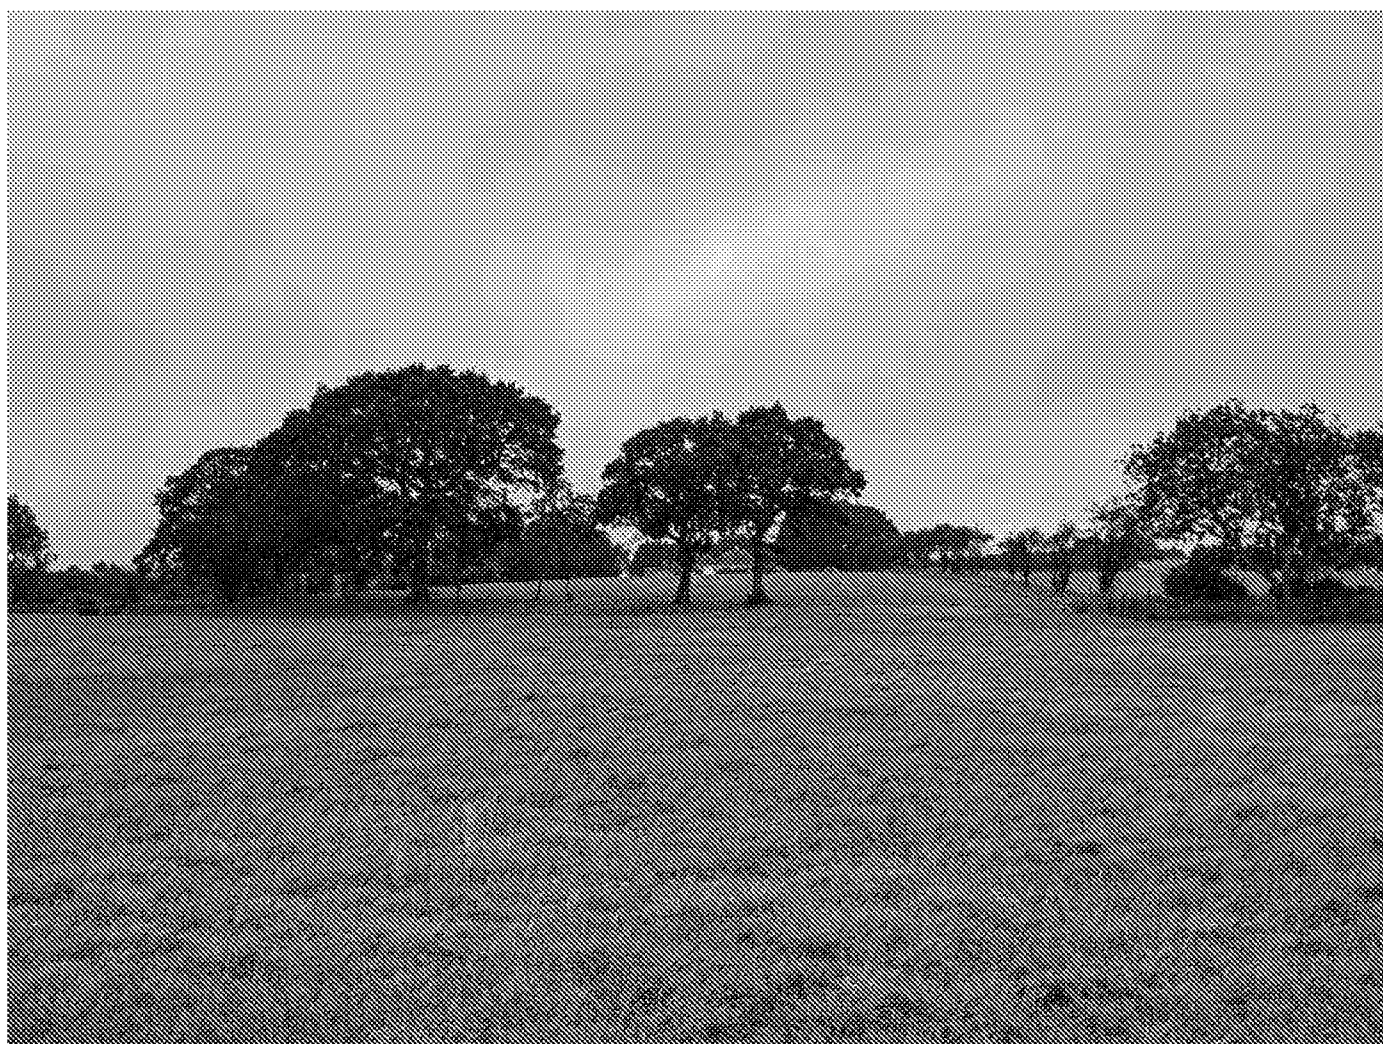
- 5.11 Beyond the improved grassland, is a sunken area which abuts a stream. The area is cut annually for hay and is considered to be a water meadow. Species such as hairy sedge (*Carex hirta*) and rushes (*Juncus spp.*) were noted. Forbs included abundant silverweed (*Argentina anserina*), and frequent red clover (*Trifolium pratense*) and redshank (*Persicaria maculosa*). The area is designated as priority habitat coastal and floodplain grazing marsh, which the current assessment accords with. There is some potential for enhancement through alteration of the cutting regime and retention of longer margins. The habitat is of moderate ecological value at the local level.

Photo 18 - Off-site marshy grassland, looking west with the site area beyond the trees.
