# Preliminary Bat Roost and Ecological Appraisal

Goose Green, Binsted

Document Reference: GS040.GooseGreenBinsted.PEA.v1

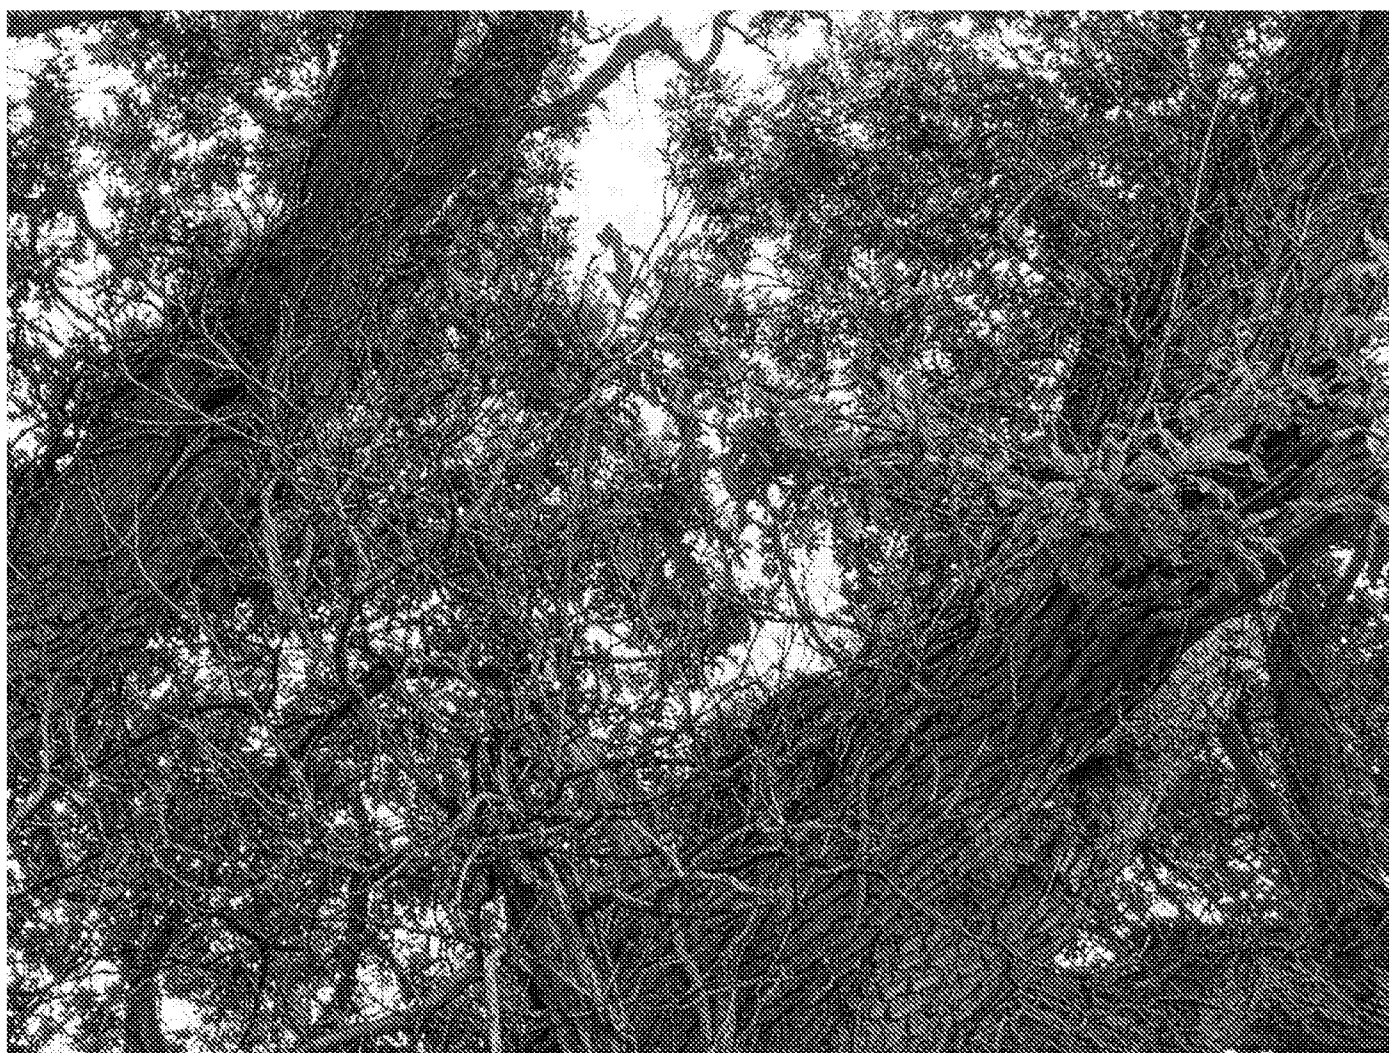
Photo 19 -Several trees to the east offer bat roost potential but shall not be impacted.
