Arboricultural Report

Background: LSDP were appointed to prepare an Arboricultural Survey & Report to satisfy Local Authority requirements in respect to the proposed construction of a commercial building with car parking and a drainage basin and a length of new access track connecting to the existing access at Stoney Brook Farm. This report is based on survey information collected in December 2024.

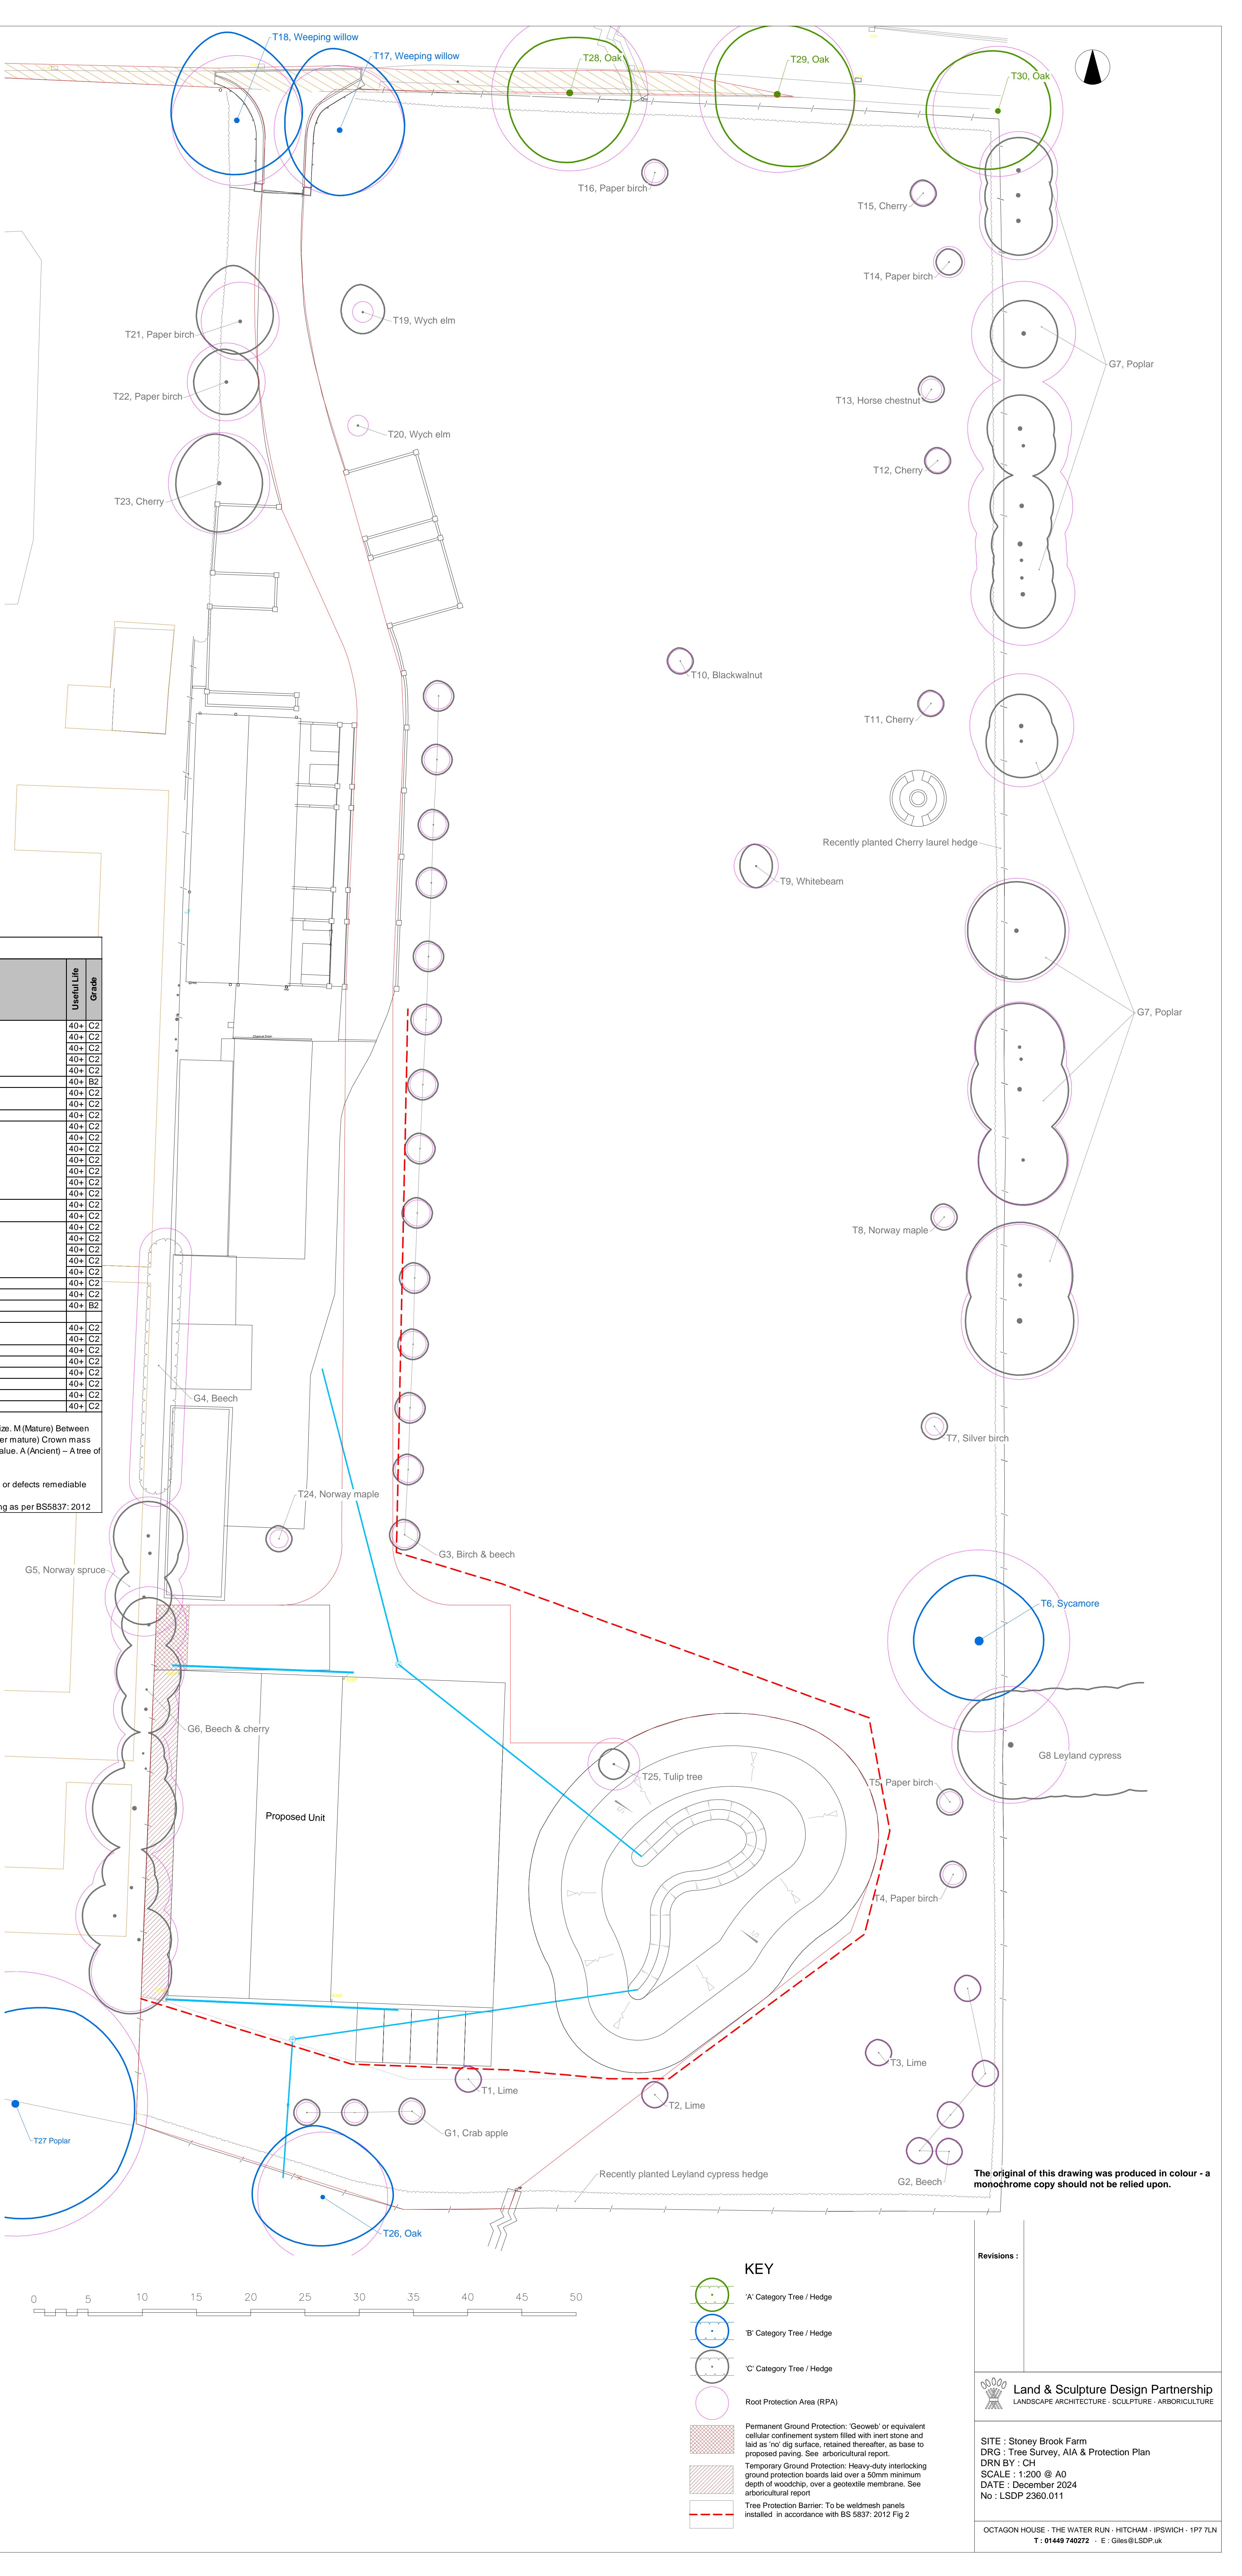
Generally: Before any machinery or materials are brought onto site and before any demolition, development or stripping of soil commences, The Root Protection Area (RPA) indicated on the drawing shall be set out and Protective Barriers and Ground protection installed as shown on the drawing.

Generally, The trees were appraised in accordance with BS5837:2012 and survey details of 26 individual trees and 10 saplings are summarised below. The rationale for tree prioritisation is outlined below, please see schedule and drawing opposite for other survey information.
