Re: Progress Garage, Yapton Lane, Arundel, BN18 0AS

This technical note describes the works which have taken place on site involving the removal of fuel storage tanks.

## Tank Removal

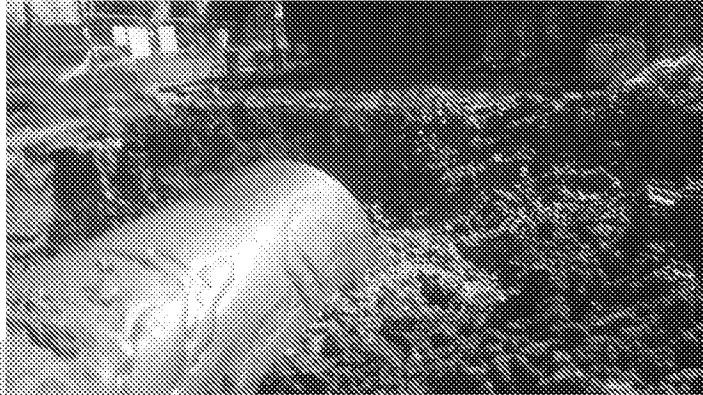
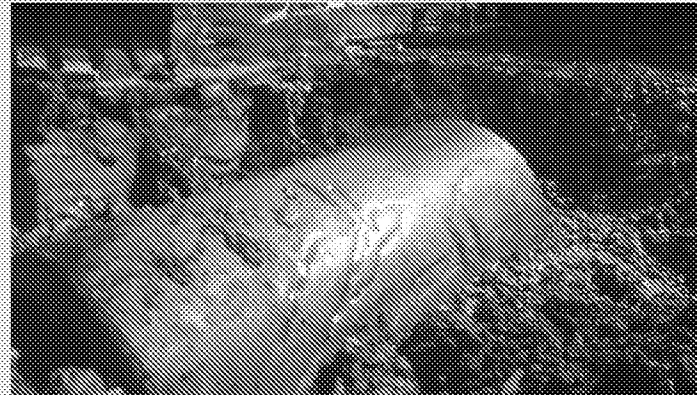
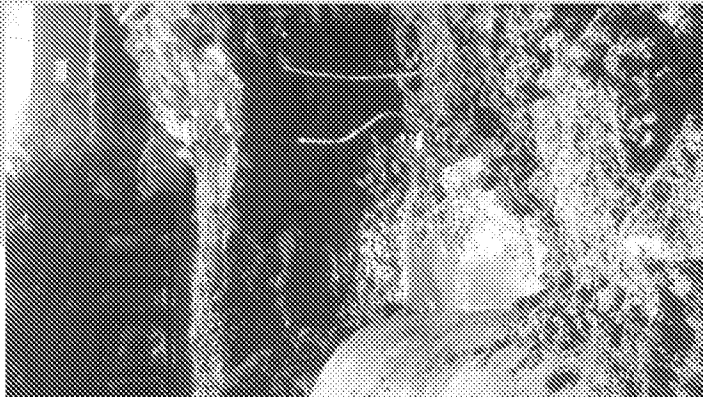
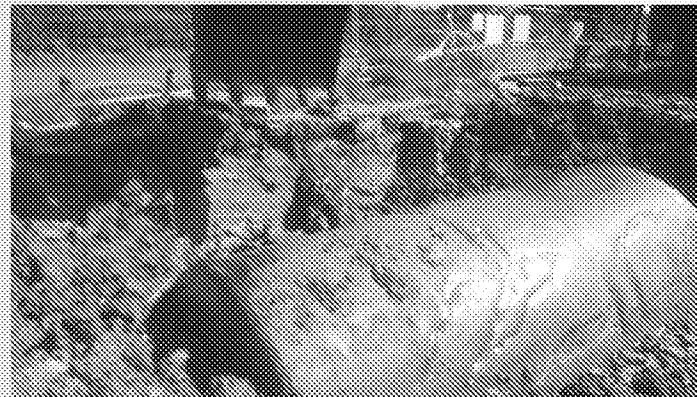
- A. Image supplied by the client during the removal of the tank on site
- B. As above
- C. As above
- D. As above

The tanks were removed (as shown in Appendix B) with waste consignment notes available within Appendix C. Following this, the pits were backfilled with crushed concrete arising from demolition taking place on site. Pictures showing the site in its current state are available within Appendix B.

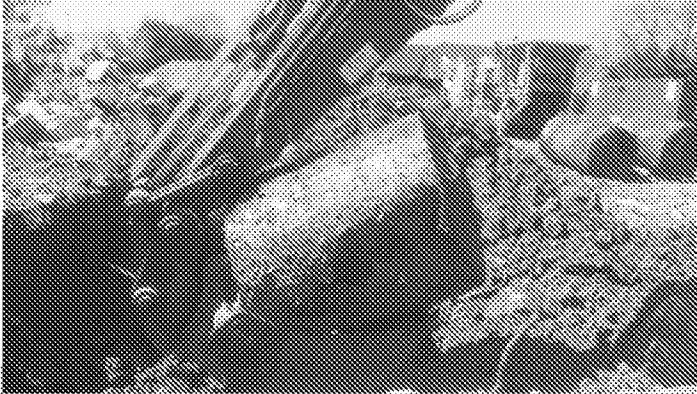
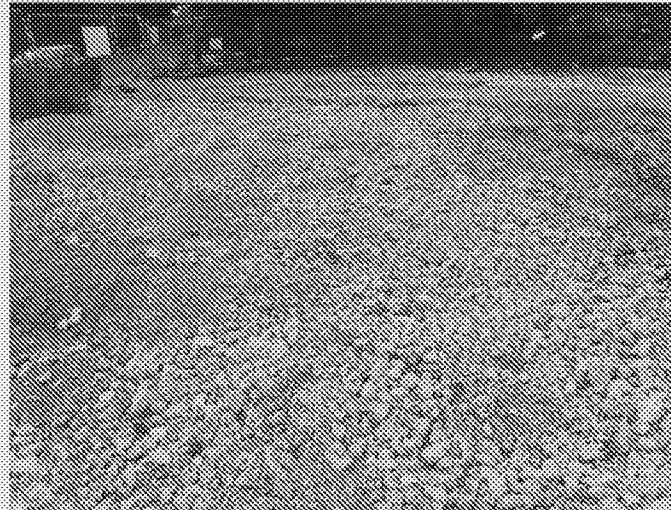
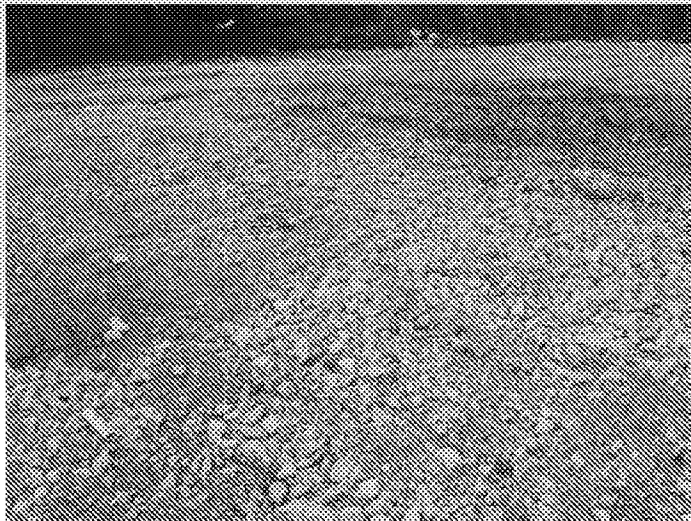
E. Image showing the site post tank removal

F. As above

G. As above

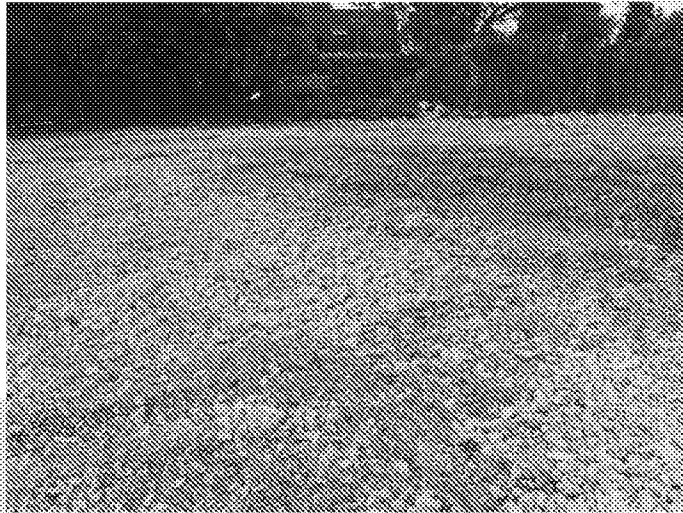
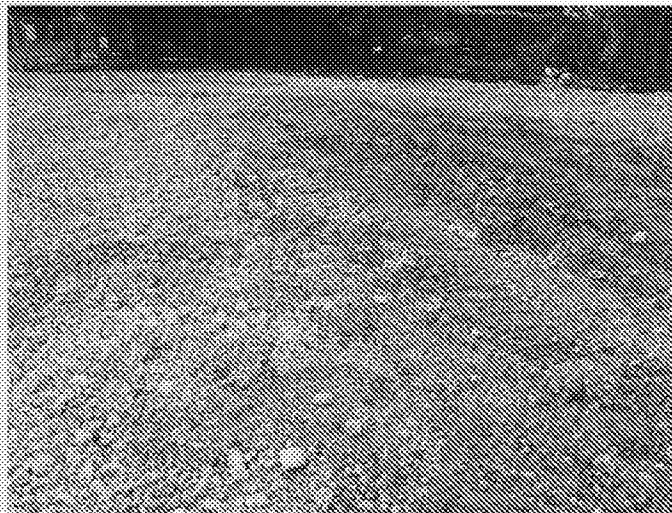
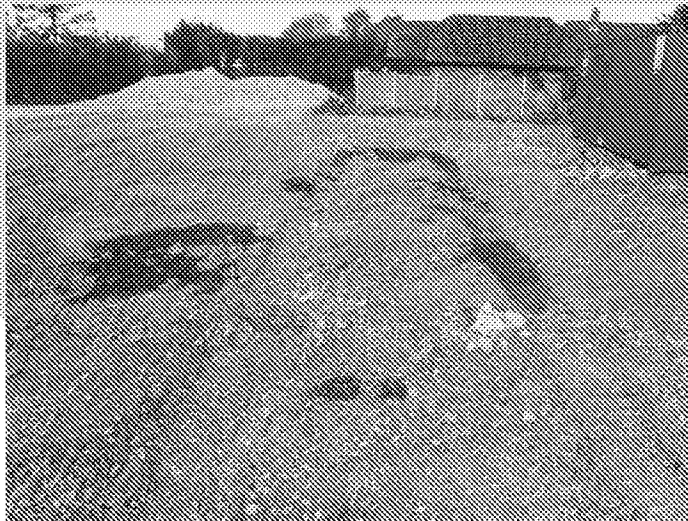
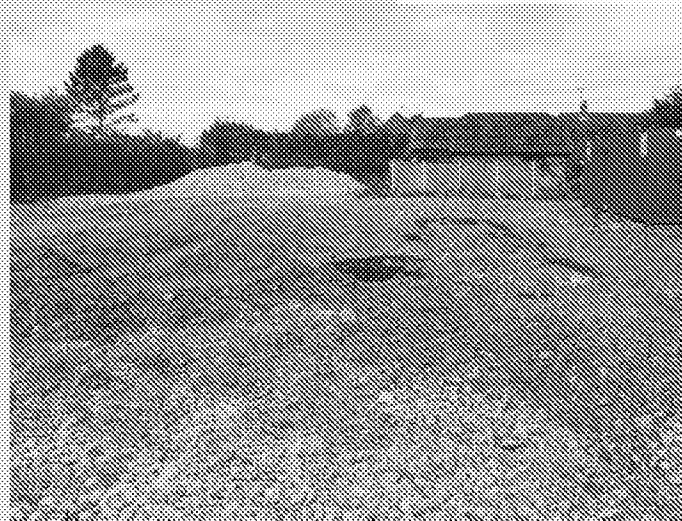
**E. Image showing the site post tank removal**

**J. As above**

K. As above

L. As above

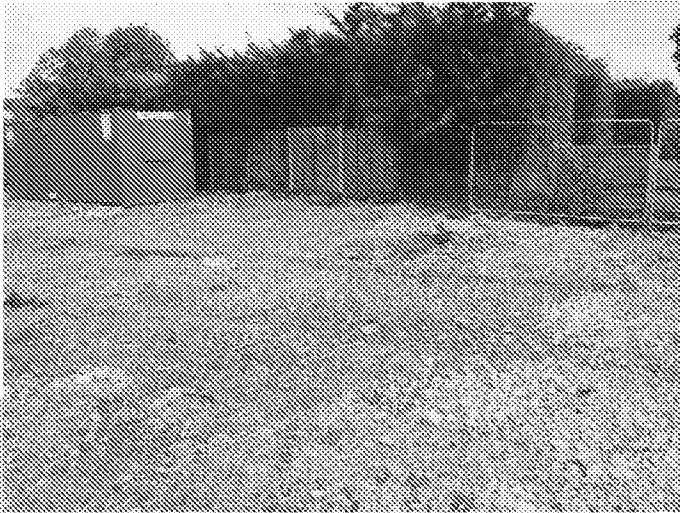
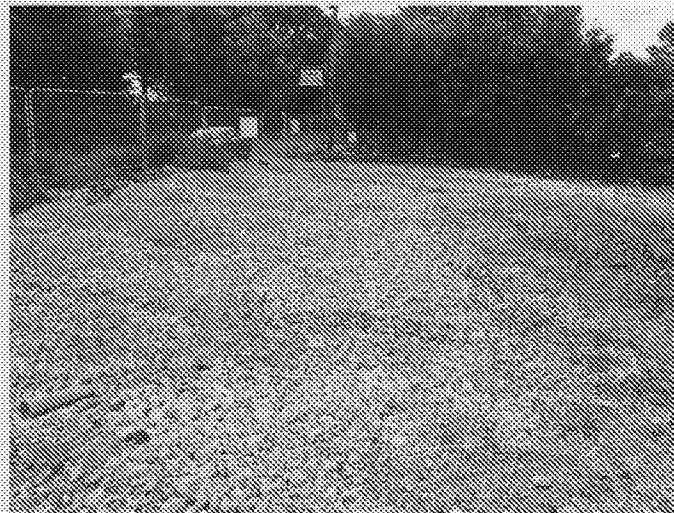
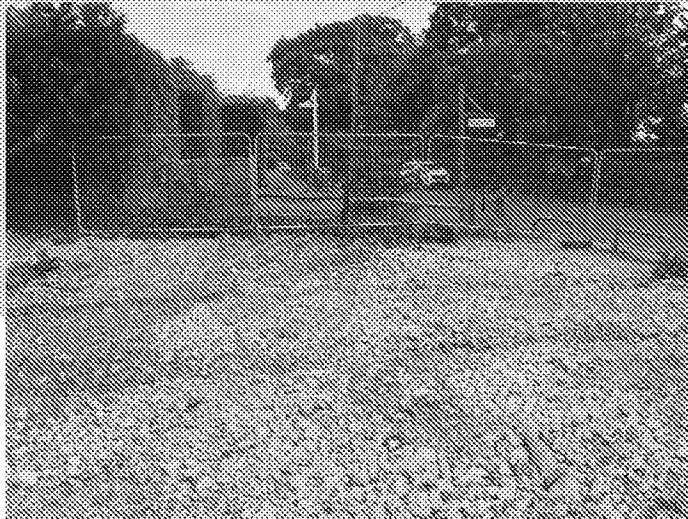
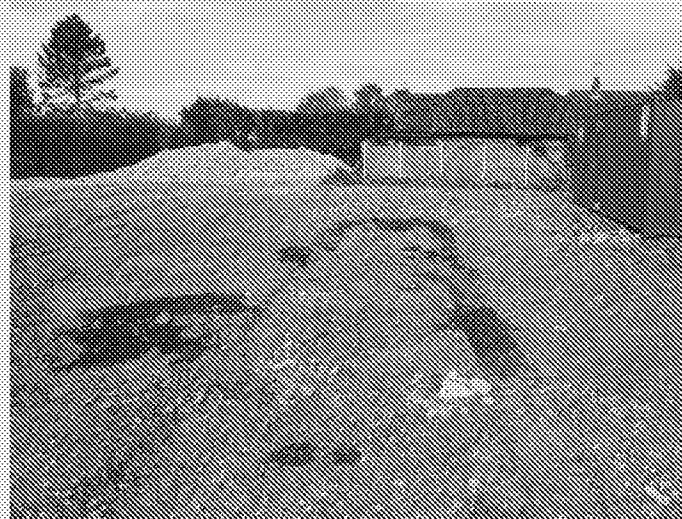
E. Image showing the site post tank  
removal

N. As above

O. As above

P. As above

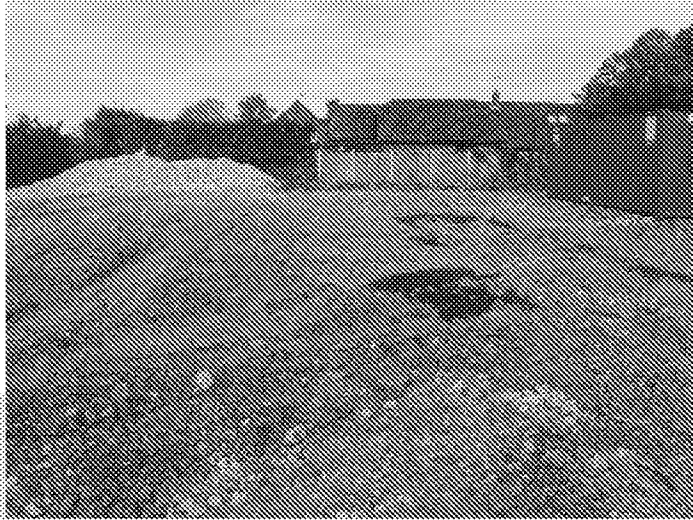
Q. Image showing the site post tank  
removal

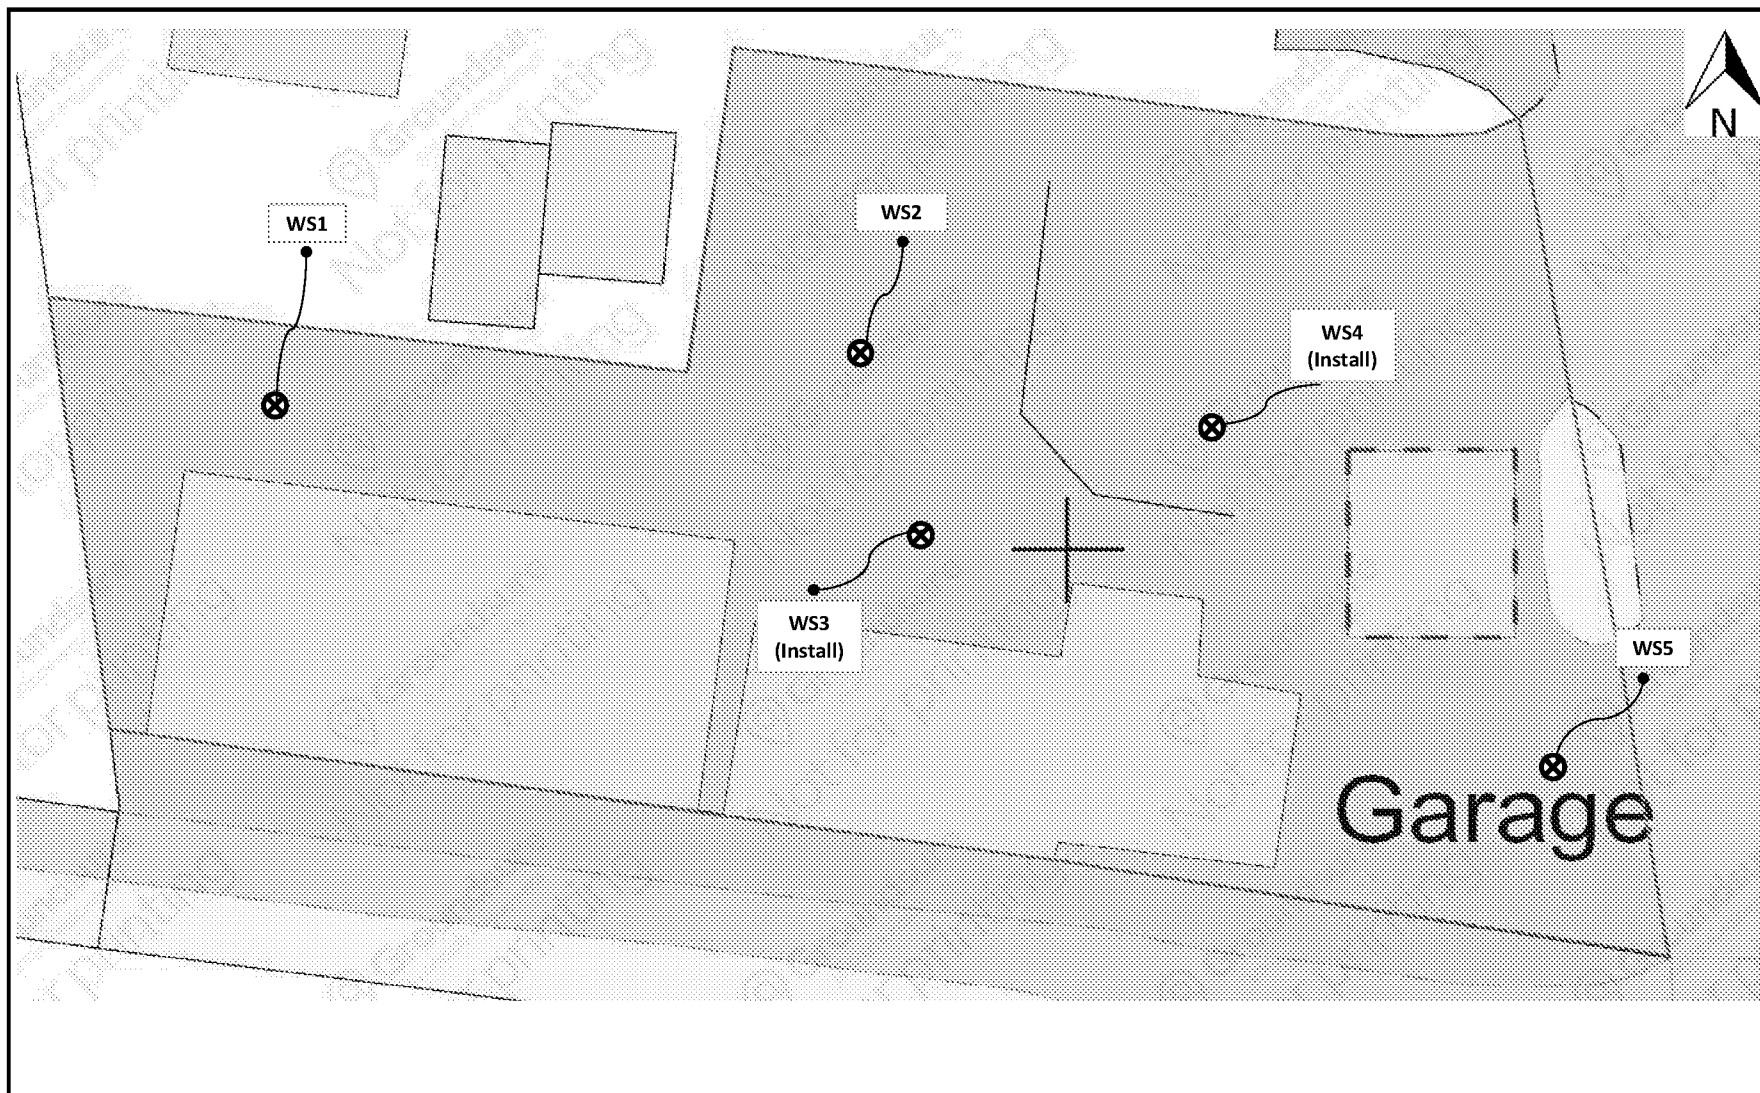
### Site Investigation Location Plan - Not to Scale

- Five (5no.) windowless sampler boreholes (WS1 to WS5) were completed, by means of a track mounted competitor dart rig, to a maximum depth of 3.00mbgl, due to shallow refusal because of dense ground conditions encountered. The locations of exploratory positions were selected relative to the historic land use and current proposed redevelopment plans for the site whilst providing a broad coverage of the site as feasibly as possible.
