**Report  
of  
Preliminary Ecological Bat Survey  
Building at Turnpike Garage  
Walberton  
12th February 2014**

A planning application is to be made for a housing development to replace the buildings on the site of Turnpike garage. One building on the site, used as a reception, has a pitched, slate tiled roof. A preliminary ecological bat survey was undertaken on this building during the daytime on 12<sup>th</sup> February 2014 by Sue Harris, ecological consultant, to support a planning application.

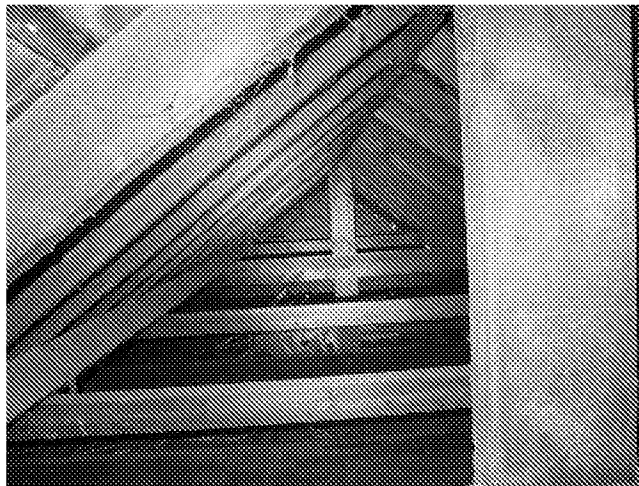
A loft lay over the whole of the building. There were both horizontal and vertical timbers in the loft space as shown in the photo below restricting potential flying area.

Only a very small amount of insulation was seen on the floor.

There was a significant amount of cobwebs in the loft.

There was good access to small animals into the loft at the eaves and at the eastern gable end.

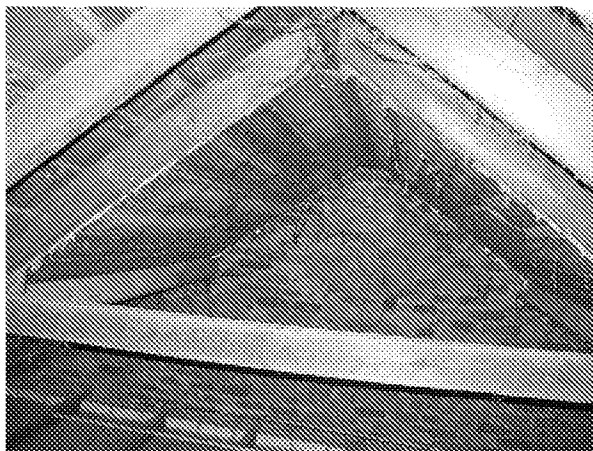
The slate roof was not lined with roofing felt or membrane but timber planks had been fitted over the rafters at the eastern end. This was damaged and open at the ends. No evidence could be seen to suggest that bats were accessing this space.

Timber on rafters at eastern end

No bat droppings or bats were seen. There was evidence of rat droppings.

The slate roof is not lined with roofing felt or membrane and hence the roof and roof void could be seen well. There was a small area in the roof where timber planks had been fitted under rafters but this was open at the ends and damaged and there was no evidence of any bat droppings under this or within where it could be seen and no evidence seen to suggest that bats were accessing this space.

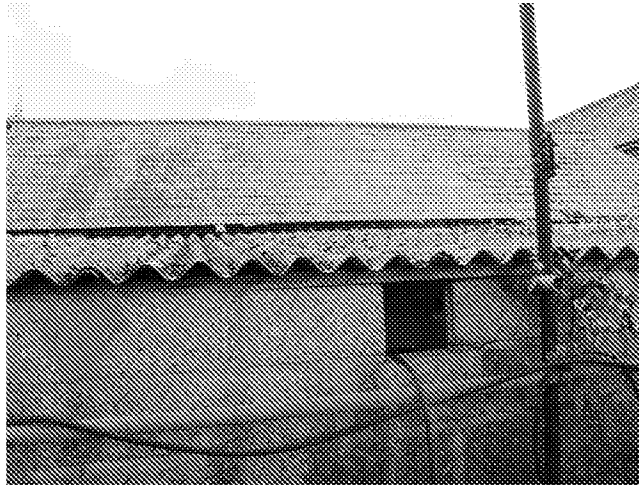
The slate roof appeared to be very well sealed on the northern side and most of the southern side. Some of slates were lifting slightly on the eastern end of the southern side but it is unlikely that these offered roosting. There were no marking suggestive of bats accessing the slightly lifting tiles

South facing roof of slate with corrugated roof of a separate building butting up to it

The western gable end was well sealed. There was access on the eastern end between battens and slates but there was no evidence on the timber under this or on the space to suggest bats were accessing this space.
