## **APPENDIX D – Annex 4 OF R&D66: 2008**

## APPENDIX F – Probe Hole Logs

| <b>Project</b><br>West Walbarton Lane, Walbarton | | | | |

## APPENDIX G – Site Photographs

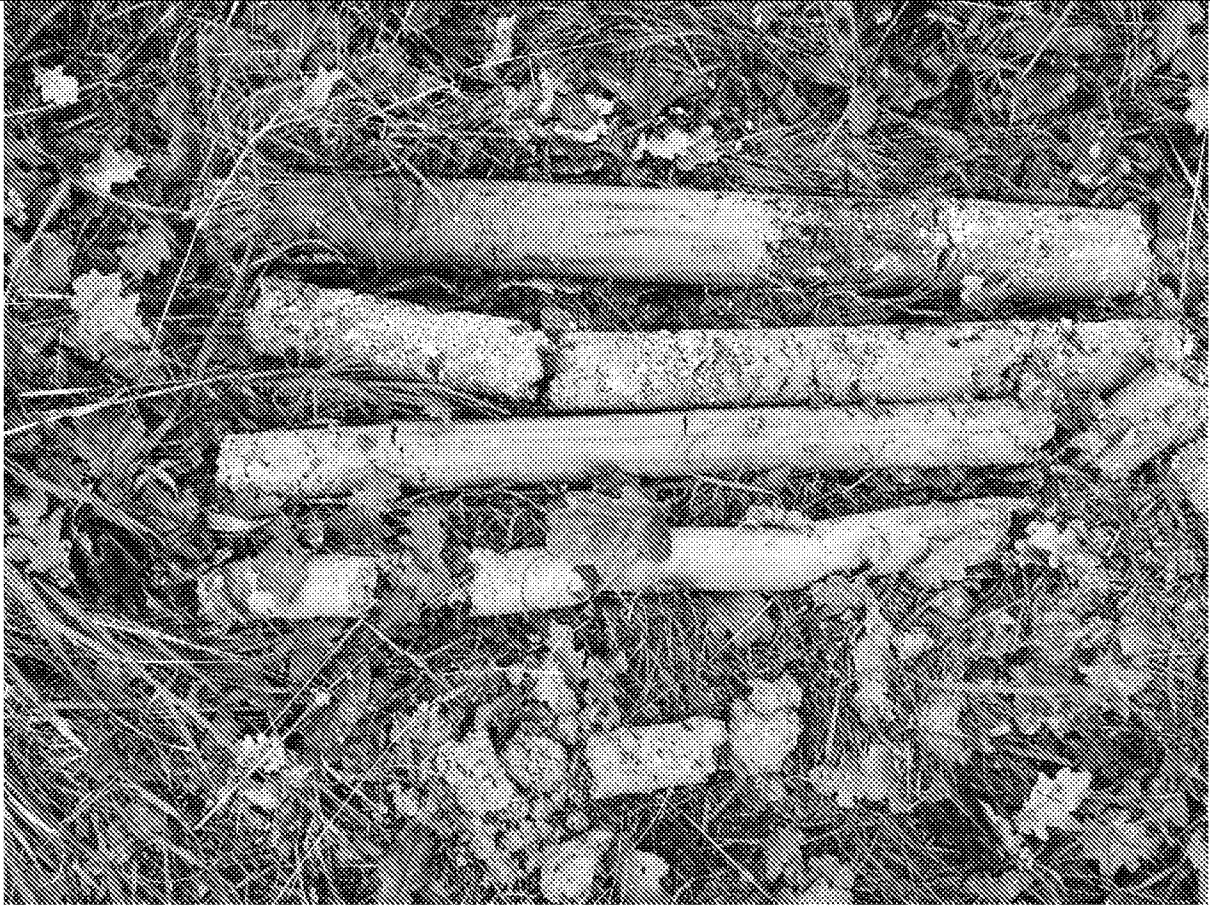
PLATE 1 – Cores from Window Sample borehole WS1

| STRATA | | | | | SAMPLES & TESTS | | | Backfill |
|---|---|---|---|---|---|---|---|---|
| | | | (1.30)<br>2.1 | Soft to firm yellow/light brown sandy very gravelly CLAY. Gravel is sub angular to angular flint | 2-2.45 | 5,5,5,6,5,6 | N=-22 | |
| | | | (2.90)<br>5.00 | Firm tending to firm to stiff with depth yellow/light brown very sandy CLAY | 4-4.45 | 6,10,11,14,12,9 | N=46 | |

| <b>GENERAL REMARKS</b><br>1 Water strike at 2.2m<br>2 Standpipe installed to 4.5m due to collapse - plain 0.5m over 4.0m slotted |

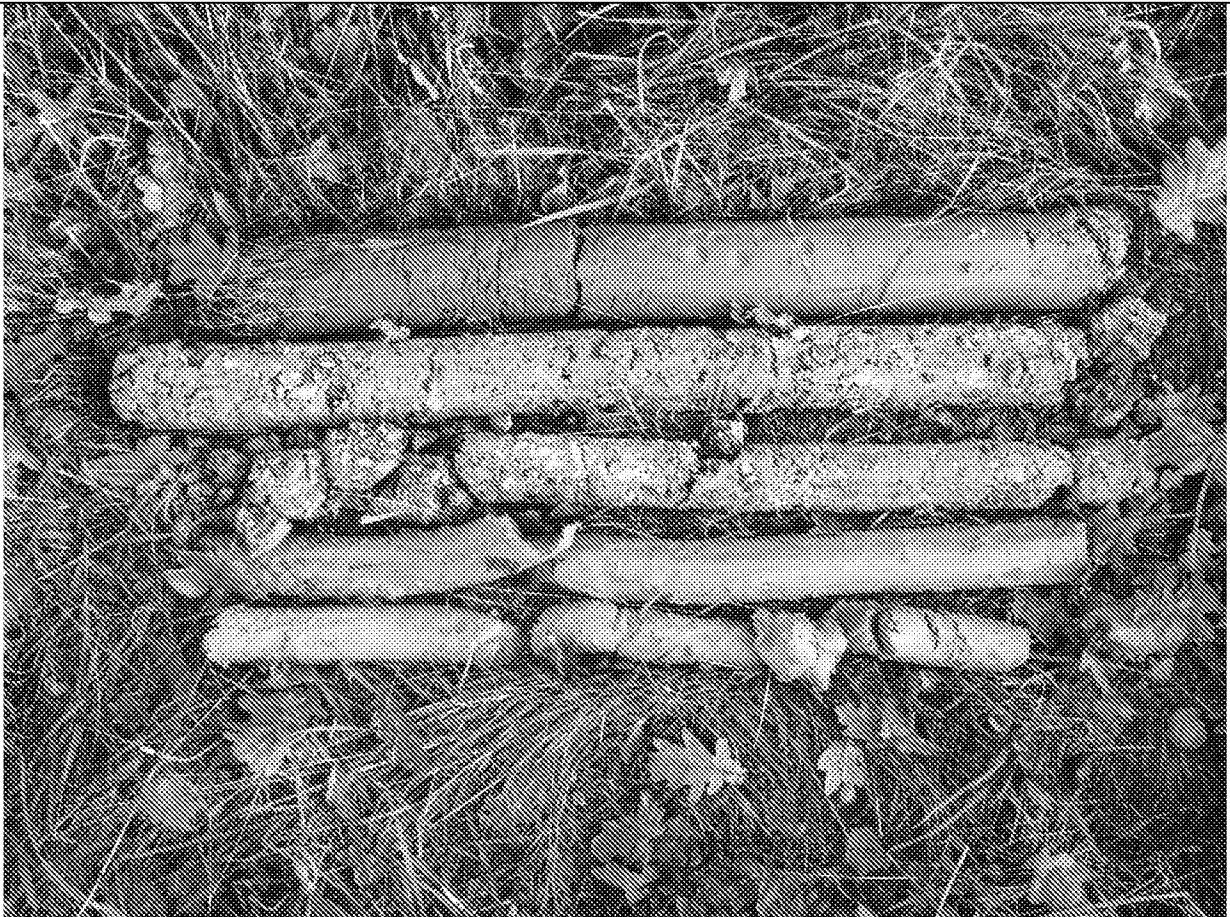
PLATE 2 – Cores from Window Sample borehole WS2

| STRATA | | | | | SAMPLES & TESTS | | | Backfill |
|---|---|---|---|---|---|---|---|---|
| | | | (2.20)<br>3.0 | Soft to firm yellow/light brown sandy very gravelly CLAY. Gravel sub angular to angular flint<br>NATURAL SOILS | 1-1.45<br>3-3.45 | 4,3,4,4,4,5<br>1,2,1,2,2,1 | N=17<br>N=6 | |
| | | | (2.00)<br>5.00 | Soft yellow/light brown very sandy CLAY<br>NATURAL SOILS | 5-5.45 | 1,0,1,1,1,0 | N=3 | |

| <b>GENERAL REMARKS</b><br>1 Water Strike at 1.1m<br>2 Standpipe installed to 4.5m due to collapse - plain 0.5m over 4.0m slotted |

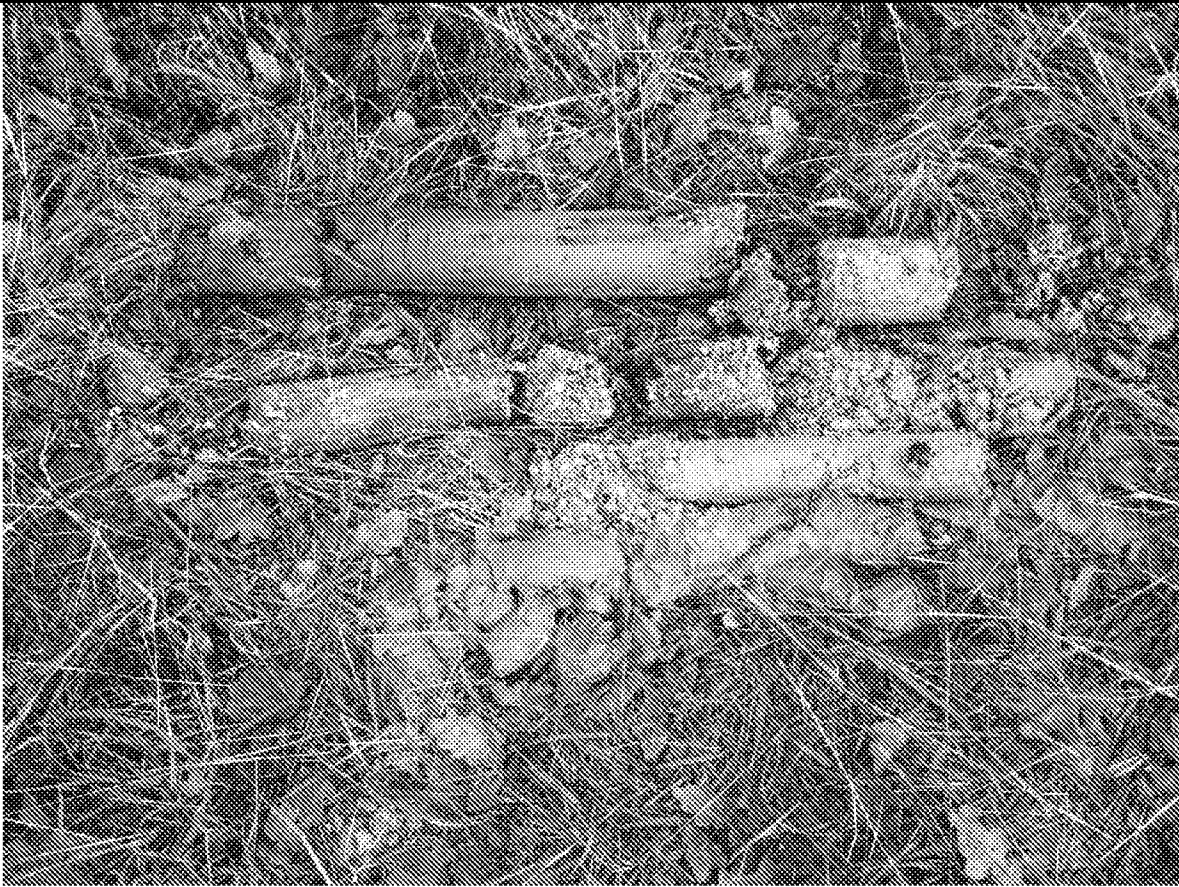
PLATE 3 – Cores from Window Sample borehole WS3

| STRATA | | | | | SAMPLES & TESTS | | | Backfill |
|---|---|---|---|---|---|---|---|---|
| | | | (1.60) | Soft to firm light grey/light brown sandy very gravelly CLAY. Gravel sub angular to angular | 1-1.45 | 3,4,3,4,3,3 | N=13 | |
| | | | (2.6) | Soft yellow/light brown very sandy CLAY | 3-3.45 | 2,2,2,1,2,1 | N=6 | |

- 1 Water strike at 0.8m
- 2 Standpipe installed to 3.8m due to collapse - plain 0.8m over 3.0m slotted

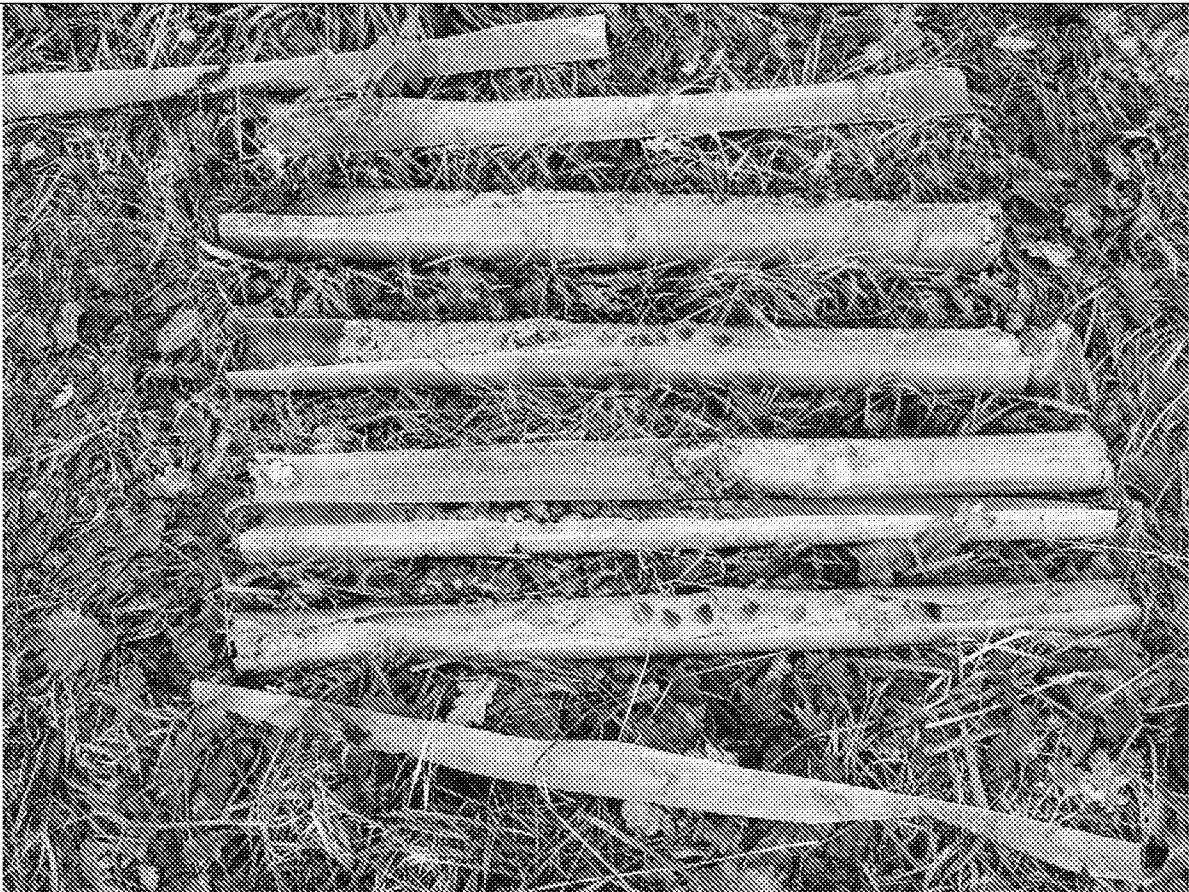
PLATE 4 – Cores from Window Sample borehole WS4

| STRATA | | | | | SAMPLES & TESTS | | | Backfill |
|---|---|---|---|---|---|---|---|---|
| | | | (1.30)<br>2.0 | Firm yellow/light brown sandy very gravelly CLAY.<br>Gravel sub angular to angular flint<br>NATURAL SOILS | 1-1.45 | 5,6,6,6,5,6 | N=23 | |
| | | | (4.00) | Soft yellow/light brown very sandy CLAY | 3-3.45 | 1,2,2,2,3,4 | N=11 | |

- 1 Water standing at surface
- 2 Standpipe installed to 6m - plain 1.0m over 5.0m slotted

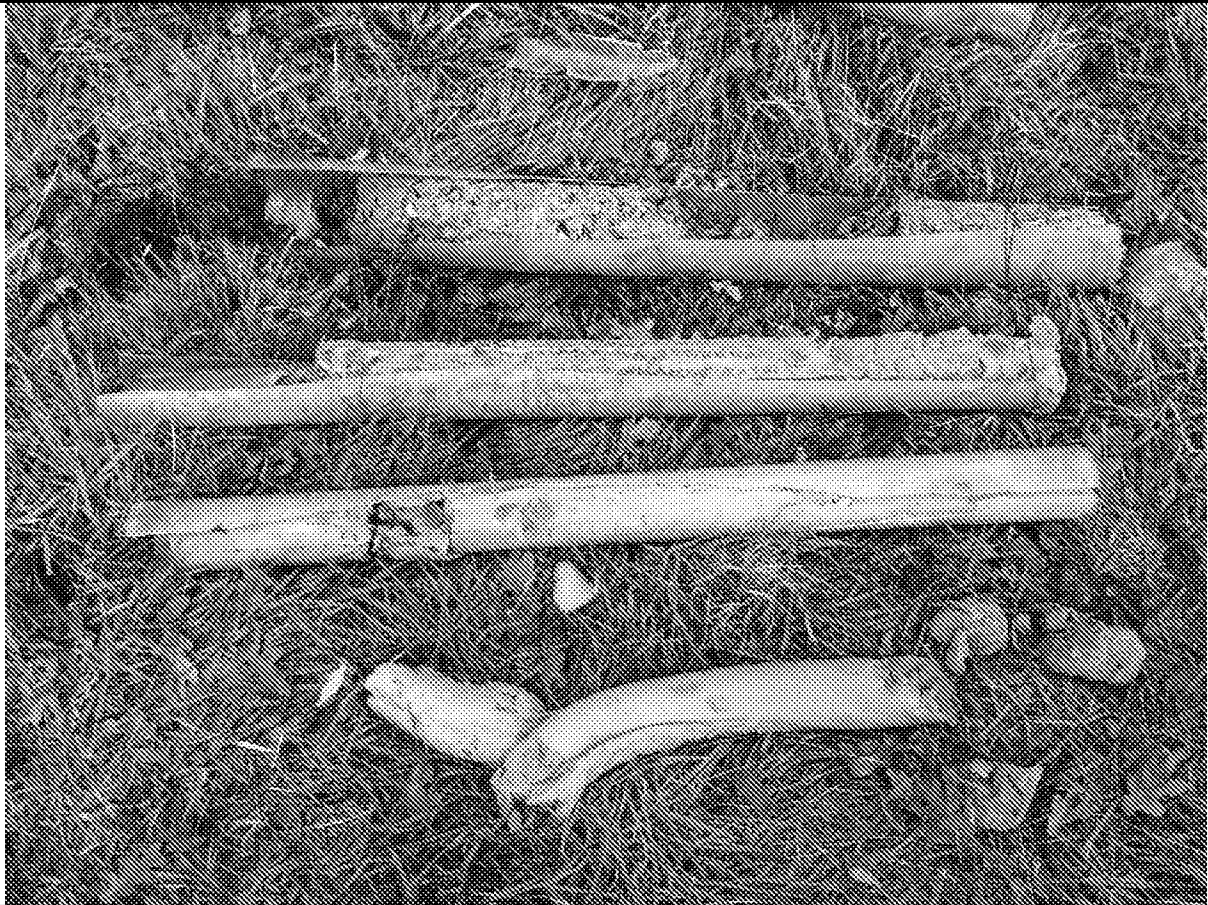
PLATE 5 – Cores from Window Sample borehole WS5

| STRATA | | | | | SAMPLES & TESTS | | | Backfill |
|---|---|---|---|---|---|---|---|---|
| | | | | Soft to firm yellow/light brown very sandy CLAY | 2-2.45 | 3,3,3,3,4,5 | N=15 | |

| <b>GENERAL REMARKS</b><br>1 Water standing at surface<br>2 Standpipe installed to 4m - plain 1.0m over 3.0m slotted |

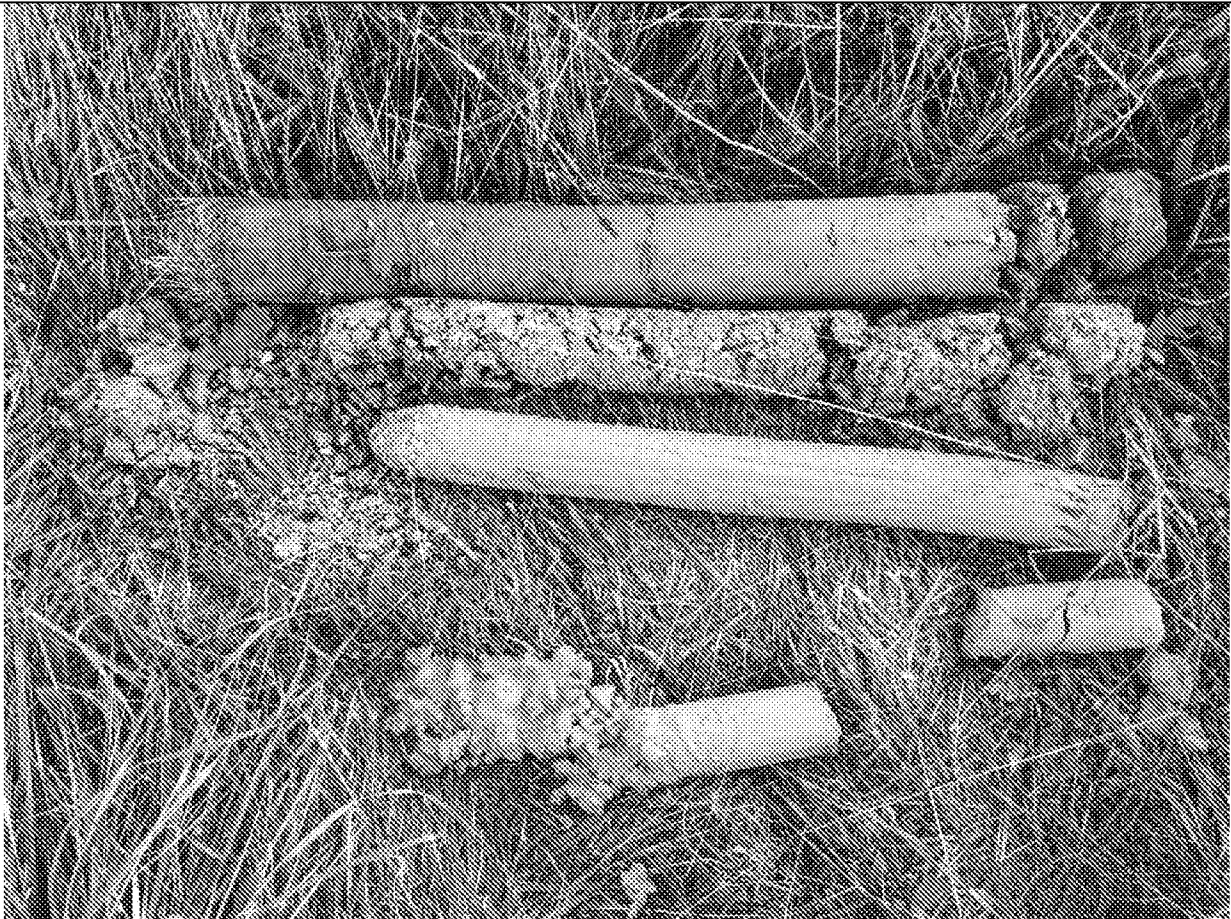
PLATE 6 – Cores from Window Sample borehole WS6 (LAP)

| <b>GENERAL REMARKS</b><br>1 Located with the area of the proposed LAP<br>2 Water strike at 1.0m<br>3 Standpipe installed to 2.6m due to collapse - plain 0.6m over 2.0m slotted |
