**ARBTECH**

**Project:**  
Midway,  
Avisford Park Road,  
Walberton,  
West Sussex,  
BN18 0AP

**Drawing:**  
Arboricultural Impact Assessment

**Drawing No:**  
Arbtech AIA 01

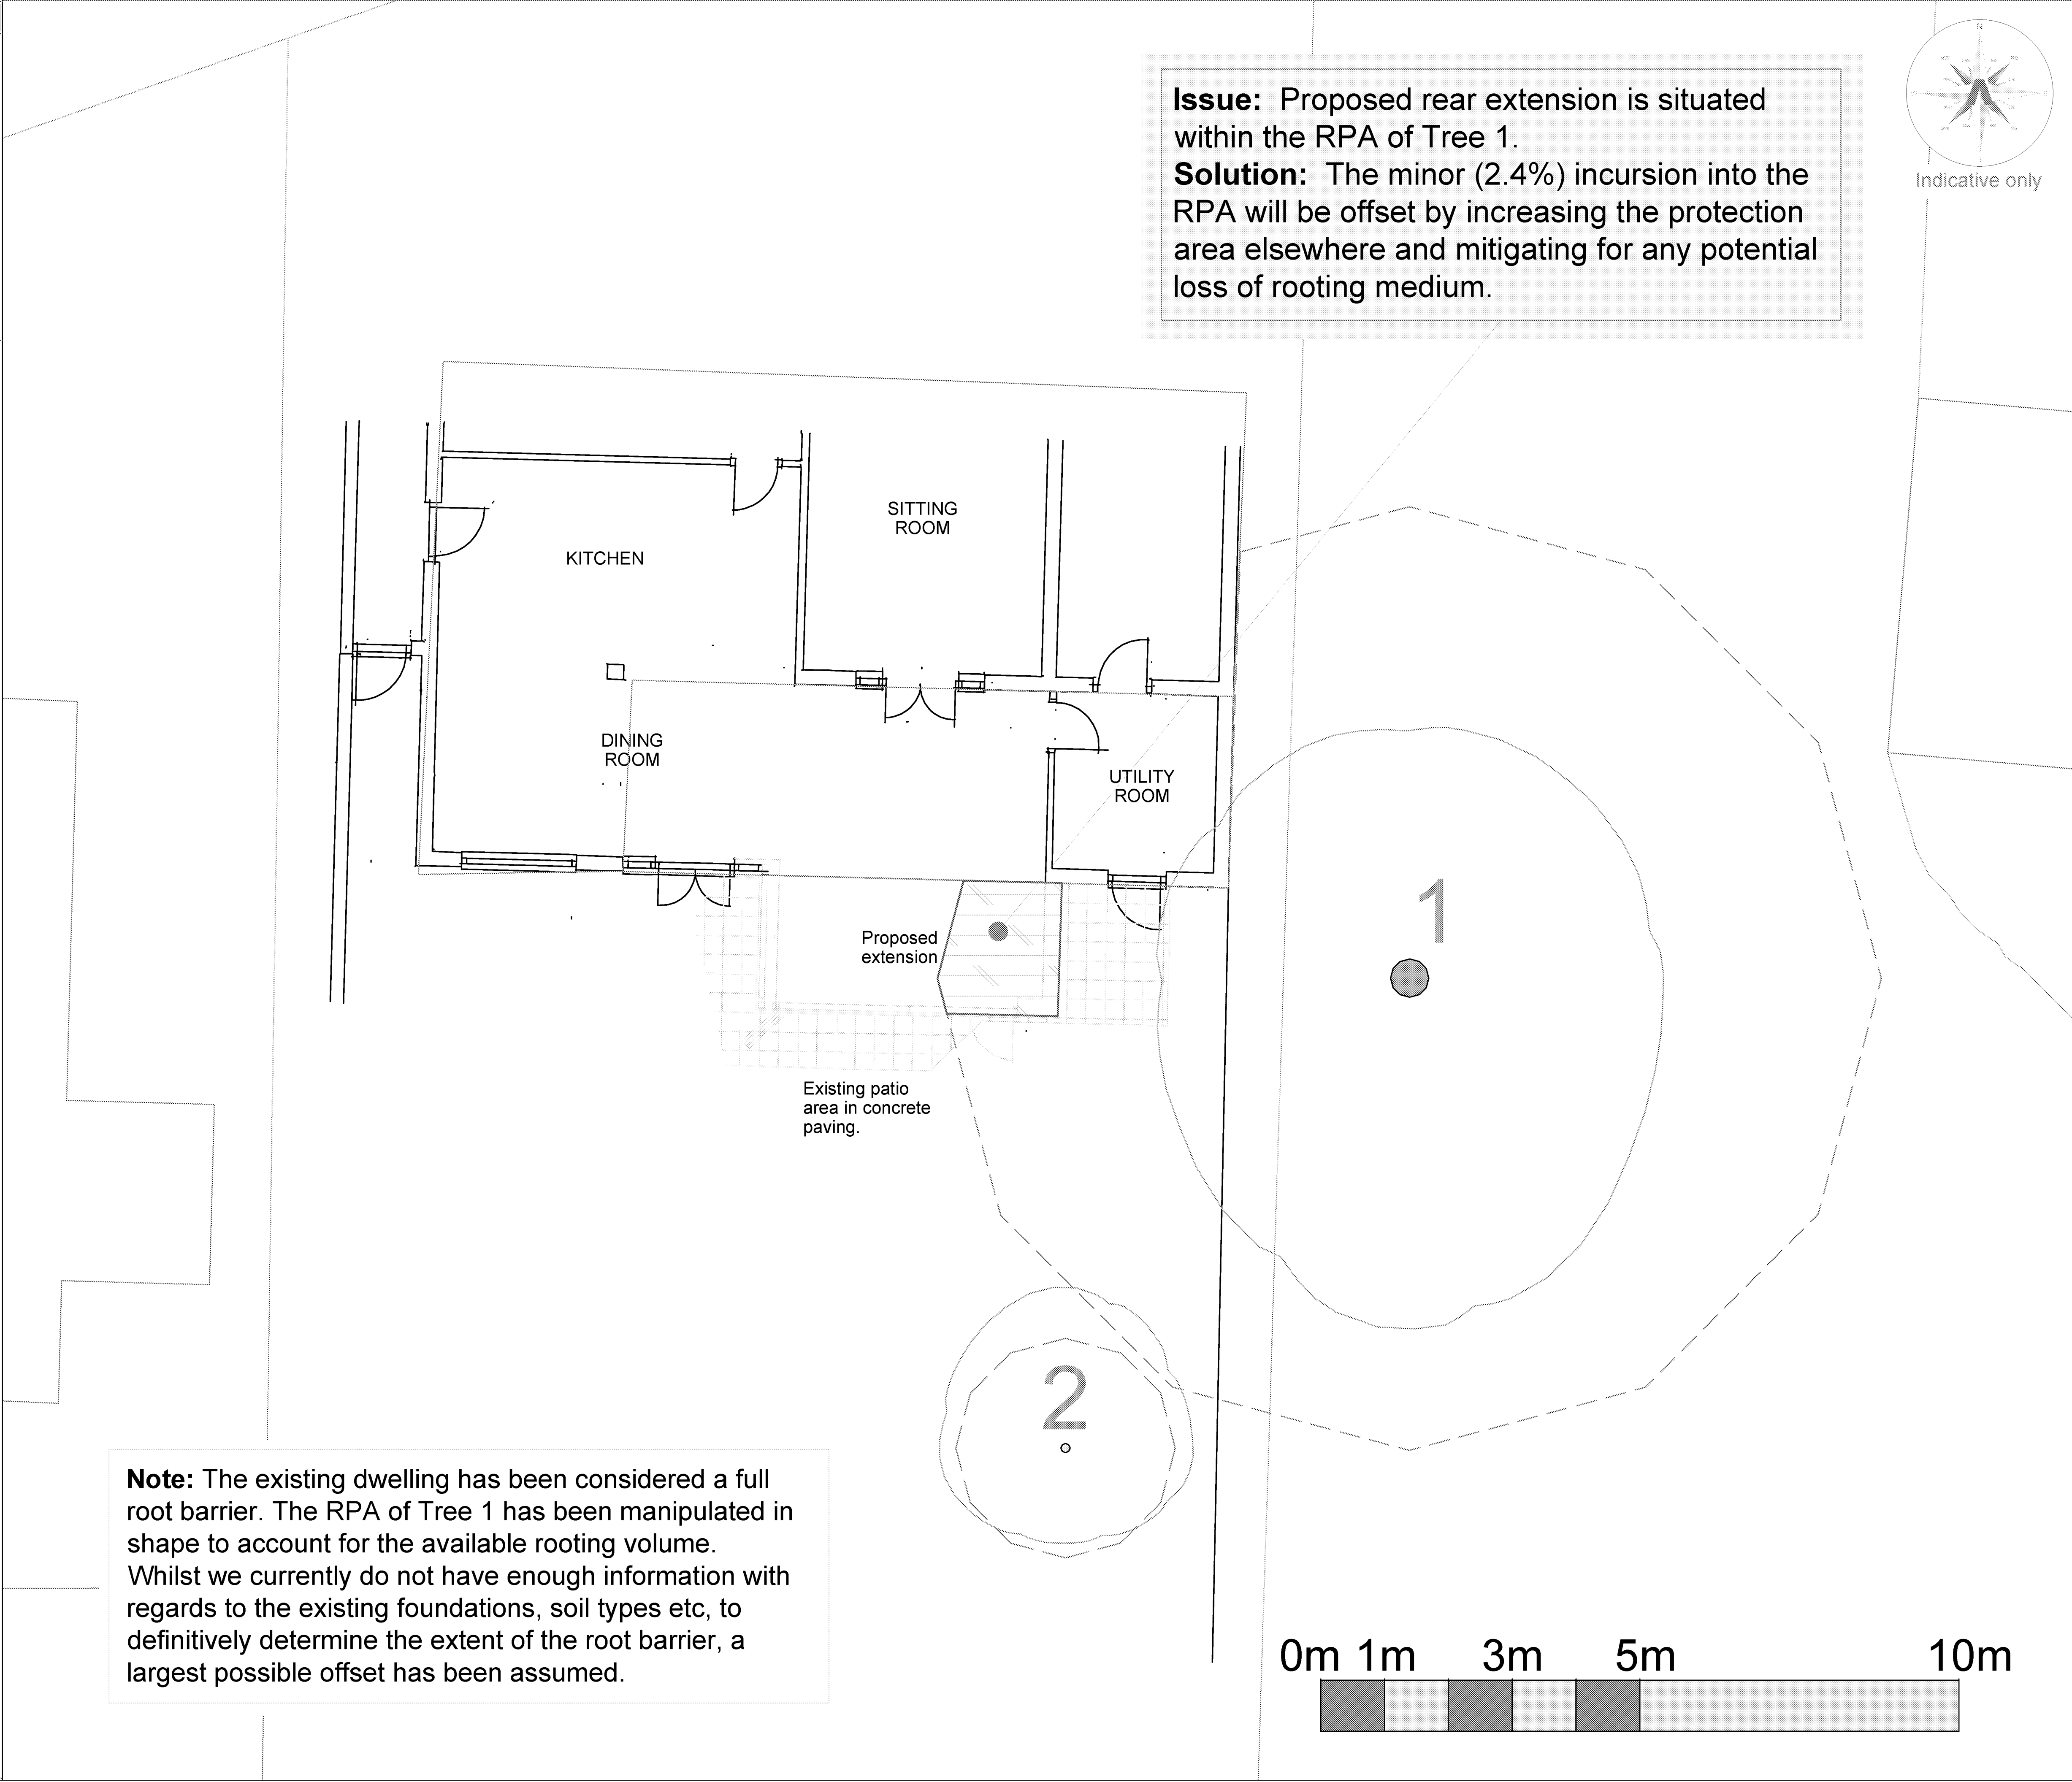
| Tree No | Species | Proposed structure | Incursion |
|---|---|---|---|
| 1 | Decidur Cedar | Extension | RPA |

| Tree No | Species | RPA (m²) | Incursion (m²) | Incursion (%) |
|---|---|---|---|---|
| 1 | Decidur Cedar | 155.6 | 3.9 | 2.4 |
