## WINTER GROUNDWATER MONITORING

LAND EAST OF TYE LANE, WALBERTON

**GROUNDWATER MONITORING REPORT**

| Reference: | GE16054-GWMR-JUNE17 |

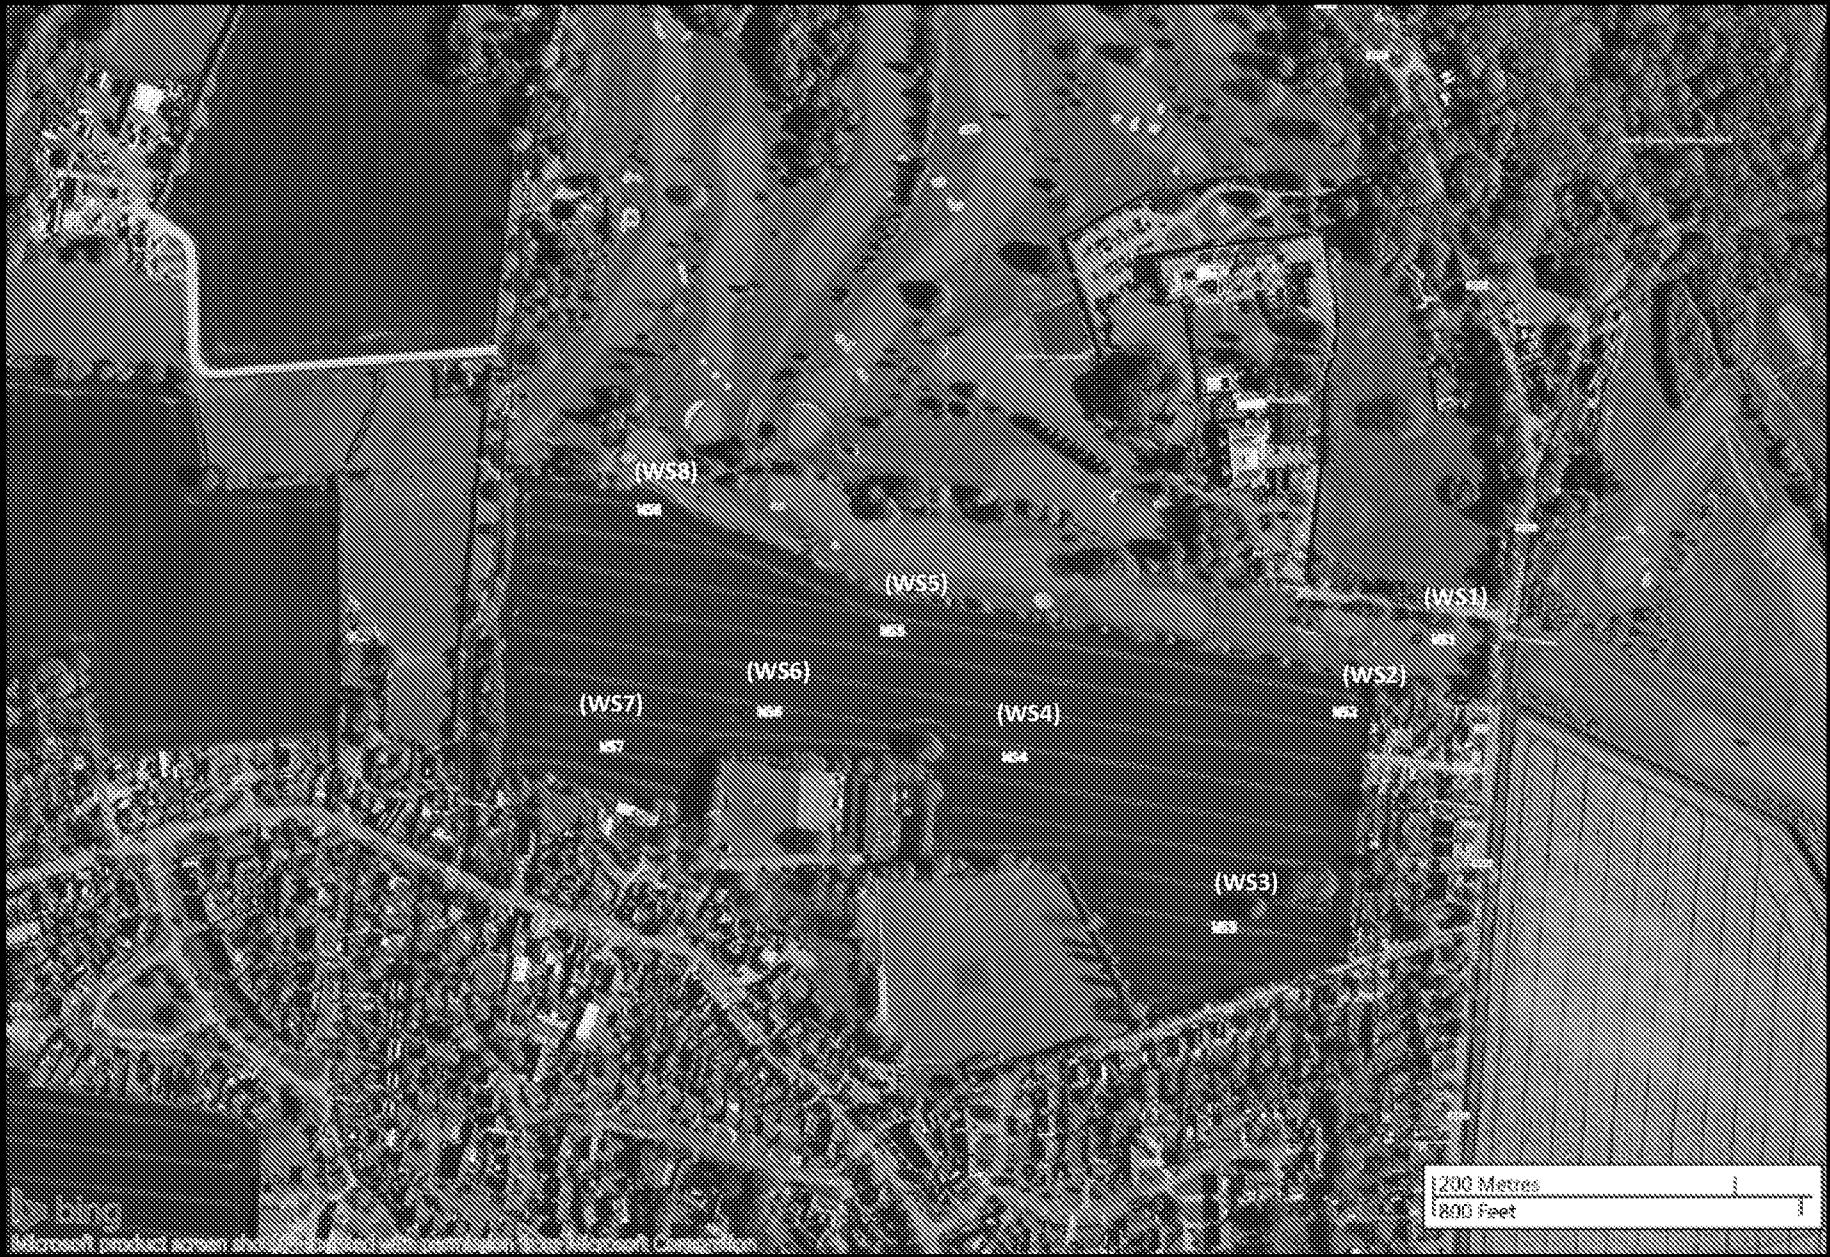
Title : Figure 1 - Site Location Plan  
Scale: 1:5000  
Engineer: Cesar Azevedo

An aerial photograph of a rural area with fields and some buildings. Overlaid on the map are several labels in parentheses: (WS8), (WS5), (WS7), (WS6), (WS4), (WS3), (WS2), and (WS1). These labels are positioned over different areas of the land. A scale bar in the bottom right corner indicates 200 Metres and 800 Feet. A Bing logo is visible in the bottom left corner of the map area.

The approximate positions of the window sampler boreholes are presented in Figure 1. For more detailed descriptions of the ground conditions at specific locations, reference should be made to the borehole logs attached in Appendix A.

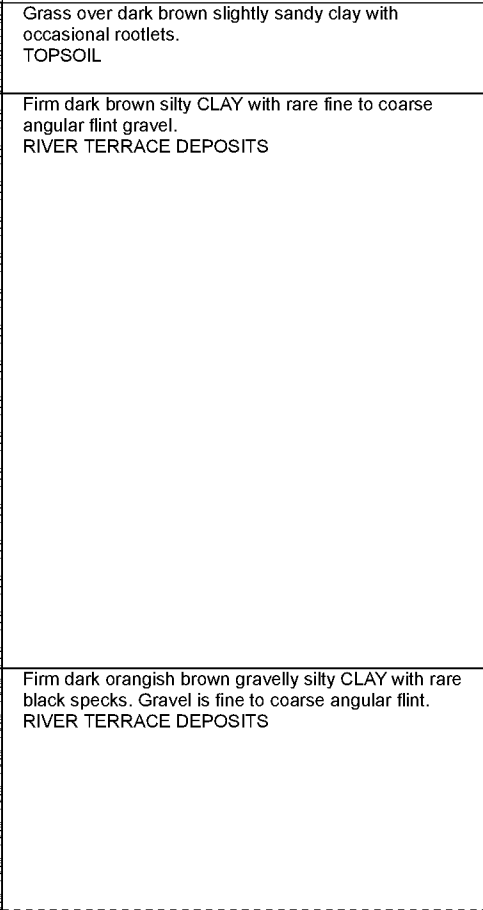
| Unit 7, Danworth Farm<br>Hurstpierpoint<br>BN6 9GL<br>www.gesl.net | | <h1 style="text-align: center;">Borehole Log</h1> | | | | Borehole No.<br><b>WS3</b><br>Sheet 1 of 1 | |

| Well | Water Strikes | Sample and In Situ Testing | | | Depth (m) | Level (m) | Legend | Stratum Description | |
|---|---|---|---|---|---|---|---|---|--|
| | | | | | 0.30 | | Grass over dark brown slightly sandy clay with occasional rootlets. TOPSOIL | | |
| | | | | | 2.20 | | Firm dark brown silty CLAY with rare fine to coarse angular flint gravel. RIVER TERRACE DEPOSITS | | |
| | | | | | 3.00 | | Firm dark orangish brown gravelly silty CLAY with rare black specks. Gravel is fine to coarse angular flint. RIVER TERRACE DEPOSITS | | |

| Casing | | Water Strikes (mbgl) | | Chiselling (mbgl) | | Remarks |
|---|---|---|---|---|---|---|
| | | | | | | Groundwater not encountered. |
