# **LAND TO THE EAST OF TYE LANE, WALBERTON**

## **A27 / A29 / FONTWELL AVENUE - POTENTIAL FURTHER JUNCTION IMPROVEMENT**

### **ROAD SAFETY AUDIT STAGE 1**

**August 2017**

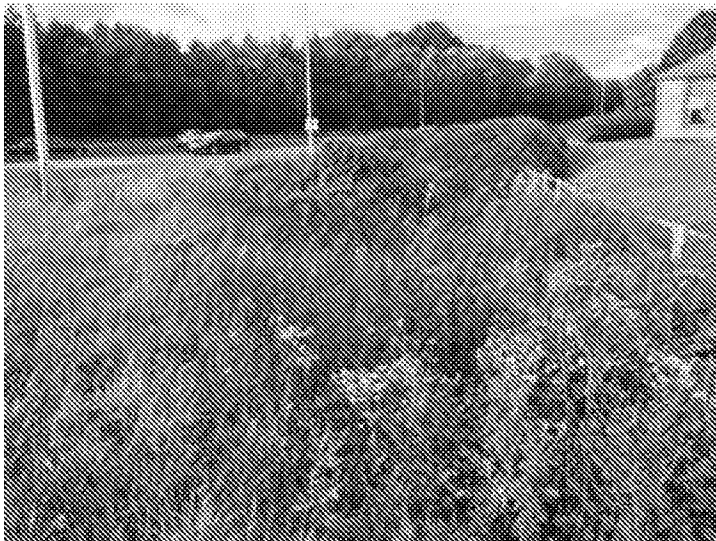
Location: A (drawing ITB11324-GA-015 Rev B) – A27 southwest bound approach to junction.

Summary: Presence of a ditch may compromise road safety.

There is an existing ditch between the proposed additional entry lane and the restaurant / hotel complex, see figure 1 below, where no protection system is proposed. Vehicles that lose control and exit the carriageway may decelerate rapidly, where injuries may be severe in nature. In addition, in winter months the ditch could hold water, which could further impede the escape of vehicle occupants.

Figure 1: Existing ditch could increase severity of a loss of control accident.

That a Road Restraints Risk Assessment Process (RRRAP) should be undertaken to determine the aggressiveness of the ditch and whether protection is needed.

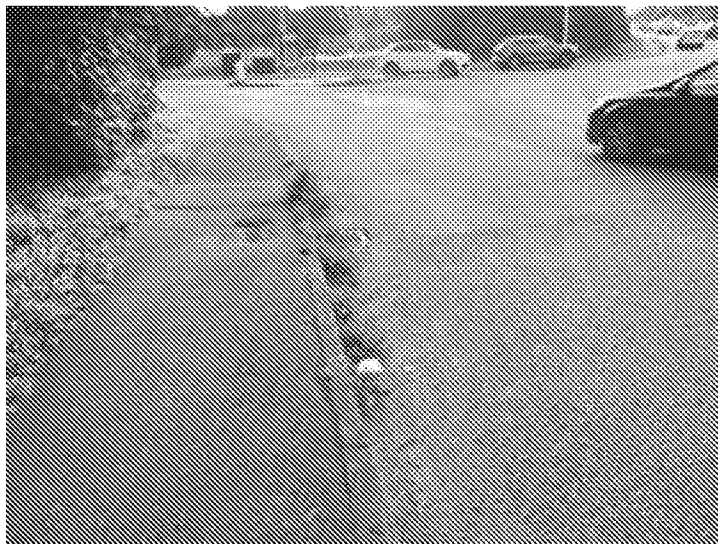
Locations: C (drawing ITB11324-GA-015 Rev B) – Circulatory carriageway between Arundel Road and Fontwell Avenue.

Summary: Insufficient drainage could lead to loss of control accidents.

The carriageway alignment between Arundel Road and Fontwell Avenue is proposed to be changed with the kerblines being brought forward. However, there is a gully on the existing alignment, see figure 2 below, where no drainage provision is proposed. Surface water on the circulatory carriageway could lead to loss of control accidents, particularly under braking conditions.

Figure 2: Drainage provision on existing kerblines.

At detailed design stage, the drainage provision should be provided for assessment.

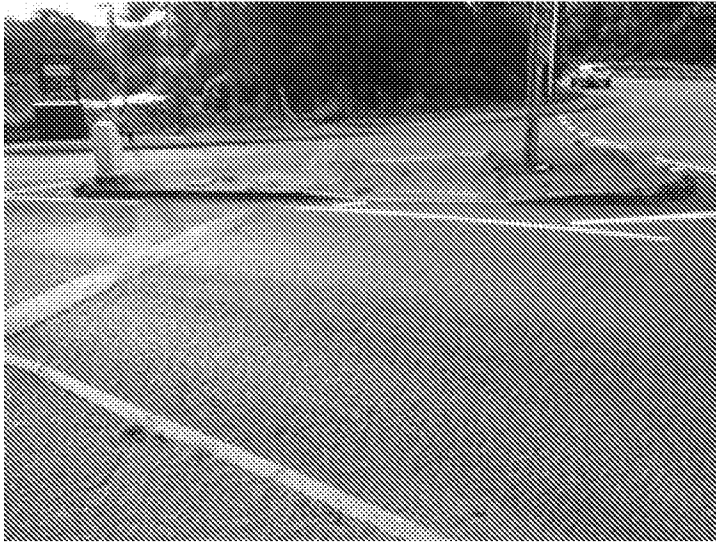
Location: F (drawing ITB11324-GA-015 Rev B) – A29 Fontwell Avenue.

Summary: Insufficient pedestrian facilities could lead to pedestrian accidents.

The A29 Fontwell Avenue arm of the roundabout currently has uncontrolled pedestrian facilities, see figure 3 below. However, no dropped kerb provision is proposed, where pedestrians, particularly the mobility impaired may trip, which could lead to pedestrian accidents.

Figure 3: Existing pedestrian facilities at junction.

That dropped kerbs should be provided in accordance with Department for Transport guidelines.
