Dandara Ltd

**Land East of Fontwell Avenue**

**Arboricultural Method Statement**

**FPCR Environment and Design Ltd**

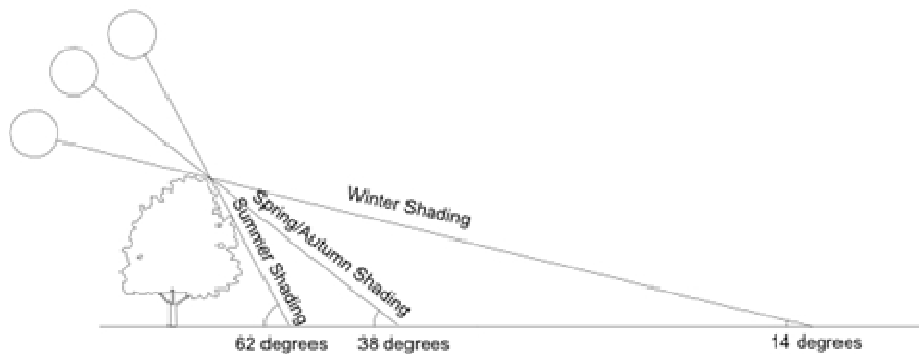
## Seasonal Shading Influence

- 1.21 Rear gardens to plots 212-217: Whilst tree cover is positioned along the southern boundary of these rear gardens, the majority of the tree cover is associated with TG10, a mixed broadleaf hedgerow with a current height of around 6m. Shade cast from this tree cover will be minimal and can be managed through annual cutting of the material. T38, a mature English oak is situated to the south east corner and is approximately 16m in height. Whilst the calculated shade pattern falls across the majority of the rear gardens to plots 216 & 217, as highlighted above the species of tree should be considered. T38, a deciduous tree which and as a species, develop an open and spreading crown form which allows light to penetrate the surrounding area. One method to negate the influence of shade would be to carry out a reduction in the lateral spread of this tree and to thin out growth internal to the crown. This would also mitigate any future pressures to prune or remove the trees from the new homeowners.

- 1.23 Rear gardens to plots 238-250: Tree cover along this portion of the southern boundary is a mixture of outgrown hedgerow and thicket growth which forms TG20, two mature beech trees which form TG21 along with T56 & T57, two mature crack willow. Any potential shading will be cast by the four individual specimens along this boundary. Whilst the beech trees are the largest with crown spreads of 9m and heights of 16m, this species is exhibit crown structures of slender branches. Once again formative pruning consisting of crown thinning and selective reductions would aid in light penetrating the surrounding garden space. T56 & T57 both exhibits slightly smaller crown proportions and crown density of willow species is considered to be less with a thin / slender leaf shape.

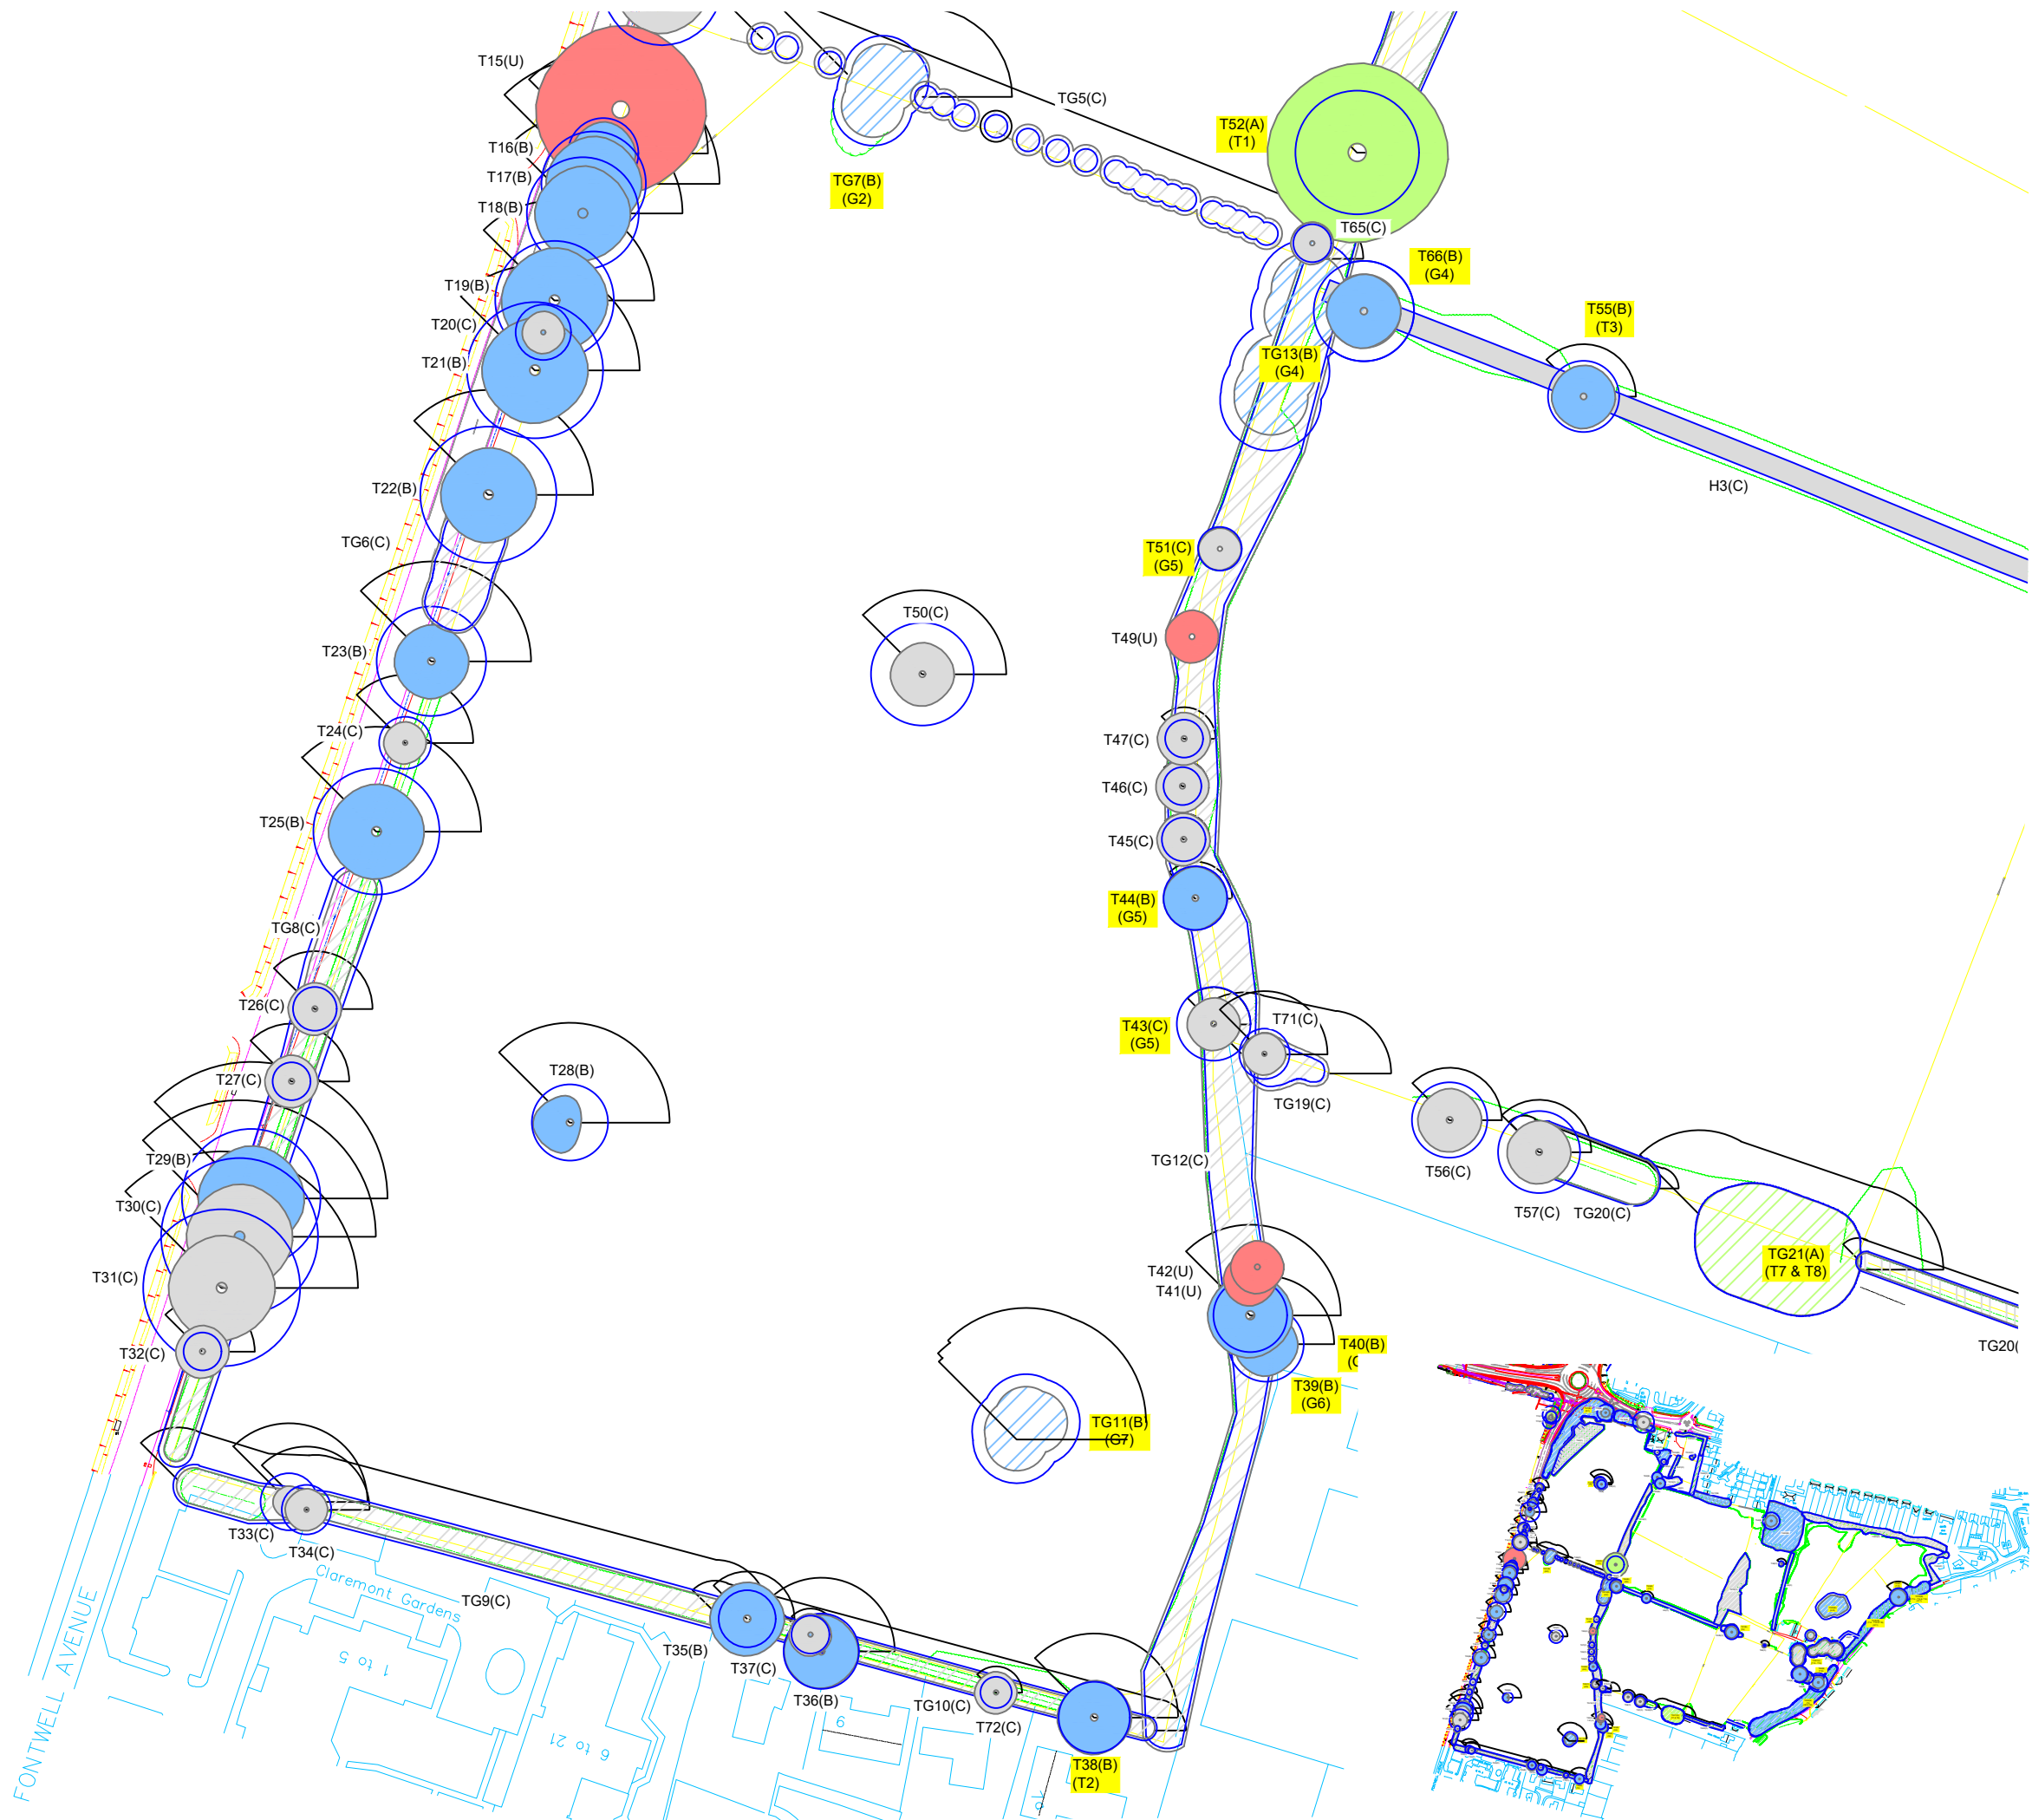
| <b>6233-T-01</b> | | - |

**KEY**

Category U - Unsuitable for Retention  
(BS 5837:2012)

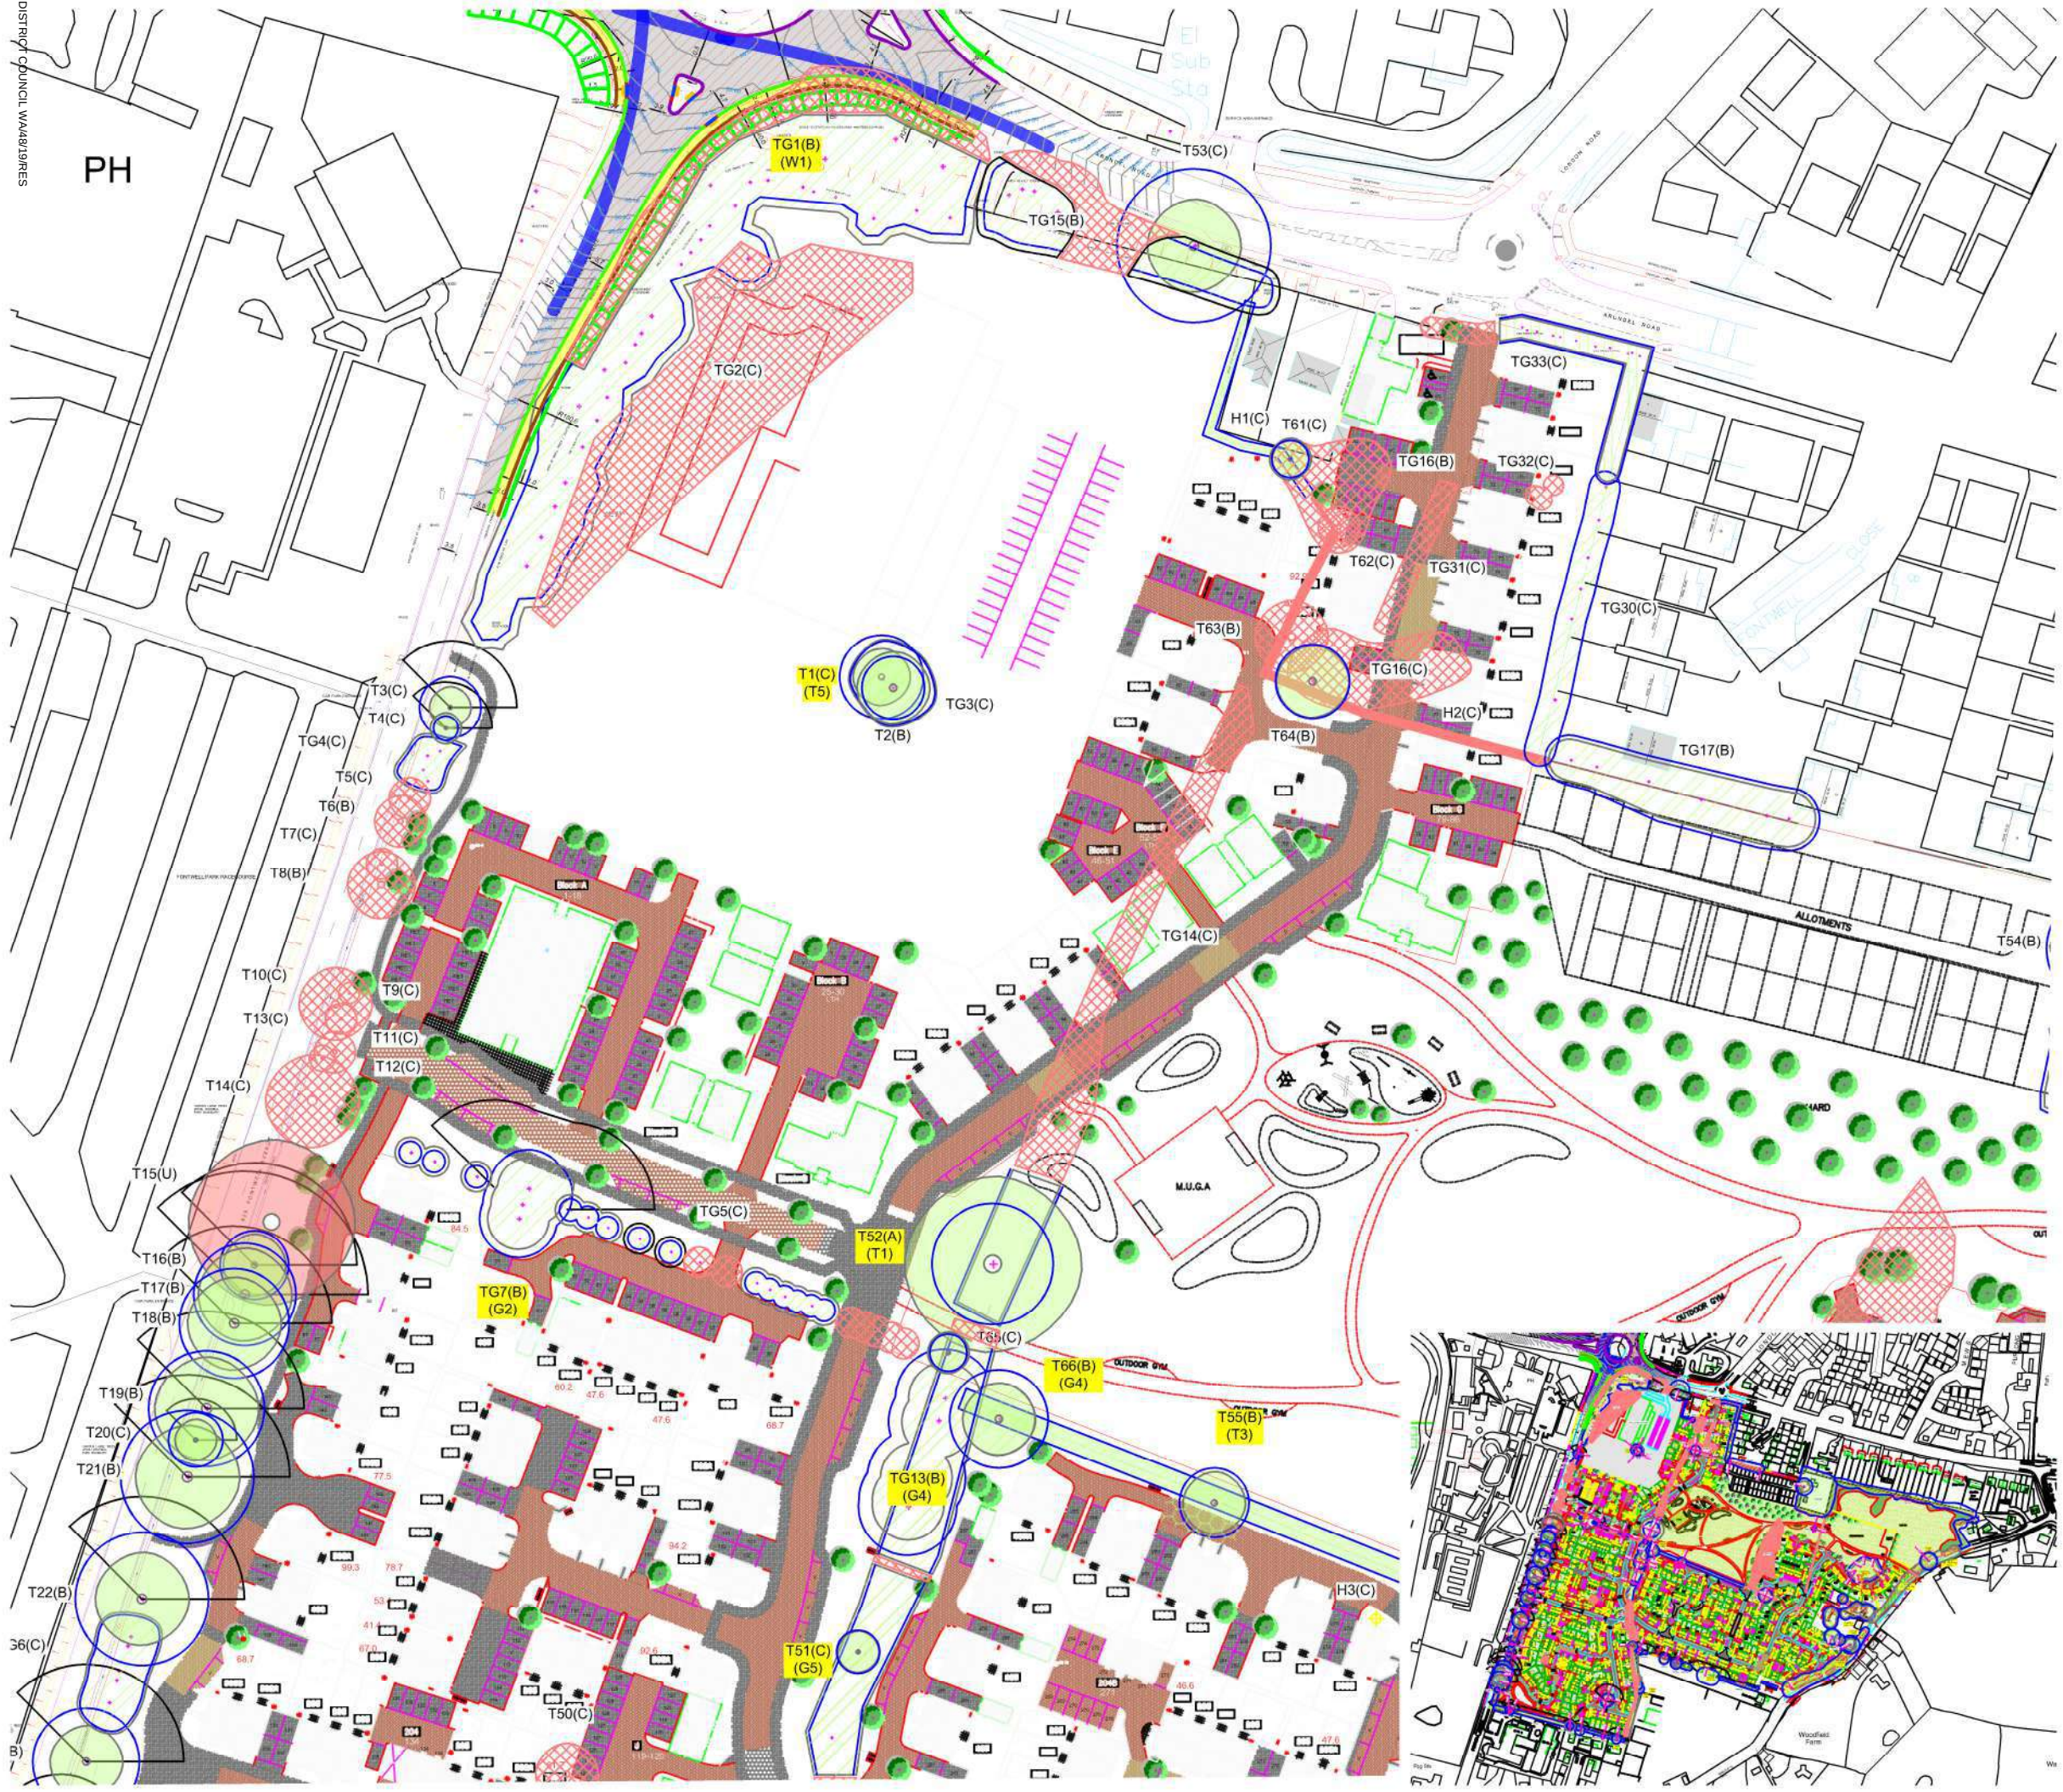
drawing number  
**6233-T-05**

**KEY**

- Tree/Group to be Retained
- Tree/Group to be removed to facilitate the proposals
- Category U - Unsuitable for retention on arboricultural grounds
- Hedgerow Proposed to be Retained and Incorporated into the New Development
- Hedgerow Proposed to be Removed to Facilitate the Development upon Approval of the Application
- Root Protection Area (the RPA has been altered where appropriate to reflect underground constraints)
- Individual / Group Number and BS Category
- Individual / Group Number and BS Category Including TPO Reference Number

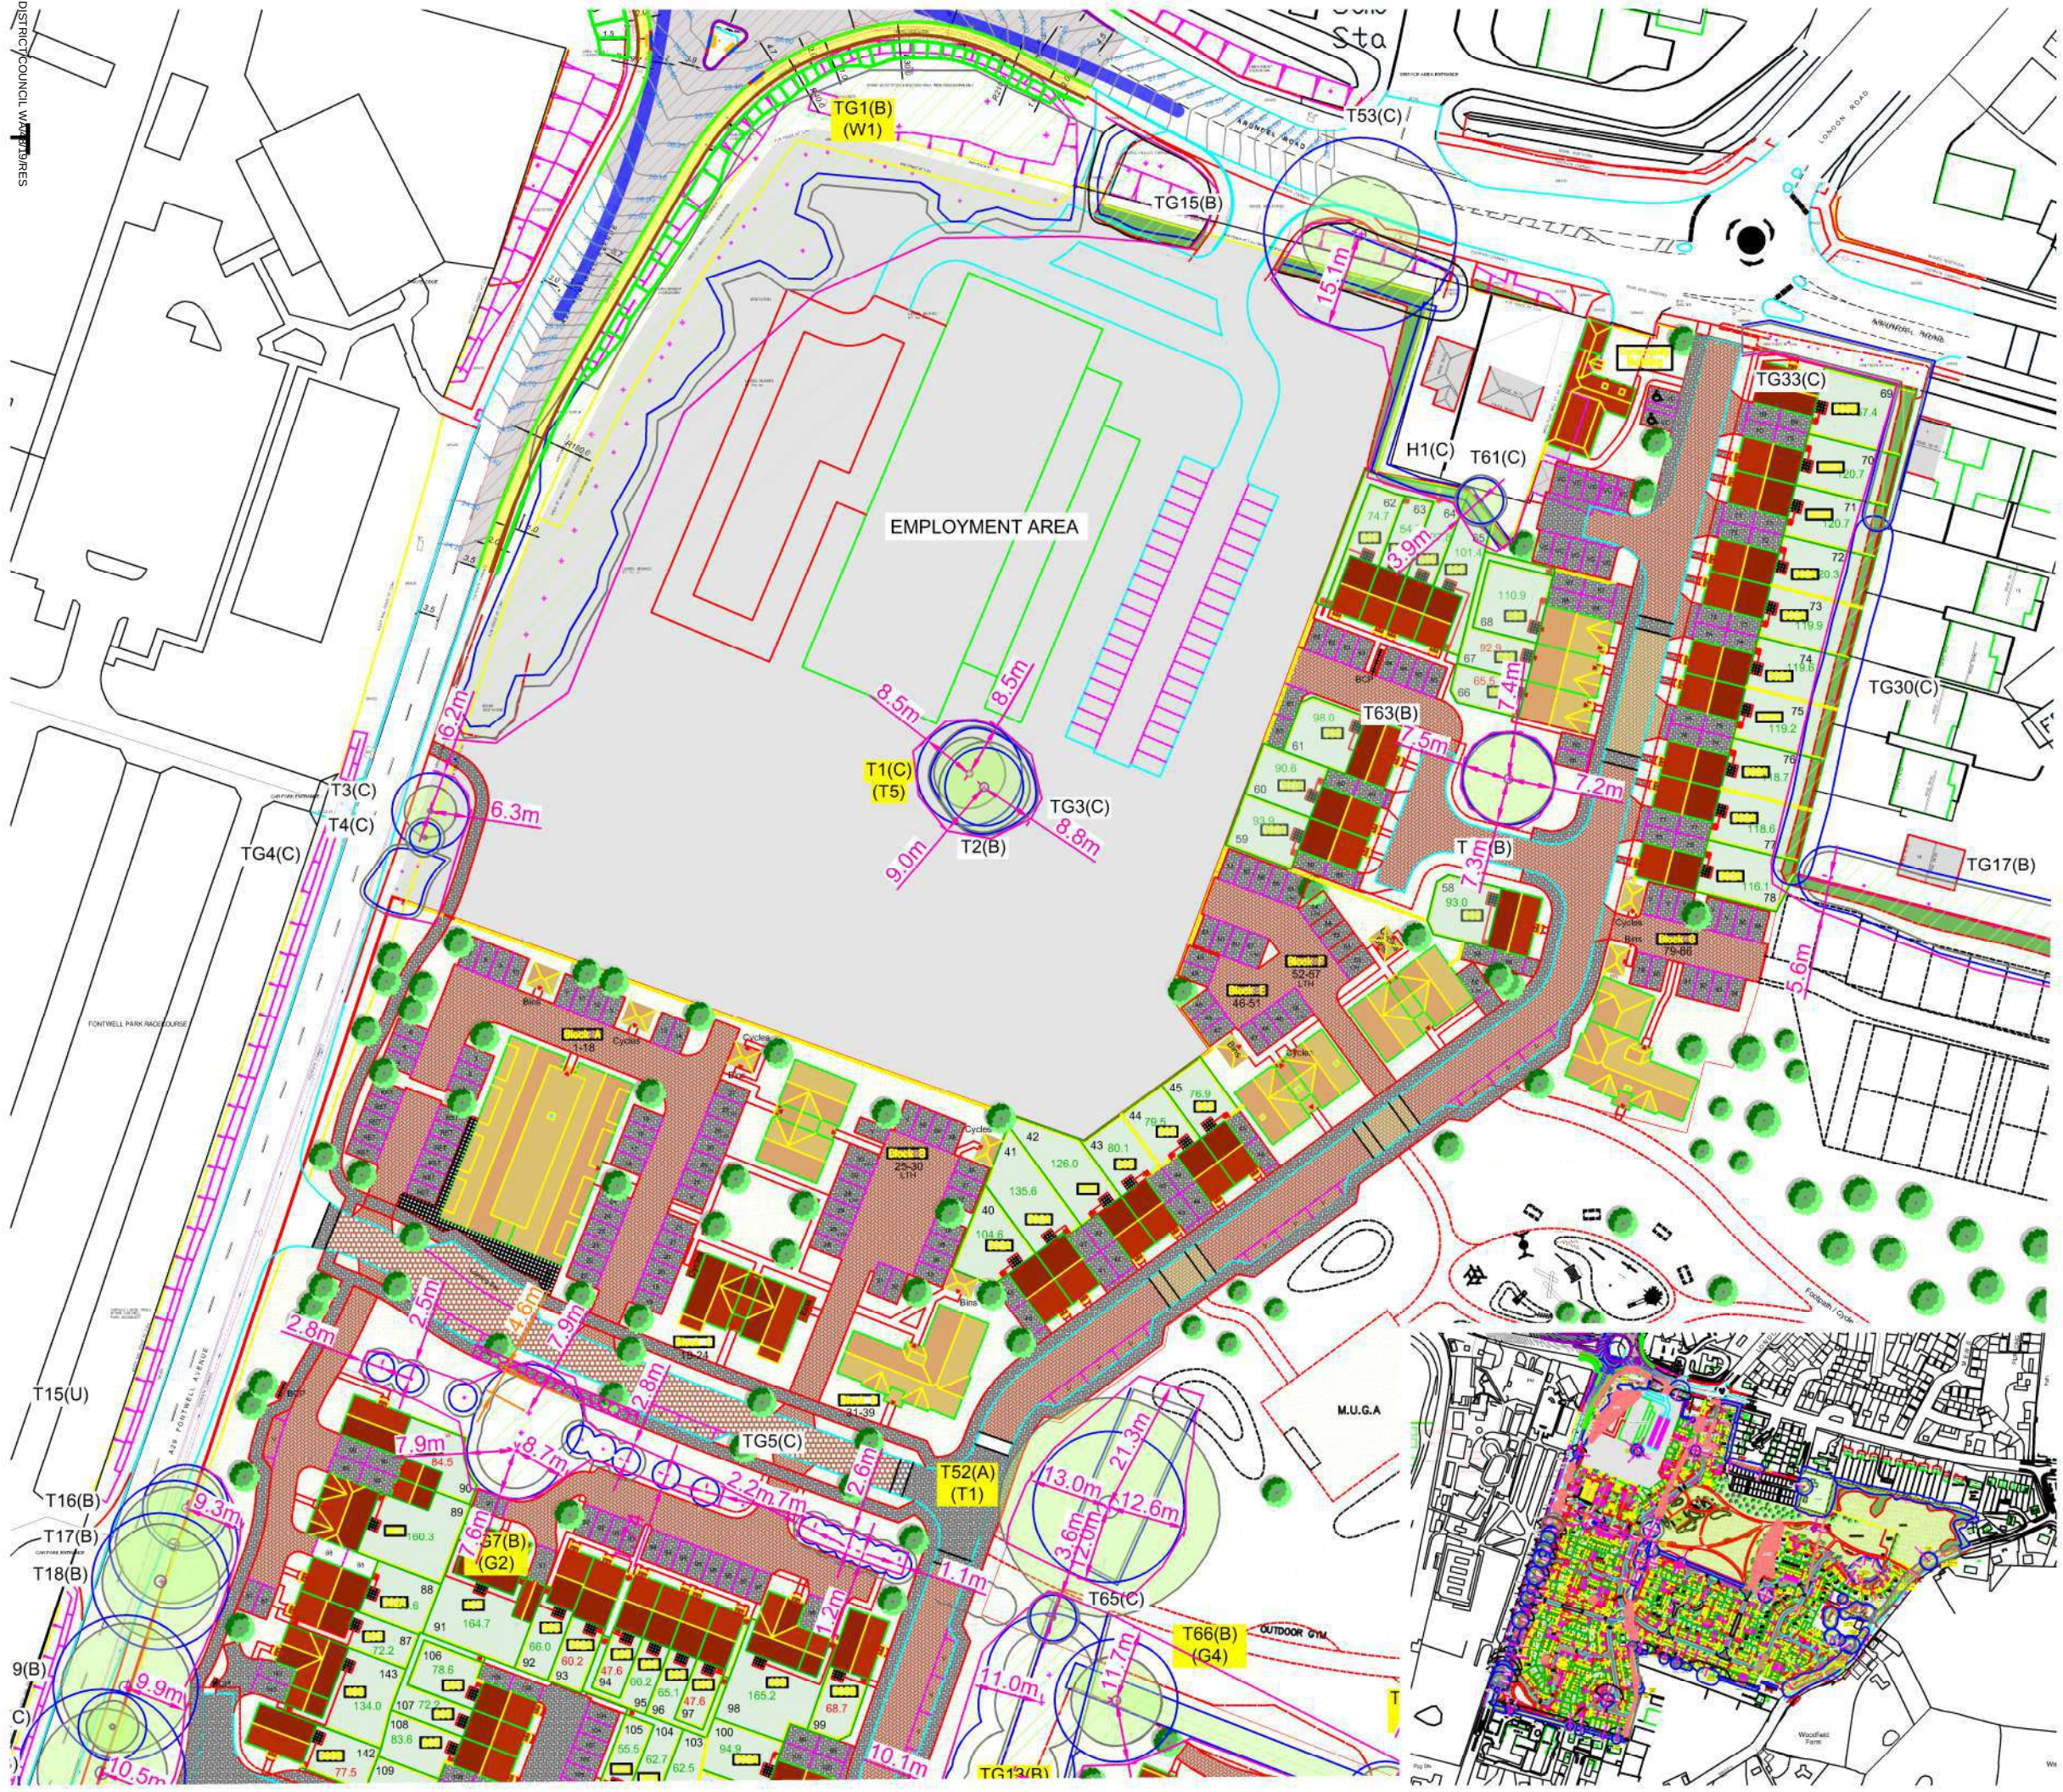
**KEY**

- Tree/Group to be Retained
- Hedgerow Proposed to be Retained and Incorporated into the New Development
- Root Protection Area (the RPA has been altered where appropriate to reflect underground constraints)
- T1 (A)  
TG1 (A) Individual / Group Number and BS Category
- T1 (C)  
TG1 (G1) Individual / Group Number and BS Category Including TPO Reference Number
- 6.0m Line of Phase 1 Protective Barriers (and distance from tree or retained structure)
- 6.0m Line of Phase 2 Protective Barriers (and distance from tree or retained structure)
- Area of Permanent No-Dig Highway, Footpath or Driveway Porous Construction

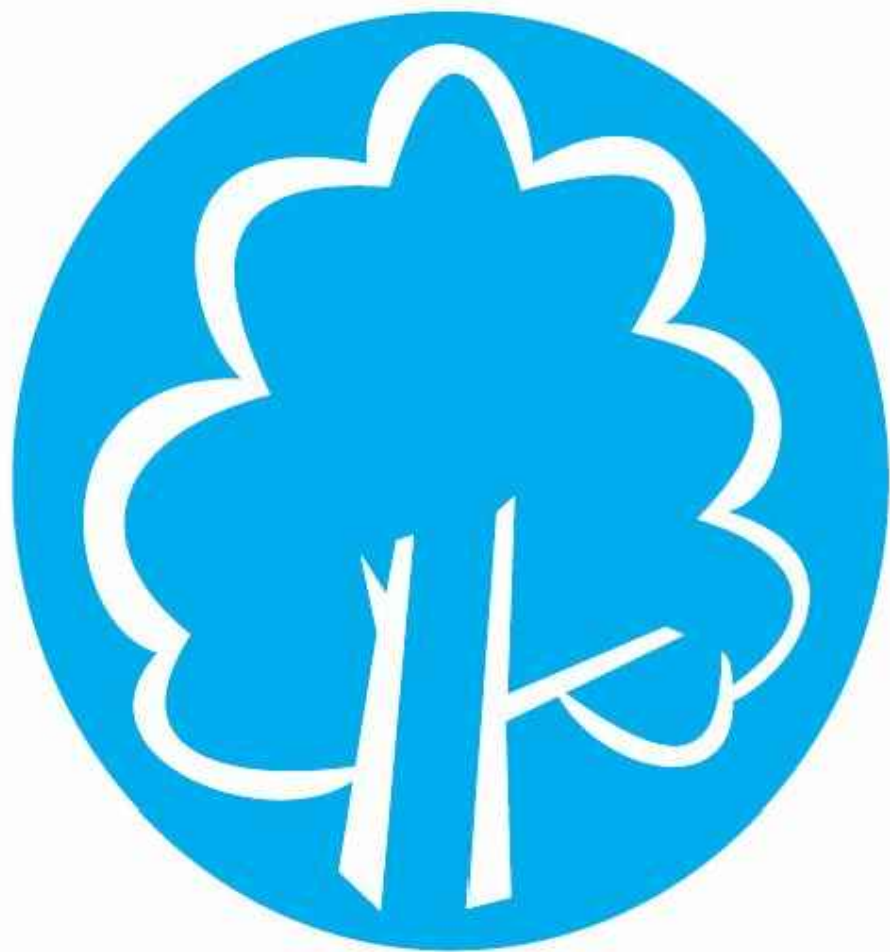
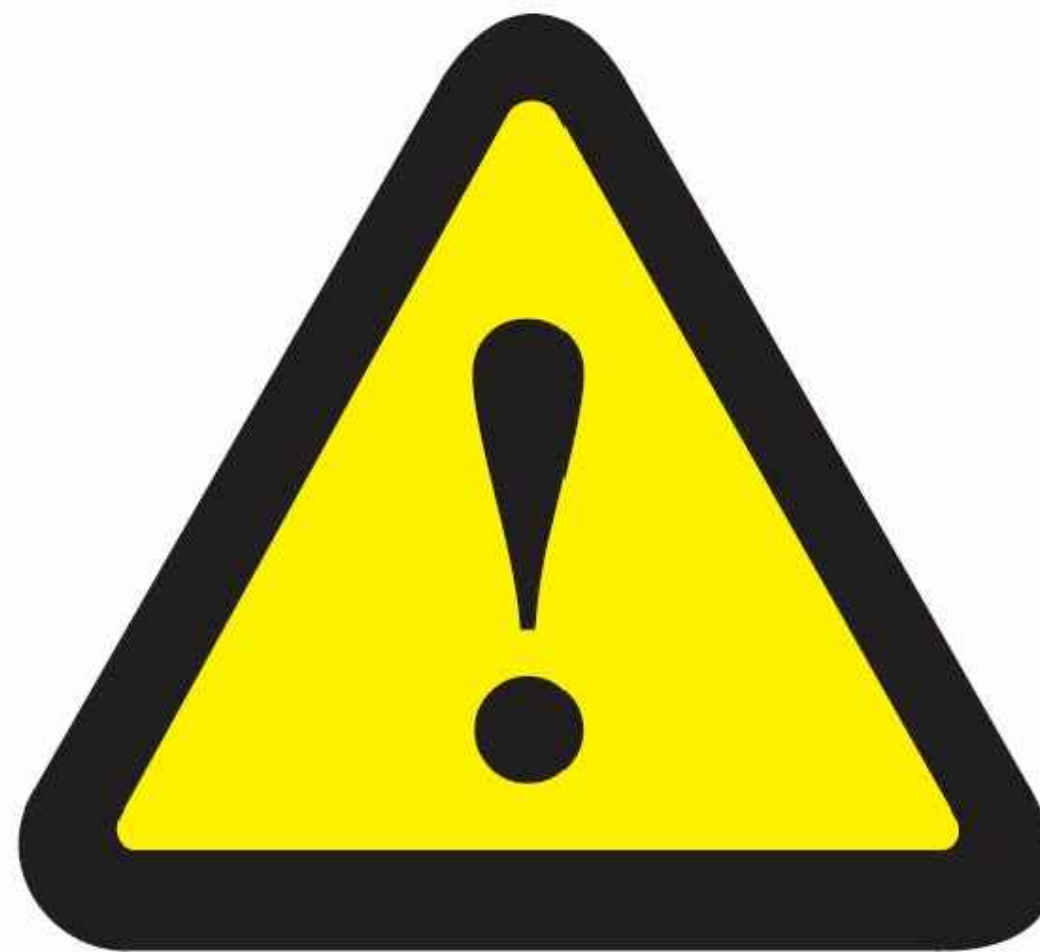
**PROTECTIVE FENCING. THIS FENCING MUST BE MAINTAINED IN ACCORDANCE WITH THE APPROVED PLANS AND DRAWINGS FOR THIS DEVELOPMENT.**

**TREE PROTECTION AREA  
KEEP OUT !**  
(TOWN & COUNTRY PLANNING ACT 1990)  
**TREES ENCLOSED BY THIS FENCE ARE PROTECTED BY PLANNING CONDITIONS AND/OR ARE THE SUBJECTS OF A TREE PRESERVATION ORDER.**  
**CONTRAVENTION OF A TREE PRESERVATION ORDER MAY LEAD TO CRIMINAL PROSECUTION**  
**ANY INCURSION INTO THE PROTECTED AREA MUST BE WITH THE WRITTEN PERMISSION OF THE LOCAL PLANNING AUTHORITY**

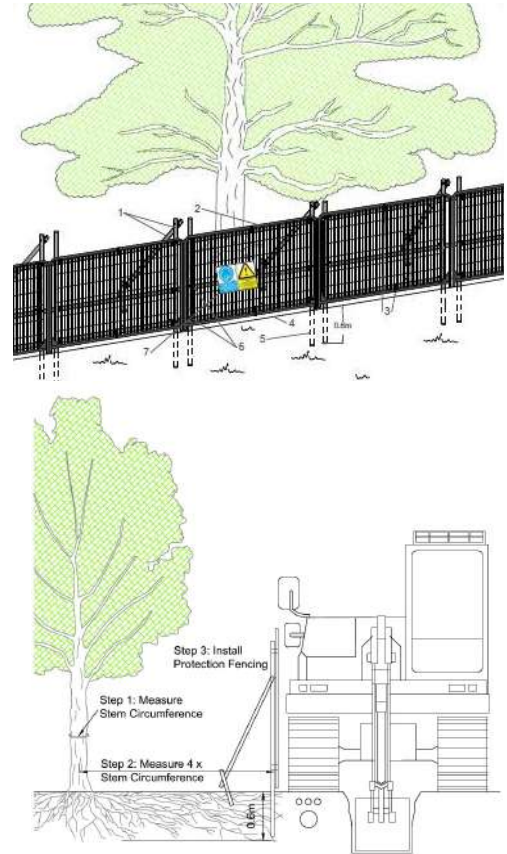
Trees make a significant contribution to the landscape character of the development and they are to be treated as important assets. To protect these assets, tree protective fencing has been installed where required across the site.

## The following points are to be considered at all times.

1. Protective fencing has been installed at the extent of the calculated root protection area (RPA) - **Do not use or access** the ground within the fenced area. This is particularly the case for placement of site offices, stockpiles of soil or fuel and material storage, storing machinery or parking of vehicles, debris or building materials or fires.

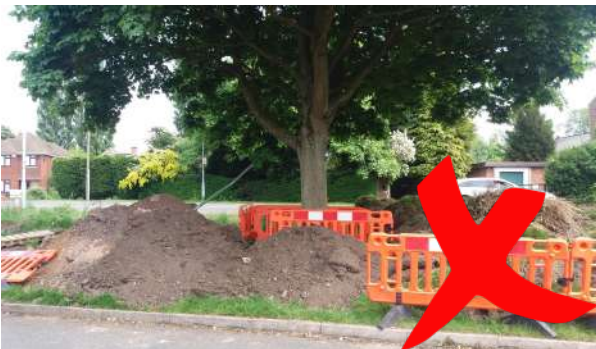
**Unacceptable** example of tree protection due to a lack of adequate fencing and poor site management. Note mounds of soil have been placed within the Root Protection Area.

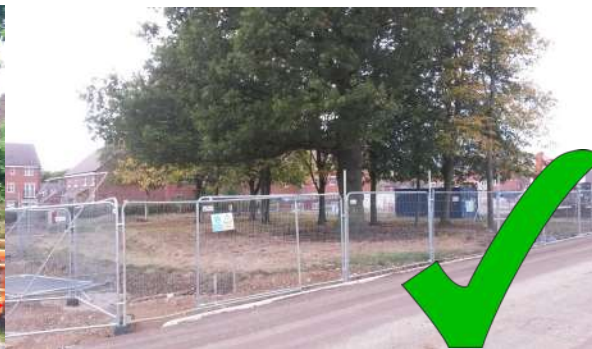
Tree Protection Fencing which has been erected prior to the commencement of any site works and the correct signage has been provided to clearly highlight that this is a protected zone.

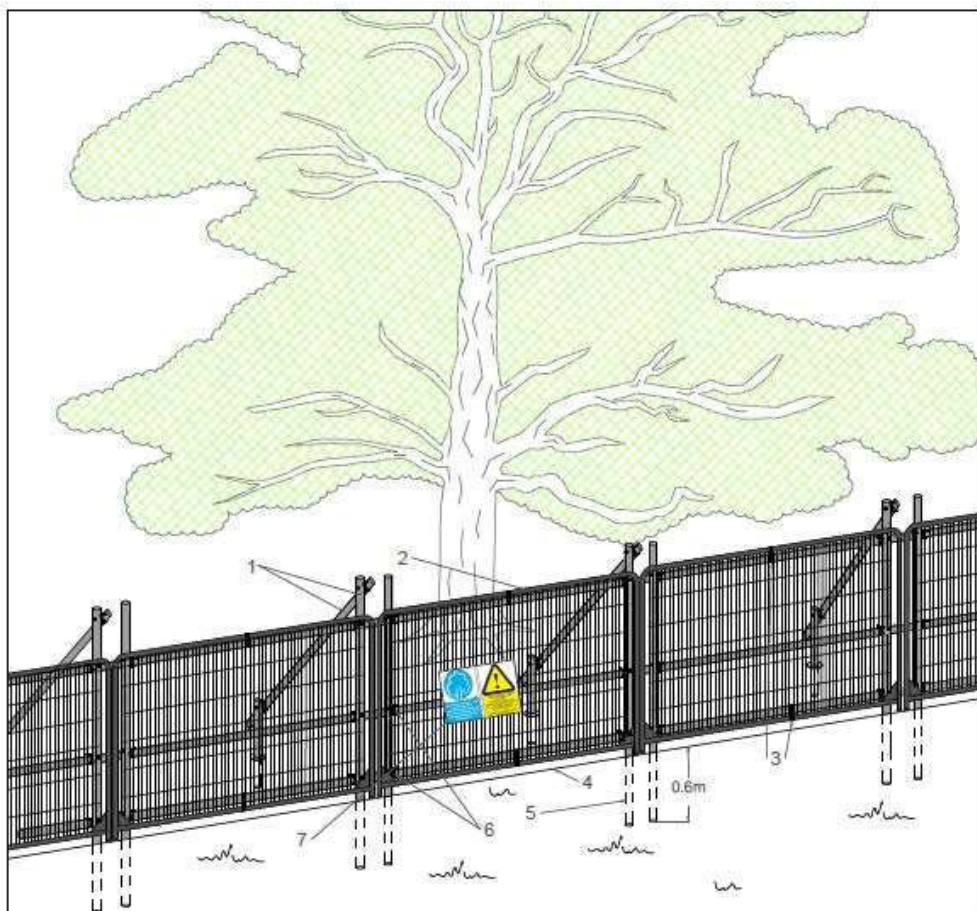
**Standard specification for High Intensity Protective Barrier**

Barriers will comprise a Heras panel framework supported by scaffold poles driven into the ground as per the specification below. Where scaffold poles cannot be driven then rubber block feet will be used:

1. Standard scaffold poles
2. Heavy gauge 2m tall galvanized tube and welded mesh infill panels
3. Panels secured to scaffold frame with wire ties
4. Ground level
5. Uprights driven into the ground until secure (min depth of 0.6m)
6. Standard scaffold clamps
7. Construction Exclusion Zone signs

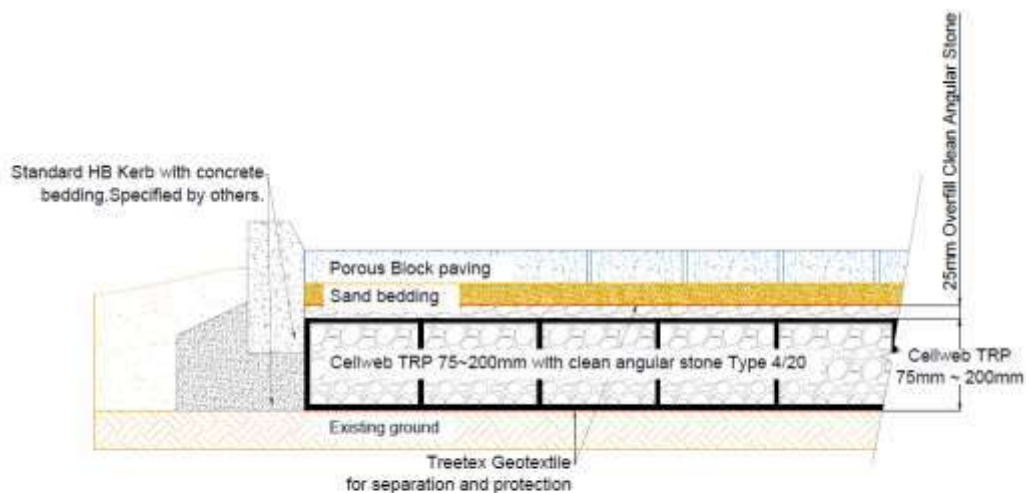
Figure 3: Cellweb 75-200mm Block Paving Standard Detail

Note: Subbase could be required depending on the existing ground CBR % and the type of traffic on the surface.

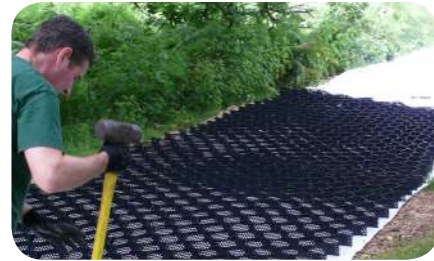
*Step 3: Lay out Cellweb® TRP*

- Lay out the collapsed Cellweb® TRP on-top of the Treetex™.
- Place one of the supplied J pins into the centre cell at the end of the panel and secure into the ground.

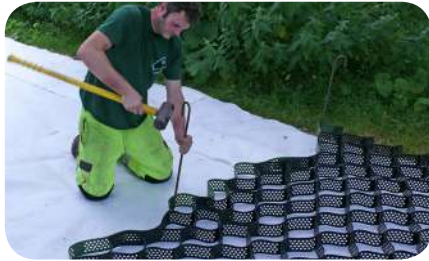
*Step 3: Pinning Cellweb® TRP*

- Pull out the Cellweb® TRP to its full 8.1m length and secure its length with another J pin.

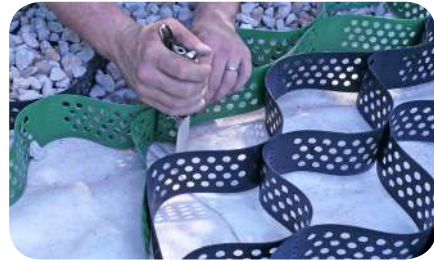
*Step 3: Stapling Cellweb® TRP*

- Now measure its width to 2.56m and secure in each of the corners with the J pins.
- Use 10 pins per panel to create a panel measuring 8.1m x 2.56m.

- This will produce a cell size of 259mm x 224mm which is the required cell aperture. Each cell must be fully extended and under tension.
- Staple adjacent panels together at each cell (see Note 3).
- If a curved path or shape is required, this should be cut when the Cellweb® TRP panel is pinned out to 8.1 x 2.56m, ensuring complete cells remain. Do not try to curve or bend the Cellweb® TRP panels into place.
- When cutting Cellweb® TRP, please bear in mind that you will lose two internal cells per cut. Across a 8.1m long panel, this equates to a loss of 0.224m x 2 along the length or 0.259m x 2 across the width.
