Fleurie Nursery  
Lake Lane  
Barnham

Outfall B (South)

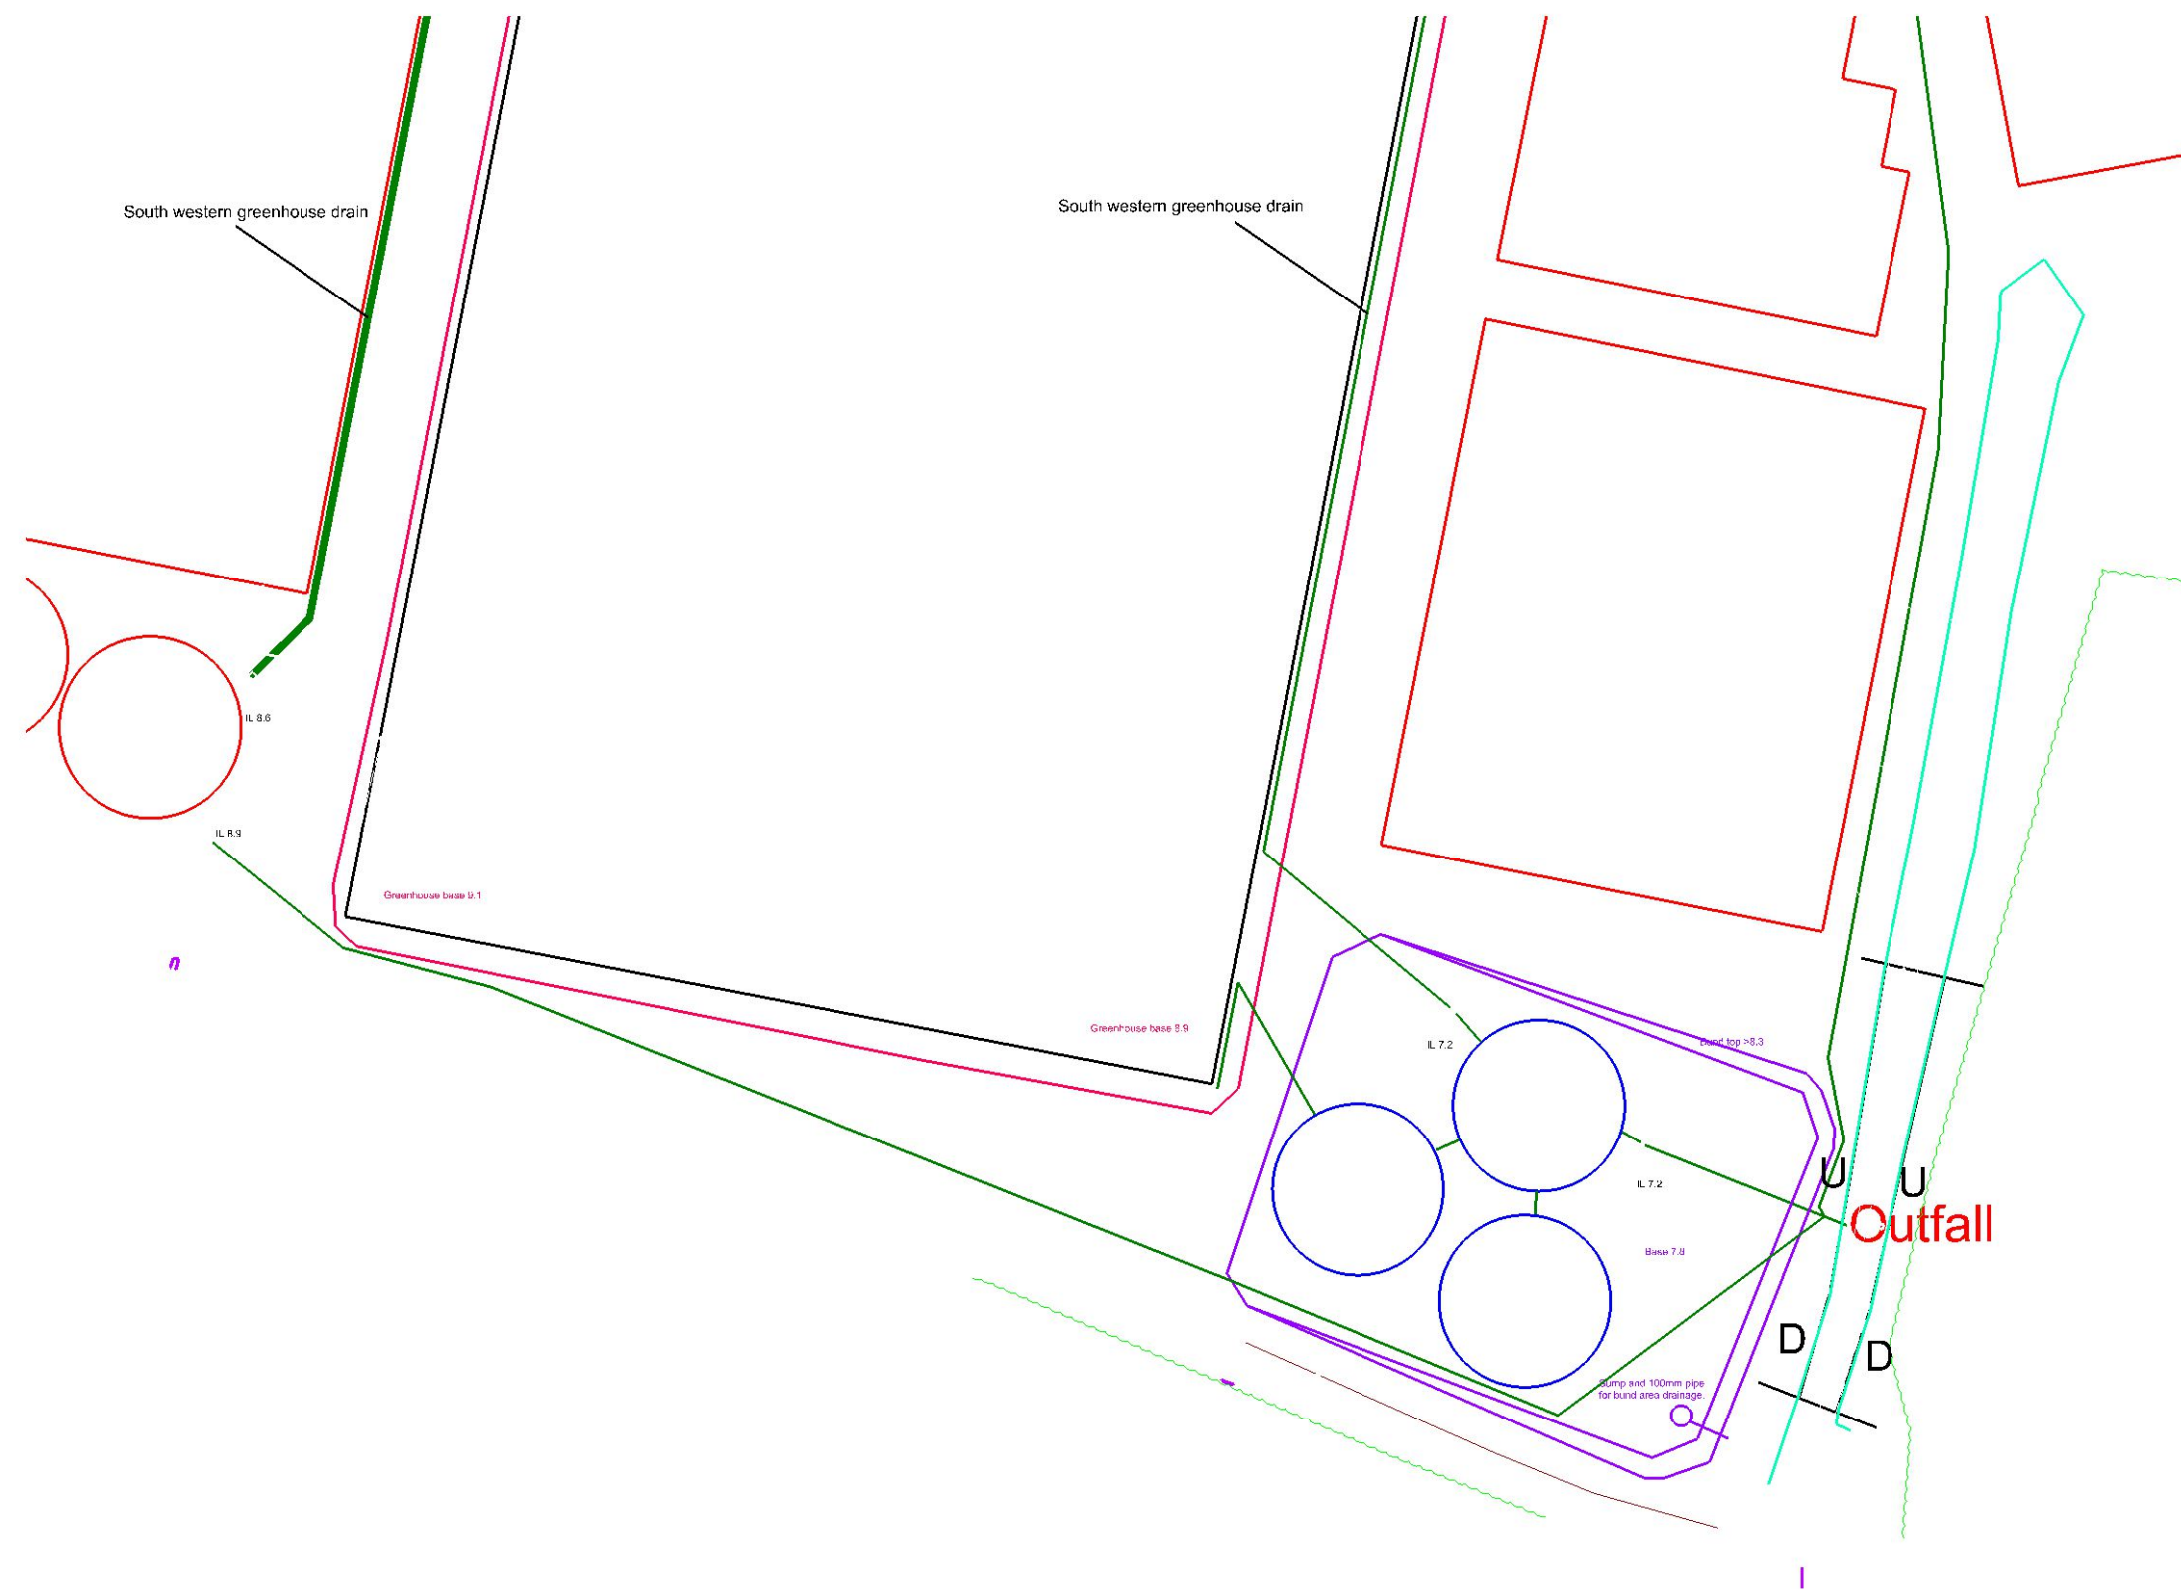
Outfall location (1:500)

For headwall installation and rock armour details see construction notes.

Discharge rates: 6.1 l/s normal, 10.57 l/s for 1:100 events.

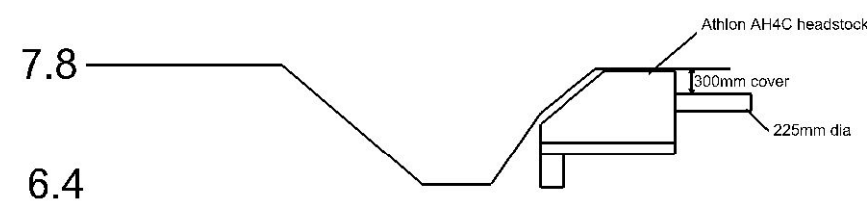
Upstream section (1:100)

(Marked U-U on plan above).

Upstream / downstream sectional views looking downstream.  
Longitudinal view from west to east.

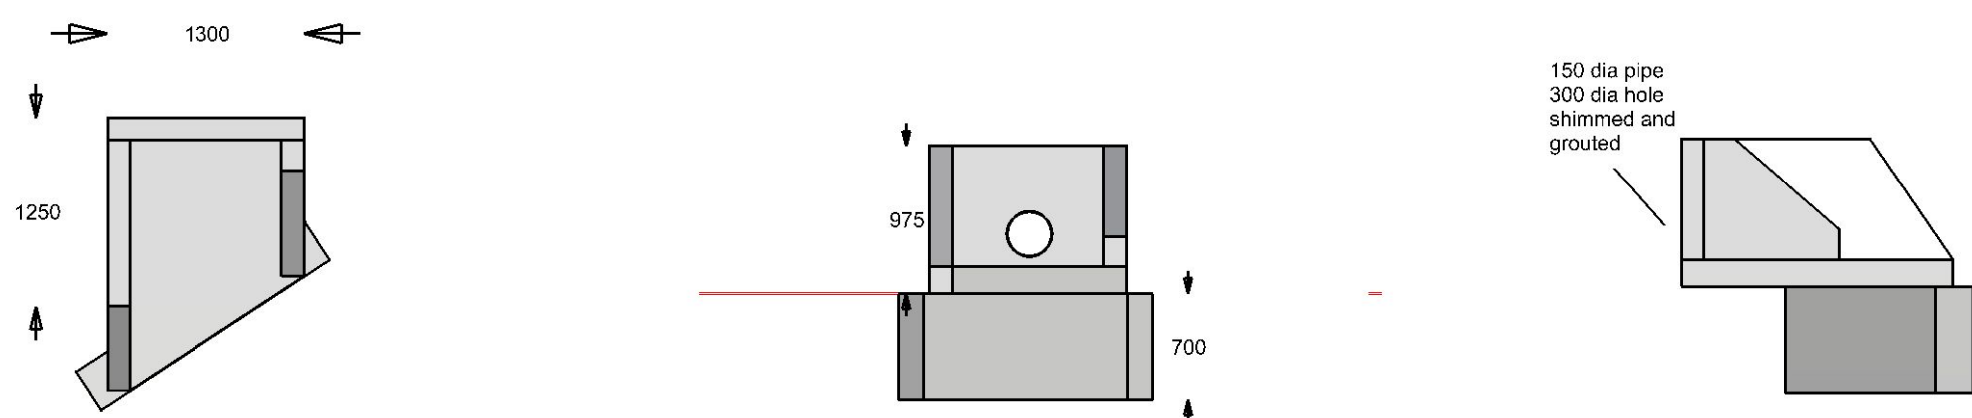
Athlon AH4C headstock (1:50)

Top

Front

Side

(Flap valve not shown for clarity)
