# PAS128:2014

Utility Survey

Slindon Gateway, Walbetron, BN18 0SG

Document ref: MSLP211690\_02 Slindon Gateway – PAS128 SURVEY  
REPORT

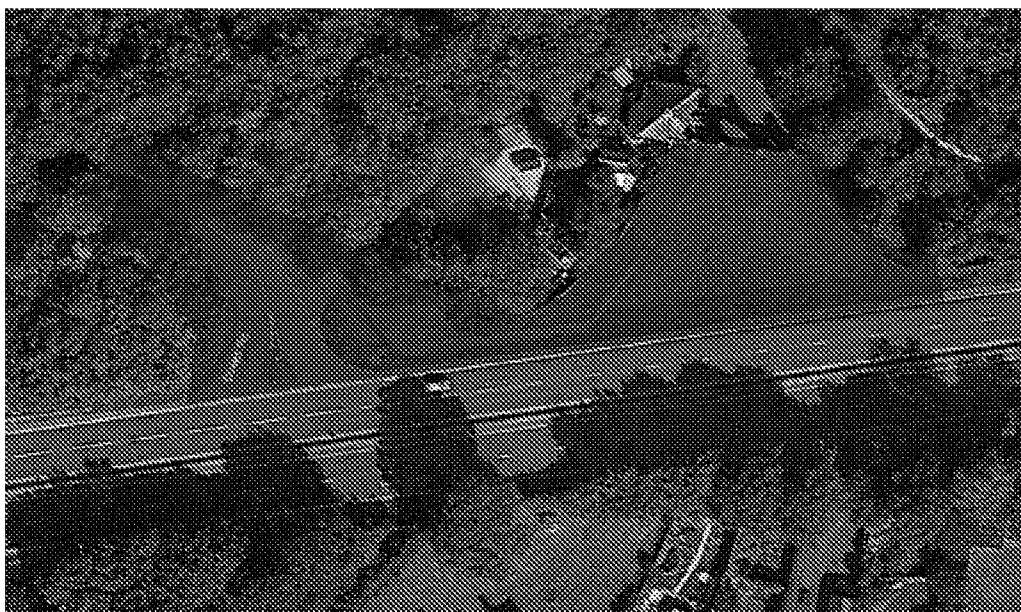
**Slindon Gateway Survey Area Extent**

Below image displays the extent of the survey area. The highlighted section in blue is the area where the Electromagnetic Location (EML) and Ground Probing Radar (GPR) survey was conducted. A safety zone, which expanded the distance 1.2 metres from the edge of the carriageway was removed from the survey area for safety reasons.

Some areas which were densely vegetated were omitted from the survey.

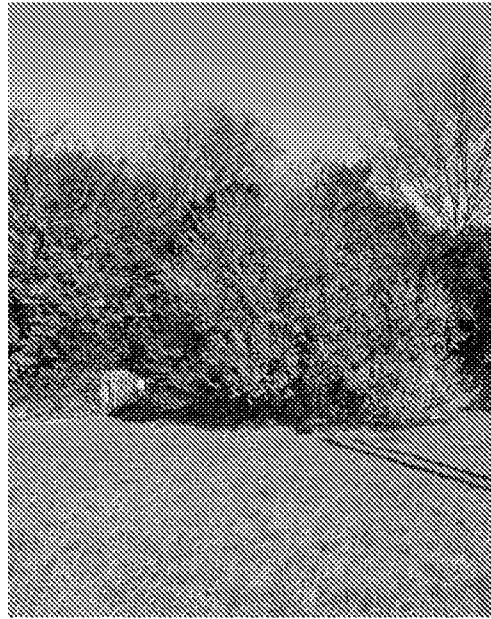
**Dense Bush to the North of the Survey Site – Unable to EML and GPR**

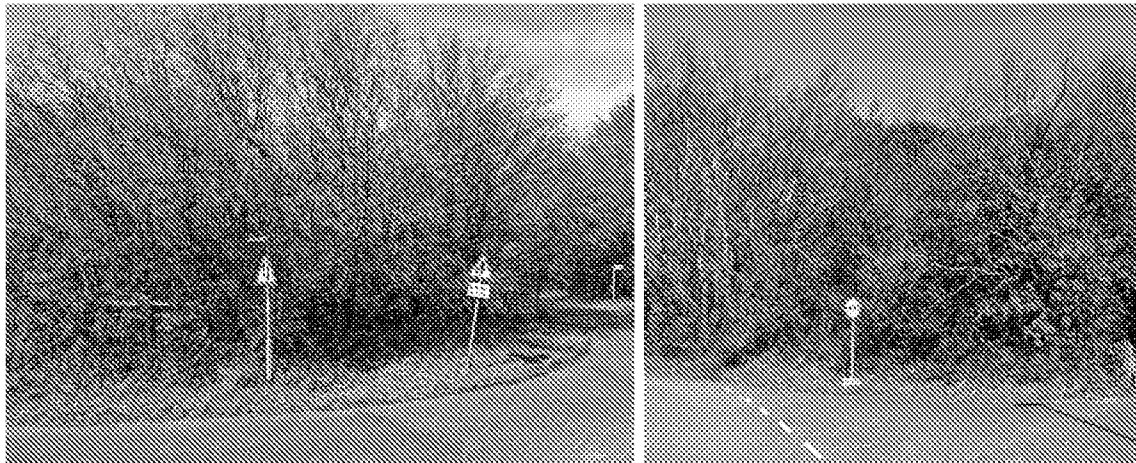
**Dense Vegetation to the West of the Survey Site – Unable to GPR**

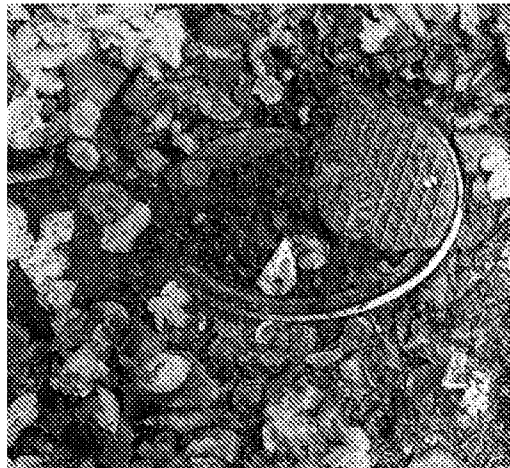
No drainage (storm, foul, or combined) inspection covers were found within the site area. However, there was a rodding eye cover which was located at the northwest section of the survey area. However, this could not be traced, as it was heavily silted, see image below. There were no drainage pipes shown on the drainage records for this area.

#### Heavily Silted Rodding Eye in Northwest Section of Survey Site

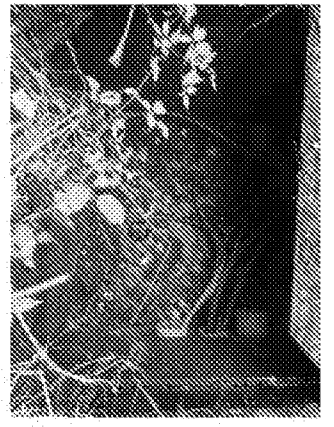
| <b>Pit No:</b> KW3<br><b>Service Type:</b> Electric<br><b>Silted:</b><br><b>Flooded:</b><br><b>CD:</b> 0.72<br><b>SF:</b><br><b>B:</b><br><b>ID:</b><br><br><b>Notes:</b> | <b>Pit Photo</b><br> | |
