## Ecology & Arboricultural Briefing Note

Land East of Tye Lane, Walberton, September 2020

**DRAWING TITLE**  
Combined Tree Retention/Removal & Protection Plan

**SCALE** 1:1250 **DRAWING NUMBER** BHA\_401\_02

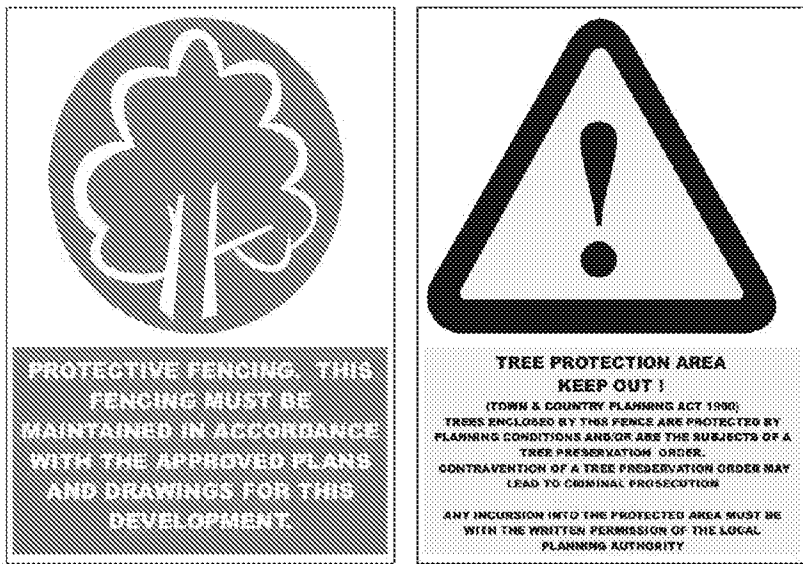
Tree Protection Barrier - Barrier to be erected prior to the commencement of works on site and not to be altered or removed until works are complete (cross check with specific requirements of any relevant planning conditions)
