**Bat Emergence Surveys**  
**Land at North Choller Farm**

- 1.1 The Ecology Partnership was commissioned by Cordial Investments to undertake bat emergence surveys at North Choller Farm – Holding 1, Choller Estate, Barnham Lane, Walberton, Arundel, hereafter referred to as ‘site’.
- 1.2 This follows a preliminary ecological appraisal (PEA) completed in March 2026 identifying three buildings with ‘low’ potential, two buildings with ‘moderate’ potential, and one building with ‘high’ bat roost potential.
- 1.3 This report presents the results of The Ecology Partnership’s surveys in and around the site, which aims specifically to assess how bats are using the site.

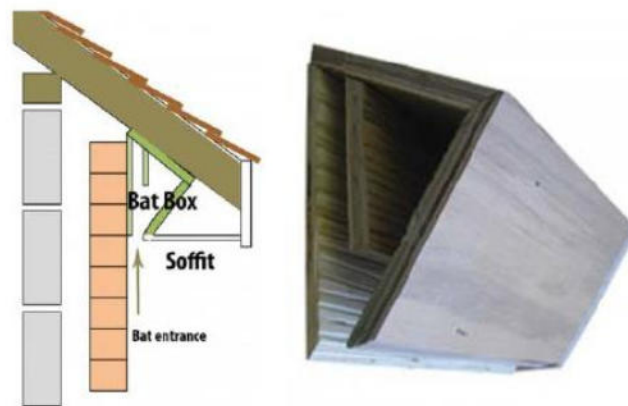
- 4.8 Another type of roost which can be incorporated into certain buildings is a soffit bat box (Figure 5). This caters for crevice-dwelling species such as pipistrelles and certain *Myotis* species such as Natterer's and Whiskered bat. This type of box makes use of an underutilised area of a building and would require no maintenance as droppings would drop through the entrance hole. These should be located on buildings close to linear features and dark corridors and if installed on private buildings, the owners should be made aware of their purpose and legal protection.

Figure 5: Soffit bat box (Wildcare)

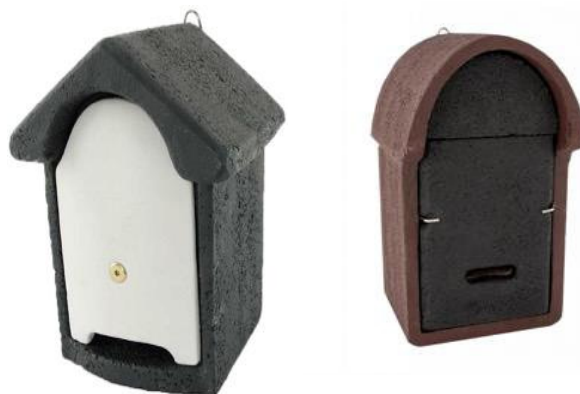
- 4.9 Tree-mounted bat boxes can also be installed in suitable retained trees onsite to create additional roosting provision. Recommended boxes include:
- Vivara Pro WoodStone Bat Box – A general purpose bat box that supports a range of species (Figure 6). These can be hung on trees in a variety of heights and aspects in order to provide a variety of micro-climates.

- Large Multi Chamber WoodStone Bat Box – This is a multipurpose box designed for larger colonies and a range of bat species including pipistrelles, noctules and brown long-eared bats. These should be hung on mature trees around the site (Figure 6).

*Figure 6: Vivara Pro WoodStone Bat Box (left) and Large Multi Chamber WoodStone Bat Box (right)*

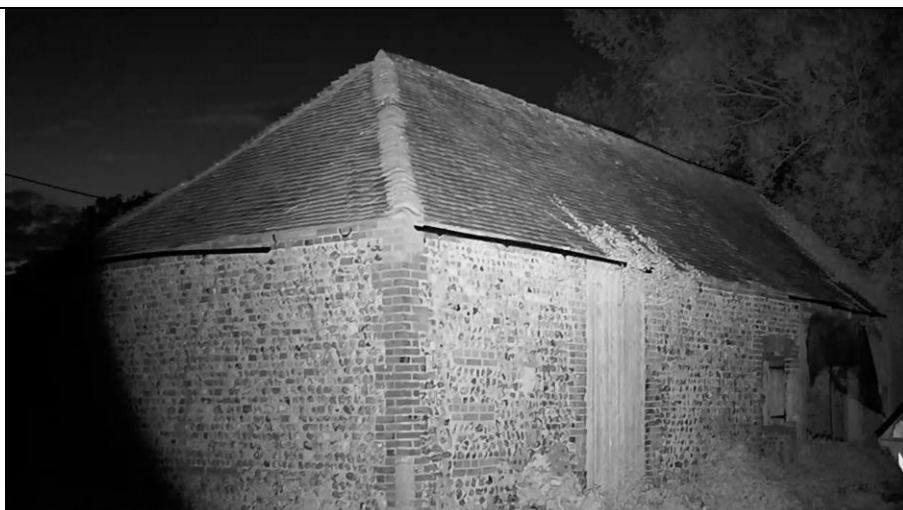
**Figure 3:**  
Screenshot of  
IR footage to  
the south-east  
of B1 on  
14/05/26

- 3.6 Overall, activity was very low, consisted wholly of common pipistrelle activity by the surveyor positioned at building B1. No bats were seen to emerge from building B1 or B2 during the survey, thermal footage was analysed and no notable bat activity was recorded.

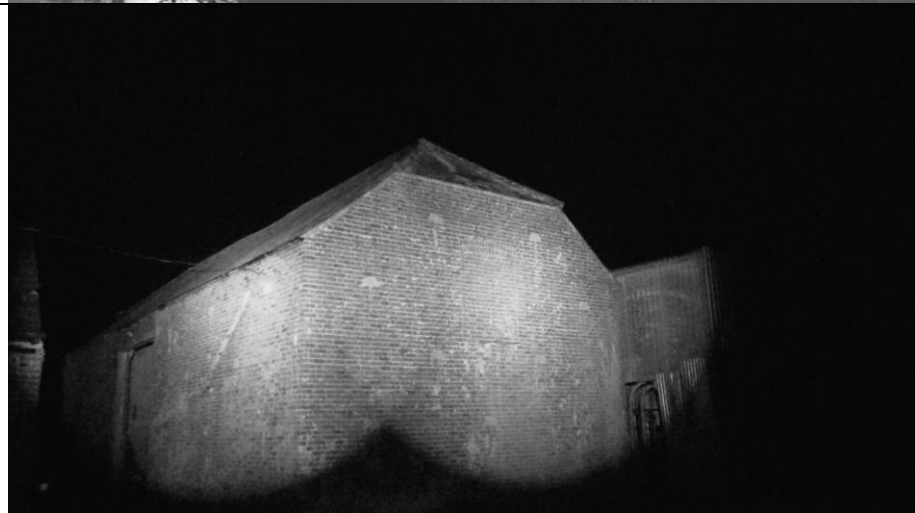
**Figure 8:**  
Screenshot of  
IR footage to  
the north-west  
of B3 on  
20/05/26

- 3.10 The last bat recorded was a common pipistrelle recorded by the surveyor positioned to the north-west of B3 at 22:15 and recorded by the second surveyor at 21:17. Overall, activity was considered to be low dominated by common pipistrelle. No bats were observed to be emerging from buildings B3 or B8; thermal footage was analysed and no notable bat activity was recorded.

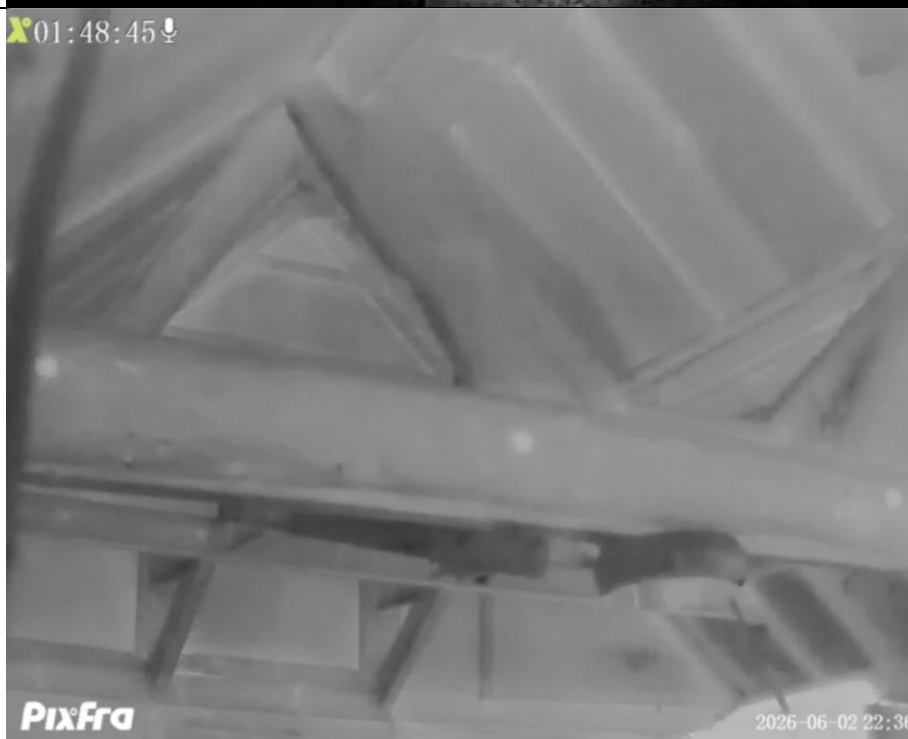
**Figure 14:**  
Screenshot of  
Thermal  
footage within  
B5 on 02/06/26

- 3.13 The last bat recorded was a common pipistrelle heard but not seen by the south-western surveyor at 22:27. Overall, activity was considered to be low, dominated by common pipistrelle activity. No bats were observed to be emerging from building B5 or B6 during the survey. One thermal was placed within B5 during this survey, the footage was analysed and no bats were recorded within the building.
