## Condition 24, Incidental Mineral Extraction Scheme Land West of Yapton Lane, Walberton

**Planning Permission:** WA/2/22/OUT

**Appeal Reference:** APP/C3810/W/22/3309365

**1.1** This Incidental Mineral Extraction Scheme has been prepared on behalf of Doswell Projects Ltd in support of the discharge of Condition 24 attached to outline planning permission WA/2/22/OUT, granted on appeal under reference APP/C3810/W/22/3309365, for residential development on land west of Yapton Lane, Walberton.

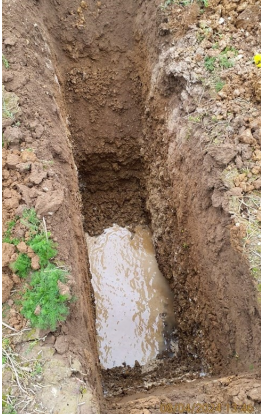
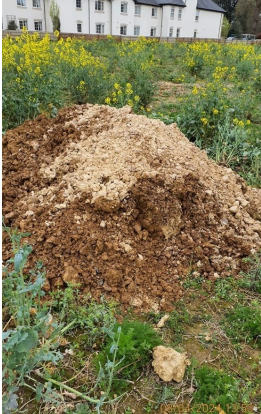
| Terminated at 2.6m bgl due to collapse. | | | | | | | | | |

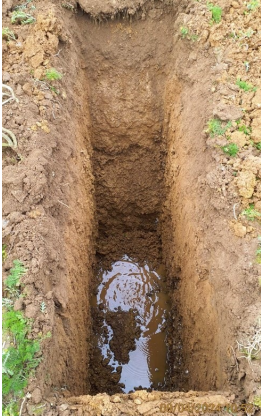
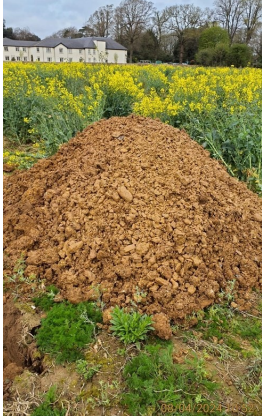
| Terminated at 2.2m bgl due to pit collapse | | | | | | | | | | | |

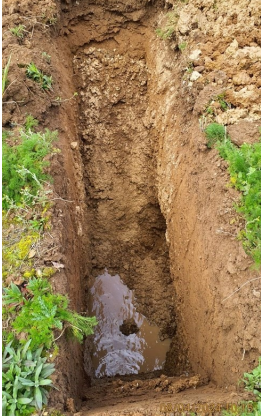
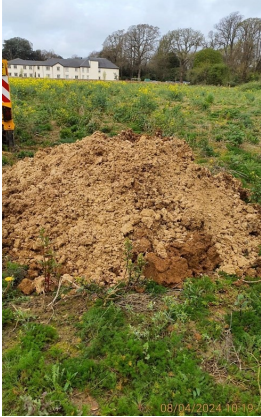
| Terminated at 2.5m bgl due to collapse. | | | | | | | | | |

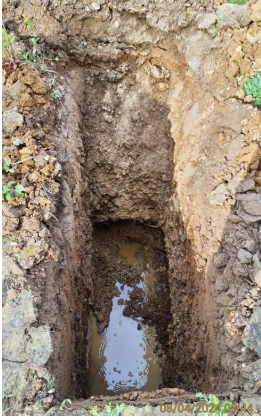
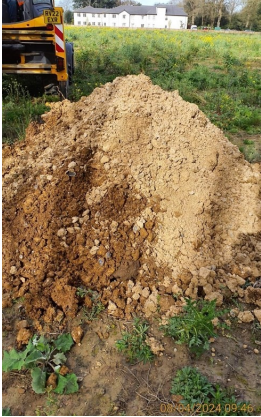
| Terminated at 2.7m bgl due to collapse. | | | | | | | | | | | |

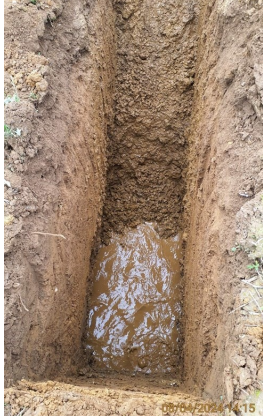
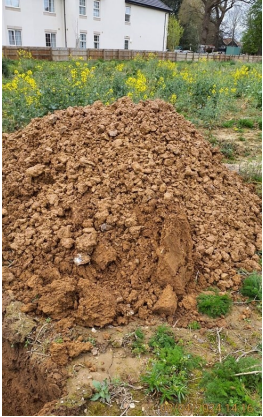
| Terminated at 2.5m bgl due to collapse. | | | | | | | | | | | | | | | | | | | | | | | | | | | |

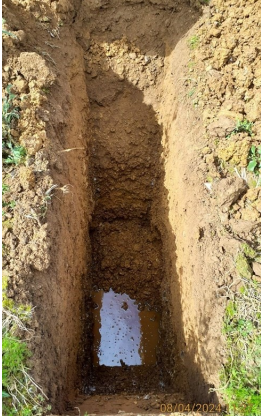
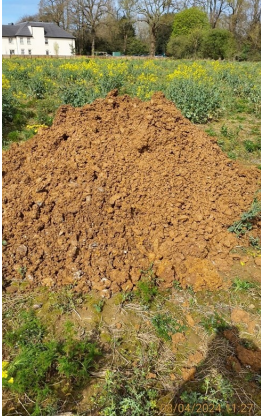
| Terminated due to pit collapse. | | | | | | | | | | |

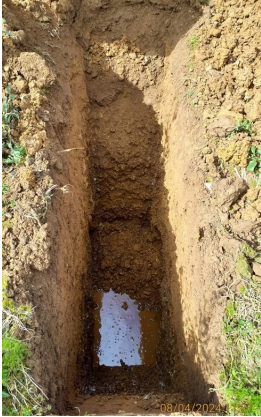
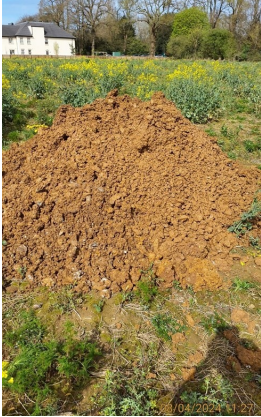
| Terminated due to pit collapse. | | | | | | | | | |

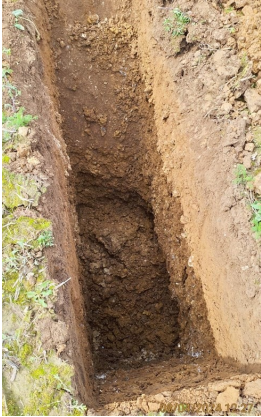
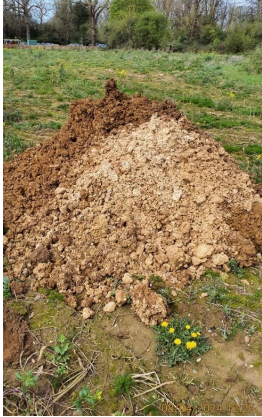
| Terminated at 2.5m bgl due to collapse. | | | | | | | | | |

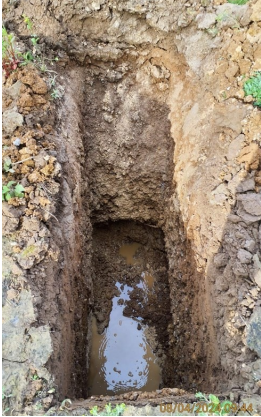
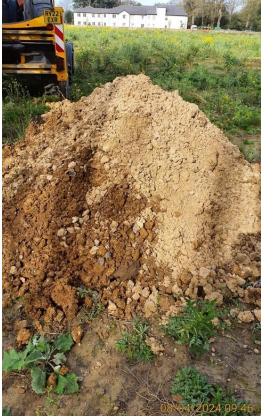
| Terminated at 2.7m bgl due to collapse. | | | | | | | | | | |

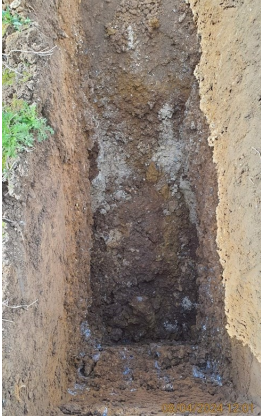
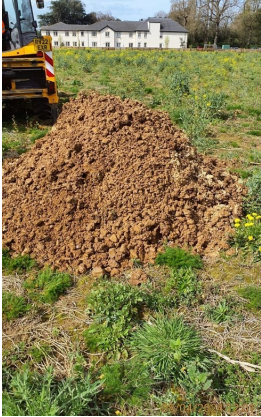
| Terminated at 2.5m bgl due to pit collapse | | | | | | | | | |

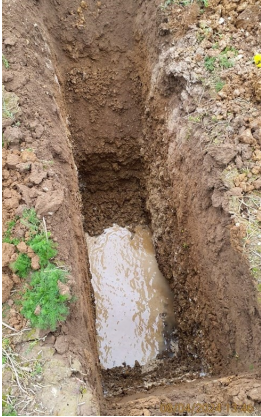
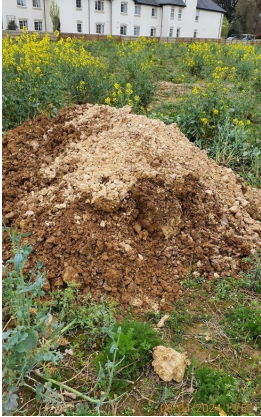
| Terminated at 2.6m bgl due to collapse. | | | | | | | | | | |
