# **Drainage Verification Report**

Barnfield House, Arundel Road, Fontwell BN18 0SD

Planning Ref: WA/80/22/PL

Ref: **C2911**

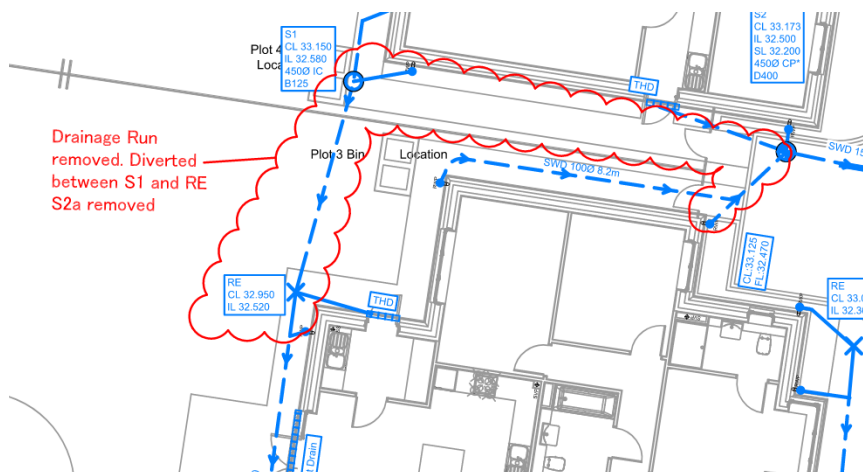
| 3.1.3 | The CCTV Drainage survey also noted that the following chambers had not been installed, and the drainage runs deviate from the approved drainage layout:<br><br>- SI - S2a: |

- 3.1.4 These changes have been highlighted by the survey company, and a copy of the revised plans can be found within **Appendix C**
- 3.1.5 Remedial works were undertaken following on from the recommendations of the initial CCTV survey and a secondary CCTV drainage survey was conducted in September 2025 which confirms that all works were undertaken satisfactorily, and that the system is clear of debris and is structurally sound. A copy of this report can be found in **Appendix A**.

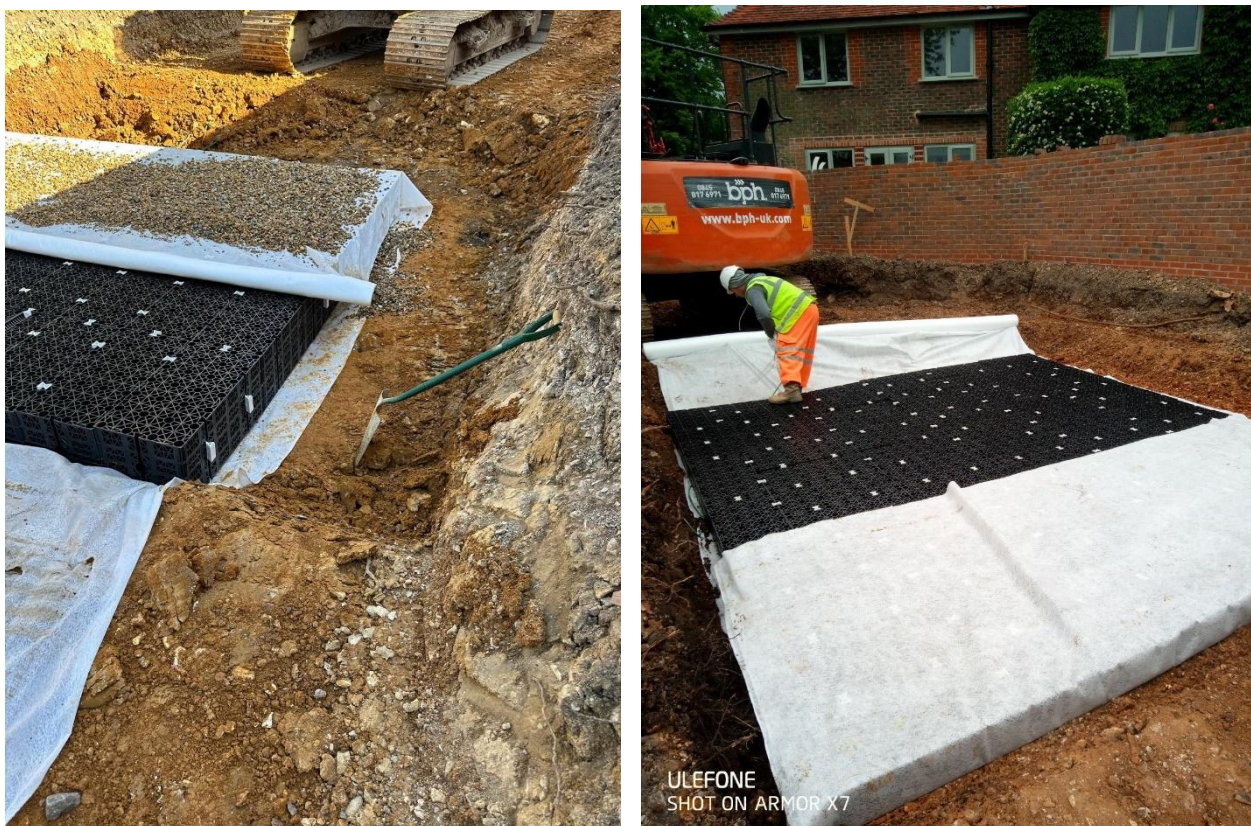
**Fig 2. Installation of permavoids**

4.2 The proposed drainage network utilises Permavoid crates to provide additional storage. A review of the installation photographs confirms that the Permavoid system has been installed correctly using the clips and it is wrapped in a permeable geotextile allowing infiltration into ground as designed.

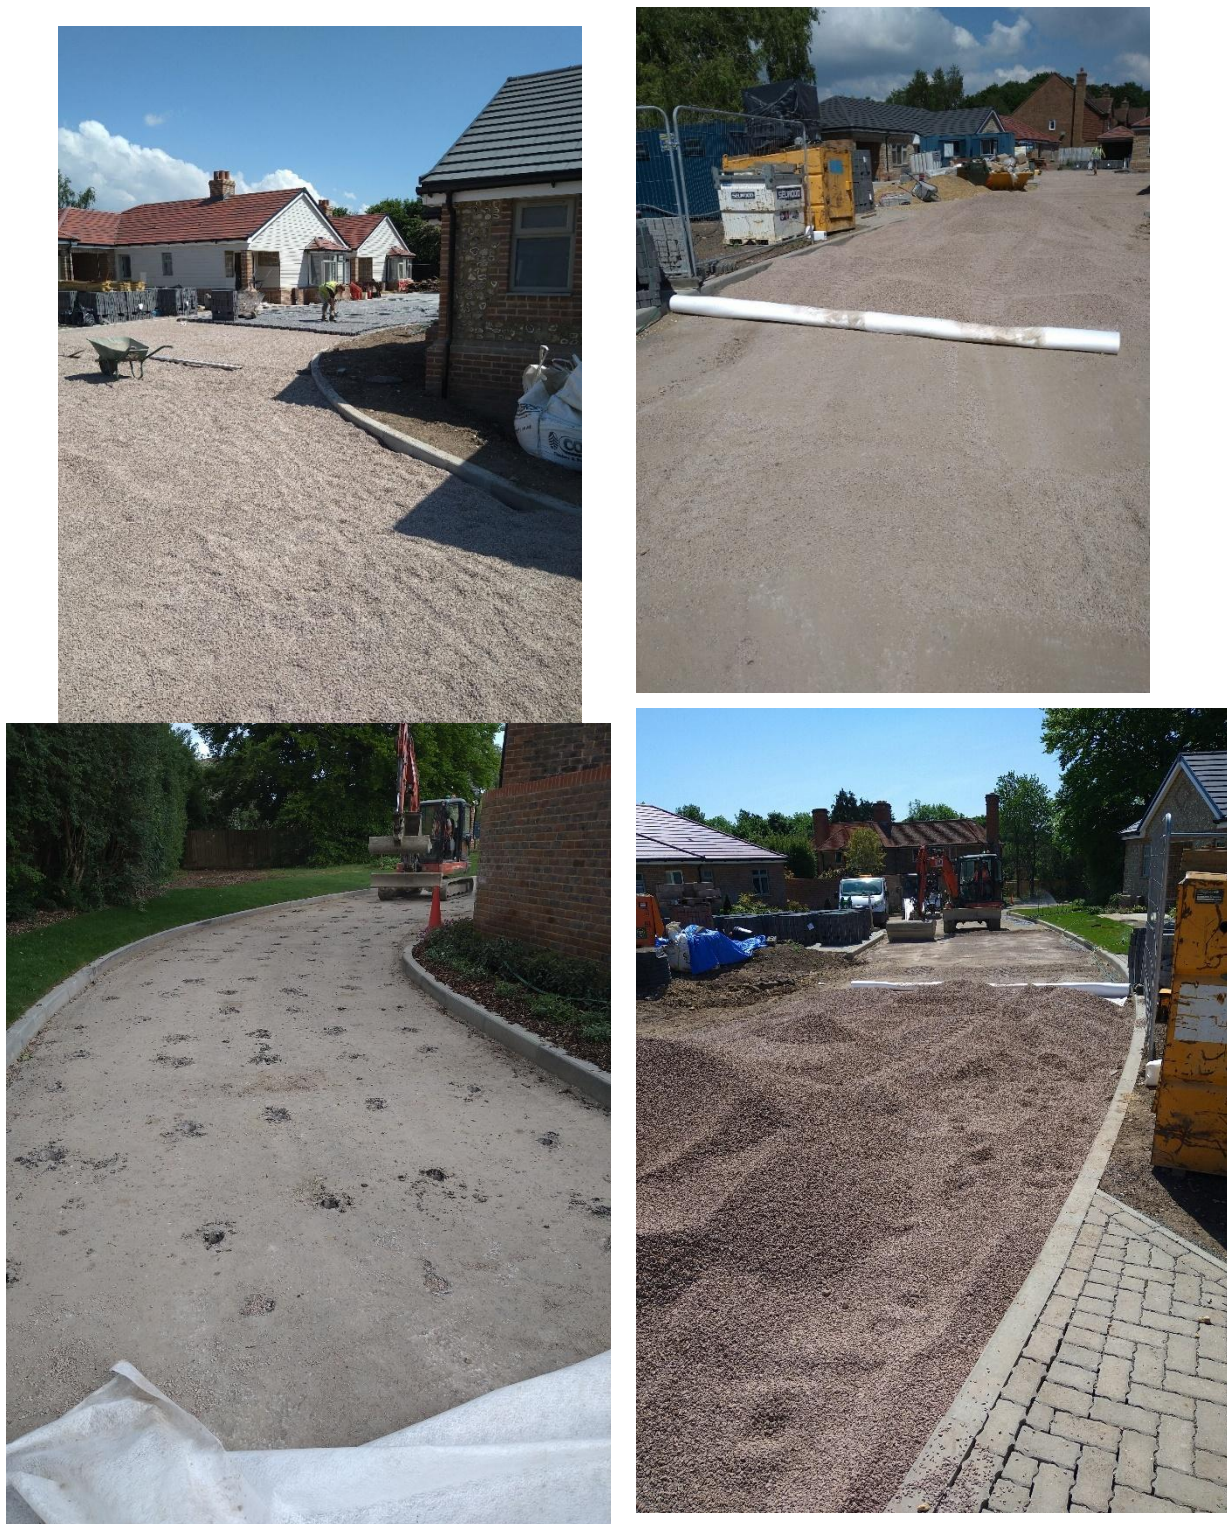
**Fig 3. Permeable Parking Areas**

- 4.3 The main SuDS feature on this site is the permeable paved area; the site photographs of the installation of the permeable paved areas confirm the correct installation of a permeable sub-base using the specified aggregate and grading alongside the installation of the correct non-woven geotextile. It is clear that the base course has also been core drilled as per the proposed construction details.

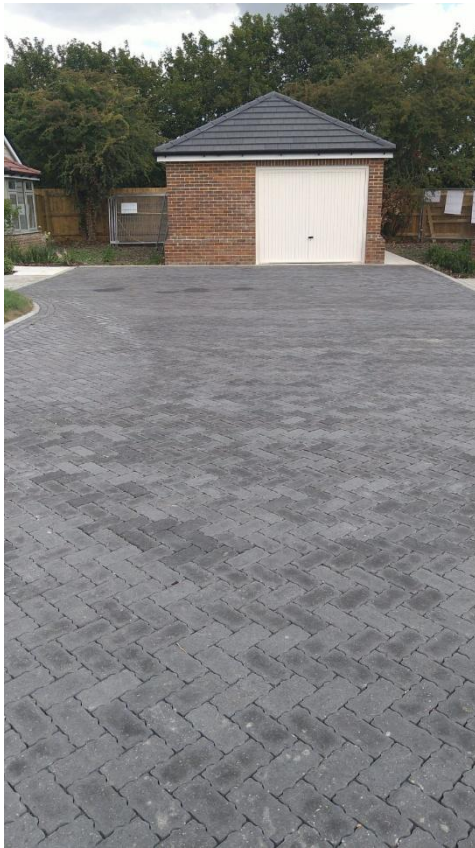
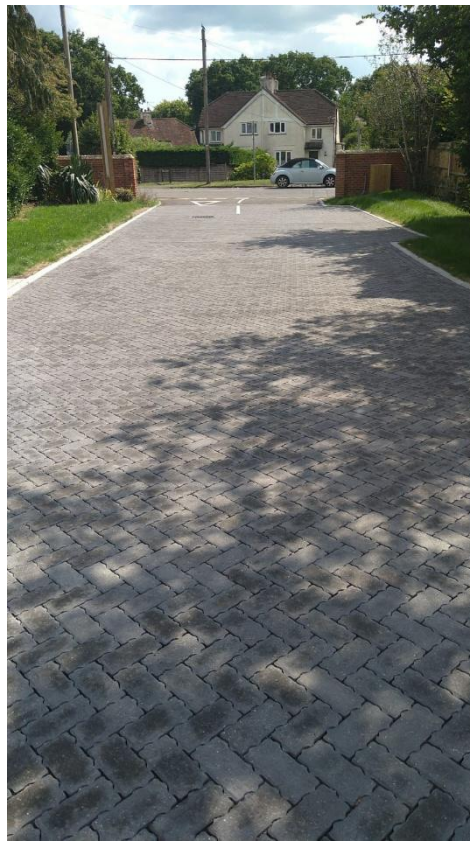
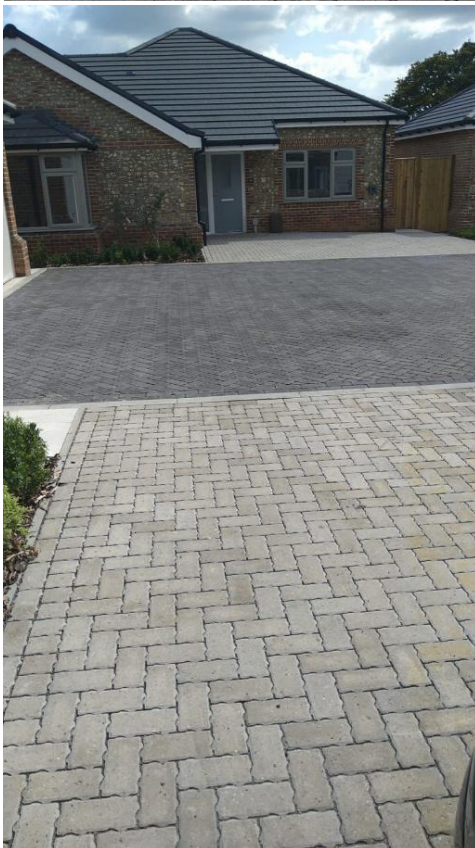
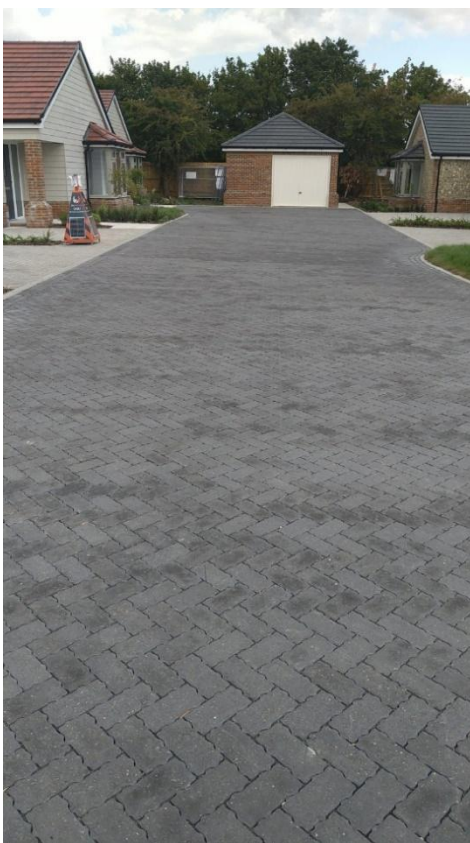
**Fig 4. Permeable Parking Areas Cont.**

4.4 The following photographs are of the as constructed permeable parking areas the day following heavy downpour:

- 6.5 The SuDS features appear to be in good working order, with the permeable areas being dry and free of any standing water following a heavy downpour the night prior. The drainage runs were noted to be clear with no standing water or debris confirming that the network is working as intended.

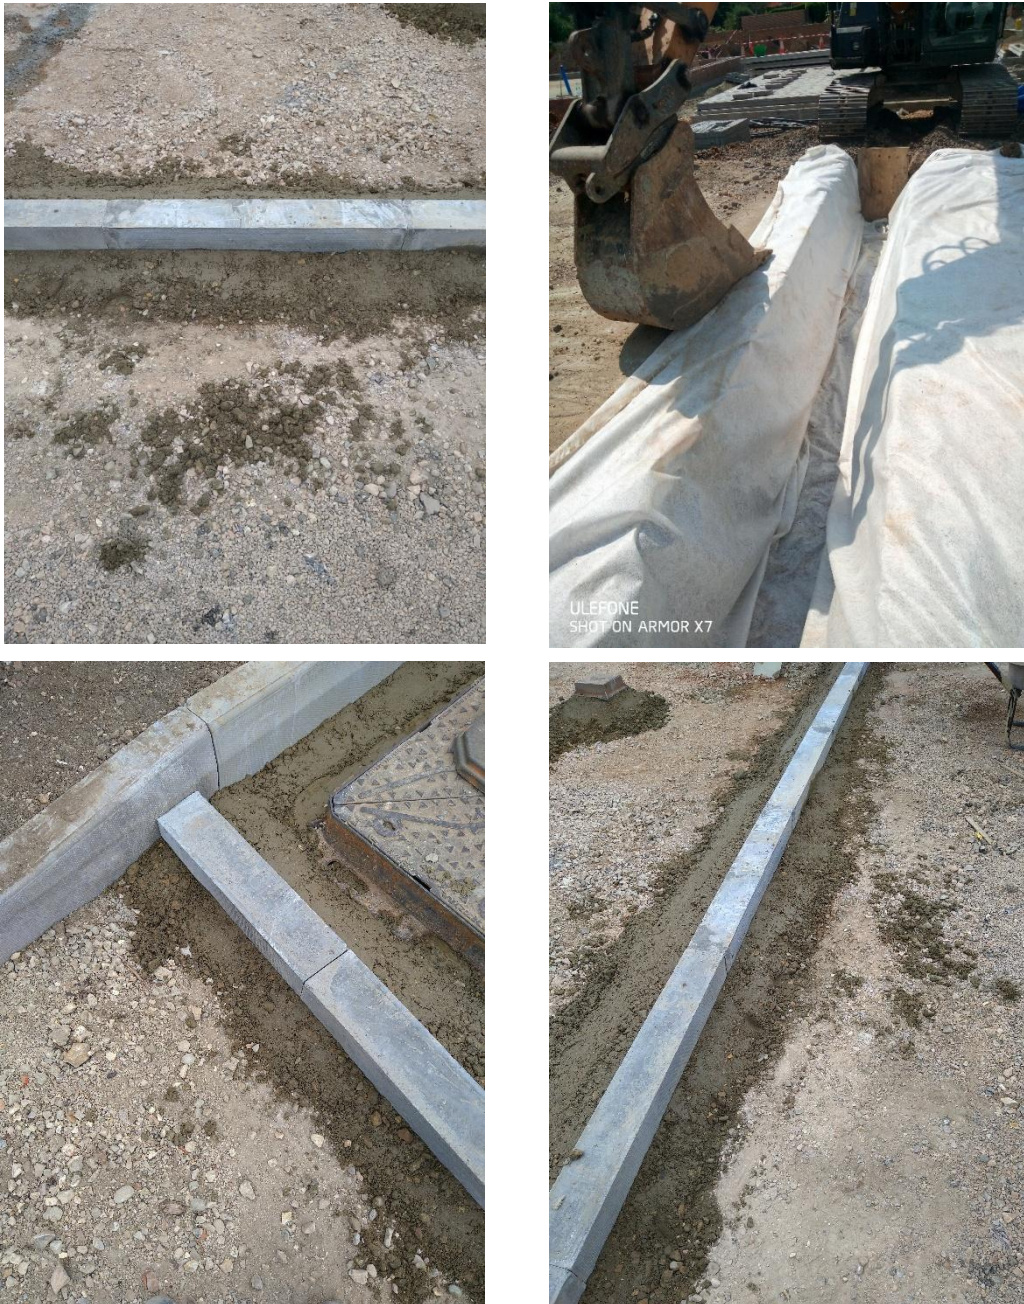
**Fig 5. Concrete Dam**

- 4.5 It was proposed that concrete dams were installed within the access road of the site to allow as much storage as possible with the sub-base of the paving. The photographs indicate that this was installed within the access road as per the design.

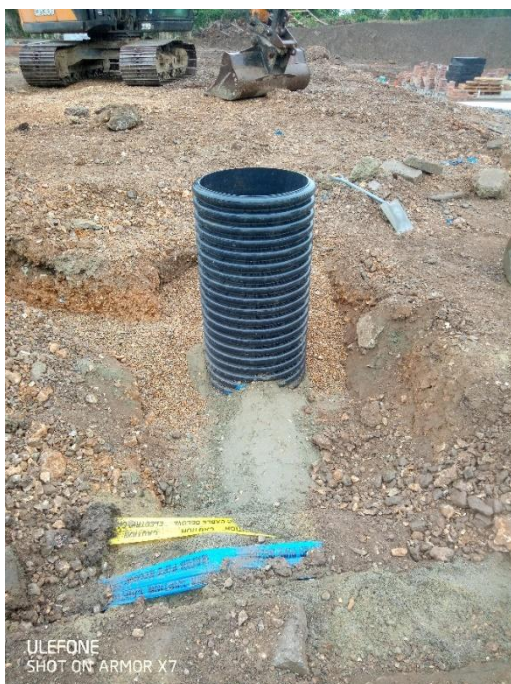
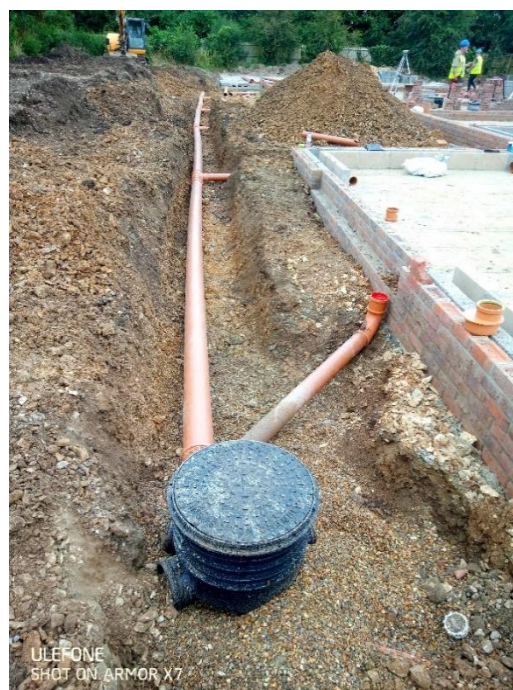
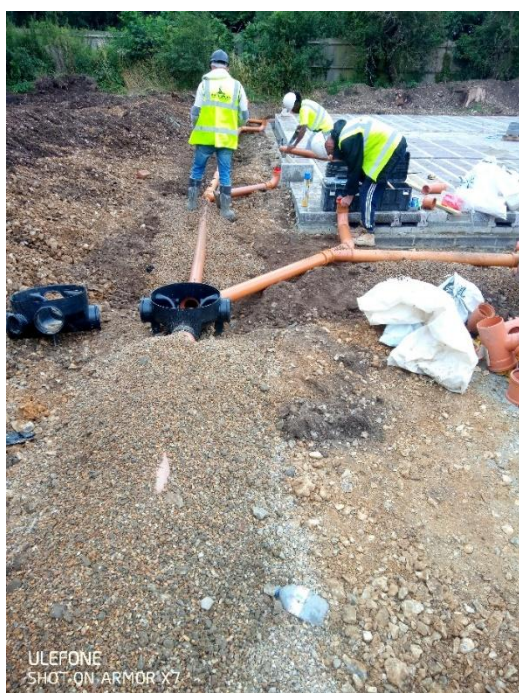
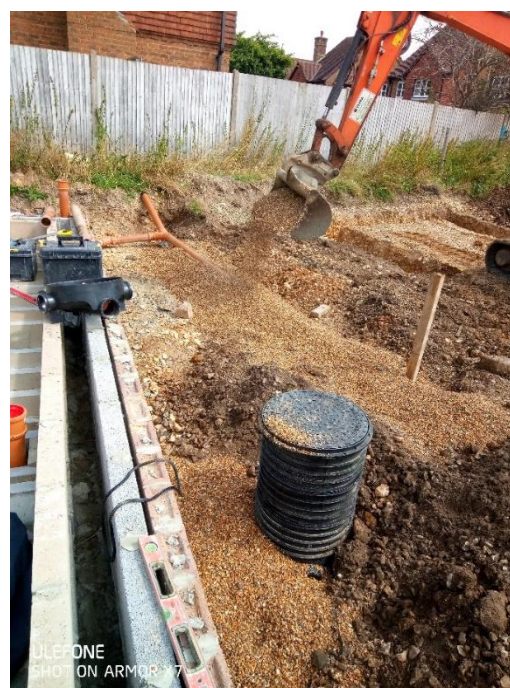
**Fig 6. Surface water inspection chambers**

- 4.6 This section will look at the installed chambers on site, in particular, the orifice flow control chambers that are proposed at the gravel trenches. The chambers looked to be installed correctly, and the drainage runs incoming align with what was on the proposed drainage layout.

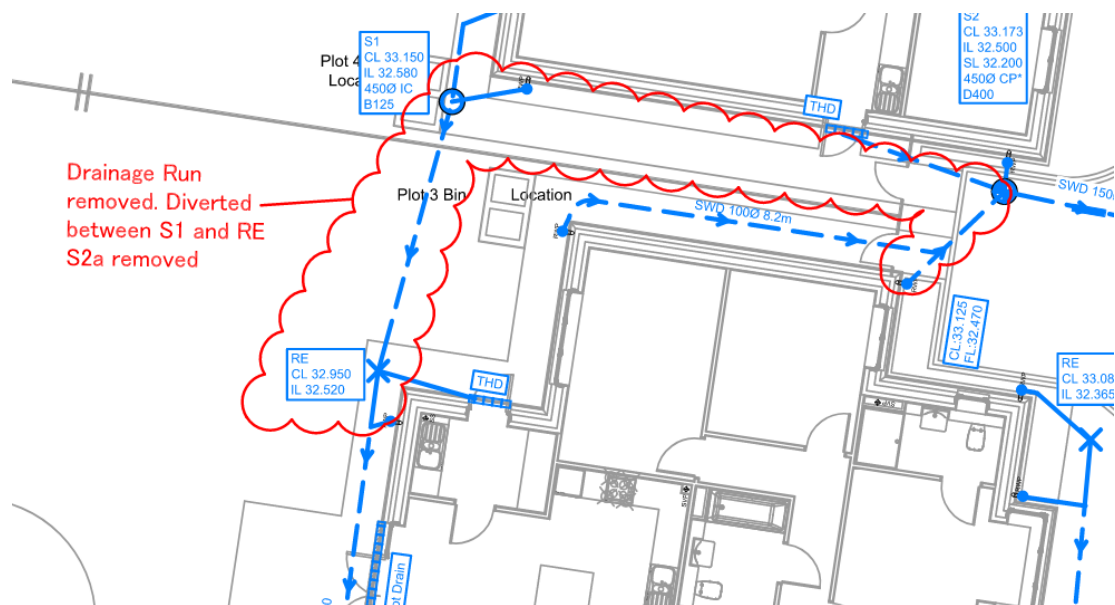
- 5.1 There are a few discrepancies between the approved drainage design and the drainage network that was installed on site. A copy of the annotated plan from the CCTV Surveyors will be supplied within **Appendix B**.
1. Chambers S1, S2a and S9 have not been installed on site with the associated drainage making the same connection downstream apart from S1 which has been diverted into the rodding eye which then discharges into S12. It should be noted that this has no impact on the effectiveness of the drainage network as the changes are minor.

- 6.4 Some discrepancies between the proposed plans and the final installed drainage were identified; however, these changes will have negligible impact on the effectiveness of the drainage network.

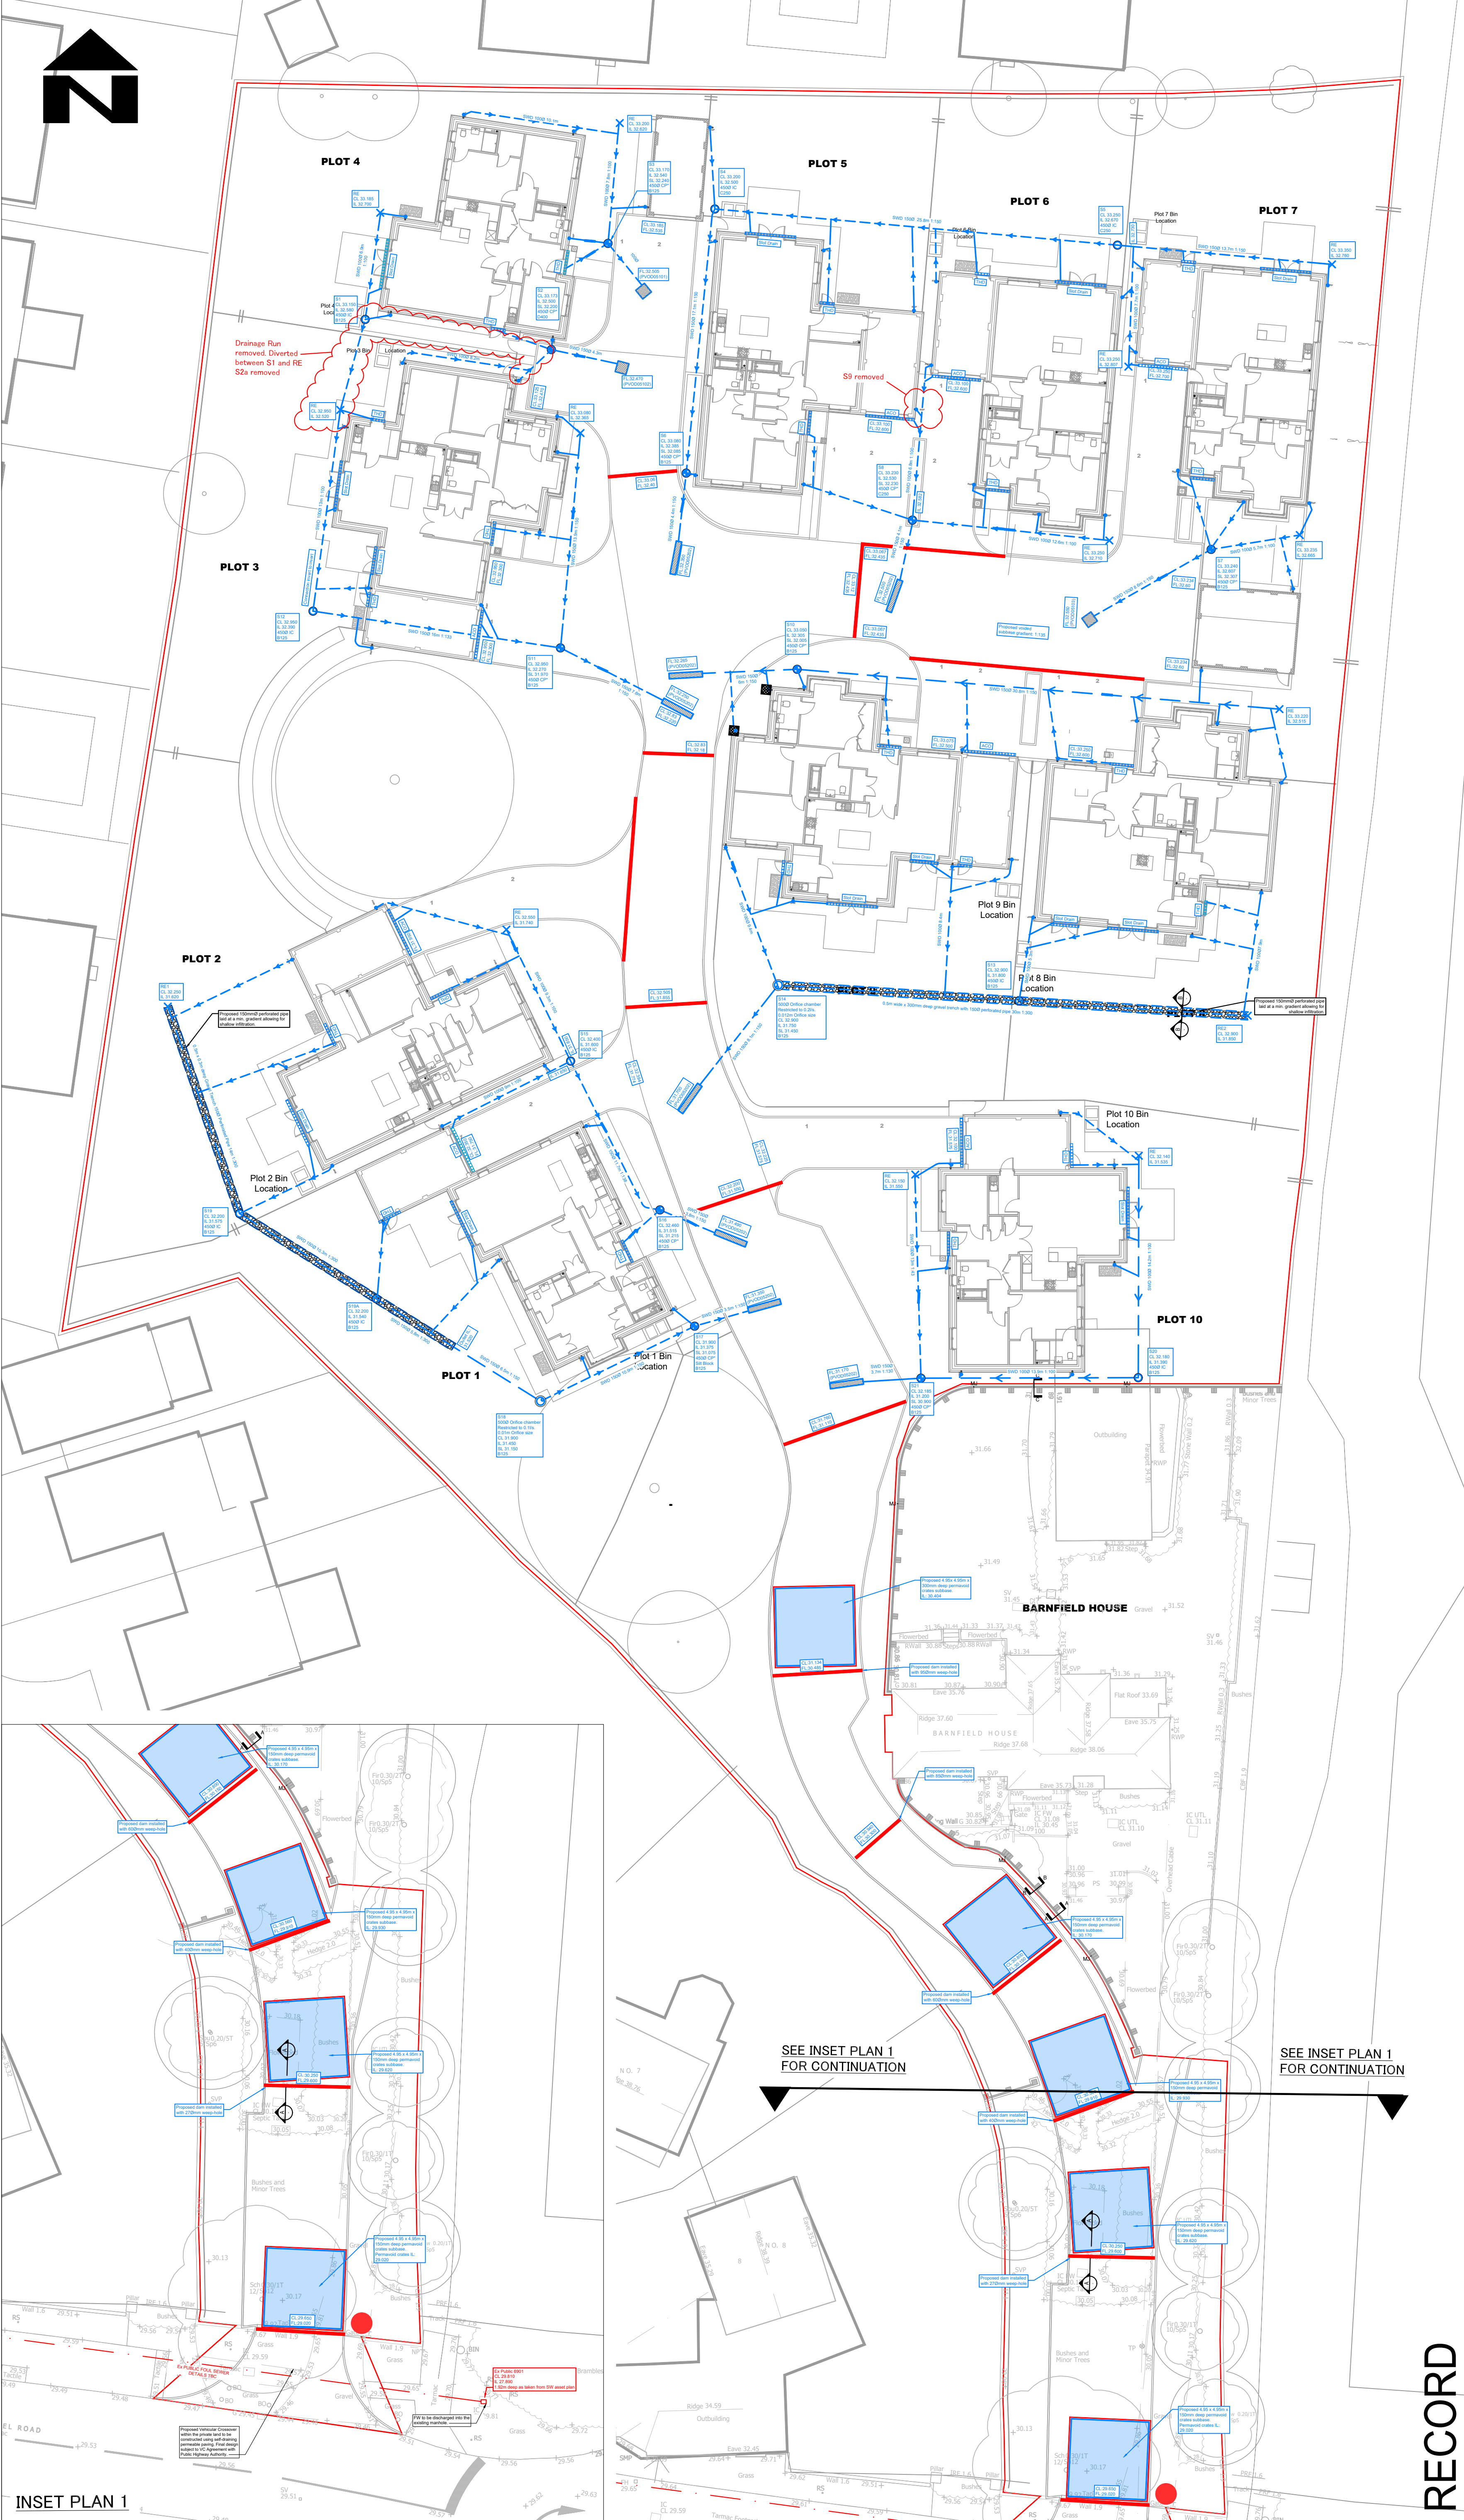
As built mark-up:

MANHOLES NOT INSTALLED FOR OPERATIONAL REASONS -  
S1  
S2a  
S9.

DRAIN LAYOUT CHANGES AMMENDED ON DRAWINGS.
