ref: A12782/260826/L1

**RE: Land Southeast of Wandleys Lane, Fontwell, Arundel, BN18 0QR – Water Pipework Assessment**

### Ground Investigation Report

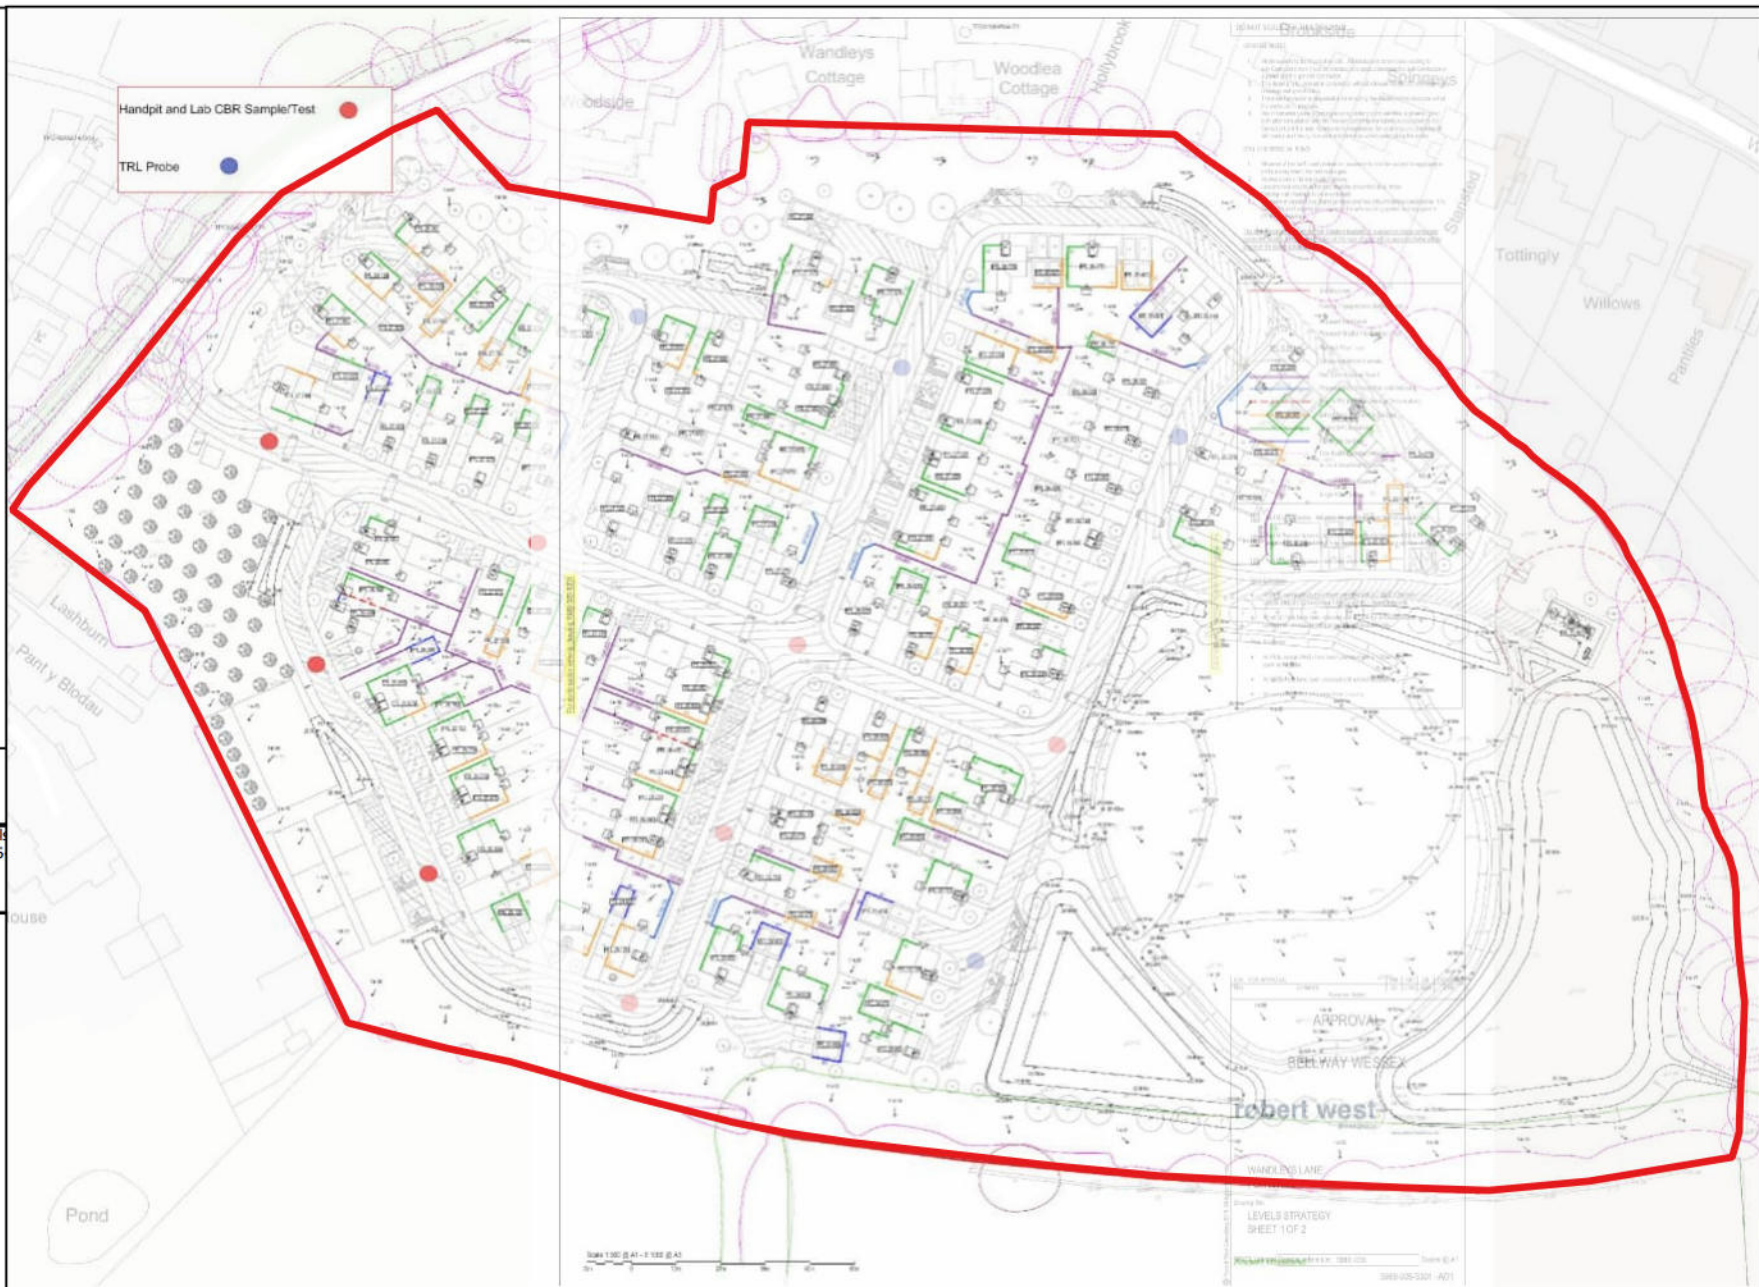
Drawing Title:  
Figure 2.0  
Proposed Development Plan

Contains client supplied drawing from Robert West (ref: Level Strategy 5988-005-5302-A01 and Levels Strategy 5988-005-5301-A01) dated 01/06/2026.
