Our ref: GE18875/LD01/200228

**RE: Land at Stakers Farm, North End Road, Yapton, Arundel, West Sussex, BN18 0DU – BRE 365 Soakage Testing**

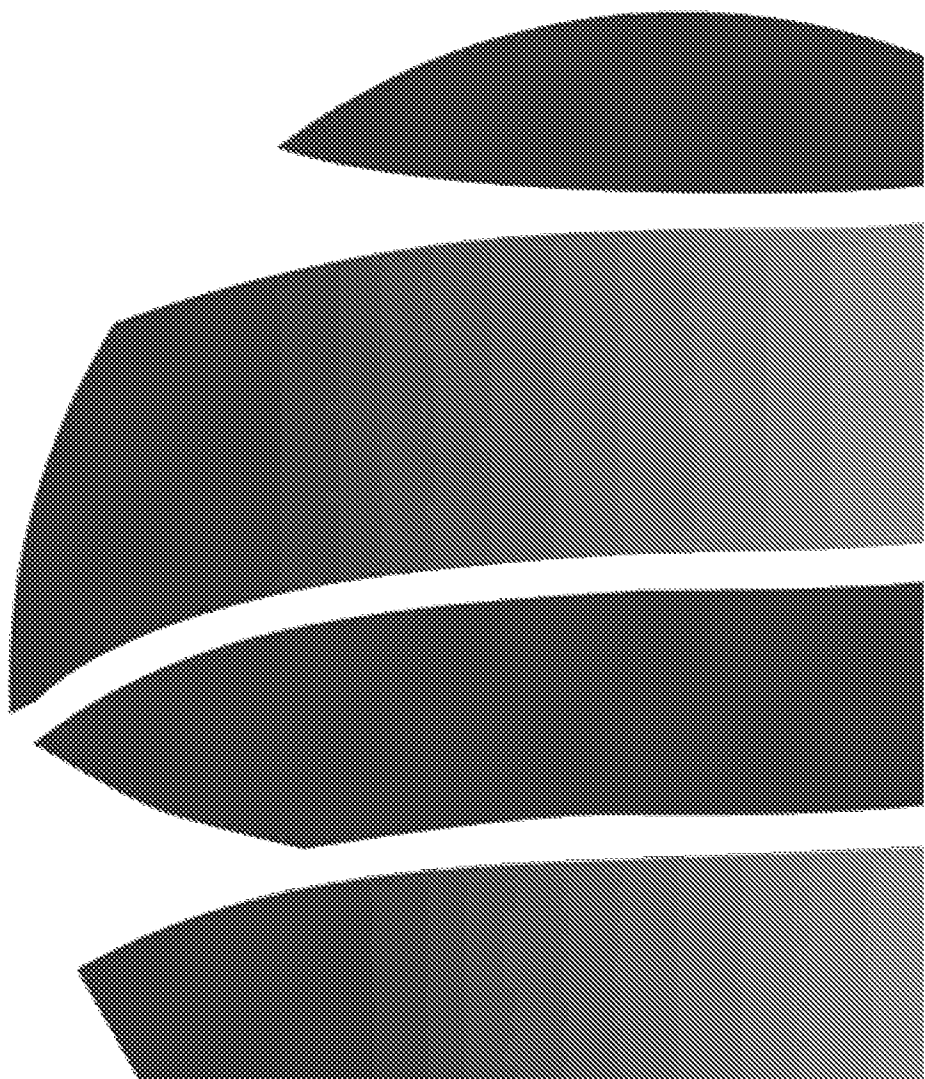
A total of eight soakage tests were undertaken within eight separate trial pits at locations specified by the Client's drainage Engineer, which targeted the proposed locations of the soakaways. The locations of these trial pits are presented in Figure 2.

Enc    Figure 1        – Locations Plan  
       Figure 2        – Exploratory Hole Locations Plan  
       Appendix A    – Exploratory Hole Logs
