# FORD LANE, YAPTON, ARUNDEL.

## TREE SURVEY & ARBORICULTURAL IMPACT ASSESSMENT

JSL3292\_773  
Tree Survey and  
Arboricultural Impact  
Assessment  
V1  
July 2021

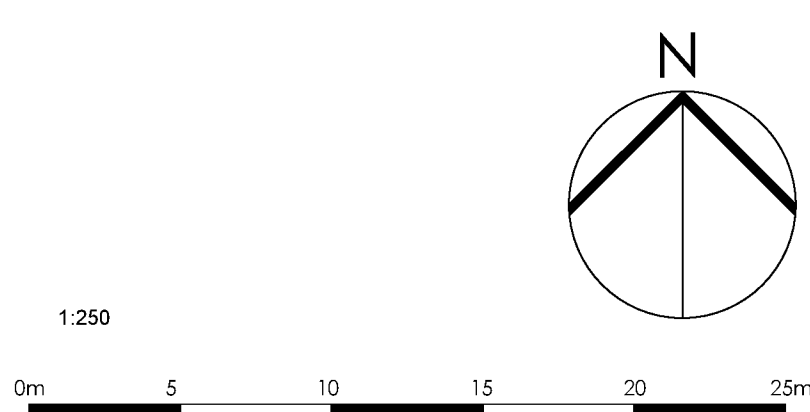
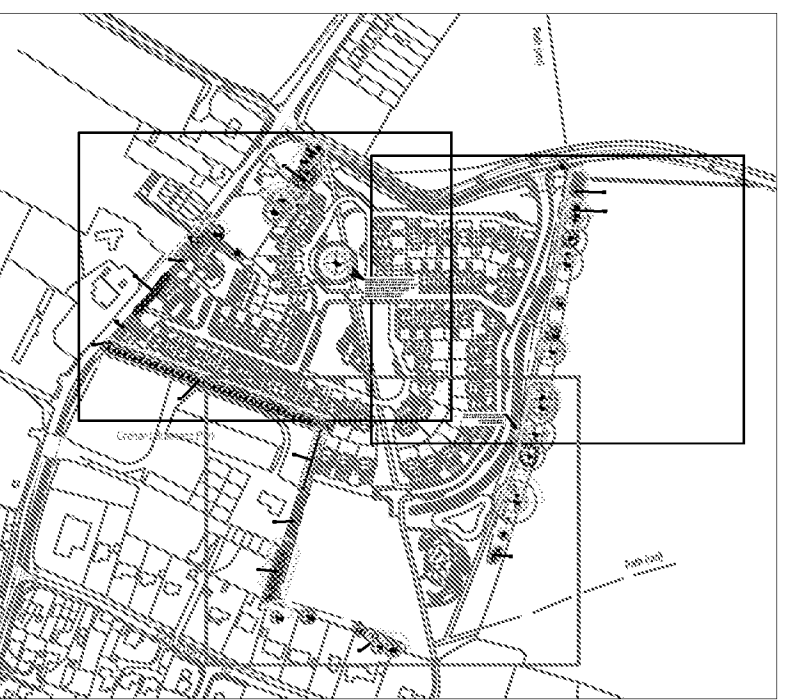
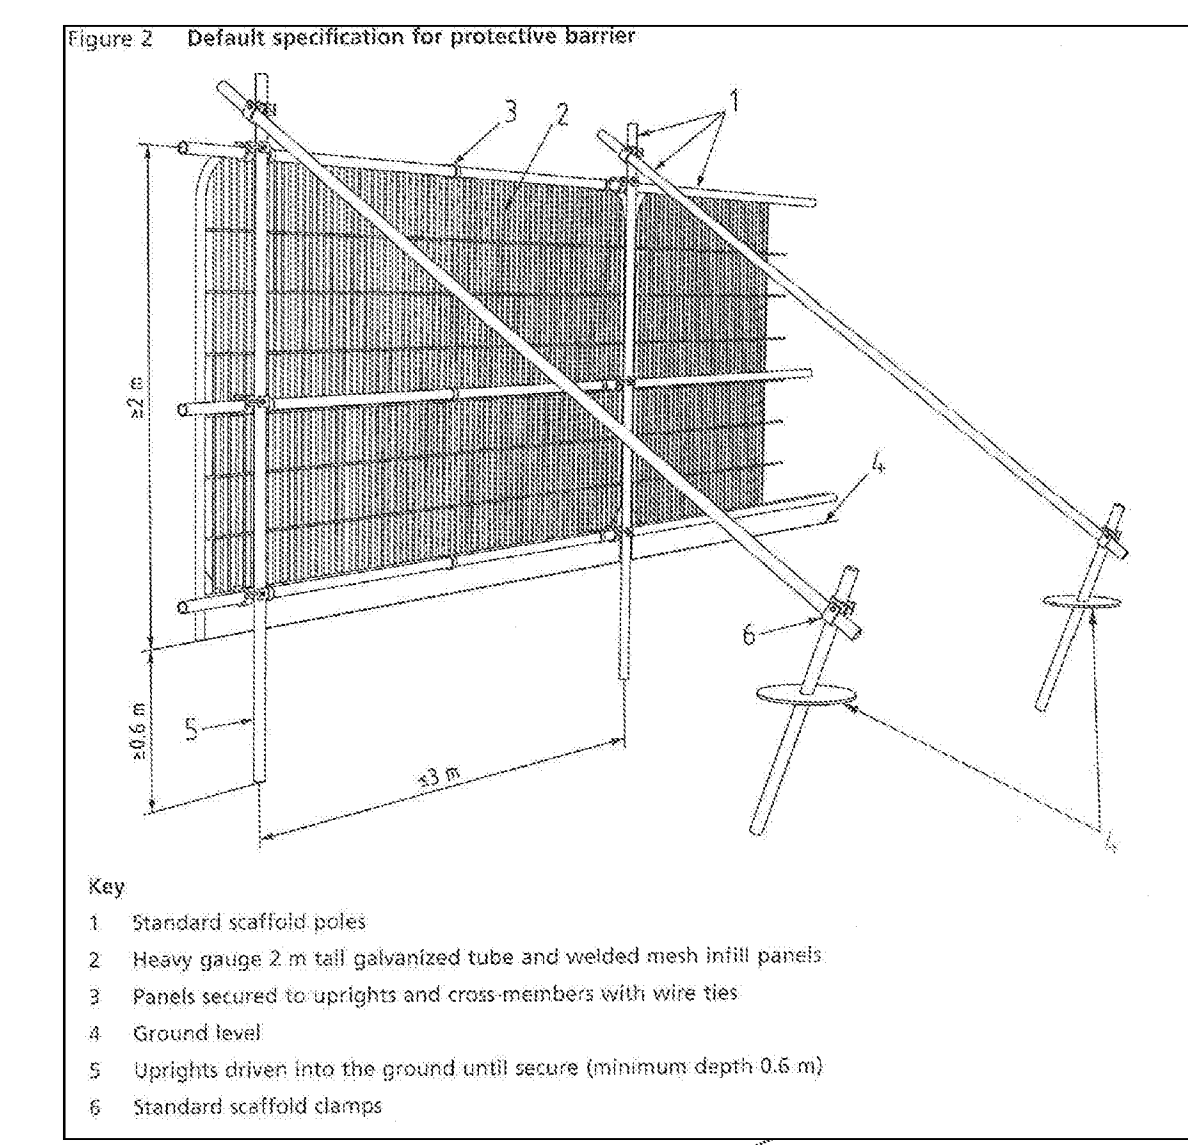
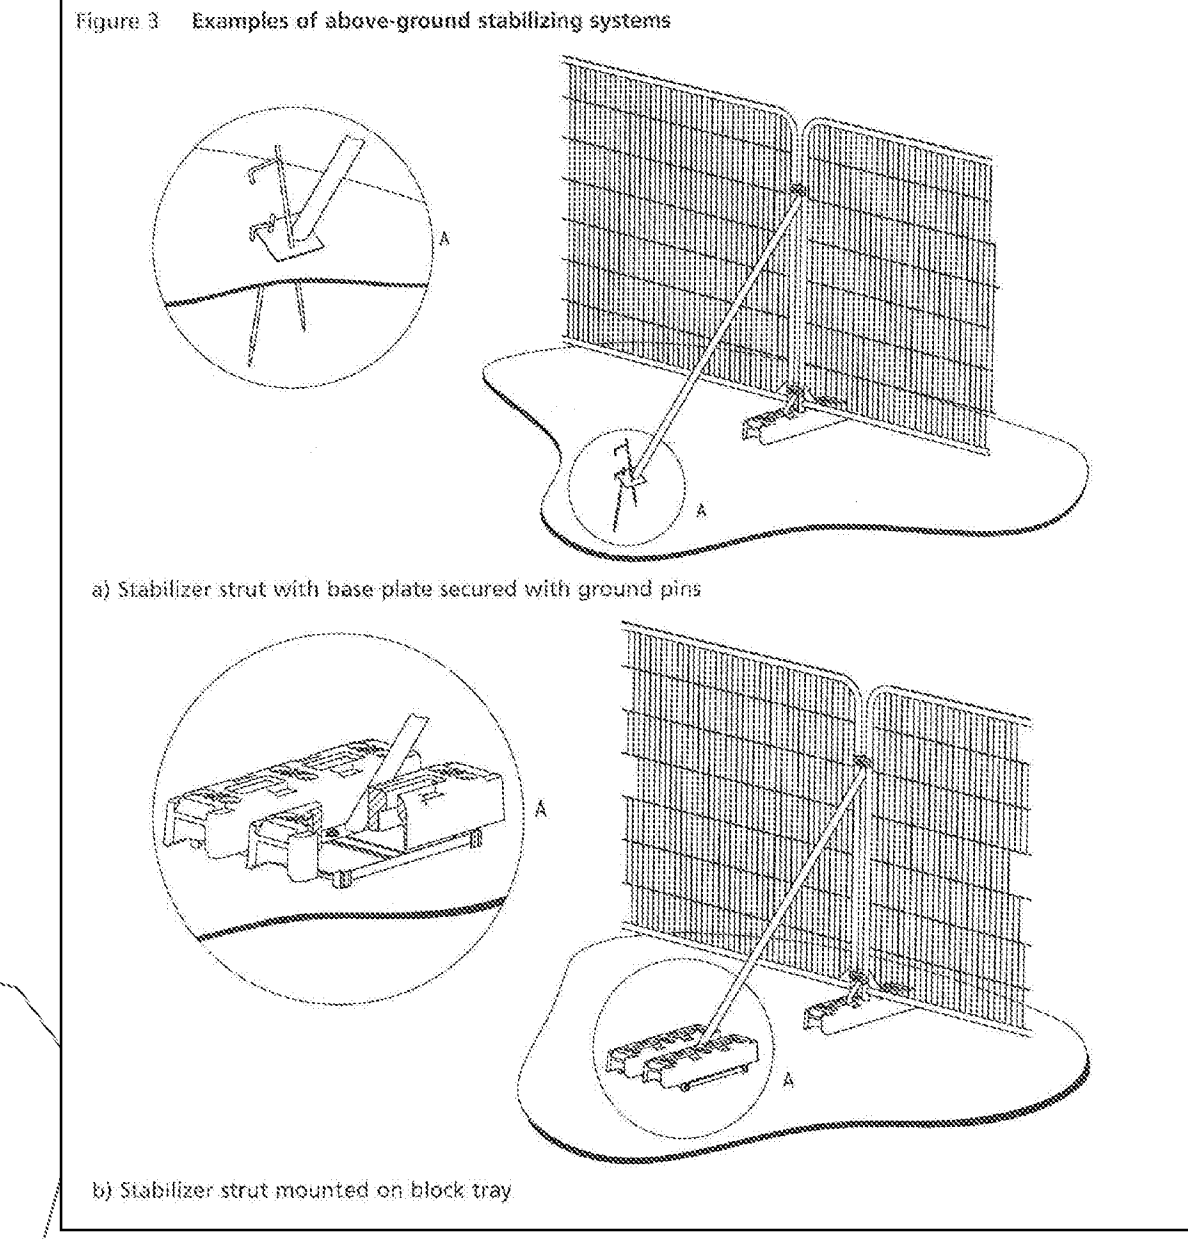
RPS Drawing / Figure Number **712** Rev **E**

- Above ground construction requiring 'No-dig' design principles in accordance with APN12.
  - 'No dig' raft or pile & pad foundation OR Excavation to be completed by hand, any required root pruning to be in accordance with BS 3998. Pruning of roots over 25mmØ to be monitored by arboriculturalist, with ongoing monitoring of trees condition by an arboriculturalist being recommended.

- Surface area to be protected in accordance with Section 6.2.3 BS - 5837:2012 for pedestrian movements.
  - Ground / soil levels reduction, in land previously disturbed (i.e. ploughed field)

- 8.3 In order to protect the RPA of G6 (part, the works will follow a “no dig” format, including raft (or similar) type foundations. Additionally, surface area protection will be required to allow pedestrian movements. (Refer to drawings JSL3292\_712-714\_Appendix C).
