## **Phase II Ground Investigation Report**

**Orchard Business Park, North End Road, Yapton,  
West Sussex BN18 0GA**

**Crayfern Homes**

**Reference: 16671/GIR**

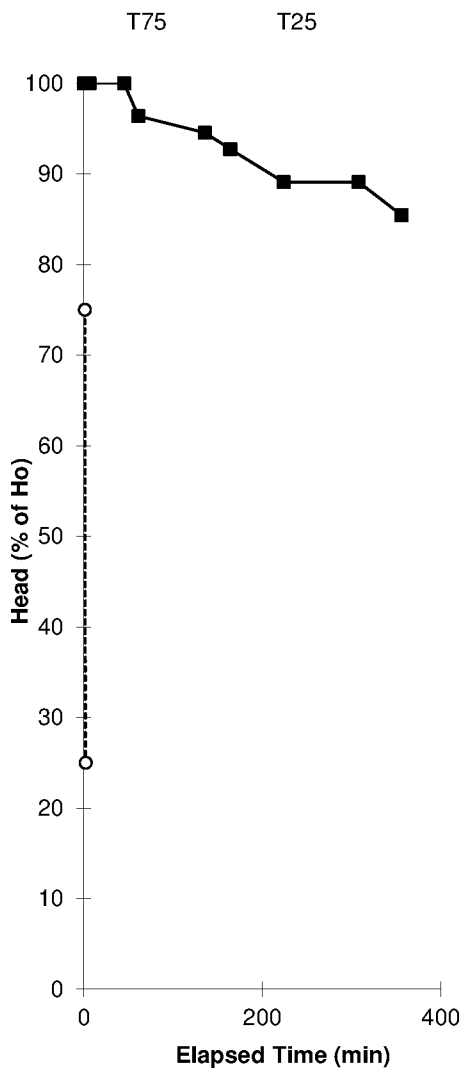
Infiltration stopped - unable to calculate infiltration rate

Considering that the noted reduction in the head of water was 11% over 5 hours (TP1), 2% over 4 hours (TP2A) and 9% over 3.5 hours (TP3), infiltration testing was only conducted once within the trial holes.

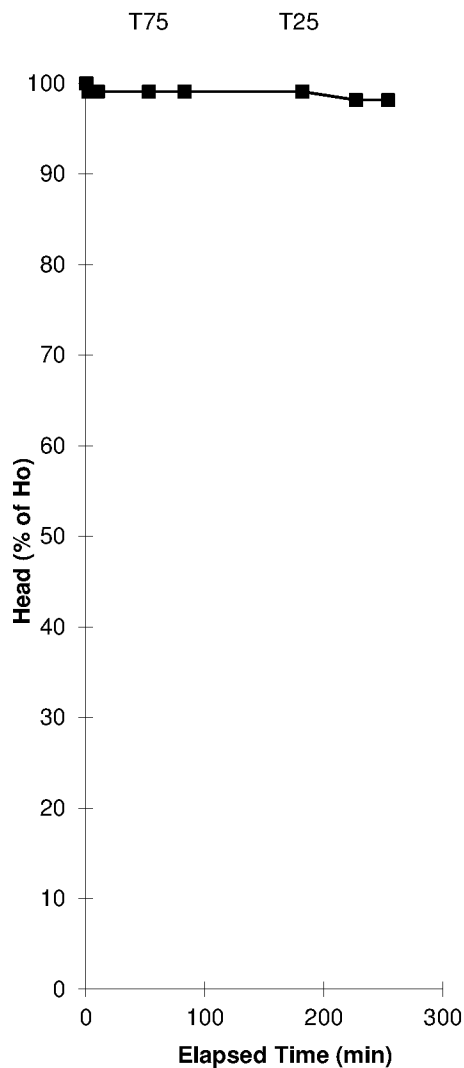
Infiltration stopped - unable to calculate infiltration rate

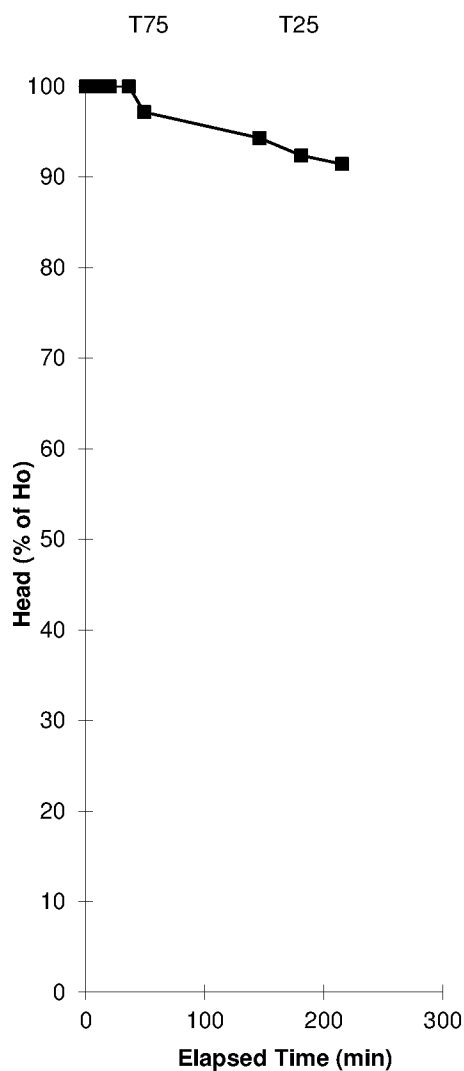
Infiltration stopped - unable to calculate infiltration rate
