Our ref: GE18965/LD01/200331

**RE: Land at Stakers Farm, North End Road, Yapton, Arundel, West Sussex, BN18 0DU – BRE 365 Soakage Testing**

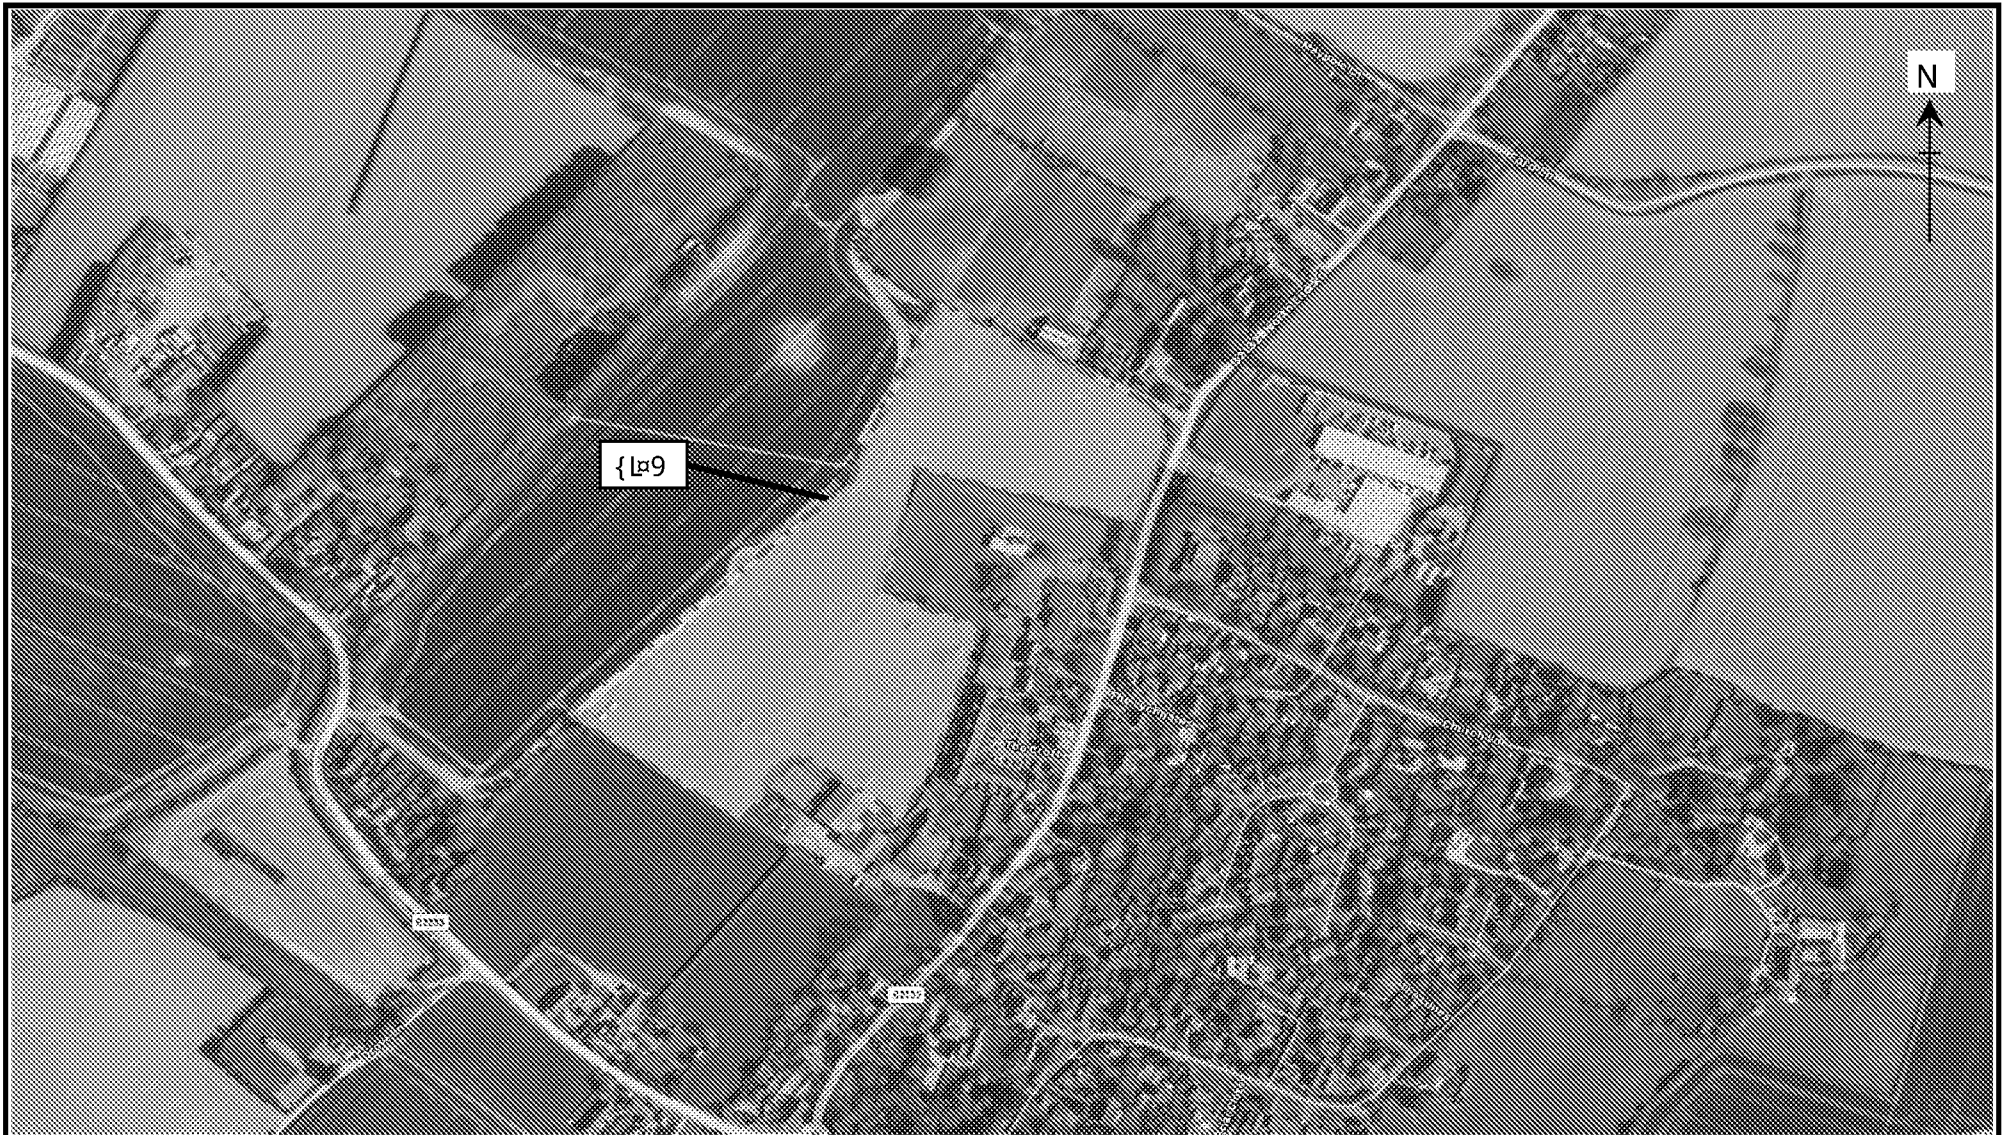
A total of eight BRE365 soakage tests within eight separate trial pits and one cable percussive borehole were undertaken at locations specified by the Client's Drainage Engineer, which targeted the proposed locations of the soakaways. The locations of the exploratory holes are presented in Figure 2.

Soakage tests were undertaken at eight locations (MAR-TP1 to MAR-TP8) in accordance with BRE Digest 365, with the depth and locations of the tests being specified by the Client's Drainage Engineer. Three soakage runs were undertaken within each position were commenced on the 24<sup>th</sup> March 2020 with testing completed on the 26<sup>th</sup> March 2020. There was insufficient fall in head to calculate an infiltration rate within MAR-TP2 and MAR-TP5 with insufficient fall in head over a three day period to calculate a rate of infiltration. Table 1 summarises the soakage rates, which were calculated based on the results of the soakage testing.

In addition, as part of the investigation, one cable percussive borehole (MAR-BH01) was drilled to a depth of 9.0m bgl. Upon completion of the borehole, a constant head permeability testing could not be undertaken due to the presence of shallow groundwater and fast groundwater ingress at depths of 3.18m and 9.00m. bgl. However, two falling head permeability tests were attempted within the borehole. Table 2 summarises the falling head permeability tests results.
