## **Supplementary Investigation Report**

**Cinders Nursery, Cinders Lane, Yapton, West Sussex BN18 0JJ**

**Reference: 17926/SIR\_R27**

**November 2019**

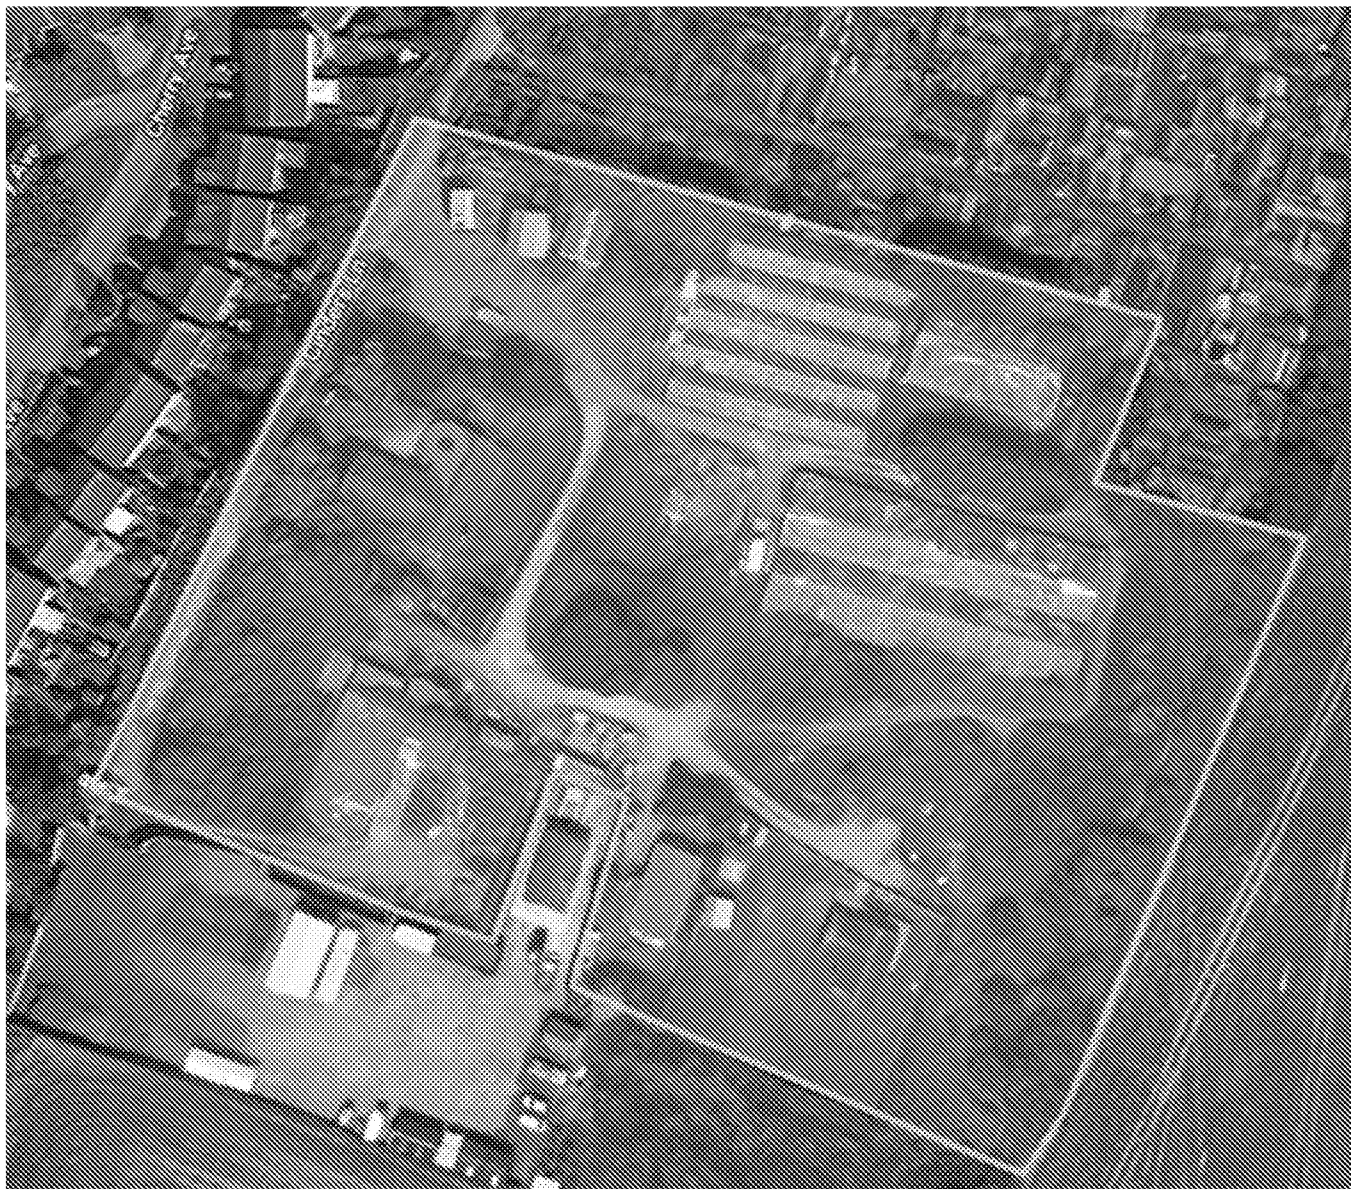
**Figure 2 – Aerial Photograph  
-Pre-demolition and  
clearance**

At the time of the Main Investigation in August 2018, the site was a former nursery comprising industrial greenhouses to the northeast and number of bungalows to the south and southeast. The greenhouses were in poor condition.

By the time of this investigation in October 2019, the site had been cleared and was open undeveloped ground. No evidence of the former tank locations, concrete buildings or greenhouses was noted on site.

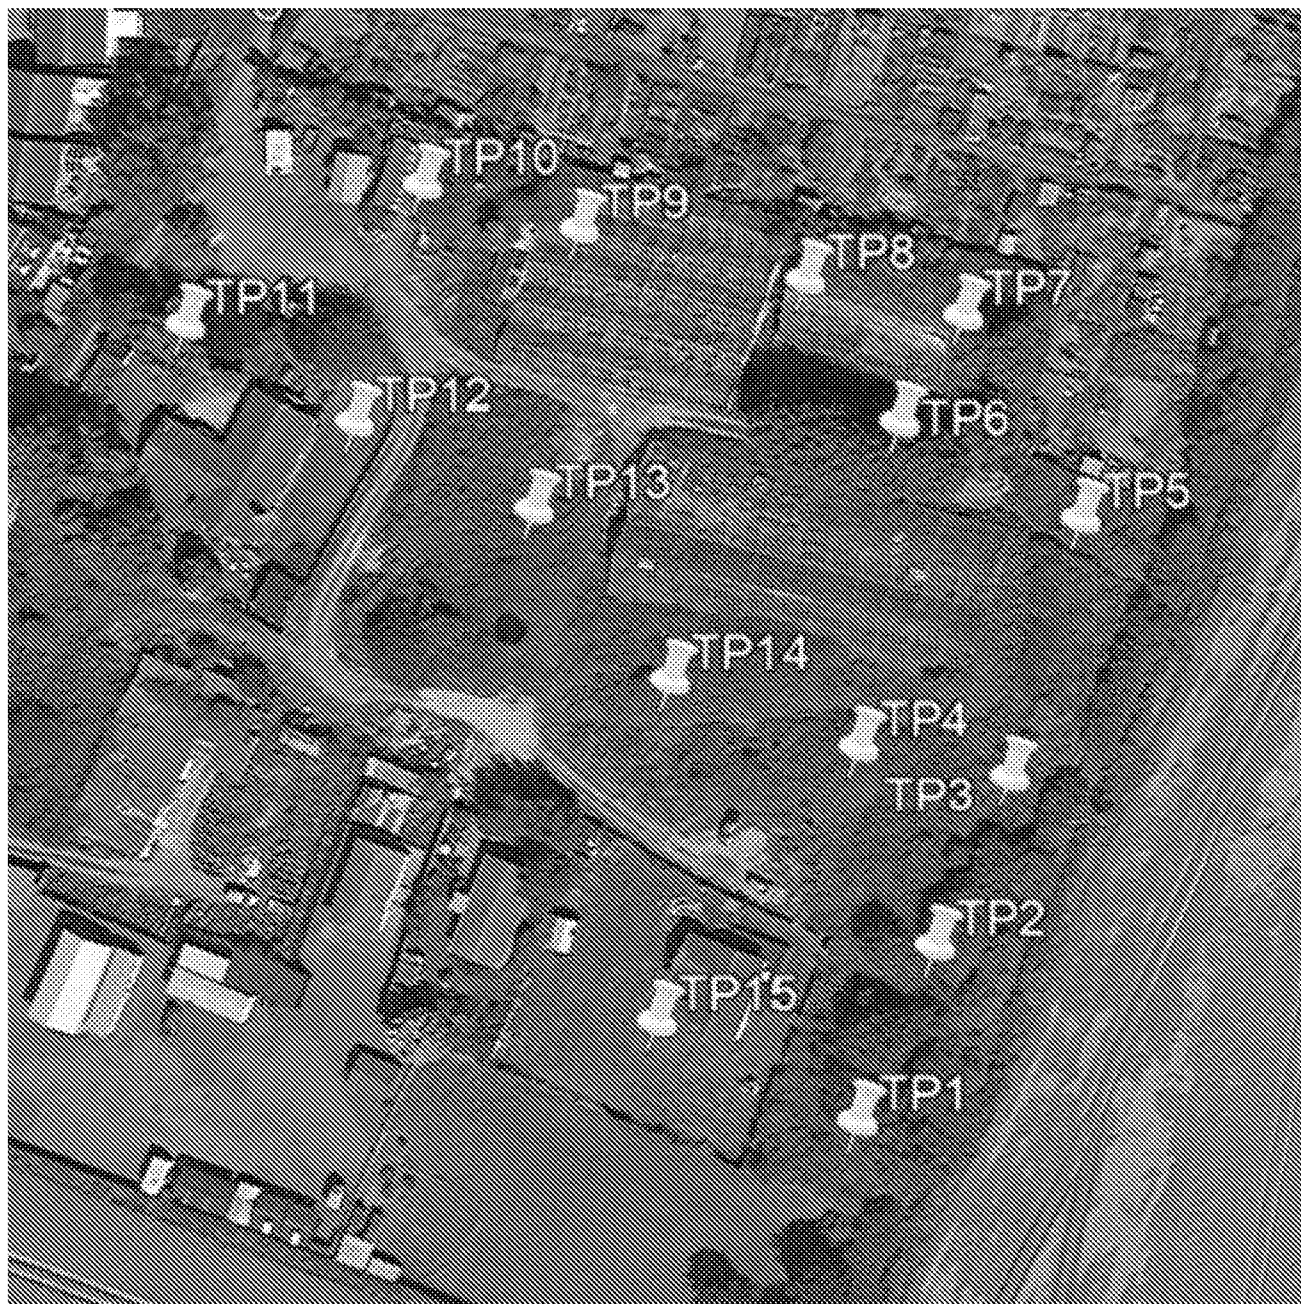
All trial hole locations from this investigation have been presented in Figure 3.
