## **Supplementary Investigation Report**

**Cinders Nursery, Cinders Lane, Yapton, West Sussex BN18 0JJ**

**Reference: 17926/SIR\_R27**

**November 2019**

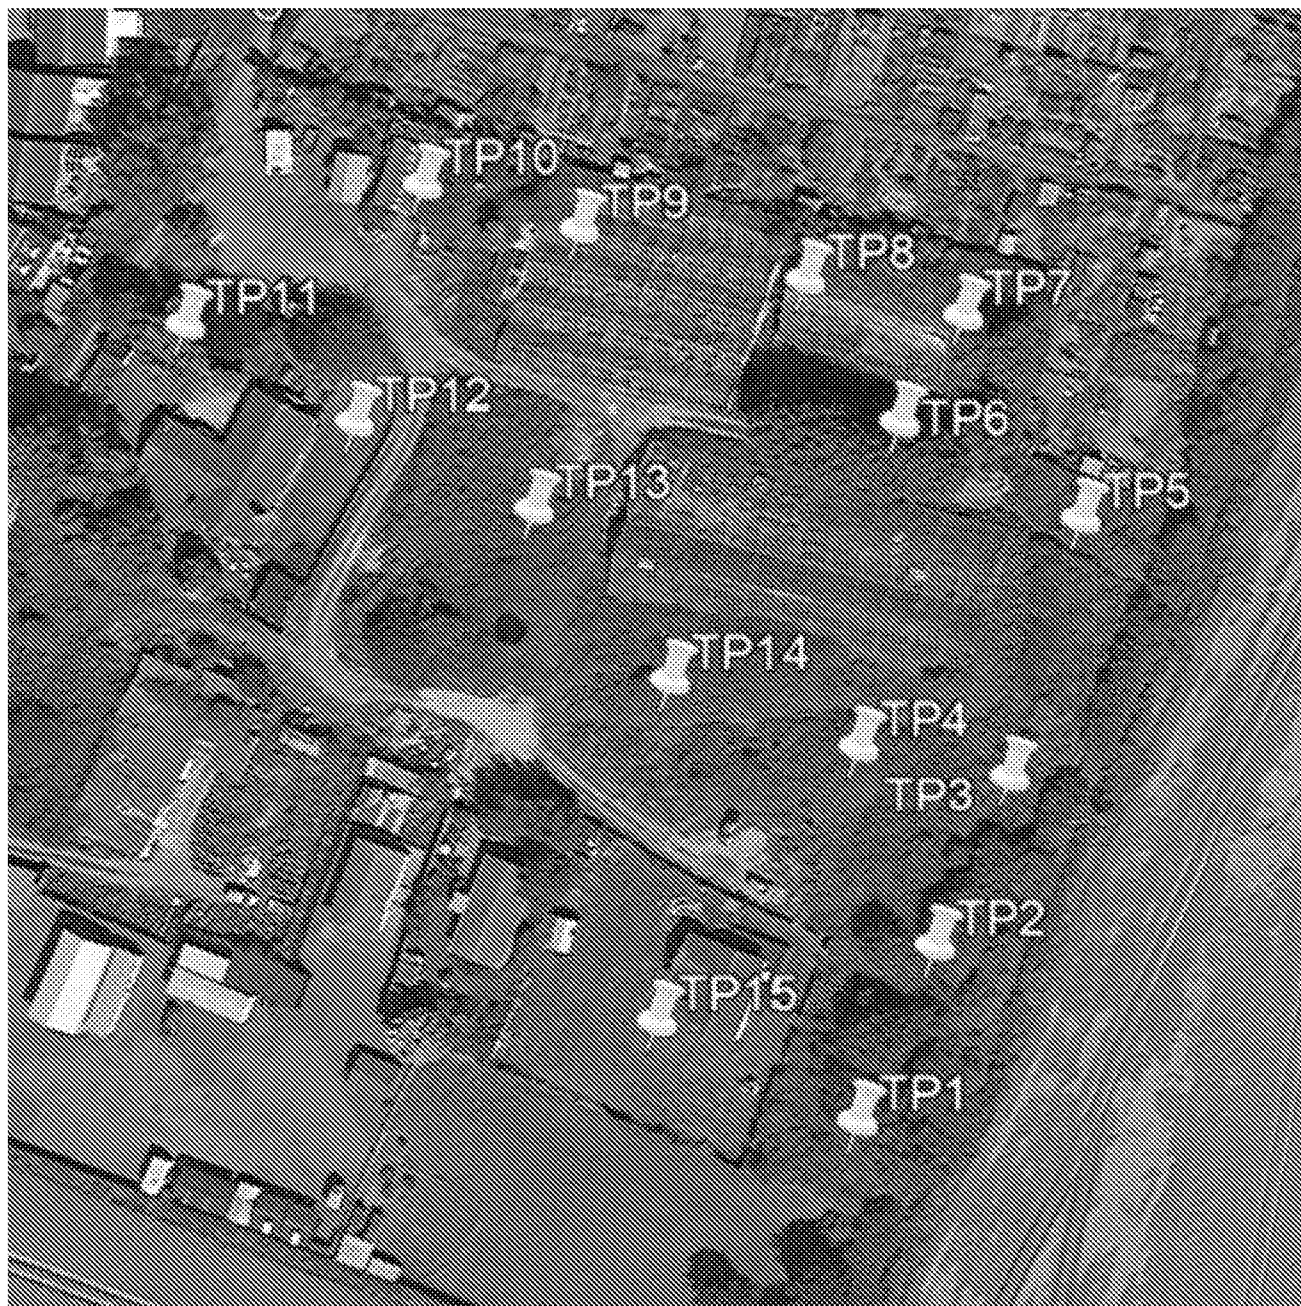
All trial hole locations from this investigation have been presented in Figure 3.
