## **Validation Report**

at  
**Cinders Lane, Yapton, West Sussex BN18 0JJ**

for  
**Crayfern Homes**

Reference: 18115/MIR\_R27  
September 2021

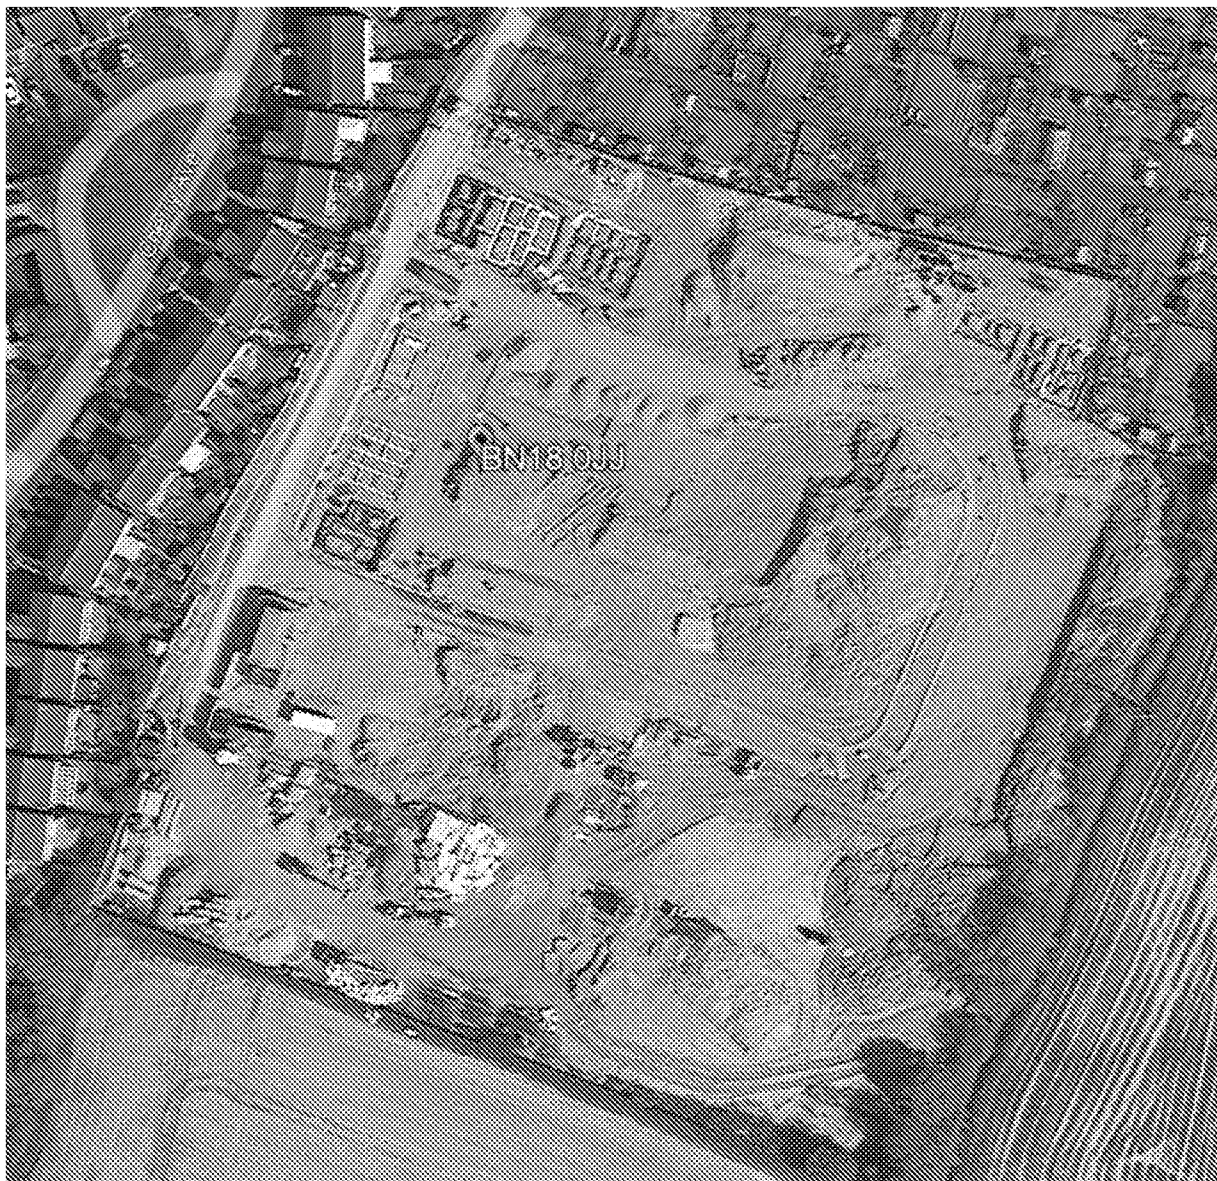
**Figure 2 – Aerial Photograph**

The site was located at Cinders Lane, Yapton, West Sussex BN18 0JJ and had an approximate O.S Land Ranger Grid Reference of SU 980 025. The site location plan is given in Figure 1. At time of writing Soils Limited understand that development works are now completed. An aerial photograph from March 2020 during development has been included in Figure 2. As built plans will be forwarded as required to the regulator on completion under planning and a copy of the Location Plan for the identified “Hotspot” (See Supplementary Investigation Report prepared by Soils Limited, referenced 17926/SIR\_R27, dated November 2019) is included as Figure 3.

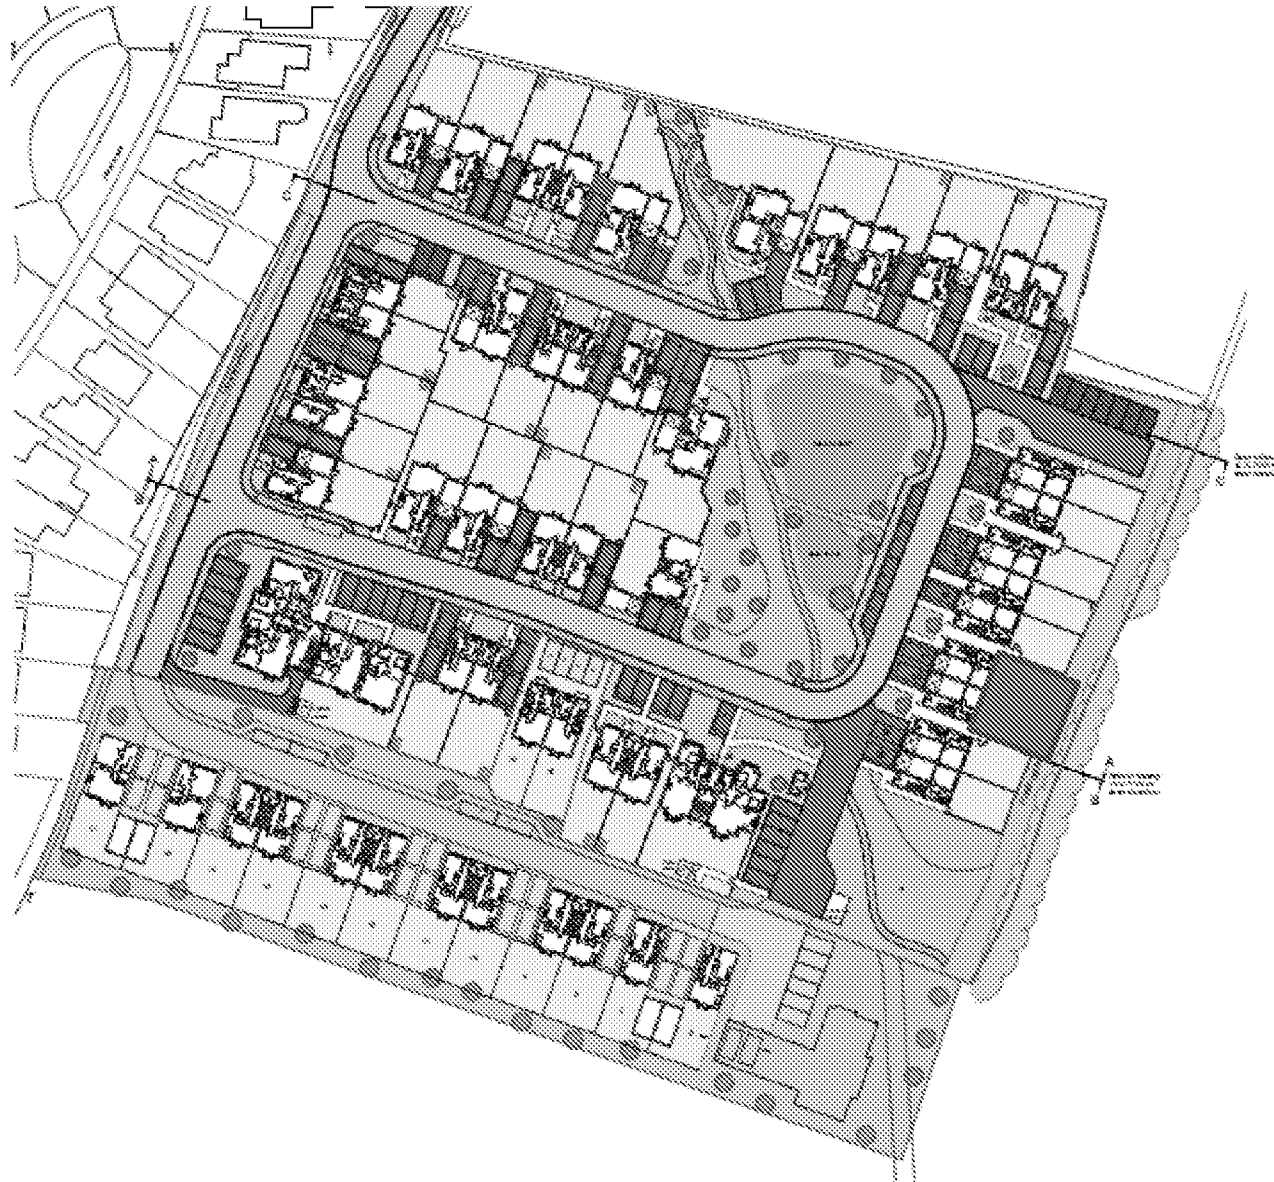
**Figure 3 – Remediation Plan**

The replacement was undertaken as agreed in all areas of proposed gardens in Plots 16 and 17, as shown in Figure 3. This action has mitigated the identified risk from the “Hotspot” to the vulnerable human health receptor by removal of source and by definition the remaining ground cannot be defined as contaminated and risk is low to negligible by default.

Plot 16 and 17 Garden areas

As such a strategy was agreed with the regulators to include as pre development groundworks the removal of materials to 600mm below ground levels in the identified garden areas of Plots 16 and 17, removal from site of this material in accordance and compliance with current waste legislation and guidance and sustainable replacement with certified clean materials produced as “wastes” from other areas of the site and activities (including foundation excavations in “natural” soils) already confirmed as suitable and fit for purpose by the remainder of the available analysis in the above-noted
