# Foul & SuDS Drainage Statement & Maintenance Plan

Land off North End Road, Yapton, West Sussex BN18 0DT

**Redrow Homes Ltd**  
Unit 1, Faraday Office Park  
Basingstoke  
Hampshire  
RG24 8QQ  
11228

**Date:** November 2021

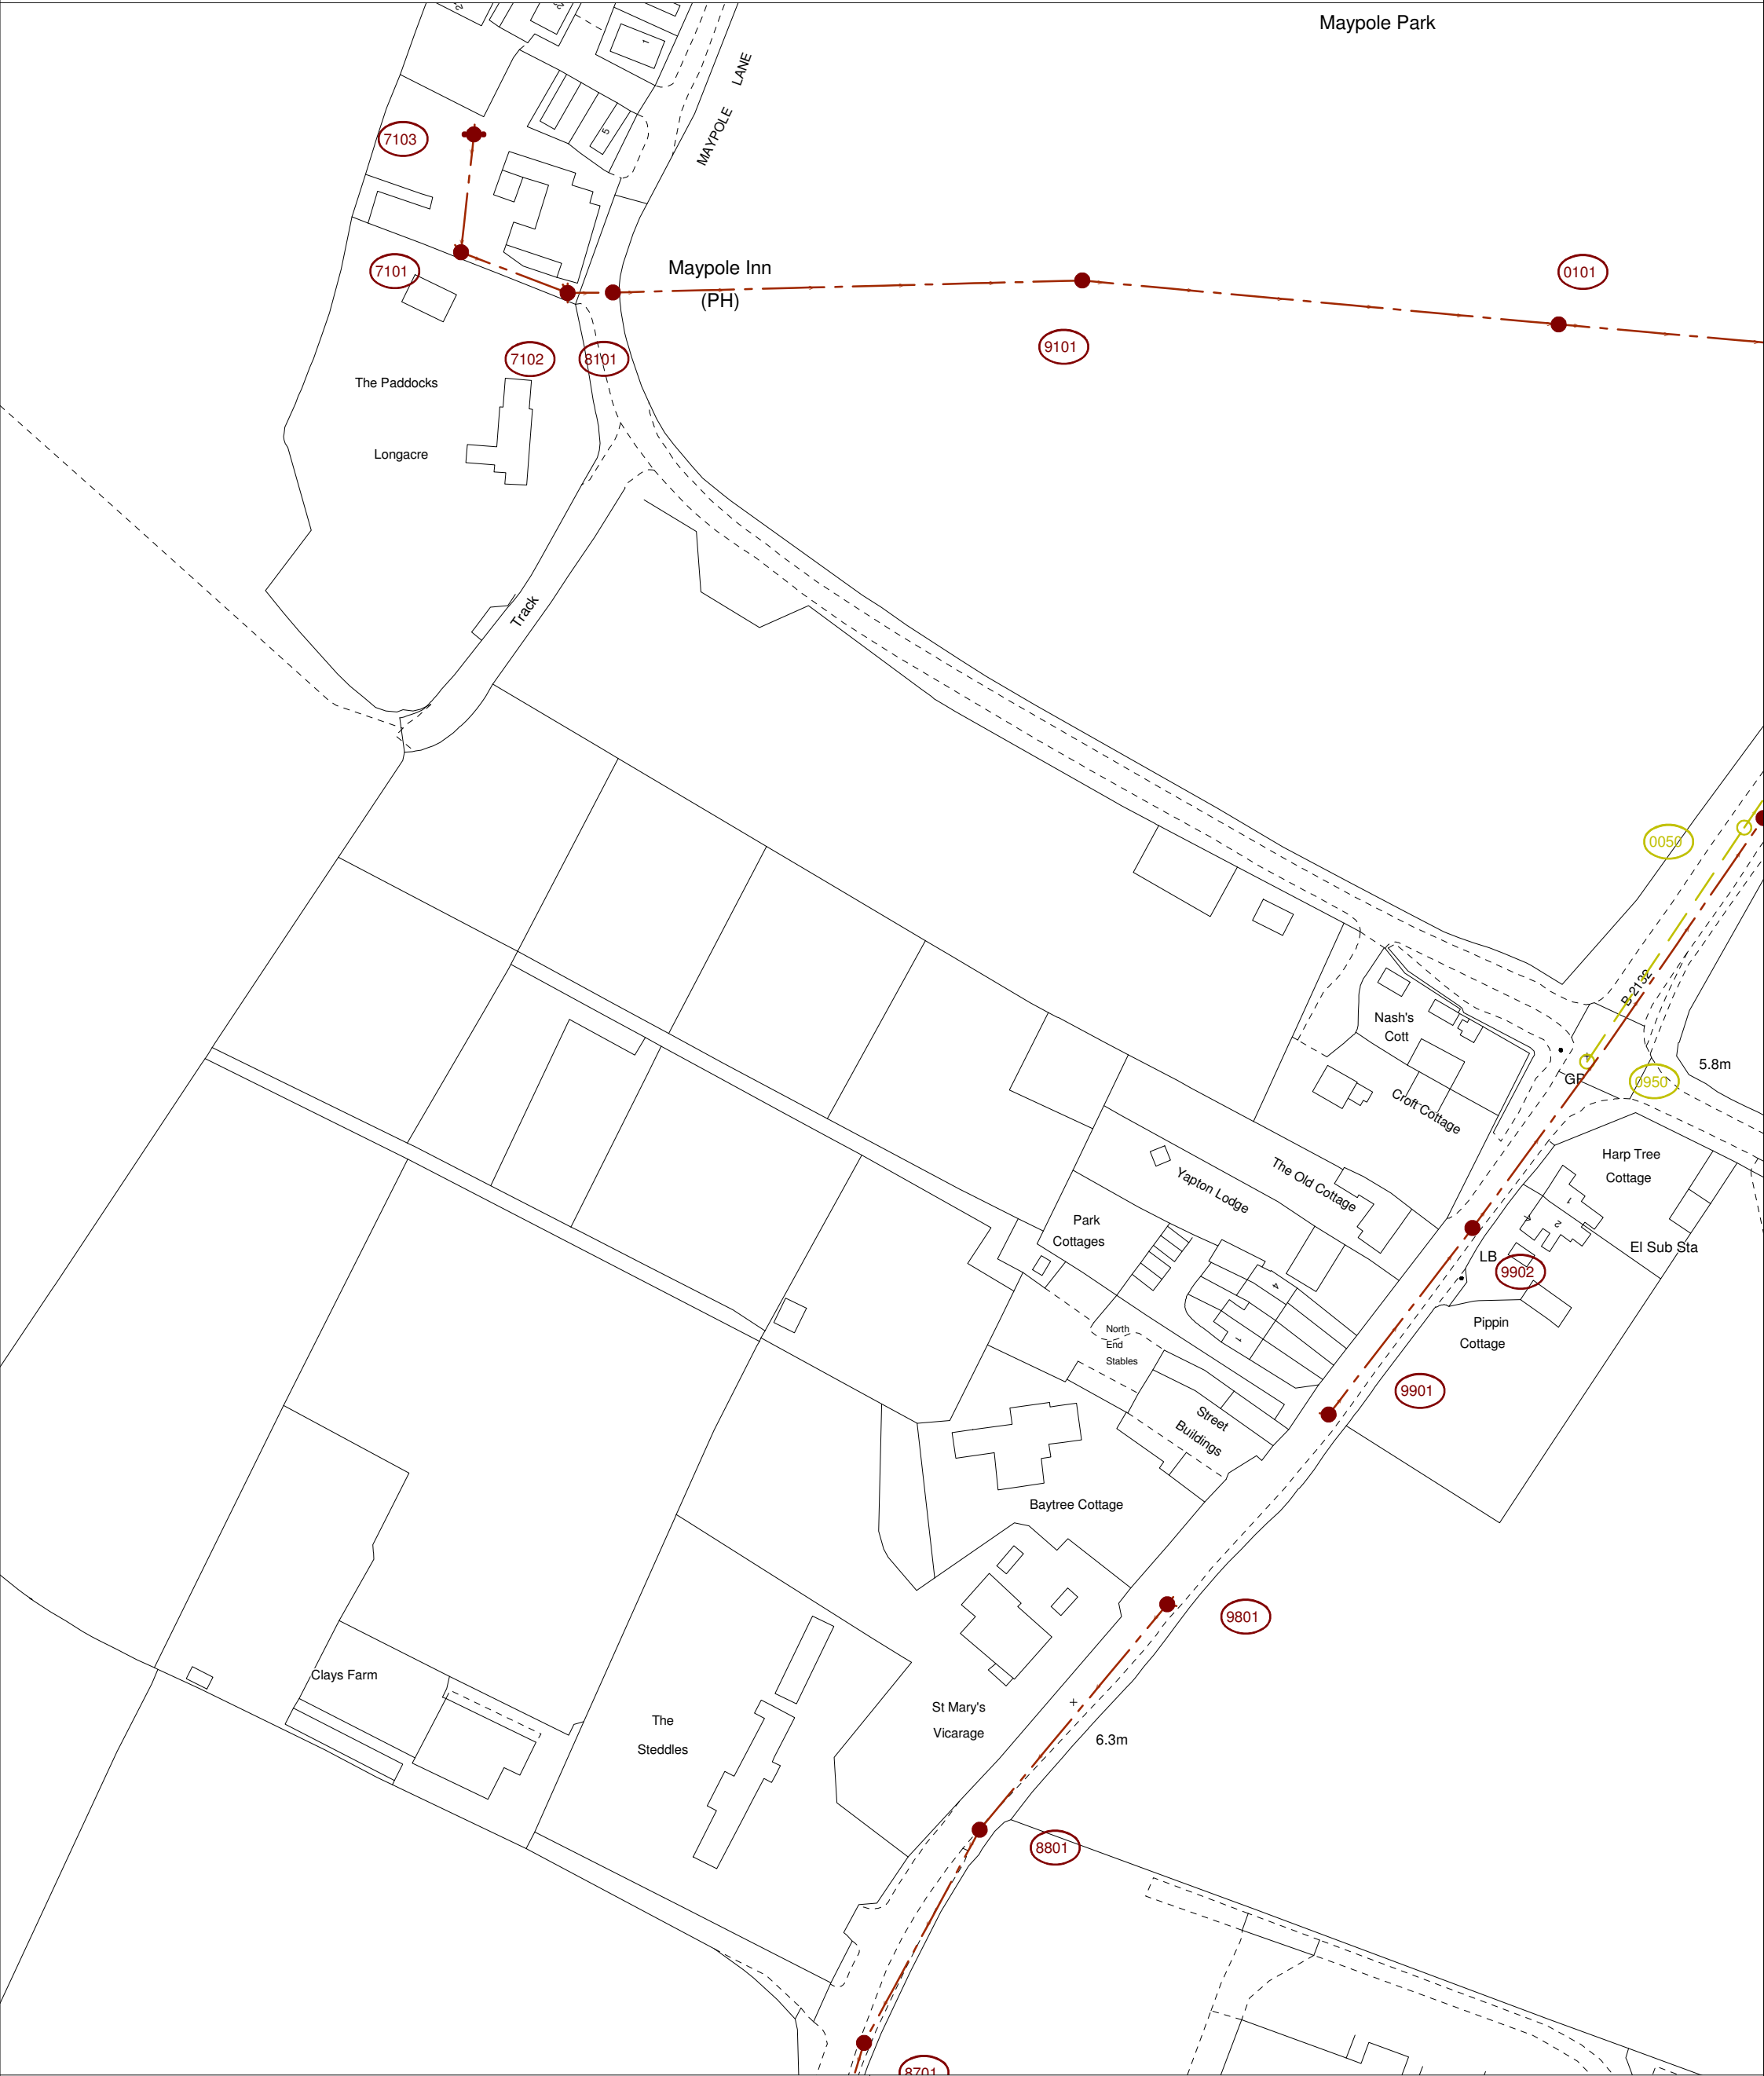
SOUTHERN WATER

The positions of pipes shown on this plan are believed to be correct, but Southern Water Services Ltd accept no responsibility in the event of inaccuracy. The actual positions should be determined on site.

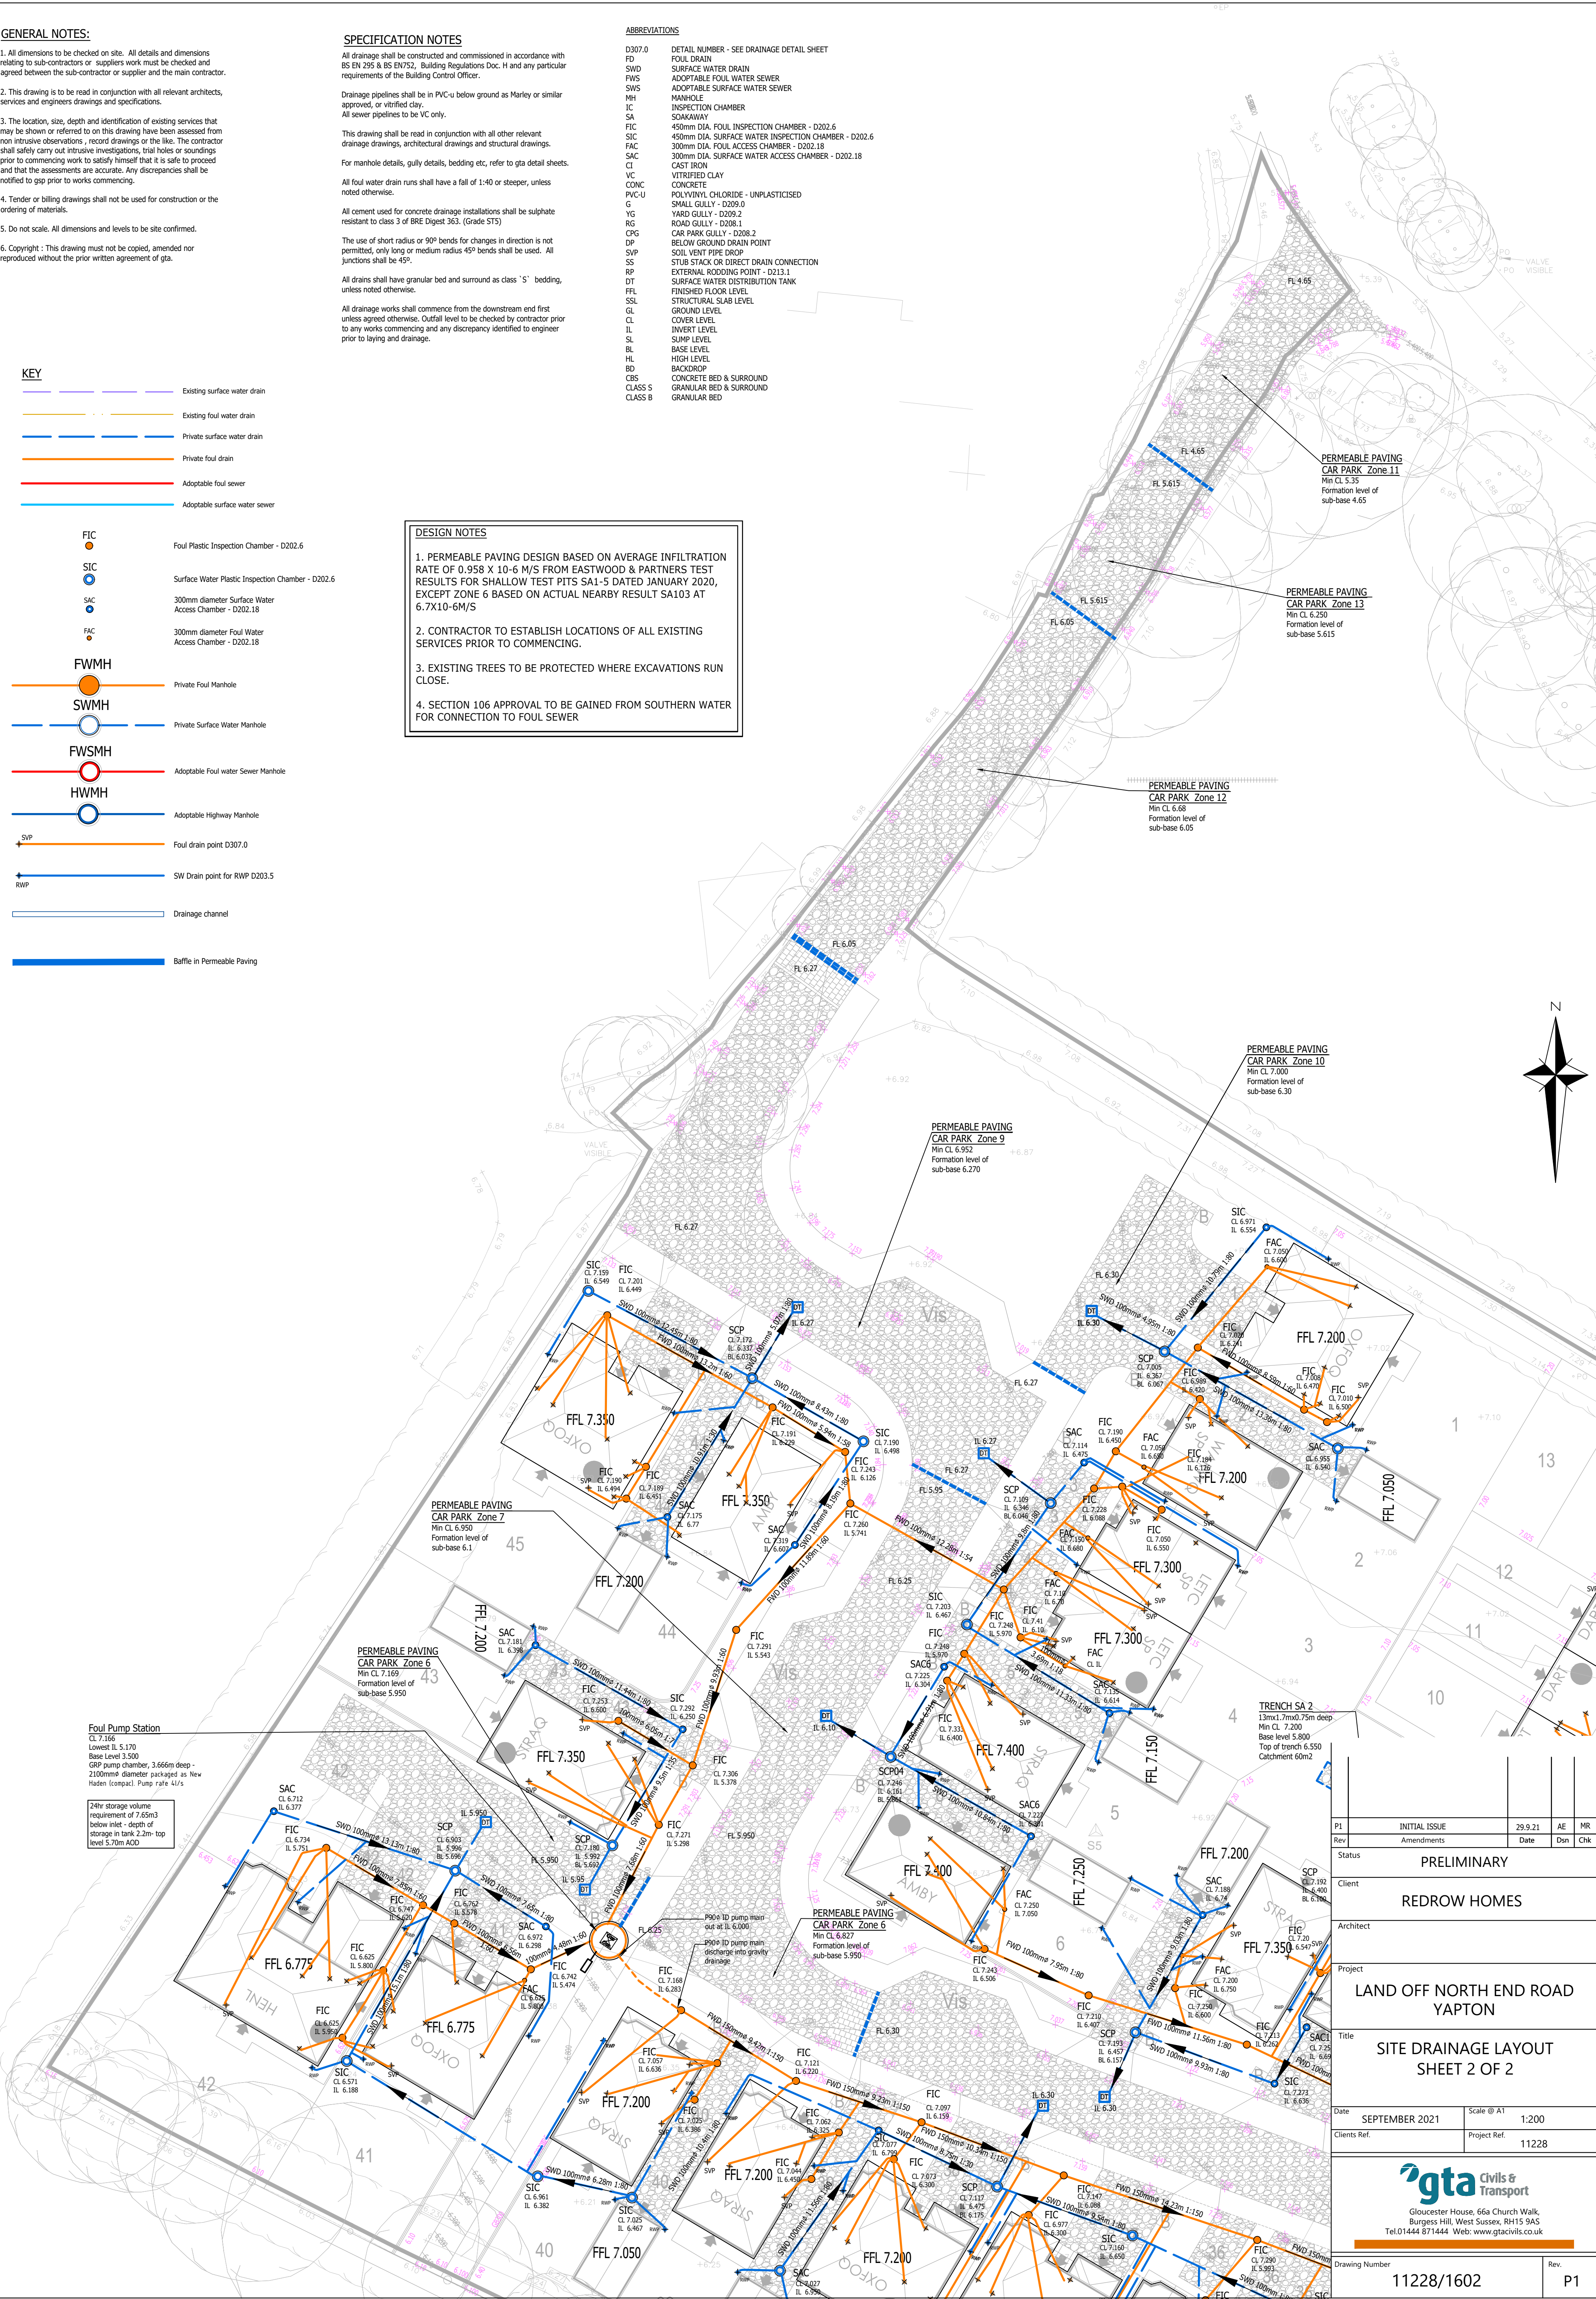
DESIGN NOTES

1. PERMEABLE PAVING DESIGN BASED ON AVERAGE INFILTRATION RATE OF 0.958 X 10-6 M/S FROM EASTWOOD & PARTNERS TEST RESULTS FOR SHALLOW TEST PITS SA1-5 DATED JANUARY 2020, EXCEPT ZONE 6 BASED ON ACTUAL NEARBY RESULT SA103 AT 6.7X10-6M/S
2. CONTRACTOR TO ESTABLISH LOCATIONS OF ALL EXISTING SERVICES PRIOR TO COMMENCING.
3. EXISTING TREES TO BE PROTECTED WHERE EXCAVATIONS RUN CLOSE.
4. SECTION 106 APPROVAL TO BE GAINED FROM SOUTHERN WATER FOR CONNECTION TO FOUL SEWER

All foul water drain runs shall have a fall of 1:40 or steeper, unless noted otherwise.

All drains shall have granular bed and surround as class 'S' bedding, unless noted otherwise.

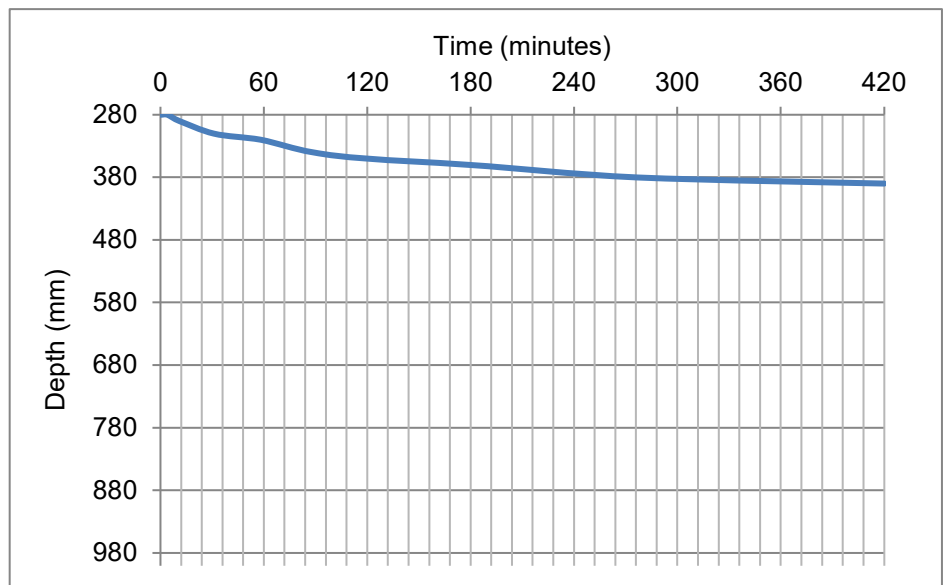
Water level at 470 mm when checked in the morning the next day.

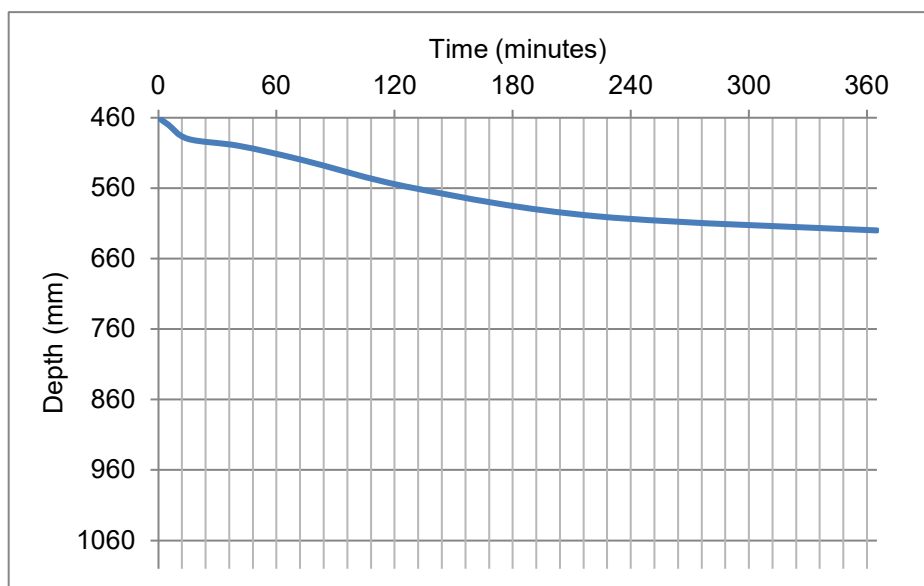
Water level at 920 mm when checked in the morning the next day.

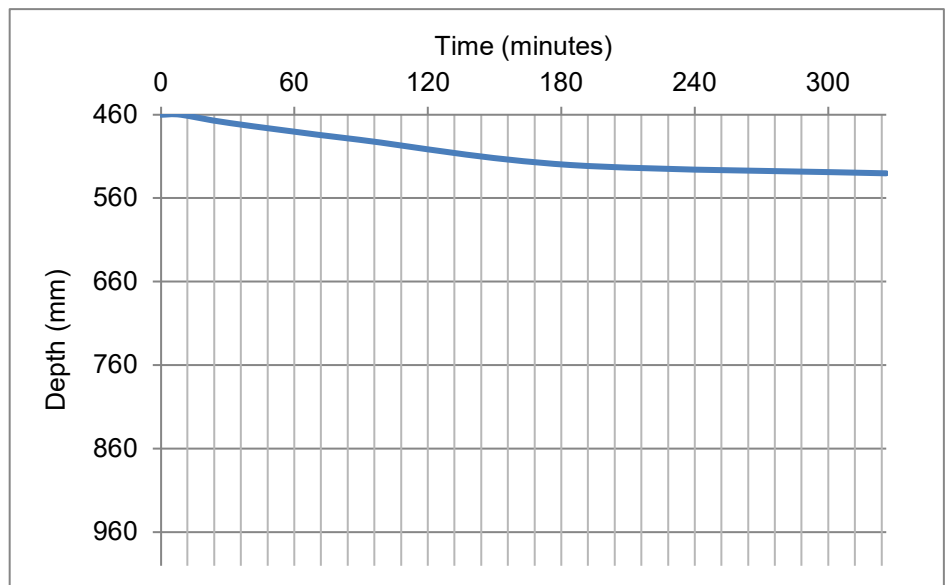
Water level at 600 mm when checked in the morning the next day.

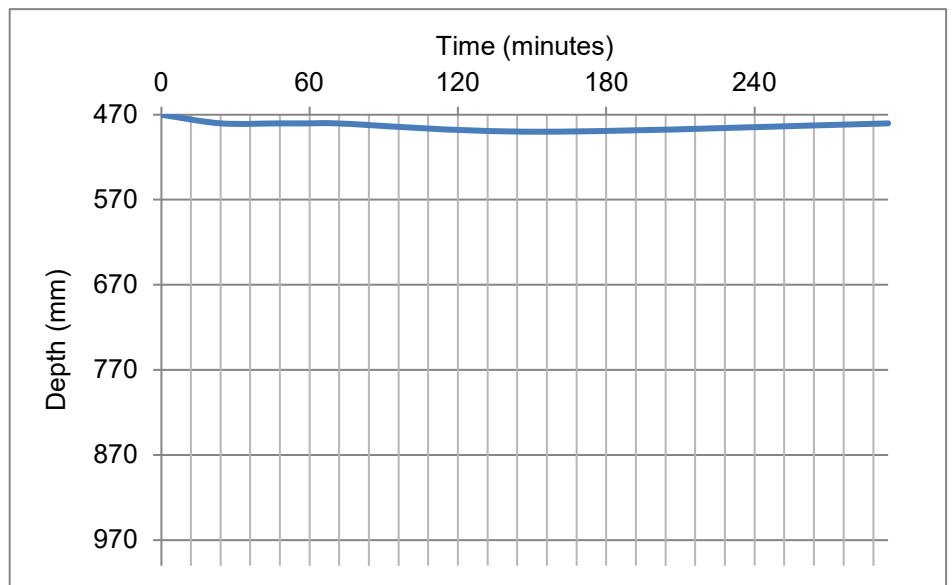
Water level at 500 mm when checked in the morning the next day.

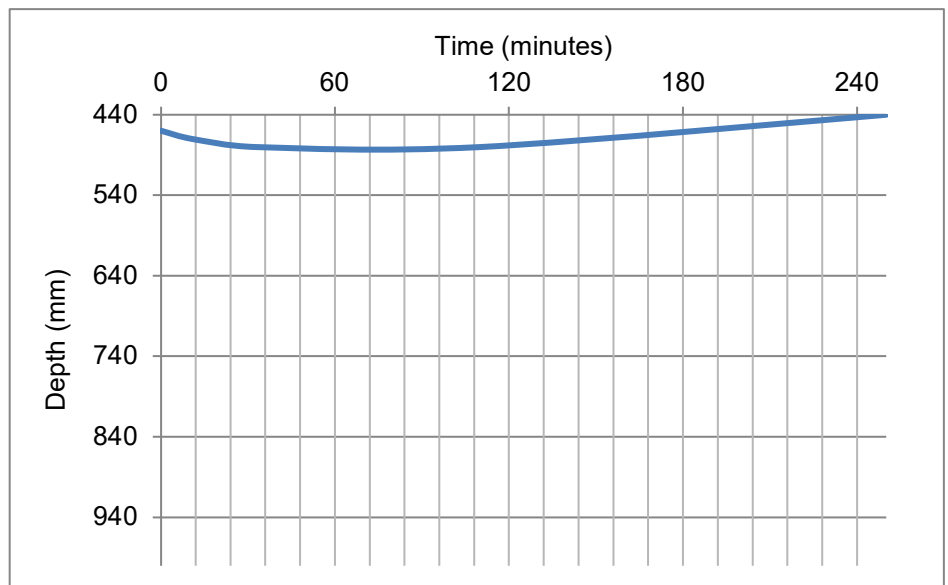
Water level at 480 mm when checked in the morning the next day.  
Water level rise thought to be a result of heavy rain during the test.

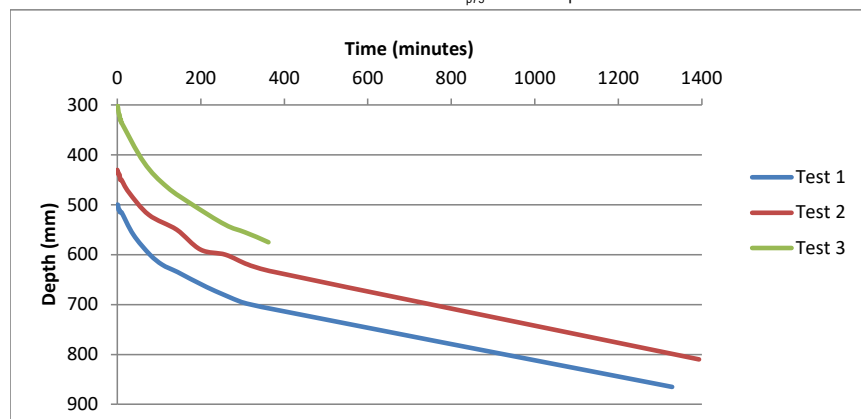
\* $t_{p75}$  value extrapolated based on rate recorded between 376 and 1393 min

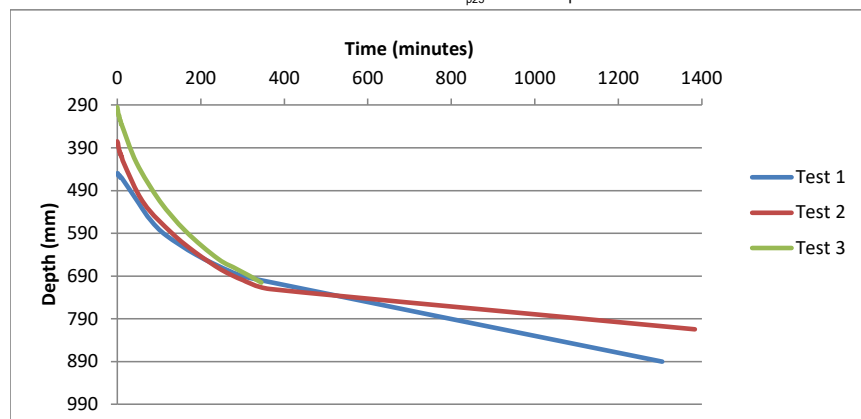
\* $t_{p25}$  value extrapolated based on rate recorded between 302 and 365 min
