**RE: YAPTON RESIDENTIAL DEVELOPMENT – BESPOKE RISK ASSESSMENT FOR PACKAGE TREATMENT PLANT DISCHARGE – STAGE 1**

SLR Consulting Ltd (SLR) was commissioned by AKSWard Ltd in October 2016 to carry out Stage 1 of a Bespoke Risk Assessment for the proposed package treatment plant discharge at Bonhams Field, Yapton, BN18 0DX. The site location is shown on Drawing 1.

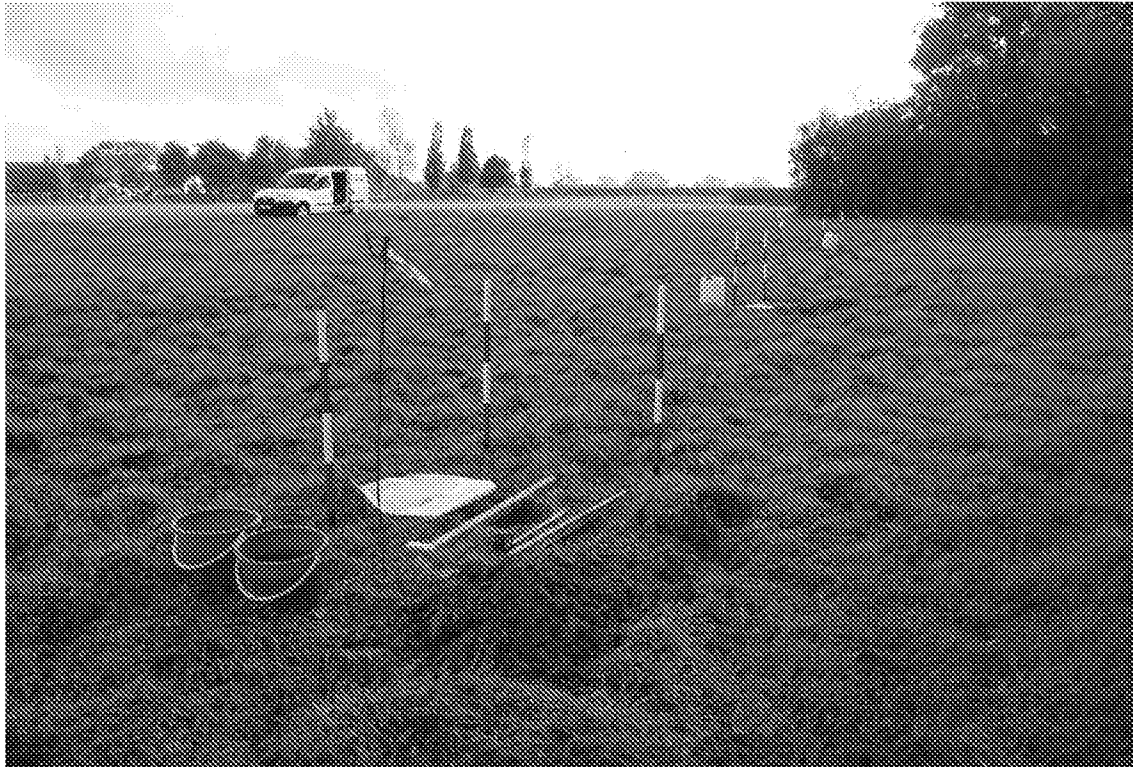
**Figure 4** View of completed hand pits facing south with suspended level loggers (HP03 near, HP01 furthest).

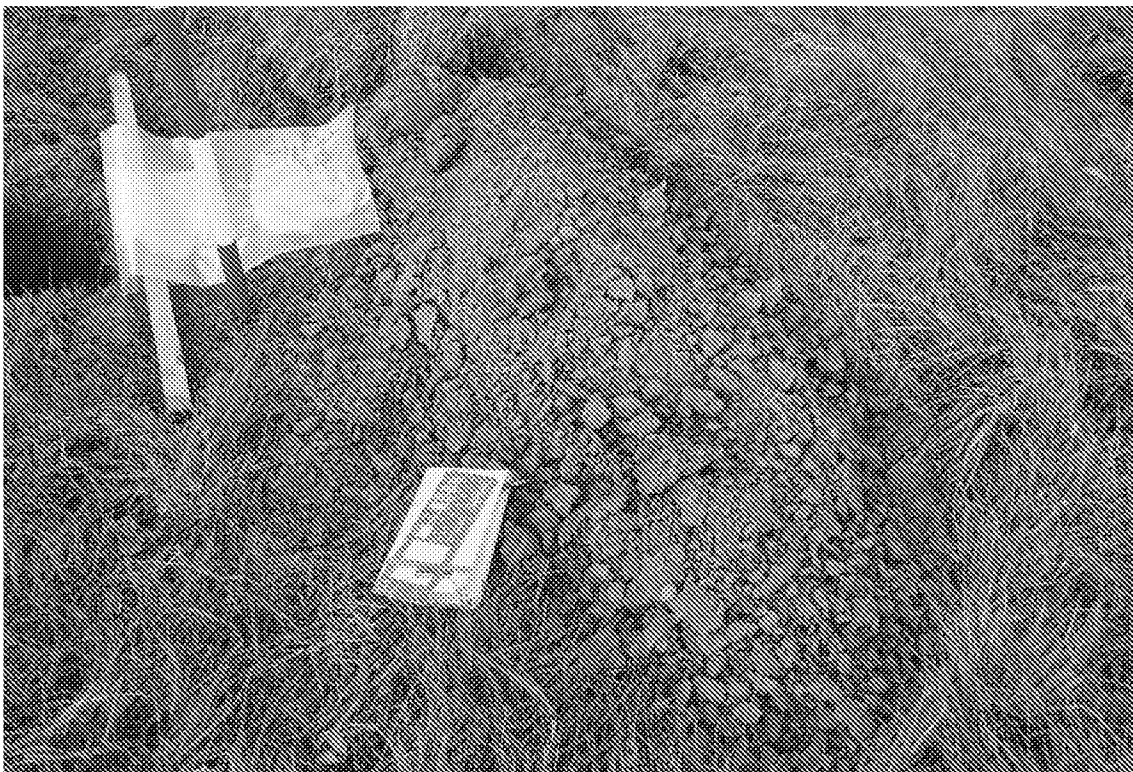
HP01 encountered rare brick gravel within the top 0.5m and as such this has been recorded as fill. However, otherwise the material appeared consistent with the natural strata.

**Figure 5** Spoil from hand pit 01 grading from slightly gravelly sandy silt to clayey silt.

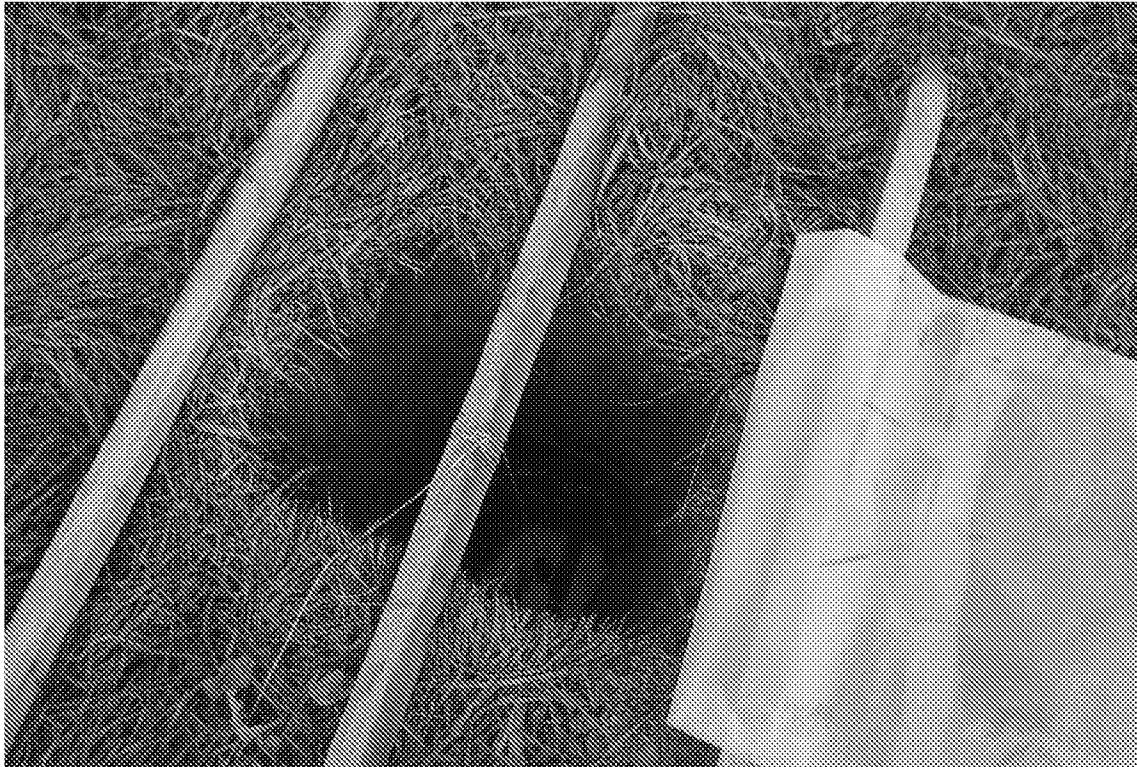
**Figure 6** Initial assessment of hand pit 01 using suspended level logger.

HP01 was filled to 0.55m bgl resulting in a saturated zone of 0.3m as shown in Table 1 Excavated hand pit depths and initial priming assessment above. Water did not soak away within 6 hours and subsequently the ground is not suitable. The pit was left overnight to continue draining and had not completely emptied 27 hours after the test began.

However water did seep from 75% and 25% of the initial saturated depth between 0.225m and 0.075m. Although not strictly applicable, as water did not seep away completely during the initial priming, a Vp value of 643.1 was calculated which is significantly above the upper limit of 100 specified.

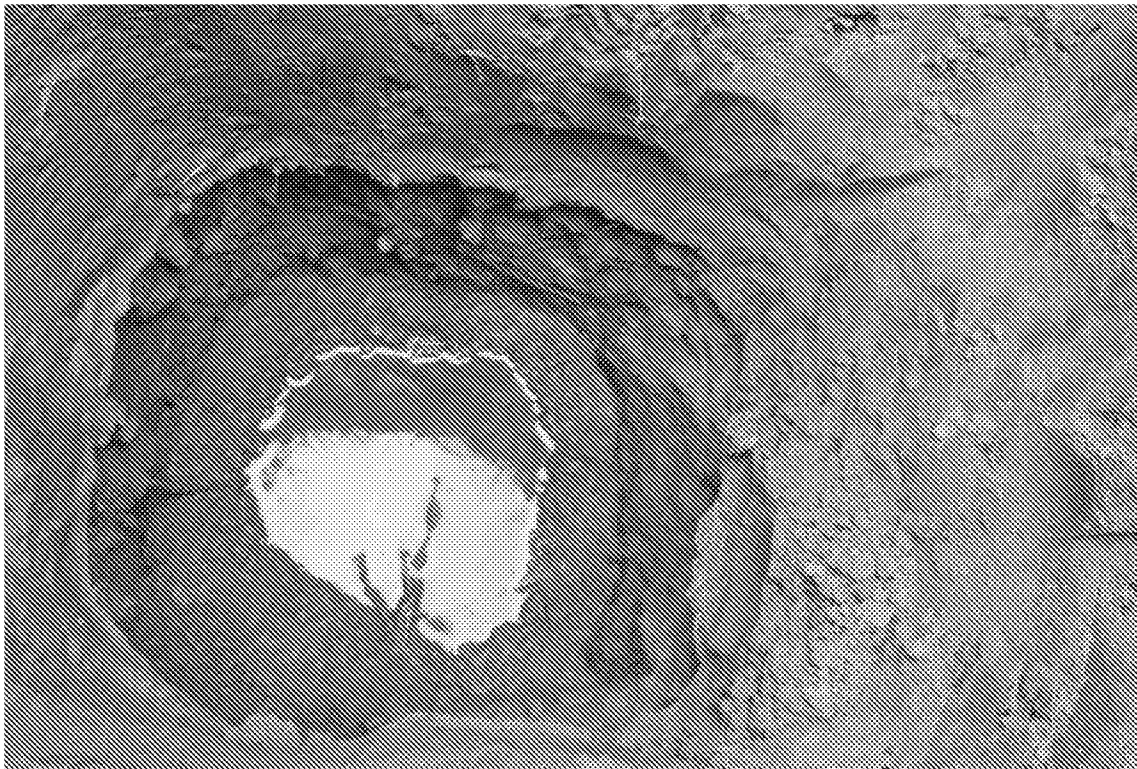
**Figure 7** Hand pit 01 after approx. 27 hours from start of initial assessment.

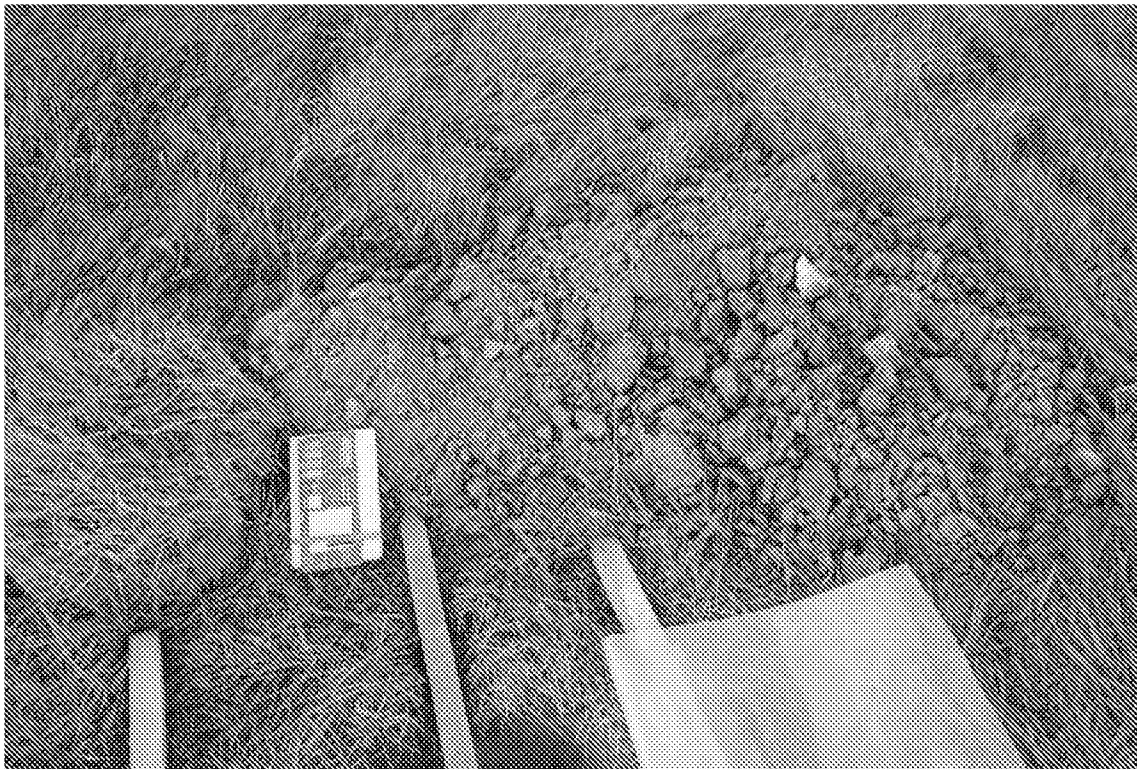
**Figure 10** Spoil from hand pit 02 grading from slightly gravelly very silty fine sand to clayey silt (left to right).

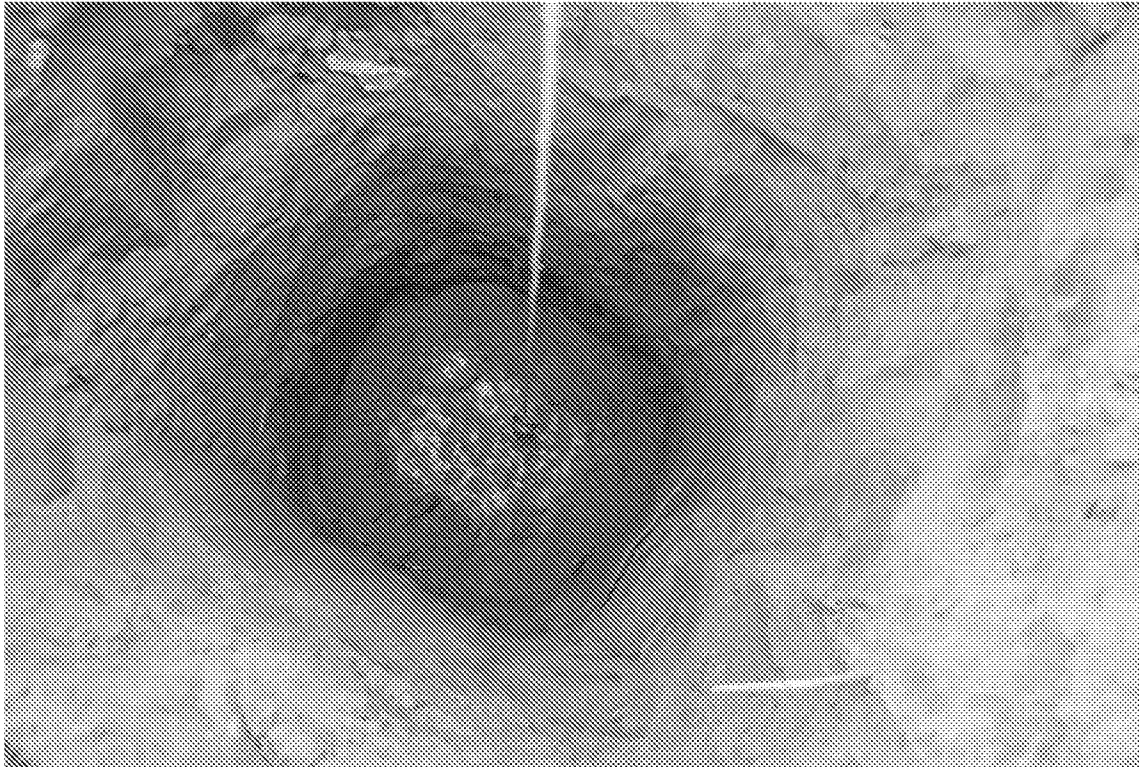
HP02 was filled to 0.7m bgl resulting in a saturated zone of 0.3m required by the published guidance. The initial priming assessment was also unsuccessful as water failed to drain away within 6 hours indicating the ground as unsuitable for an infiltration system. The water did, however, soak away overnight, taking approximately 21 hours.

**Figure 13** Photograph showing hand pit 02 drained completely after being left overnight during initial assessment.

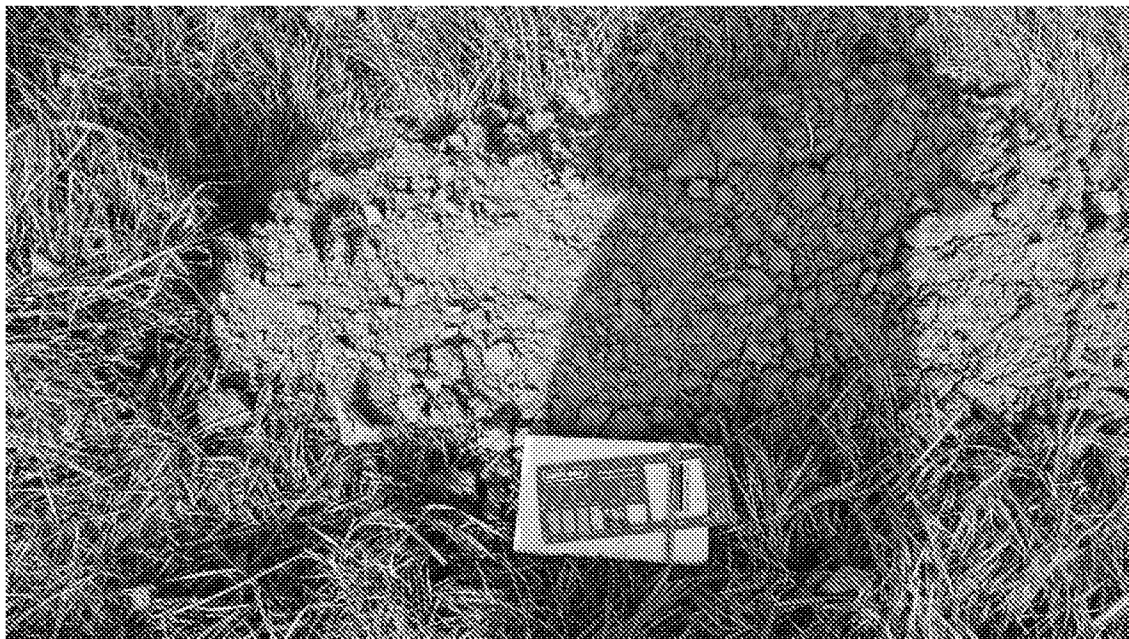
**Figure 15** Spoil from hand pit 03 grading from slightly gravelly very silty fine sand to clayey silt with rare flint gravel (left to right).

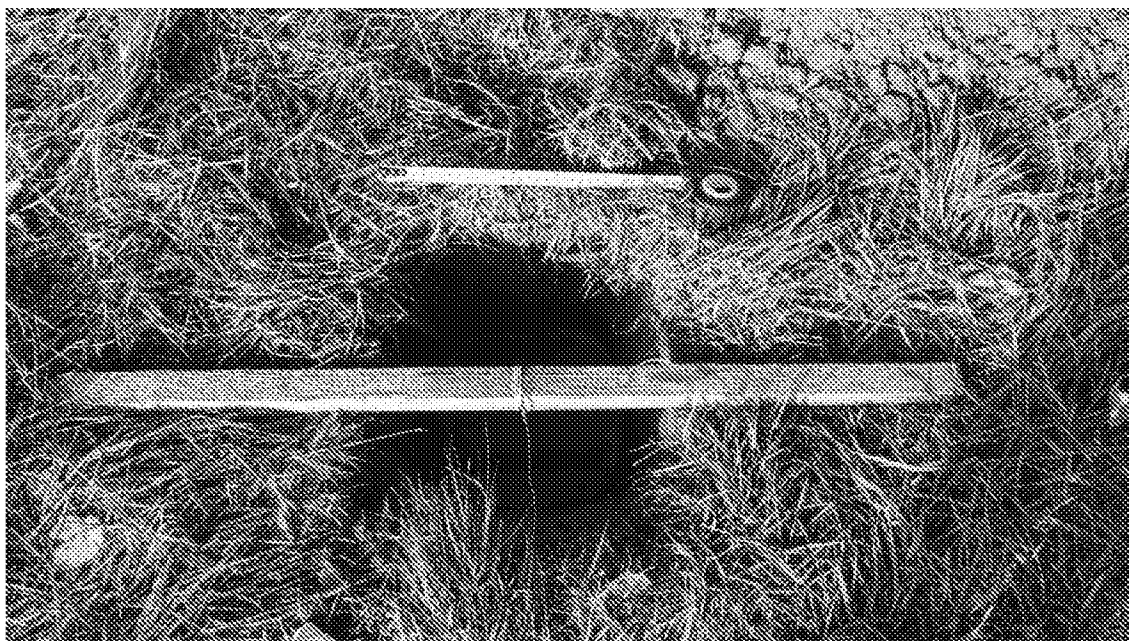
**Figure 18** Configuration of initial assessment of hand pit 03 using suspended level logger showing dimensions of hand pit.

HP03 was filled to 0.45m bgl resulting in the saturated zone of 0.3m required by the published guidance. Similarly to the first two hand pits, the water did not seep away within 6 hours and the ground is therefore indicated to be unsuitable. When left overnight water in the shallowest pit did not completely drain away or reach the 25% level after 27 hours.

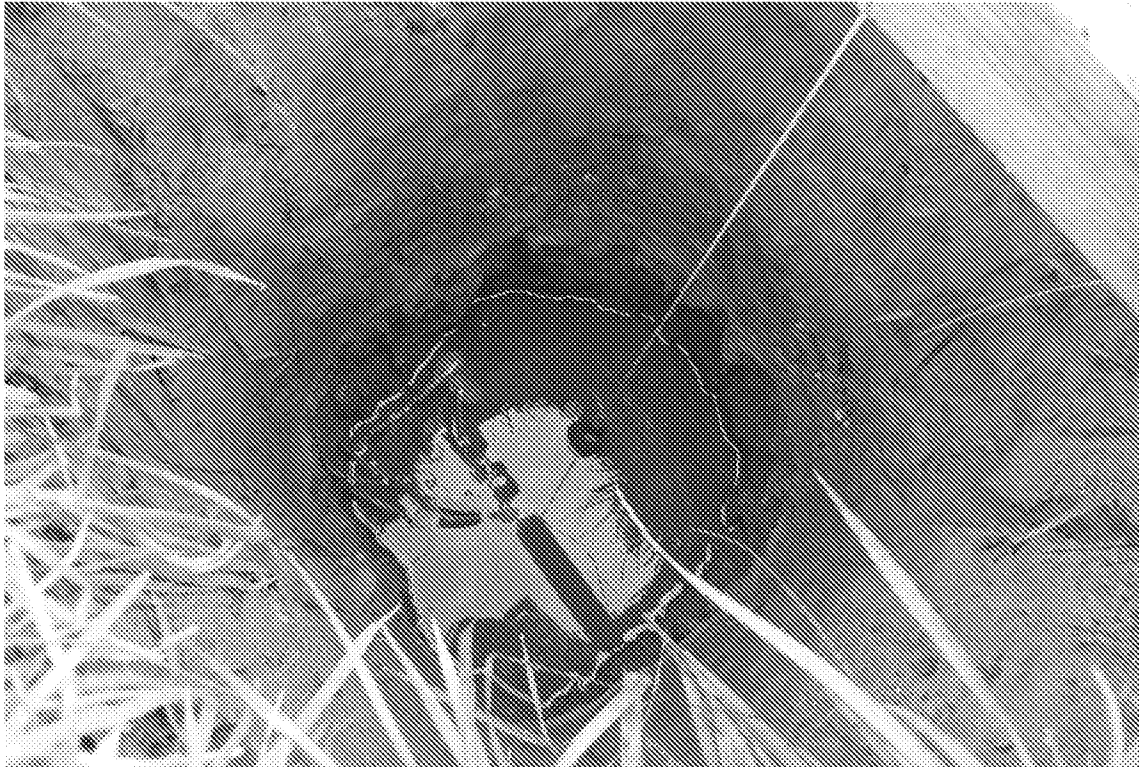
Data recorded from the suspended level logger was extrapolated to provide a Vp value of 960, which is an order of magnitude higher than the limits specified by British Standards.

**Figure 17** Photograph showing hand pit 03 approx. 27 hours after beginning the initial assessment. Level logger is approx. 5cm from base of 0.75m pit.
