**FORD LANE**  
**YAPTON, WEST SUSSEX**  
**SOIL RESOURCE SURVEY**

**TOHA Document Ref:** TOHA/21/6563/ML

**Date:** 13/01/2021

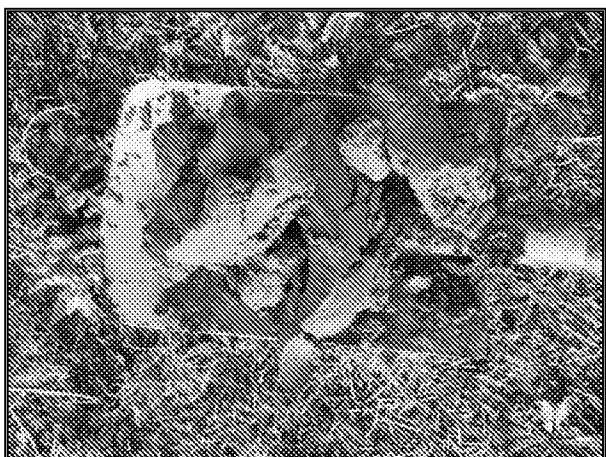
| <b>Subsoil</b><br>(All trial holes)<br>310/390 – 1000mm | Yellowish brown (Munsell Colour 10YR 4/6), slightly moist to moist, slightly plastic, very slightly calcareous, moderately stony, SILTY CLAY LOAM with a moderately developed structure (weak structural strength). No observable deleterious materials were recorded. |

Plate 5: Typical *Subsoil* arisings.

The *Subsoil* is anticipated to offer severe drainage restrictions following the normal construction phases. **Therefore, for all options below, we recommend that the subsoil is thoroughly decompacted and prepared prior to spreading the topsoil.**

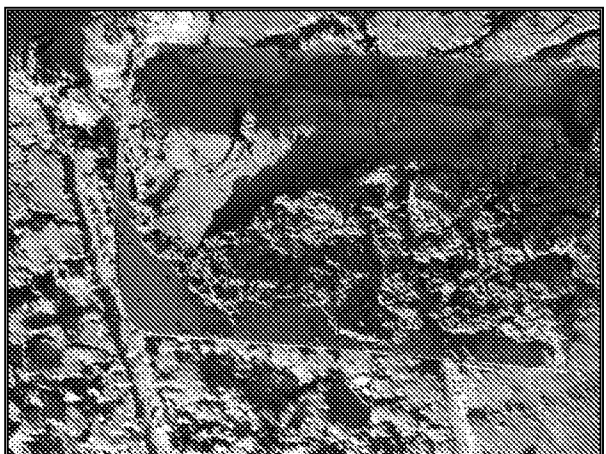
| <b>Stockpiled Topsoil</b> | Wet at surface. Slightly moist from below surface, plastic to very plastic, very slightly calcareous SILTY CLAY LOAM, with a poor to massive structure (structureless). Slightly stony, including occasional stones up to 25mm in length. No observable deleterious materials were recorded. |

Plate 7: Typical *Topsoil* arisings from stockpile.

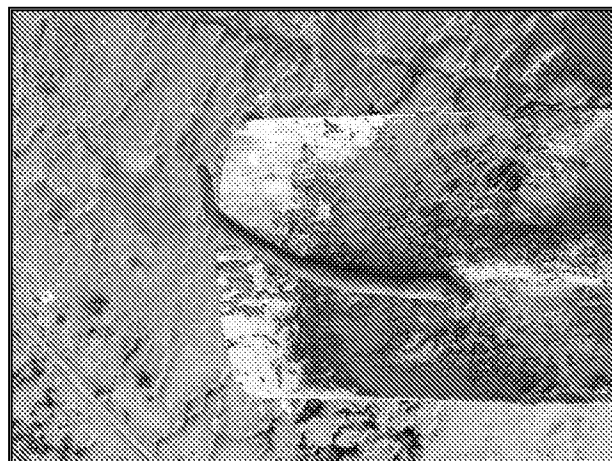
**The topsoil contained within the stockpiles was moist to very moist, very plastic in consistency and displayed a severely degraded soil structure (structureless).**

Plate 8: Example of plastic condition of stockpiled topsoil.

The topsoil within the stockpiles (*Stockpiled Topsoil*) showed signs of physical degradation following operations to strip and store the topsoil. In its current condition, this topsoil will suffer from a lack of drainage and aeration, and should be expected to result in waterlogging after periods of rainfall and anaerobism (oxygen depletion). These conditions make the topsoil unsuitable for landscape purposes. The topsoil could be improved for re-use by 'reconditioning' to restore its soil structure and reaerate the topsoil.

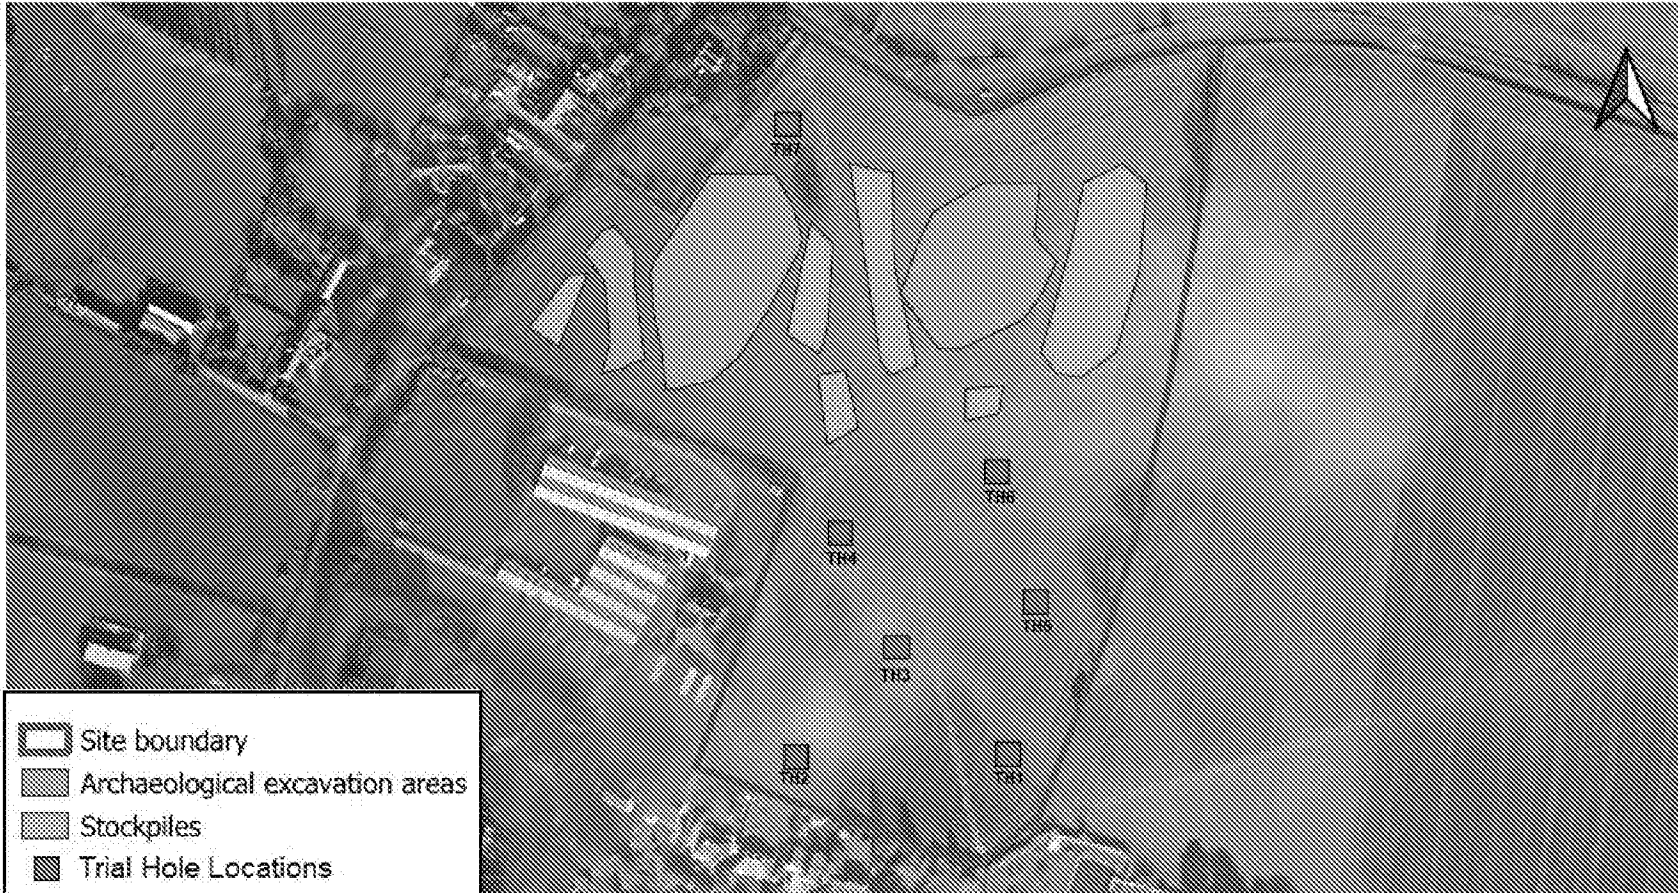
### Appendix 1 – Site Plan Showing Site Layout and Trial Hole Locations

The locations of our trial holes and existing stockpiles are indicated on the site plan in **Appendix 1**.
