## **Phase II Ground Investigation Report**

**Orchard Business Park, North End Road, Yapton,  
West Sussex BN18 0GA**

**Crayfern Homes**

Phase II Ground Investigation Report (GIR)

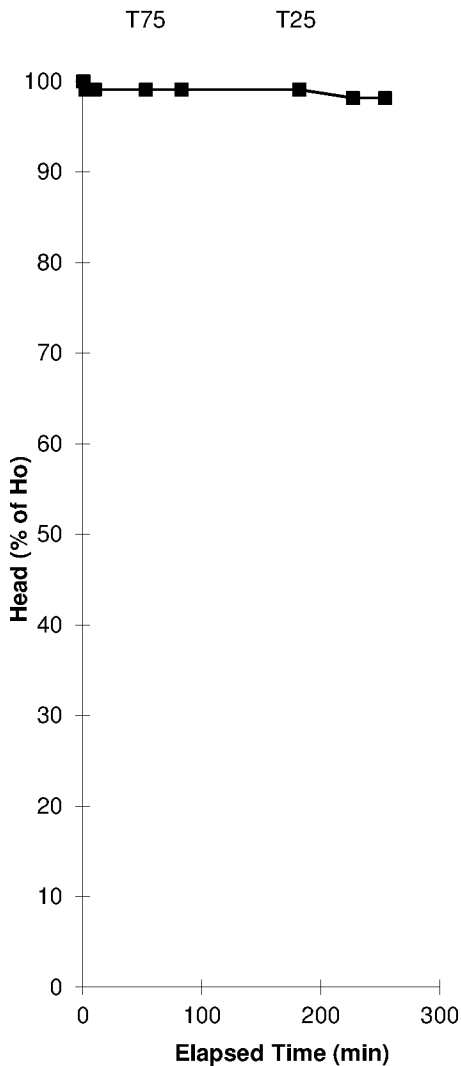
Infiltration stopped - unable to calculate infiltration rate

Considering that the noted reduction in the head of water was 11% over 5 hours (TP1), 2% over 4 hours (TP2A) and 9% over 3.5 hours (TP3), infiltration testing was only conducted once within the trial holes.

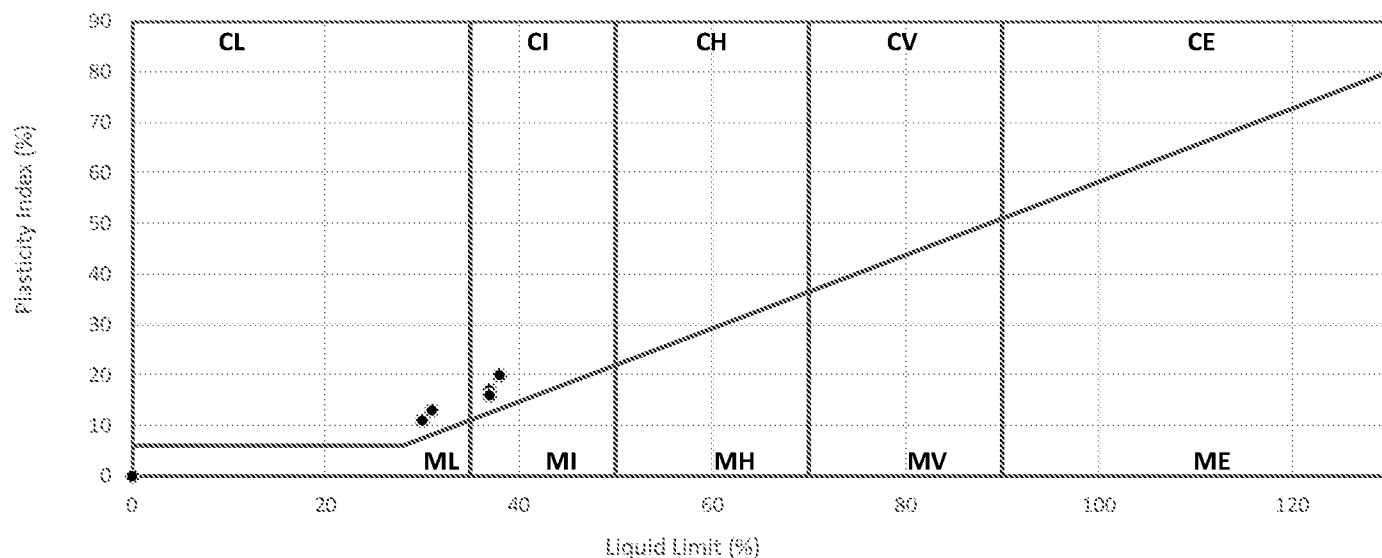
### PLASTICITY CHART FOR CASAGRANDE CLASSIFICATION

Symbols: NP : Non Plastic # : Liquid Limit and Plastic Limit Wet Sieved
