# Heritage Statement

## The Twelfth of Never – Replacement Rear Door

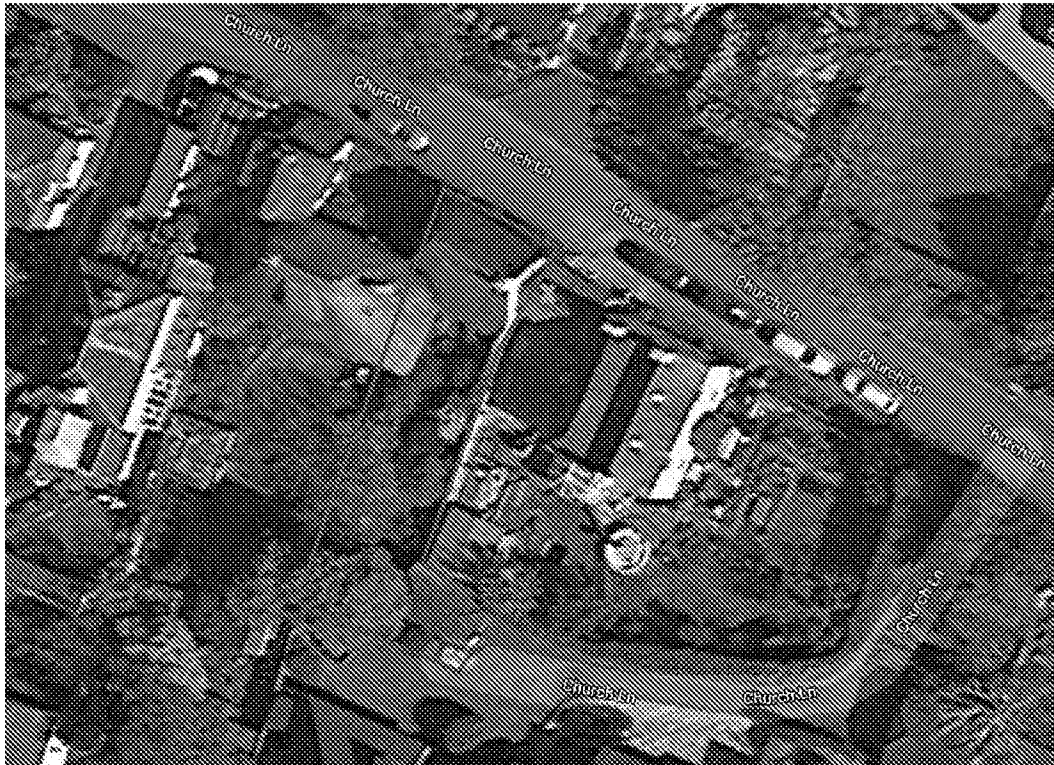
**Figure 1 – Aerial photo showing location of rear door and property location plan**

Red line = Red line boundary of property  
Red X = Location of rear door access to private garden  
Blue X = Coachman's Cottage  
Orange X = Hazel Cottage store / garage

This heritage statement has been prepared in support of an application for permission to replace a rear door that provides access from the house to the private rear garden of the property: The Twelfth of Never, Church Lane, Yapton, BN18 0EH (Fig 1).

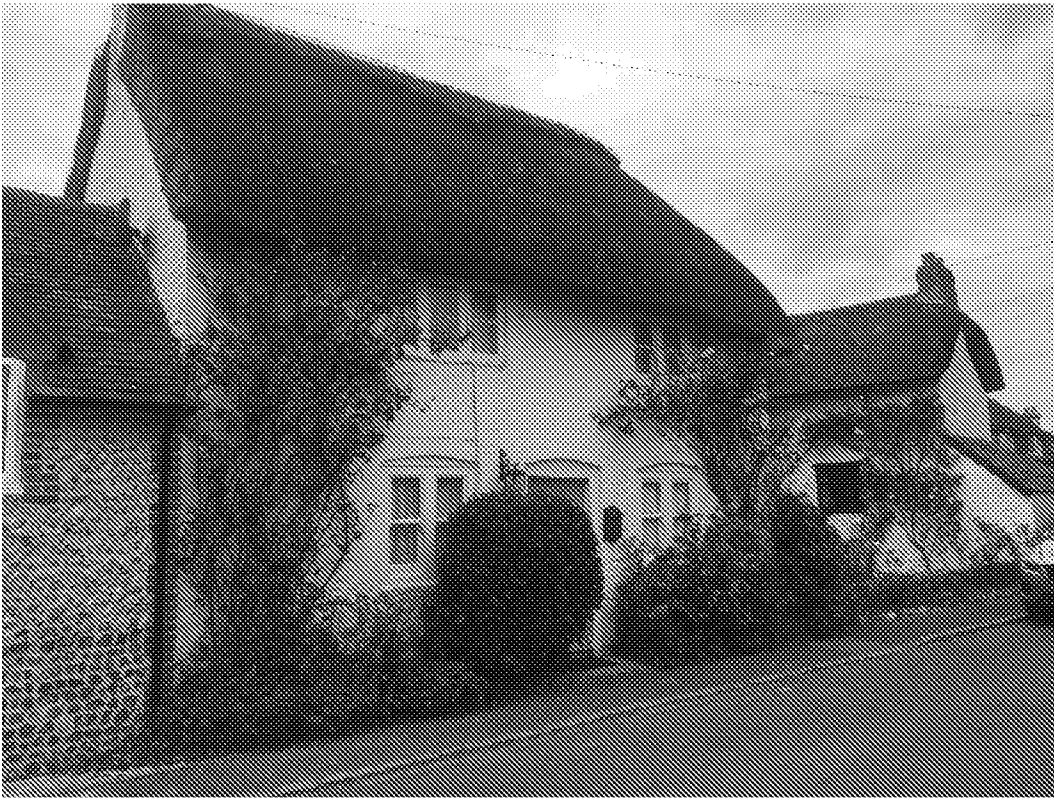
**Figure 2 – 2020 photo of the front of the property**

Photo taken from church lane in late summer 2020.

Externally the property retains a number of original features (Fig 2). This includes the brick, flint and quoin façade visible from the lane (although this has been painted over) and a thatched roof. Although the listing details two casement windows, the front of the property is in fact made up of four windows, two on each storey. All of these windows are sash, except for the upstairs main bedroom window (the left-hand window as viewed from the lane) which is casement and appears to be a 20<sup>th</sup> century alteration. Evidence that the original style would have been sash can be seen from a photo of the cottage from 1890 (Fig 3). This shows all the front windows to be sash.

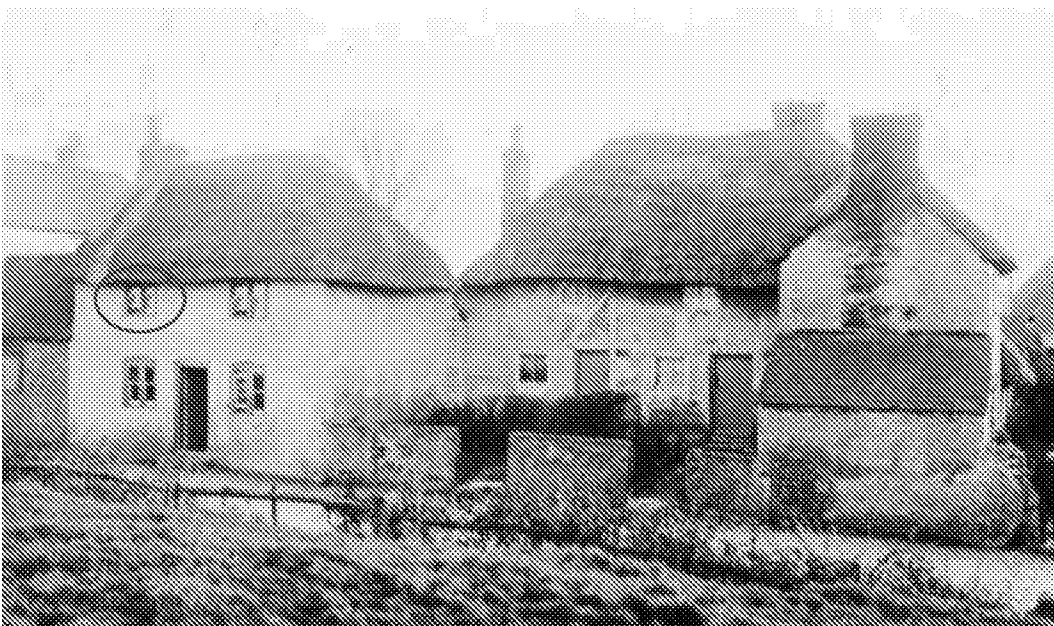
**Figure 3 – Photo of the property in 1890**

Source: <http://vaptonghistory.org.uk/places/places-houses/oldest-house/>  
Red circle = original sash window to main bedroom

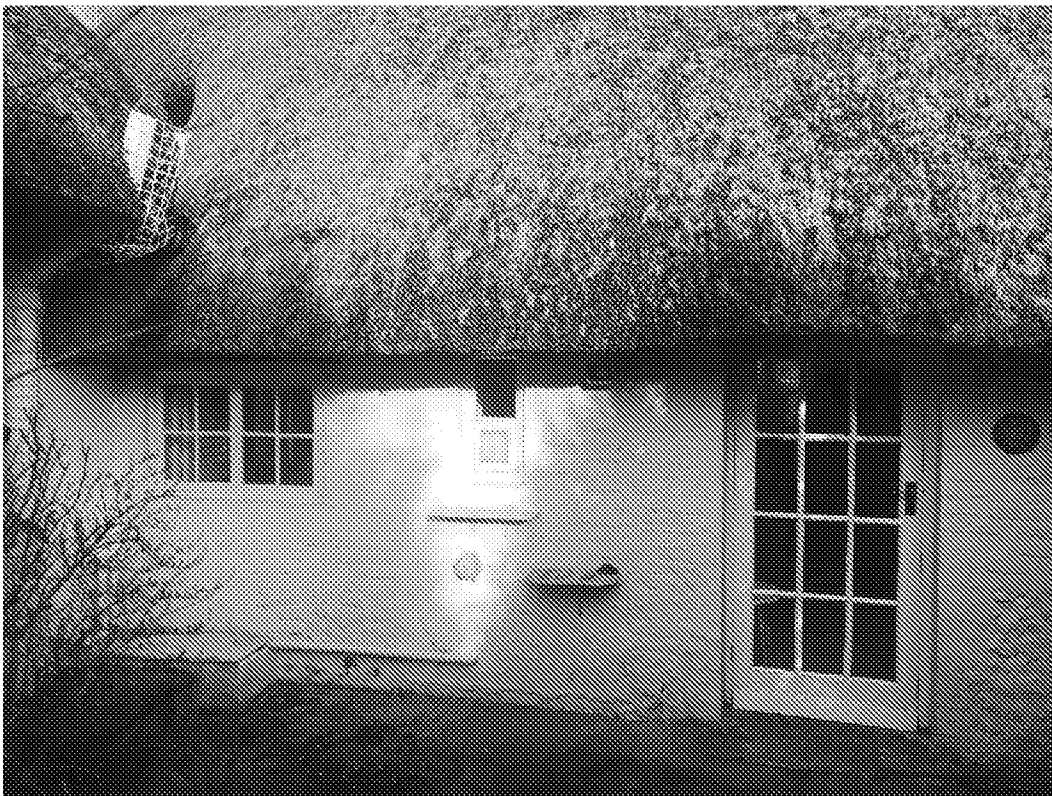
**Figure 4 – 2020 photo of the rear of the property**

Photo taken from rear garden patio

The rear of the property has been significantly altered to add a ground floor bathroom and provide additional space in the main living room. This addition has resulted in the roof being extended to ground floor at the rear of the property, creating a cat slide style thatched roof (Fig 4). It is possible this addition happened sometime in the 20<sup>th</sup> century, as Figure 5 shows the property without the extension in 1912. Figure 6 shows the same angle with the extension today.

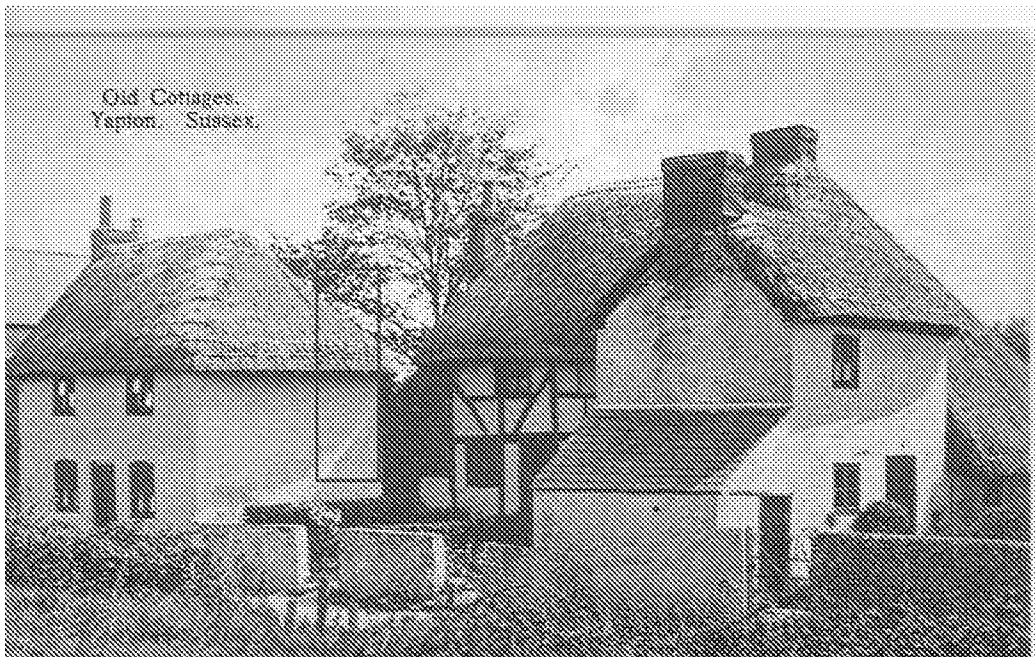
**Figure 5 – Postcard of property 1912**

Source: <http://yaptonhistory.org.uk/places/places-houses/oldest-house/>  
Red Rectangle = No rear extension

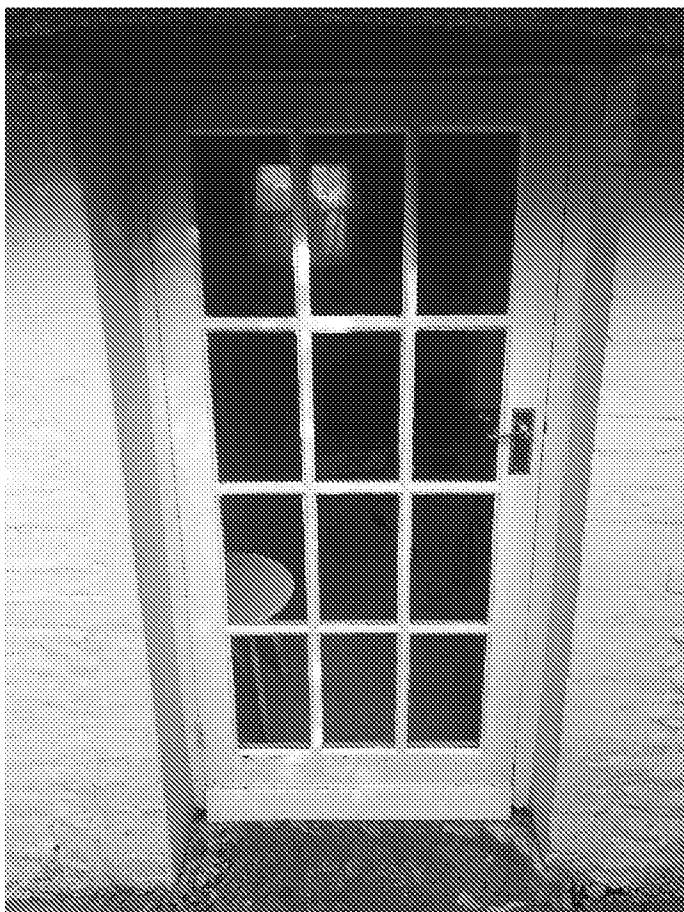
**Figure 9 – Rear door**

Photo taken from outside

This hypothesis is further strengthened by an assessment of the two windows and glazed door to the rear of the property. One of these windows is a non-original casement window (Fig 7), the other a small non-original metal framed window and cat flap (Fig 8). The glazed rear door is the subject of this application and is also not an original feature. It has a similar glazing bar profile and construction to the rear casement window (Fig 9). It is likely that both windows and this door are no older than the 20<sup>th</sup> century, and the casement window and door were fitted at the same time.

The works include the removal and replacement of the existing wooden glazed rear door with a new door that will copy the design of the existing door. It will be hardwood constructed with twelve glazed panels separated by Ovolo 22mm glazing bar. It will be painted to match the existing white finish. A brass handle will be used. It will open out as the existing door does.

Where the door differs from the existing door, will be in the use of 4mm clear float argon filled double glazing with a 16mm spacer. Additionally, the locking system will be a multi-point hook locking system. For further detail on the existing door and proposed door see the Design and Access Statement that accompanies this application.

The new door will reflect the character and appearance of the existing door, using the same materials, door furniture finish and design. The existing rear door is not original (it is believed to have been installed in the 20<sup>th</sup> Century), has suffered from extensive rot and is poorly fitted allowing water to get into the property. Consequently, it can be sympathetically replaced without affecting the properties historic and special architectural features. Whilst the works will ensure that the building is kept in a good state of repair, is made weathertight, will improve thermal performance and make the property more secure.
