ARBORICULTURAL IMPACT ASSESSMENT

Land at Bilsham Road, Yapton

5304-RPS-XX-EX-RP-AR-9108
Land West of Bilsham Road
Arboricultural Impact
Assessment
V3
April 2025

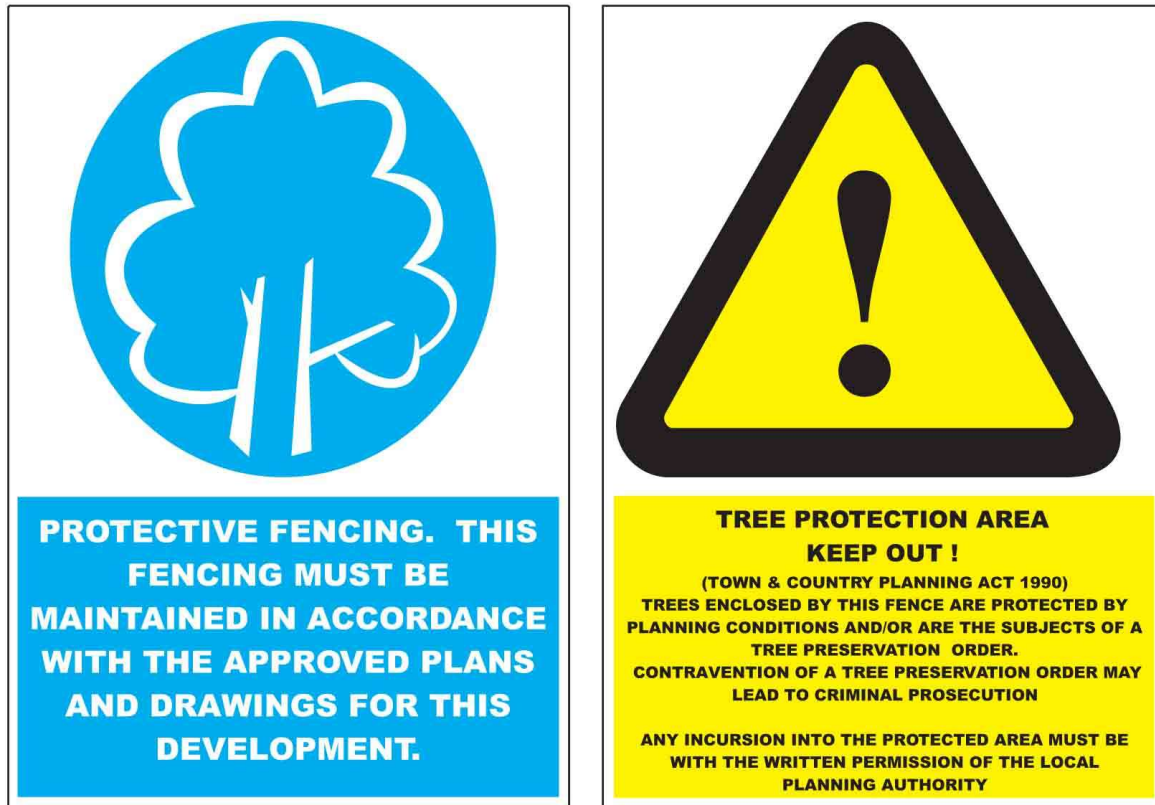
Construction Exclusion Signage – Example

- 6.40 Signs detailing the purpose of the protective fencing shall be attached to the fencing at 10m intervals. Such signs should be weatherproof and shall be substantially in the form of the specimen provided at Appendix D. Signs must be replaced as necessary should they be removed or become illegible.
