## Soakage Test Report

Site: Sunny Mead Farm, North End Road, Yapton BN18 0DL

Project Reference: J13840

Exploratory Hole Location Plan

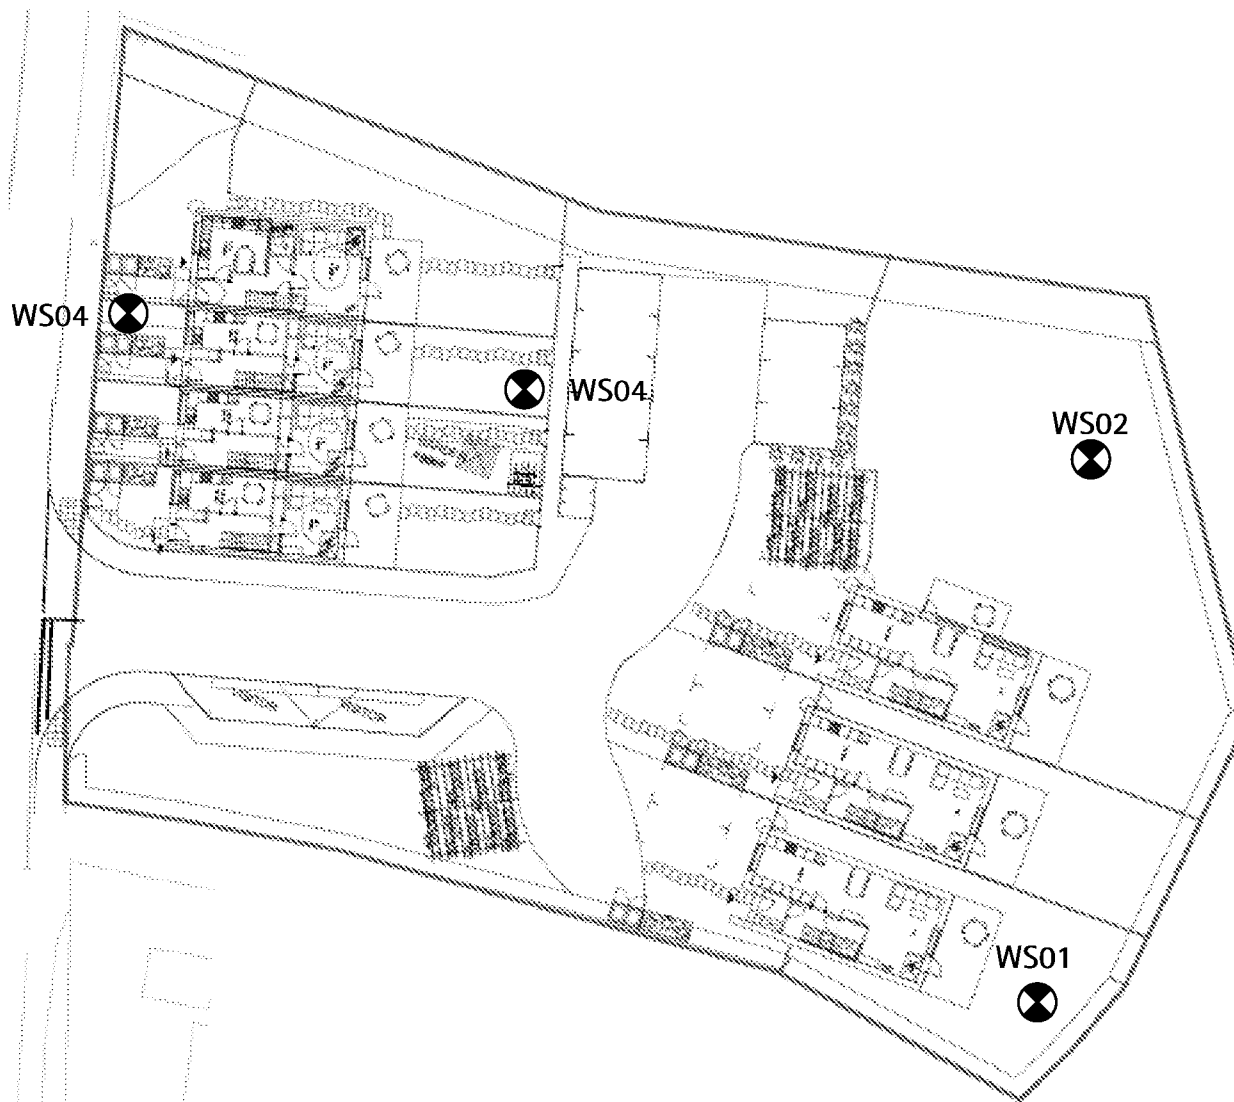
Fig No: 1

NB: Positions of Boreholes and/or Trial Pits are only indicative unless dimensioned

A total of three soakage tests were carried out across the site, at the locations shown on the attached site plan (Figure 1). It is noted that the current site usage, layout and overgrowth constrained the positions of potential suitable testing locations. The full results of the soakage tests are appended, however, the soakage rate from each borehole is summarised in the table below.

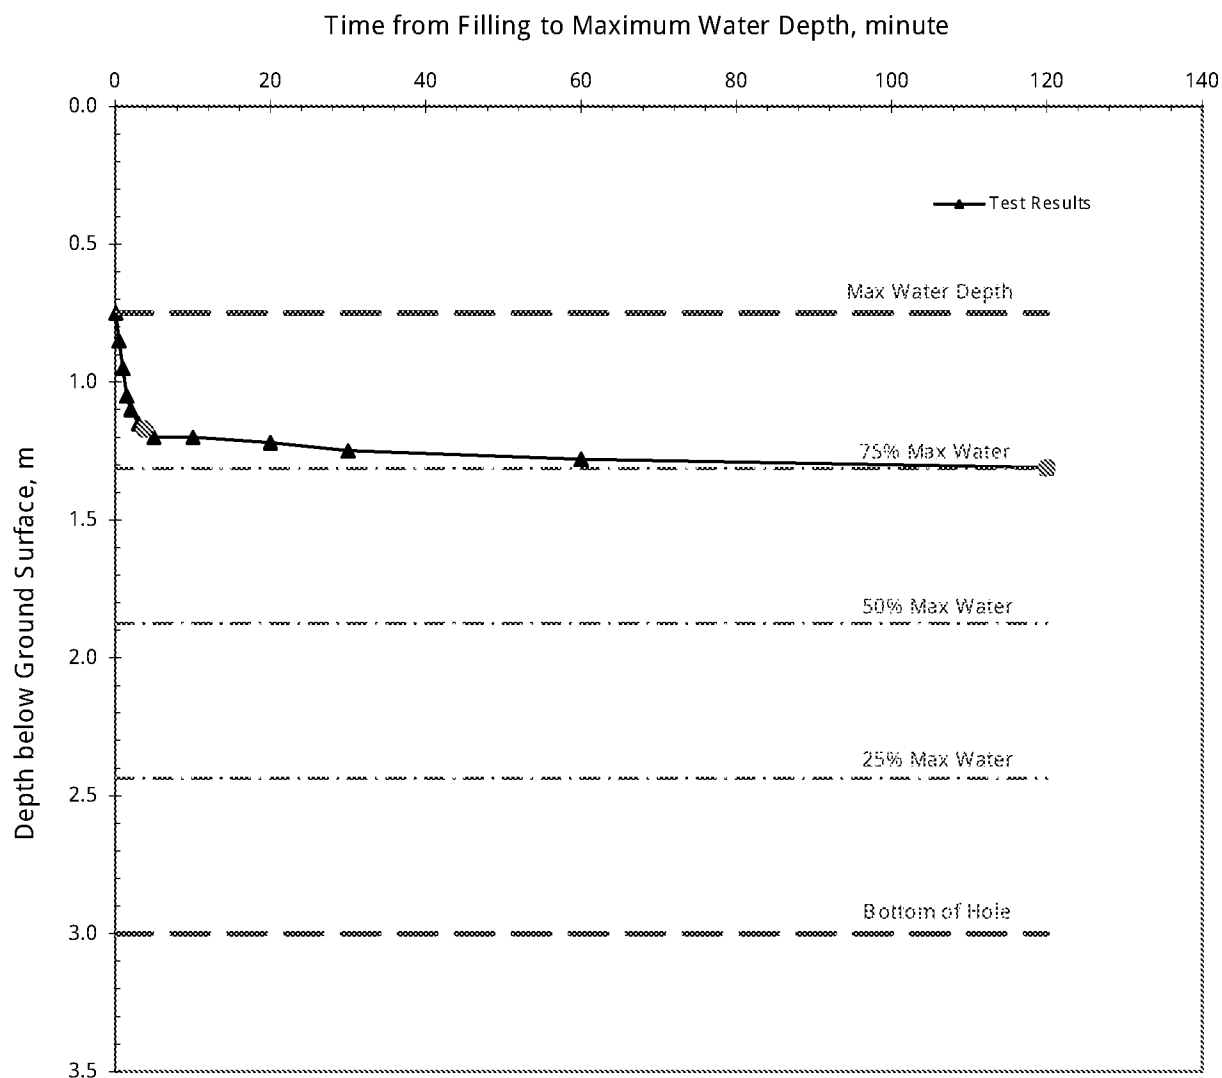
Test Hole No: WLS02  
Test No: Test No 1 (Initial)

| Diameter of Borehole, m | 0.150 | Depth to Water at Start of Test, m | 0.750 |
| Depth to End of Borehole Casing, m | | Max Water Dropdown during Test, m | 0.560 |
| Depth to Borehole Base, m | 3.000 | Total Soakage Test Time, min | 120.0 |
| Depth to Top of Permeable Soils, m | | Mean Internal Discharge Area, m <sup>2</sup> | 0.847 |
| Depth to Groundwater Surface, m | | Discharge Rate, litre/min | 0.021 |
| Void Assumed within Borehole, % | 100% | BRE Soil Infiltration Rate, m/sec | 4.19E-07 |

| Results of Preliminary BRE 365 Soakage tests | | | | |
|---|---|---|---|---|
| WLS02 | 3 | 0.025 | 4.19E-7 | Exploratory hole collapsed during testing to 1.34m bgl between the 120 and 180 minute reading. Non-compliant value calculated. |

| WLS02 | No 1 | 3.00 | 0.025 | 0.025 | 4.19E-7 | Pit was not emptied; Non compliant value was calculated. | Exploratory hole collapsed during 2 and 3 hour reading. |

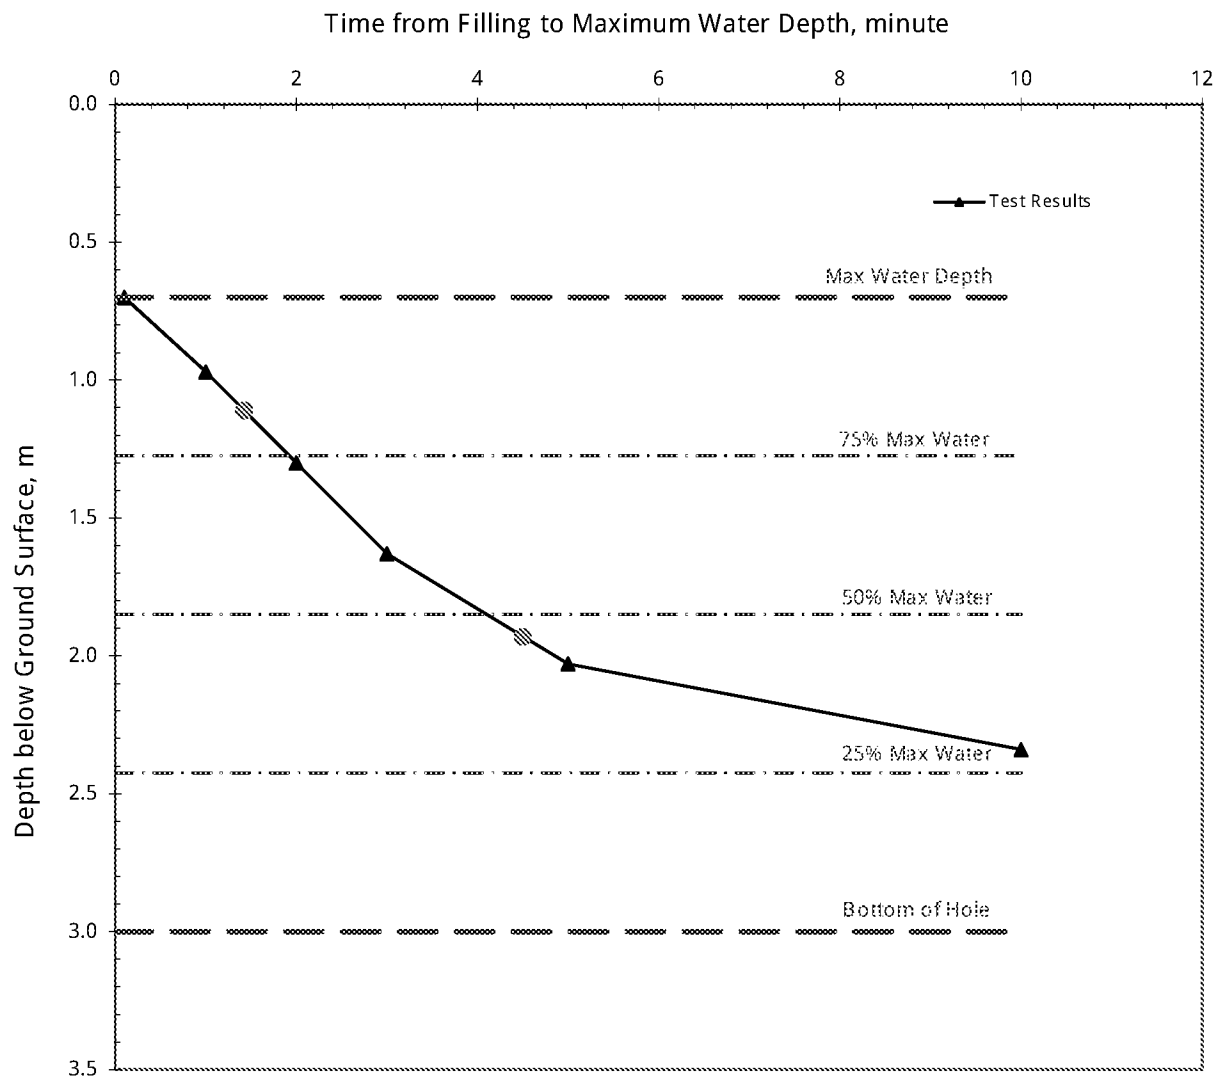
Test Hole No: WLS03  
Test No: Test No 1 (Initial)

| Diameter of Borehole, m | 0.150 | Depth to Water at Start of Test, m | 0.700 |
| Depth to End of Borehole Casing, m | | Max Water Dropdown during Test, m | 1.640 |
| Voids Assumed within Borehole, % | 100% | BRE Soil Infiltration Rate, m/sec | 1.10E-04 |

| WLS03 | No 1 | 3.00 | 6.59 | 5.25 | 8.75E-5 | Pit was not emptied; Non compliant value was calculated. | Depth to existing ground water level was 2.34m. |

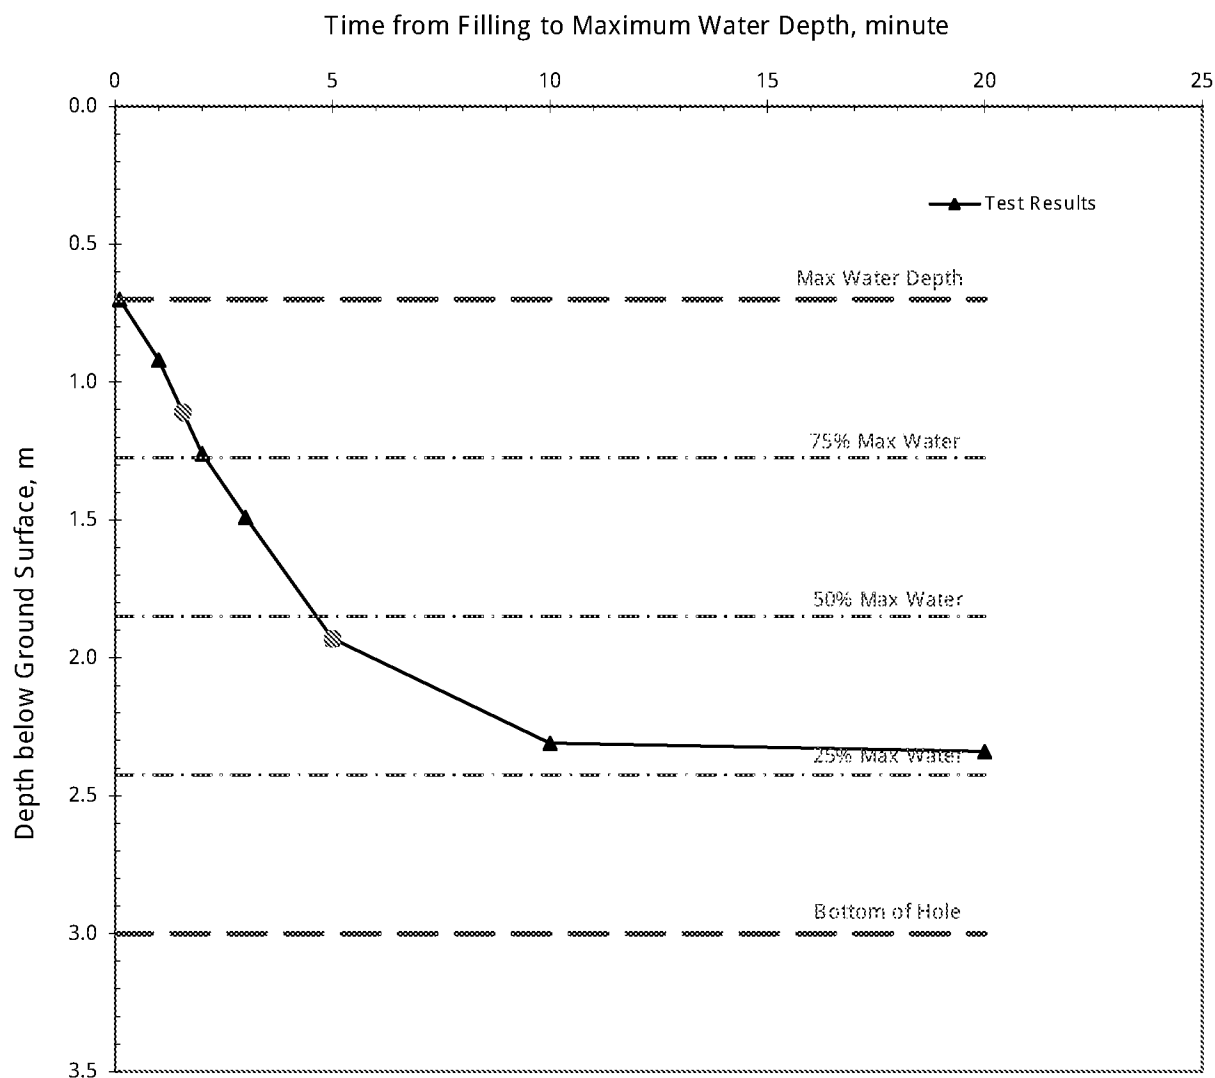
Test Hole No: WLS03  
Test No: Test No 2 (Repeated)

| Diameter of Borehole, m | 0.150 | Depth to Water at Start of Test, m | 0.700 |
| Depth to End of Borehole Casing, m | | Max Water Dropdown during Test, m | 1.640 |
| Voids Assumed within Borehole, % | 100% | BRE Soil Infiltration Rate, m/sec | 9.81E-05 |

| WLS03 | No 2 | 3.00 | 5.89 | | | Pit was not emptied; Non compliant value was calculated. | |

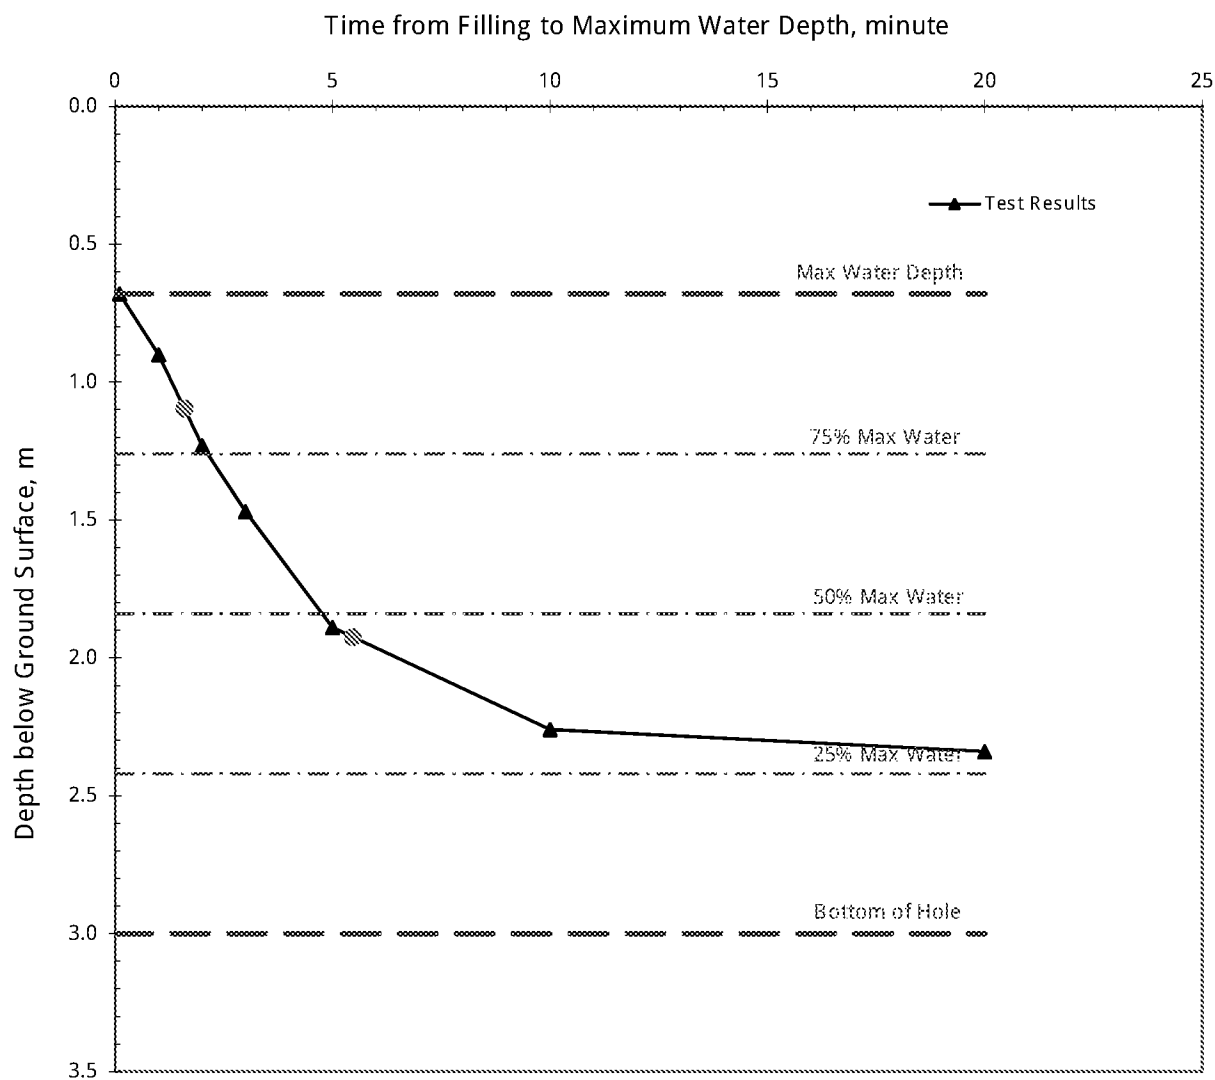
Test Hole No: WLS03  
Test No: Test No 3 (Repeated)

| Diameter of Borehole, m | 0.150 | Depth to Water at Start of Test, m | 0.680 |
| Depth to End of Borehole Casing, m | | Max Water Dropdown during Test, m | 1.660 |
| Voids Assumed within Borehole, % | 100% | BRE Soil Infiltration Rate, m/sec | 8.75E-05 |

| WLS03 | No 3 | 3.00 | 5.25 | | | Pit was not emptied; Non compliant value was calculated. | |

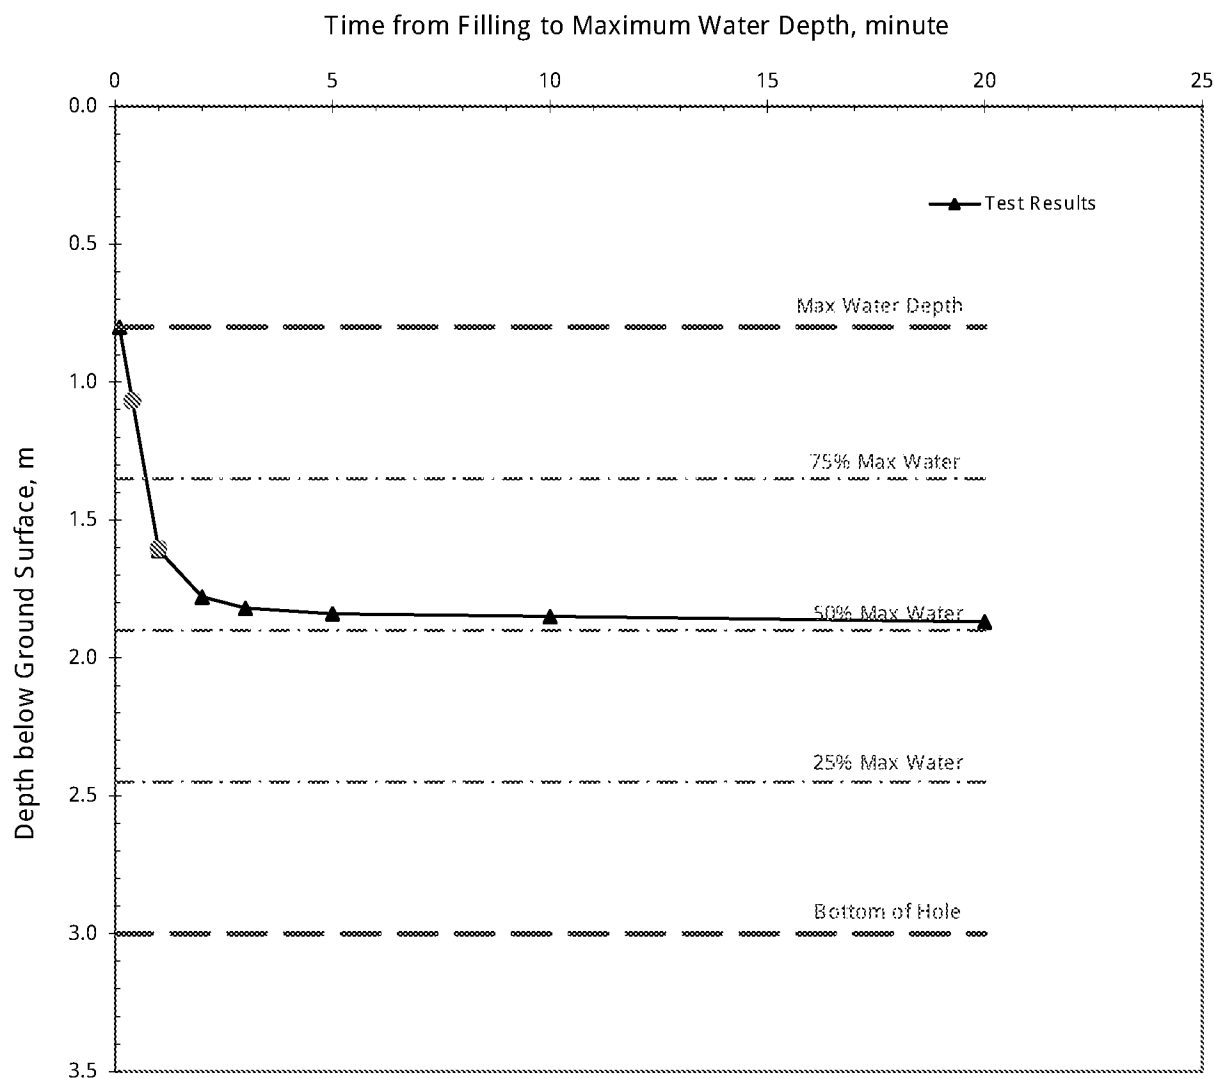
Test Hole No: WLS04  
Test No: Test No 1 (Initial)

| Diameter of Borehole, m | 0.150 | Depth to Water at Start of Test, m | 0.800 |
| Depth to End of Borehole Casing, m | | Max Water Dropdown during Test, m | 1.070 |
| Voids Assumed within Borehole, % | 100% | BRE Soil Infiltration Rate, m/sec | 3.30E-04 |

| WLS04 | No 1 | 3.00 | 19.82 | 10.13 | 1.69E-4 | Pit was not emptied; Non compliant value was calculated. | Depth to existing ground water level was 1.87m. |

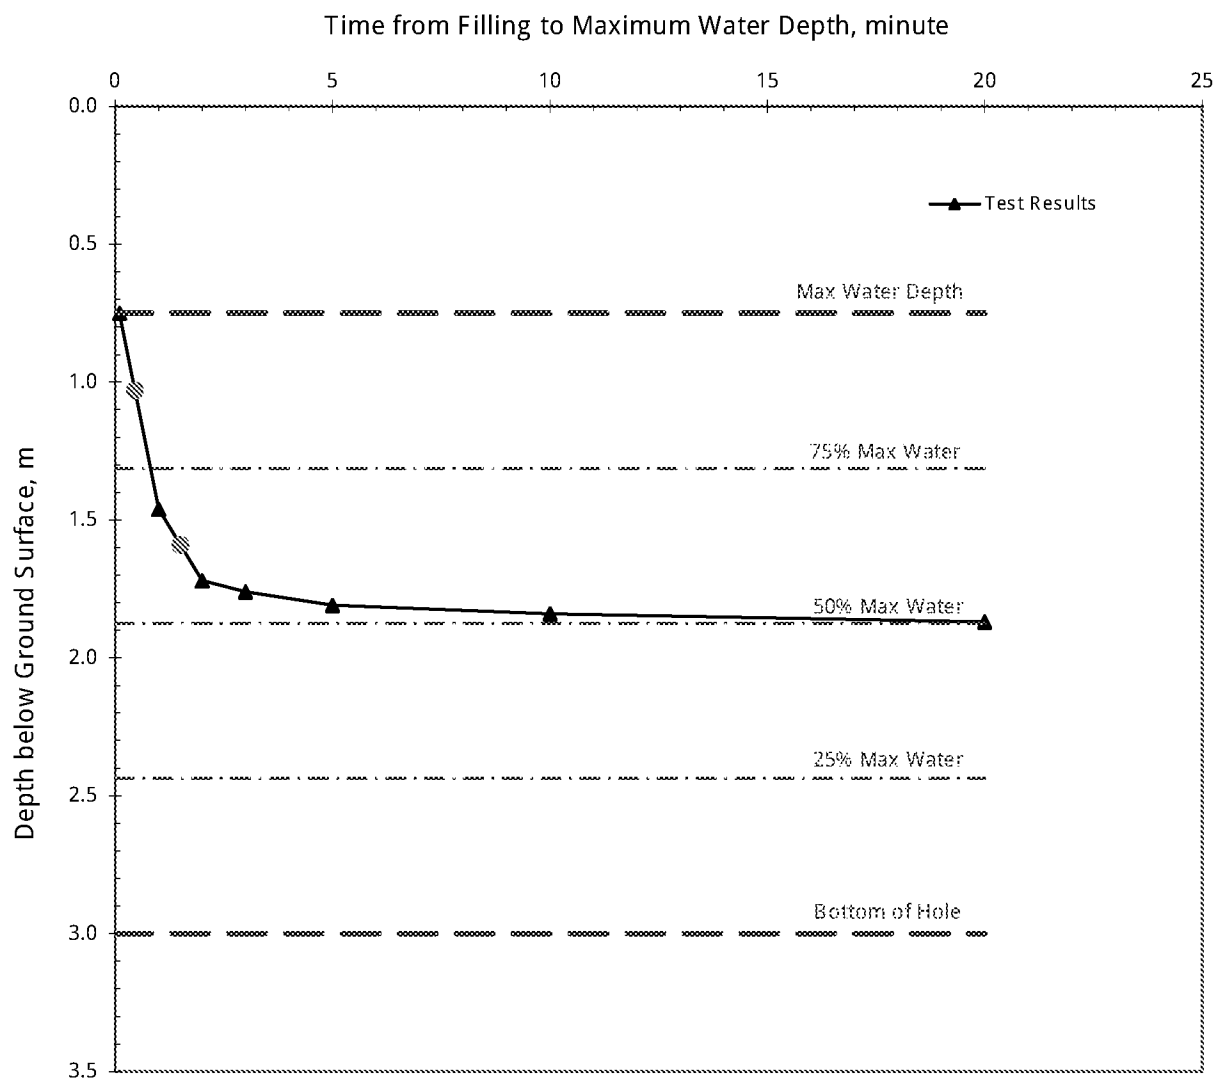
Test Hole No: WLS04  
Test No: Test No 2 (Repeated)

| Diameter of Borehole, m | 0.150 | Depth to Water at Start of Test, m | 0.750 |
| Depth to End of Borehole Casing, m | | Max Water Dropdown during Test, m | 1.120 |
| Voids Assumed within Borehole, % | 100% | BRE Soil Infiltration Rate, m/sec | 1.94E-04 |

| WLS04 | No 2 | 3.00 | 11.63 | | | Pit was not emptied; Non compliant value was calculated. | |

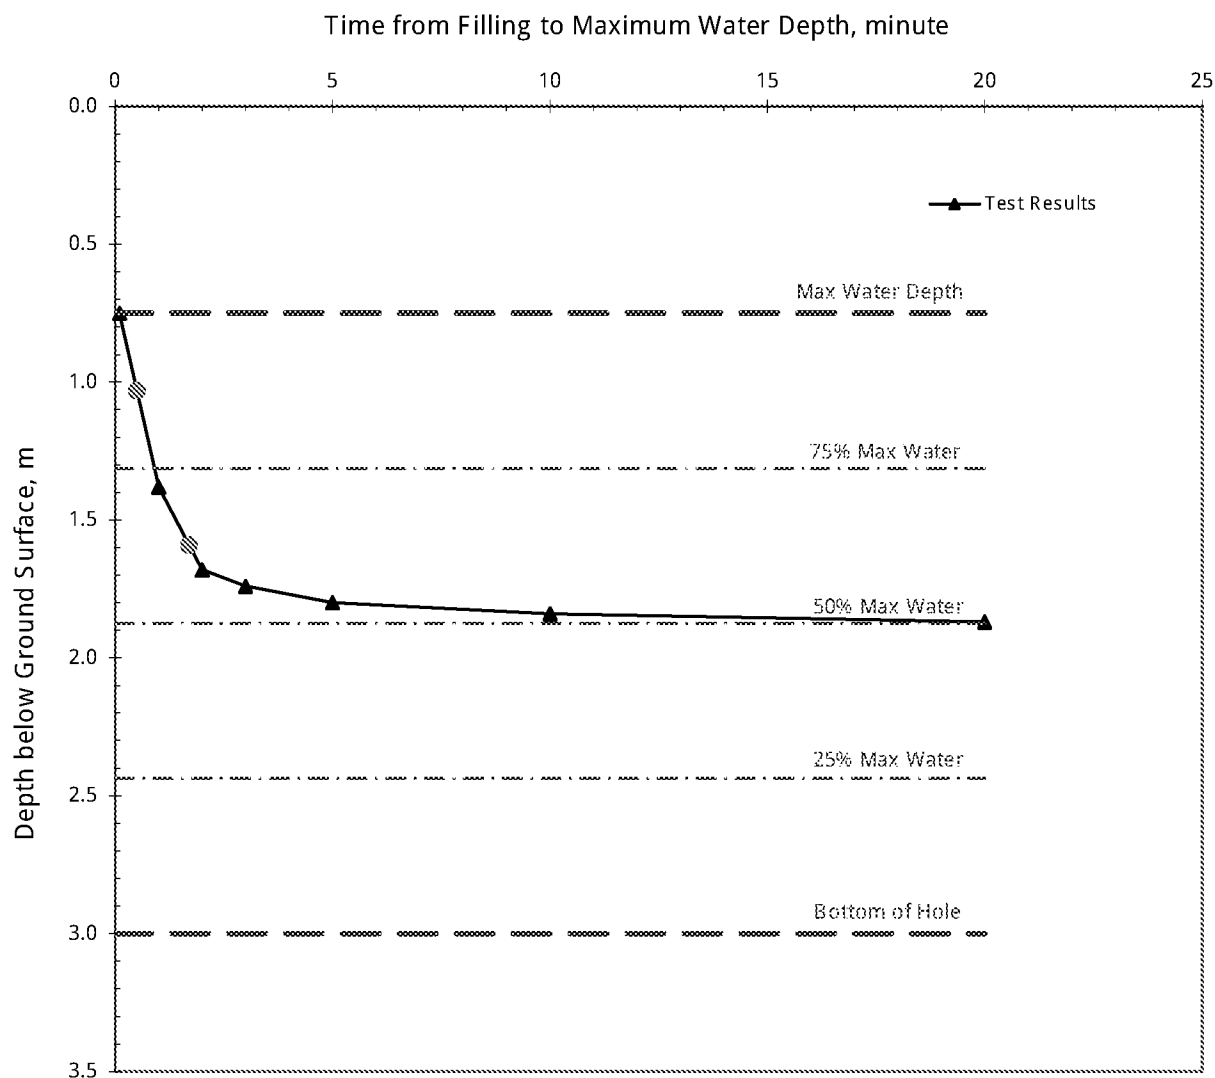
Test Hole No: WLS04  
Test No: Test No 3 (Repeated)

| Diameter of Borehole, m | 0.150 | Depth to Water at Start of Test, m | 0.750 |
| Depth to End of Borehole Casing, m | | Max Water Dropdown during Test, m | 1.120 |
| Voids Assumed within Borehole, % | 100% | BRE Soil Infiltration Rate, m/sec | 1.69E-04 |

| WLS04 | No 3 | 3.00 | 10.13 | | | Pit was not emptied; Non compliant value was calculated. | |
