# Soakaway Feasibility Report

## Land at Bilsham Road, Yapton

**BRD2693-OR3-A**

**March 2019**

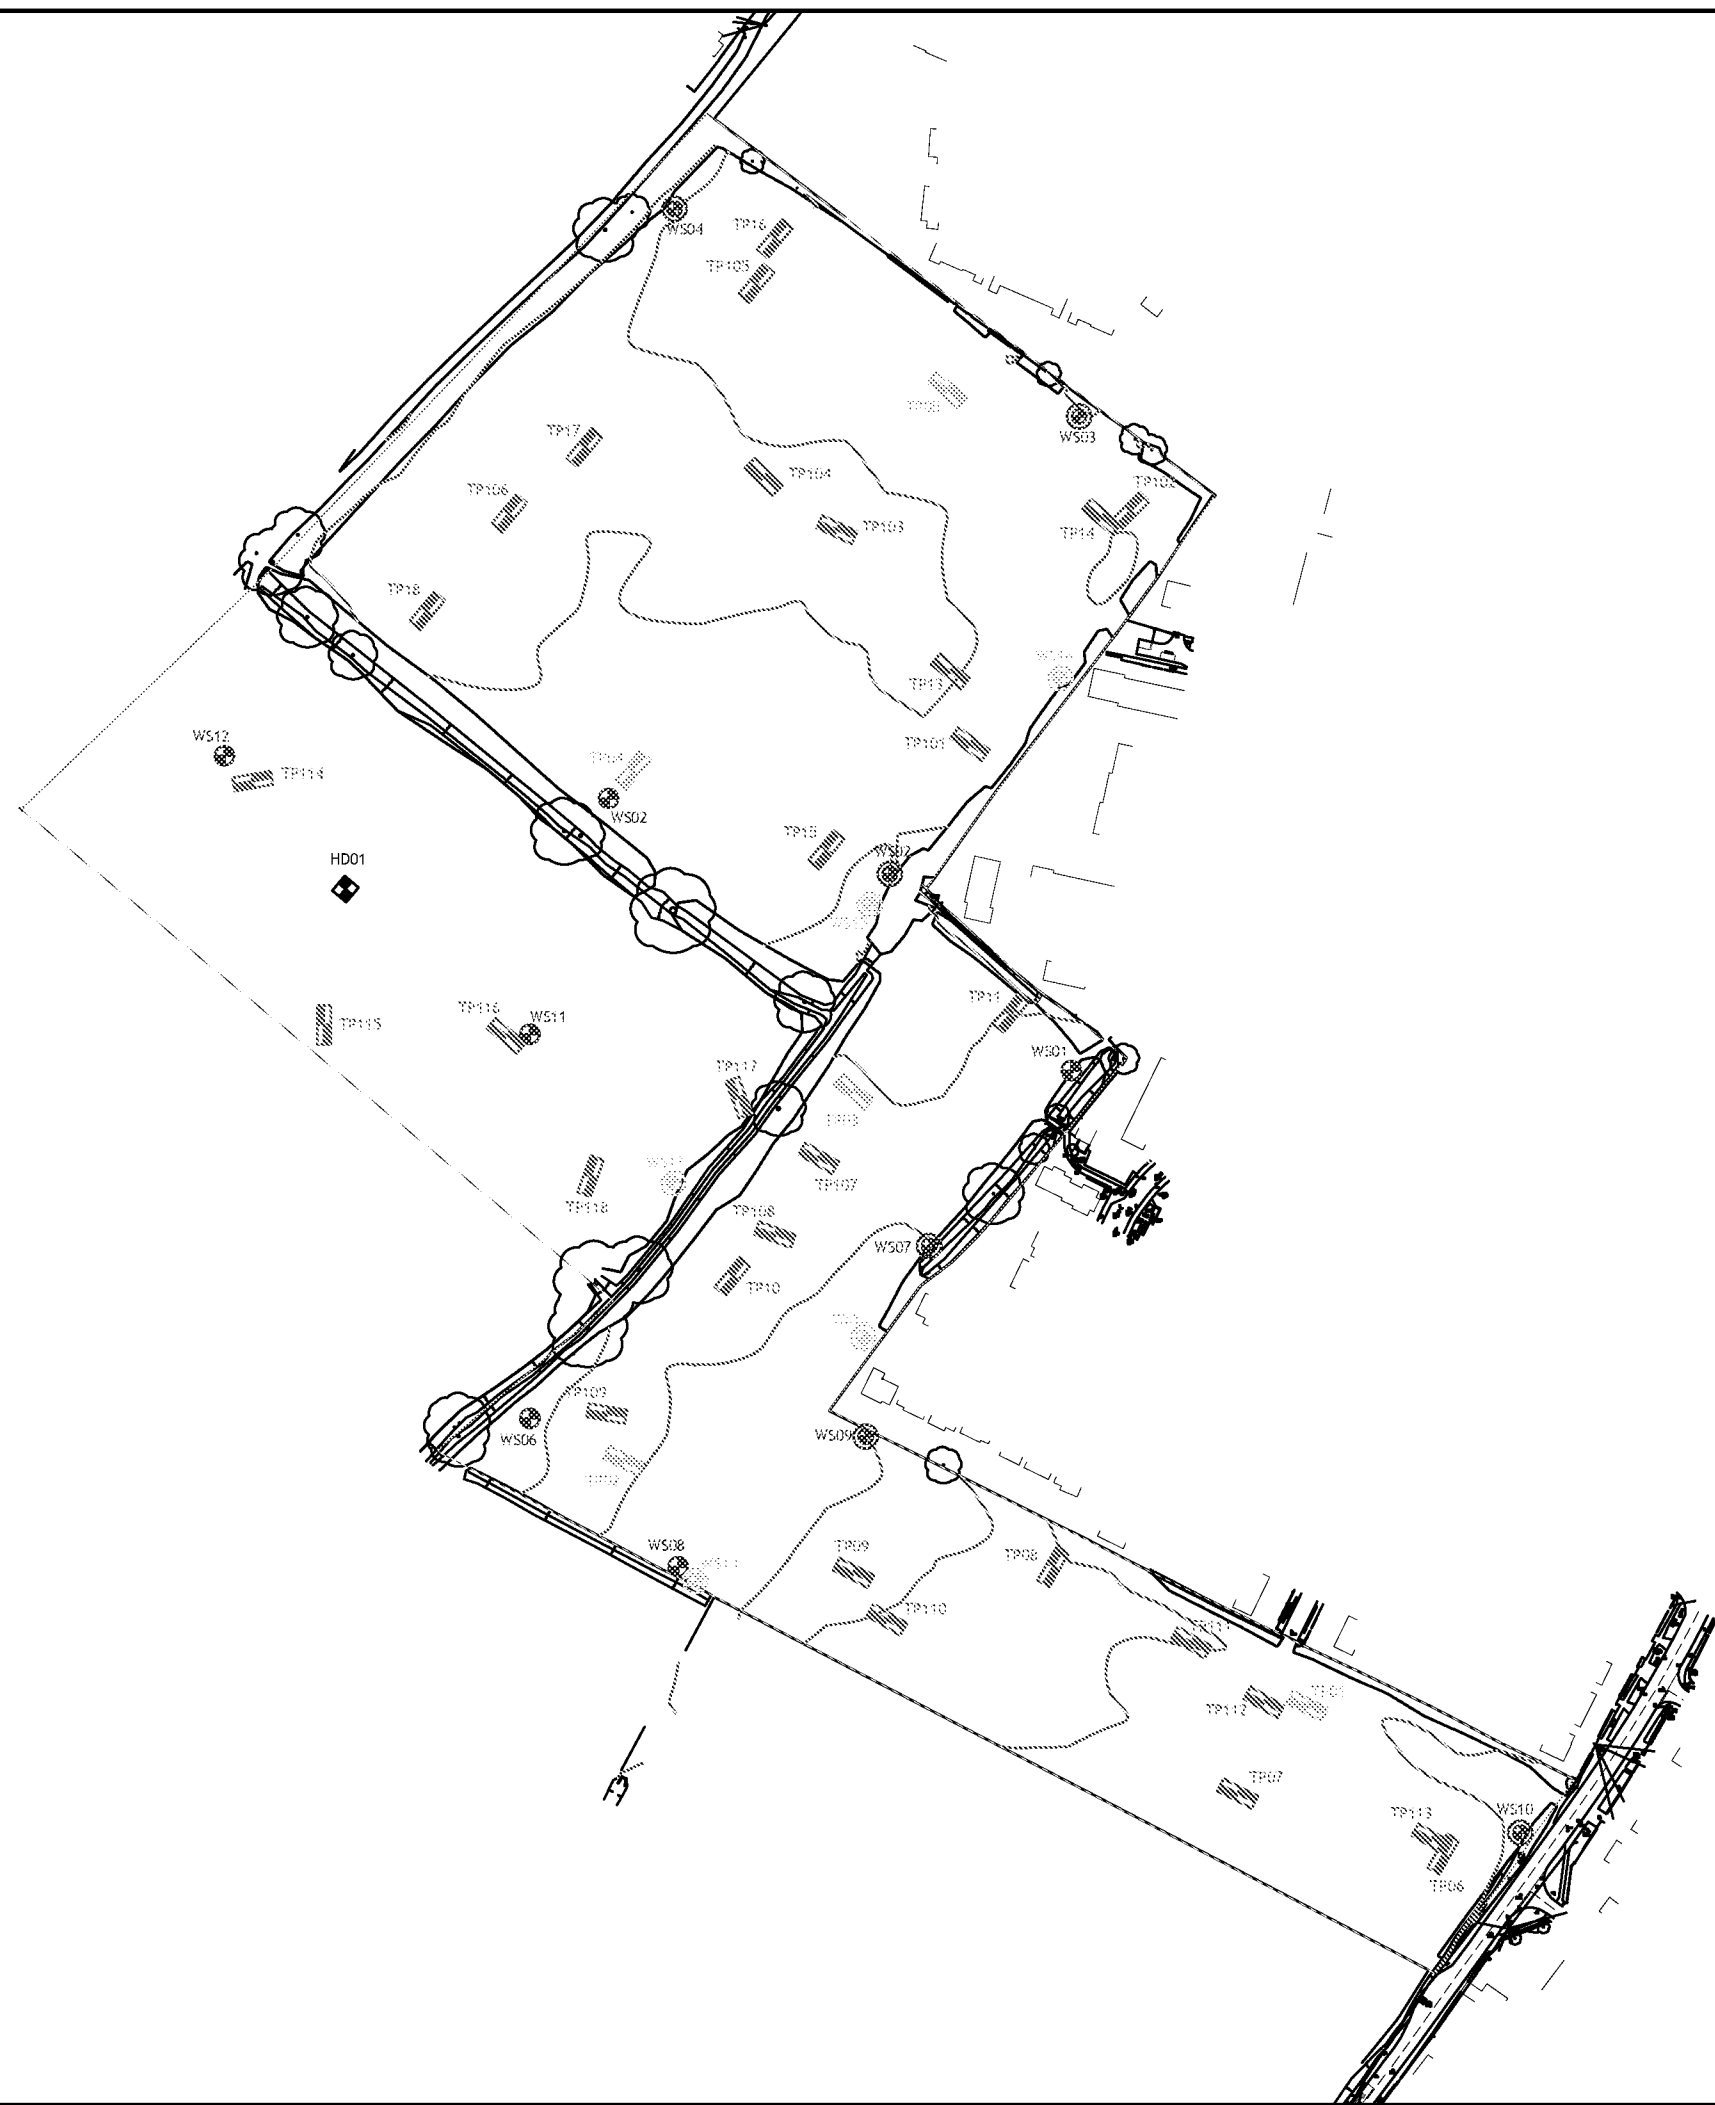
- BRD Soakage Test Pit (February 2019)
- BRD Soakage Test Pit
- BRD Trial Pit
- BRD Hand Dug Pit
- BRD Windowless Sample Borehole with Monitoring Well Installation (October 2018)
- BRD Windowless Sample Borehole
- BRD Windowless Sample Borehole with Monitoring Well Installation
- Site Boundary

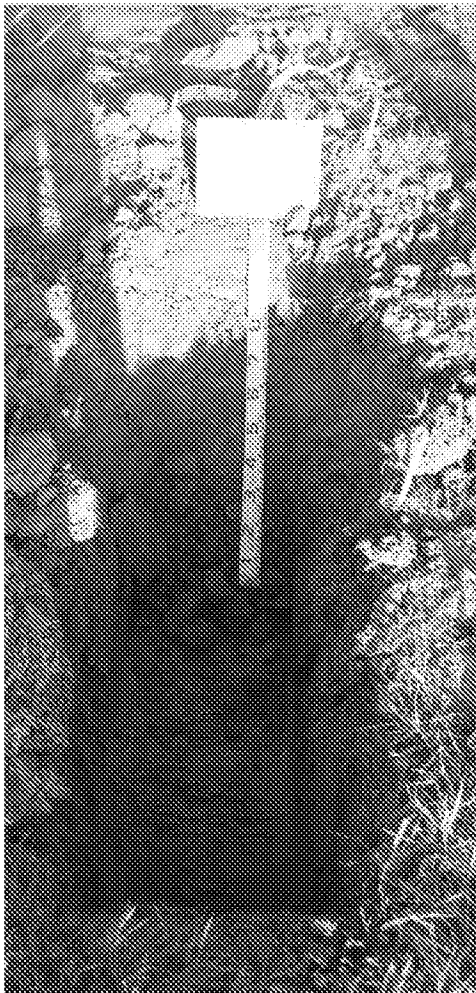
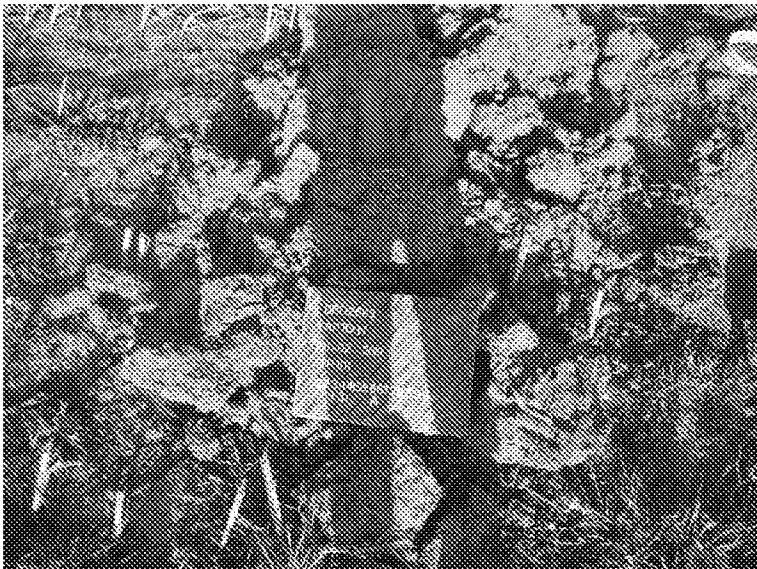
| TRIAL PIT | SOIL INFILTRATION RATE | | STRATUM TESTED |
|---|---|---|---|
| TP101 | Test 1 | Permeability too low to calculate soil infiltration rate. | 0.30m - 1.60m: Firm, brown to orangish brown, silty CLAY with rare fine to coarse, subangular gravel of flint. |

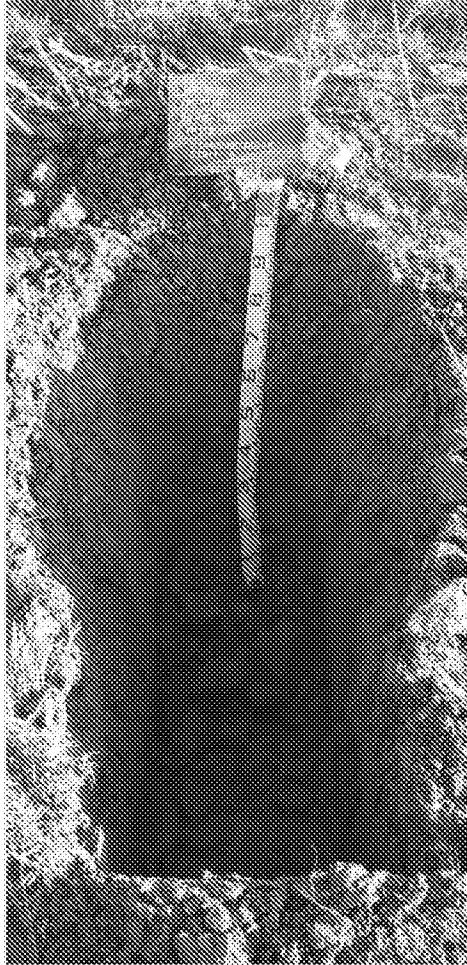
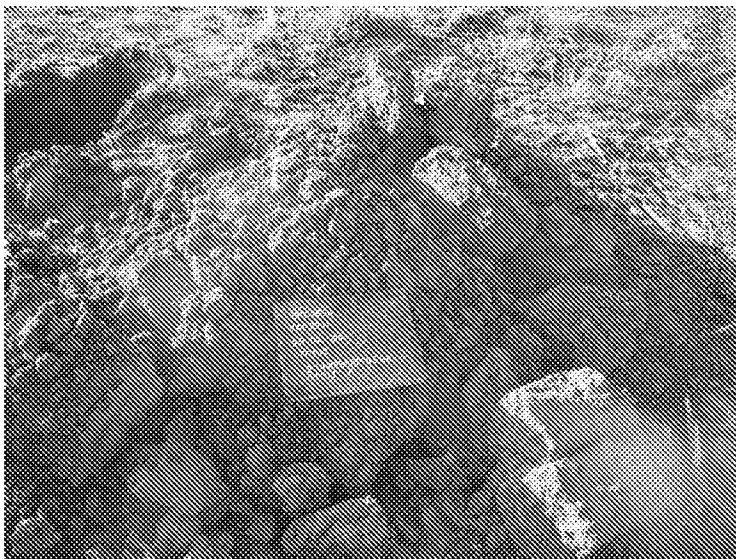
| TRIAL PIT | SOIL INFILTRATION RATE | | STRATUM TESTED |
|---|---|---|---|
| TP102 | Test 1 | Permeability too low to calculate soil infiltration rate. | 0.30m - 0.85m: Firm, brown to orangish brown, silty CLAY with rare fine to coarse, subangular gravel of flint.<br>0.80m - 1.30m Medium dense, light orange and light brown with some reddish, slightly gravelly, silty, fine SAND. |

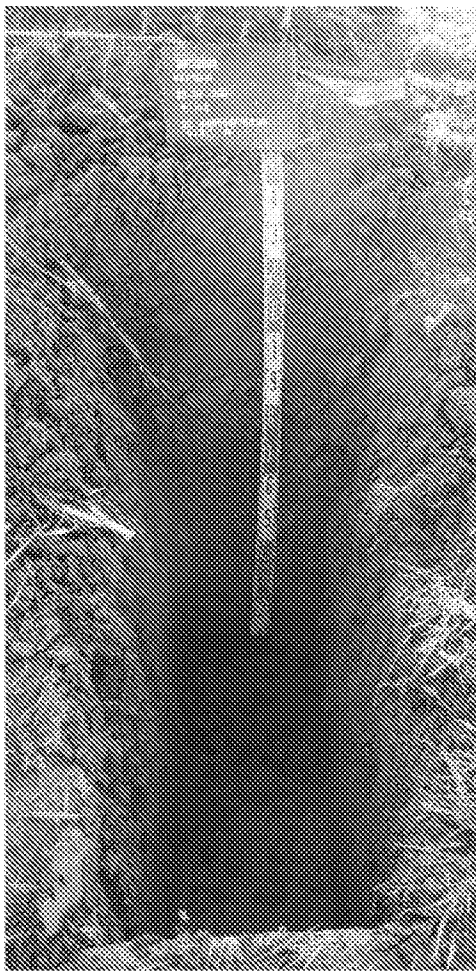
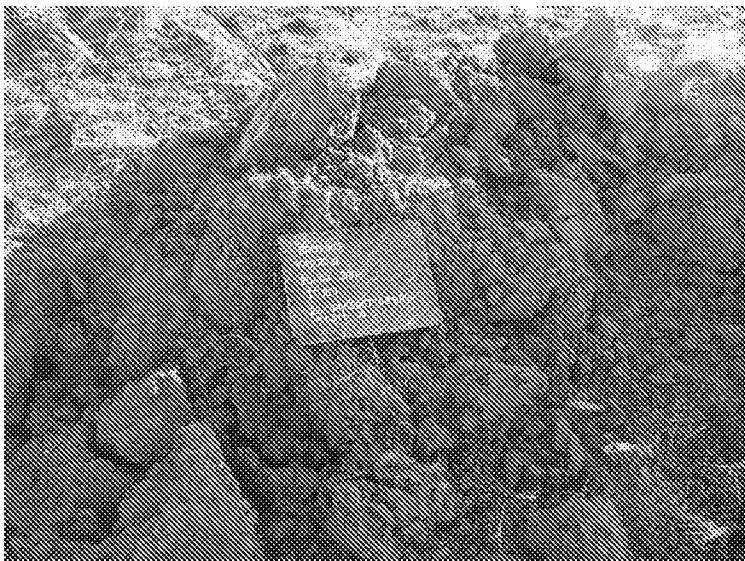
| TRIAL PIT | SOIL INFILTRATION RATE | | STRATUM TESTED |
|---|---|---|---|
| TP103 | Test 1 | Permeability too low to calculate soil infiltration rate. | 0.30m -1.25m: Firm, brown to orangish brown, silty CLAY. Occasional fine to coarse, subangular gravel of flint. |

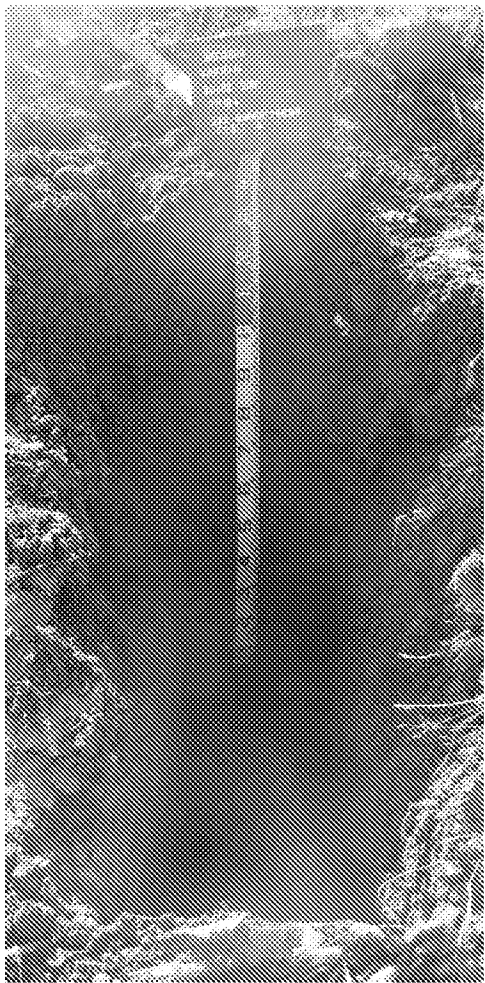
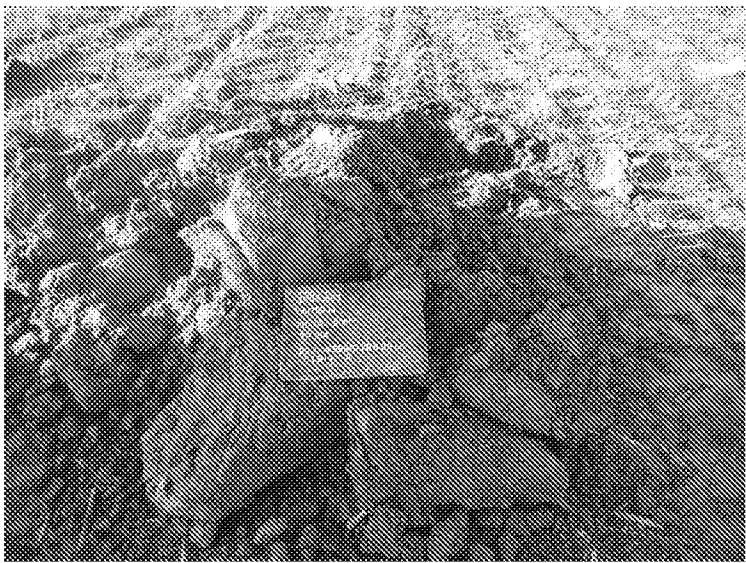
| TRIAL PIT | SOIL INFILTRATION RATE | | STRATUM TESTED |
|---|---|---|---|
| TP104 | Test 1 | Permeability too low to calculate soil infiltration rate. | 0.30m - 1.20m: Firm, brown to orangish brown, silty CLAY with rare fine to coarse, subangular gravel of flint. |

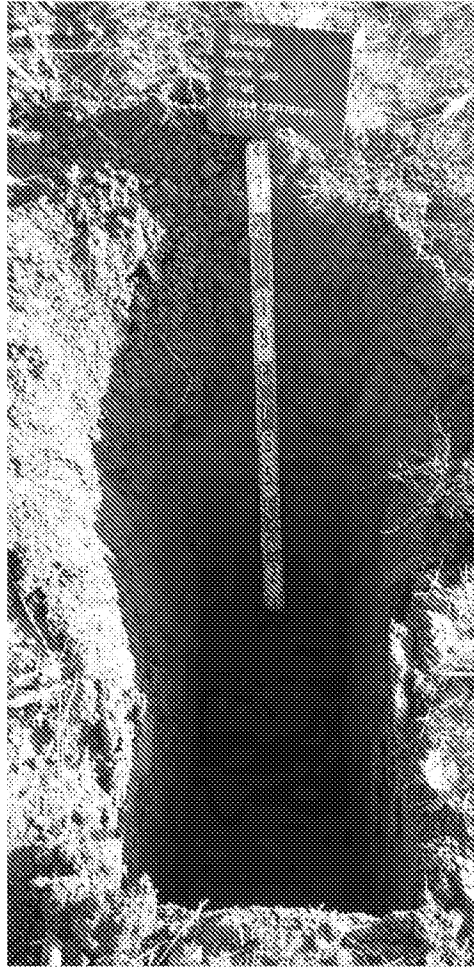
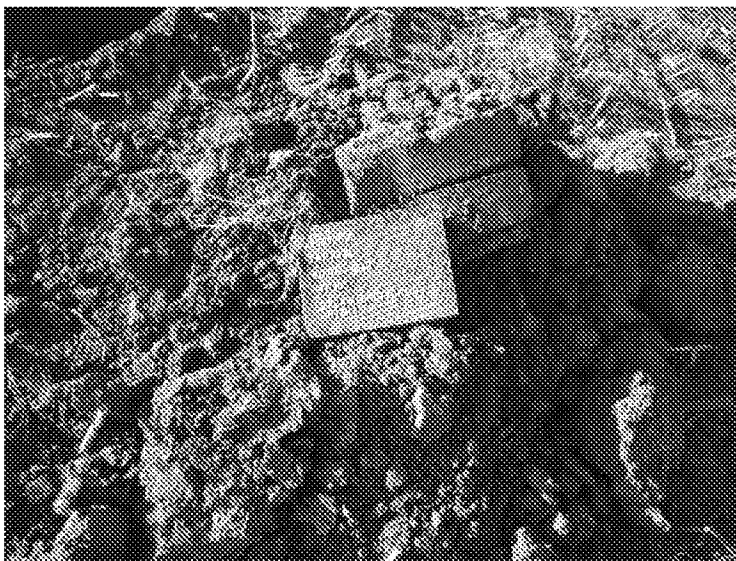
| TRIAL PIT | SOIL INFILTRATION RATE | | STRATUM TESTED |
|---|---|---|---|
| TP105 | Test 1 | Permeability too low to calculate soil infiltration rate. | 0.30m - 0.70m: Firm, brown to orangish brown, silty CLAY with rare fine to coarse, subangular gravel of flint.<br>0.70m - 1.20m: Firm, brown to orangish brown, mottled light grey, silty CLAY. Occasional gravel is fine to coarse, angular flint. |

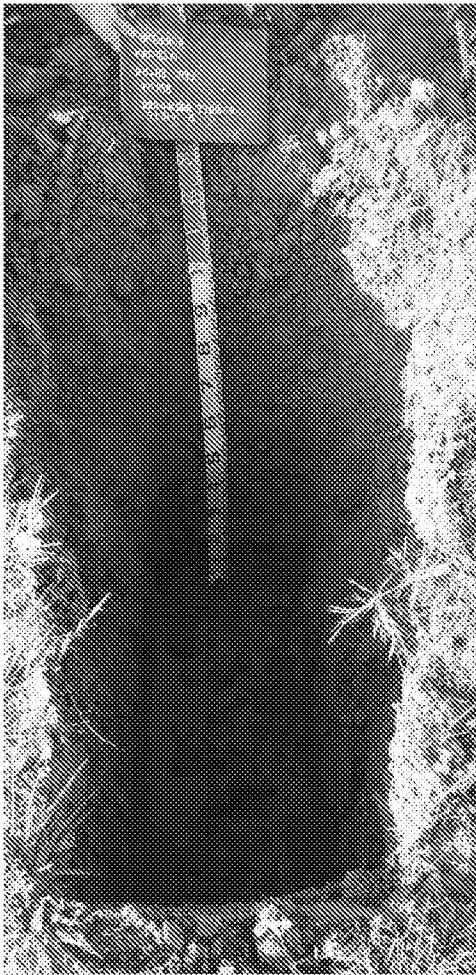
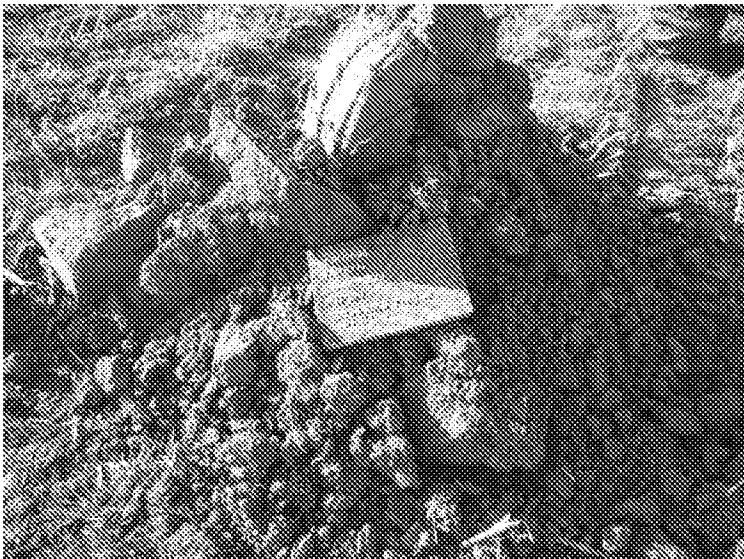
| TRIAL PIT | SOIL INFILTRATION RATE | | STRATUM TESTED |
|---|---|---|---|
| TP106 | Test 1 | Permeability too low to calculate soil infiltration rate. | 0.30m - 1.20m: Firm, brown to orangish brown, silty CLAY with rare fine to coarse, subangular gravel of flint. |

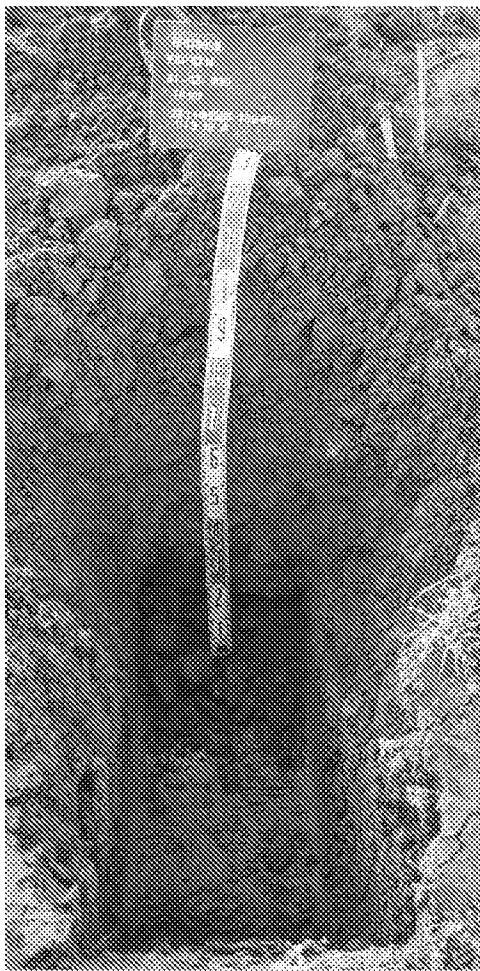
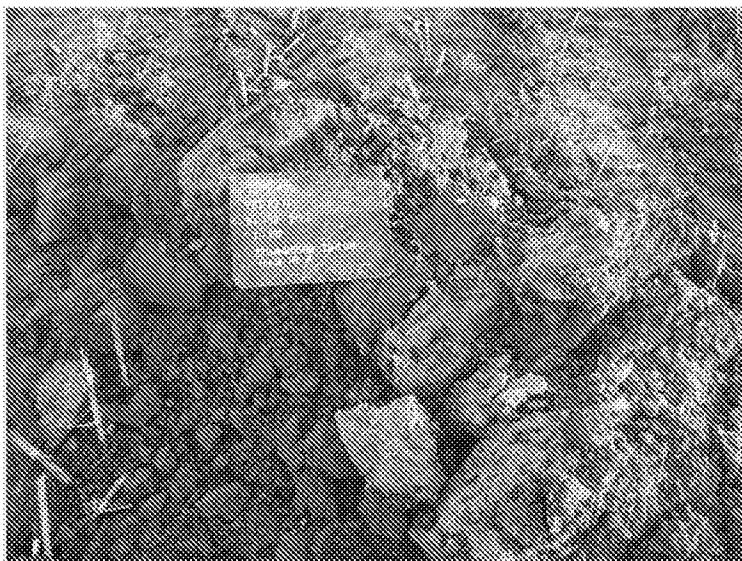
Groundwater was not encountered whilst forwarding the exploratory holes, however very wet sand was found at depths between 0.75m to 0.80m bgl in trial pits TP107 and TP108 which may suggest that the groundwater level was close to the bottom of the trial pits in both locations.

| TRIAL PIT | SOIL INFILTRATION RATE | | STRATUM TESTED |
|---|---|---|---|
| TP107 | Test 1 | Permeability too low to calculate soil infiltration rate. | 0.30m - 0.40m: Firm, brown to orangish brown, silty CLAY.<br>0.40m - 0.85m: Firm, wet, brown and orangish brown mottled light grey, slightly gravelly, silty CLAY. |

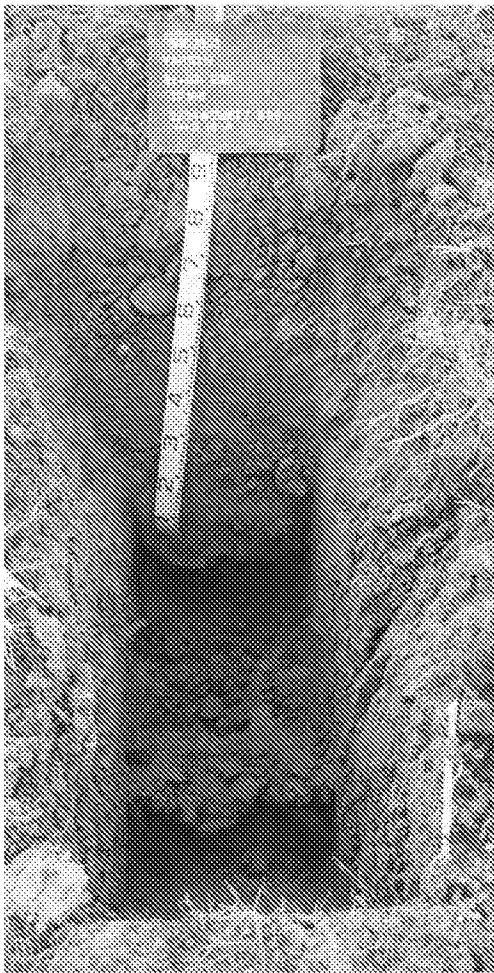
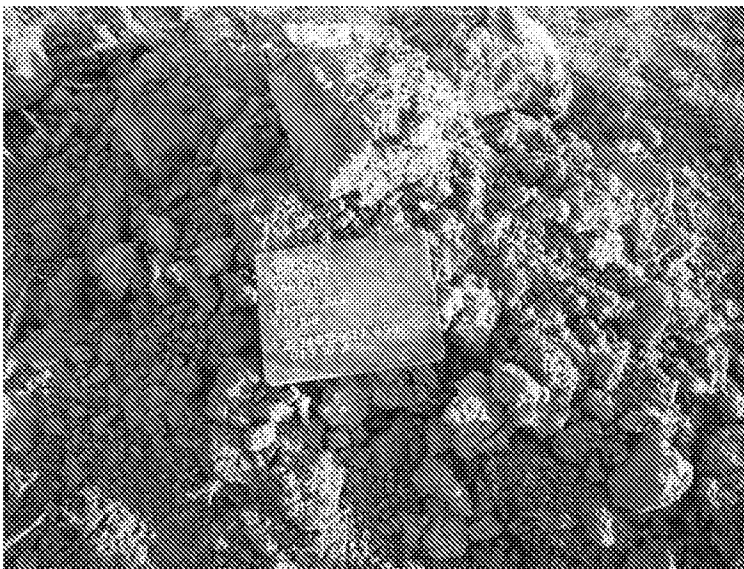
| TRIAL PIT | SOIL INFILTRATION RATE | | STRATUM TESTED |
|---|---|---|---|
| TP108 | Test 1 | Permeability too low to calculate soil infiltration rate. | 0.30m - 0.85m: Firm, wet, brown, yellowish brown and orangish brown mottled light grey, slightly gravelly, silty CLAY. |

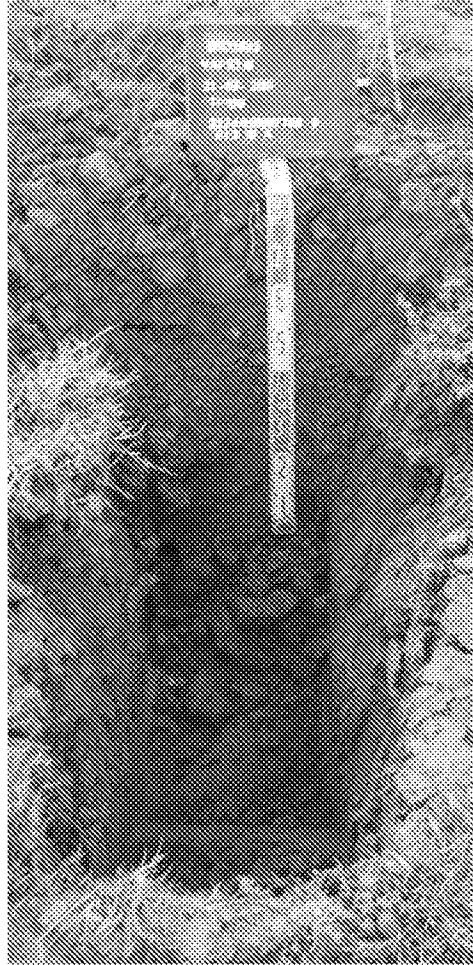
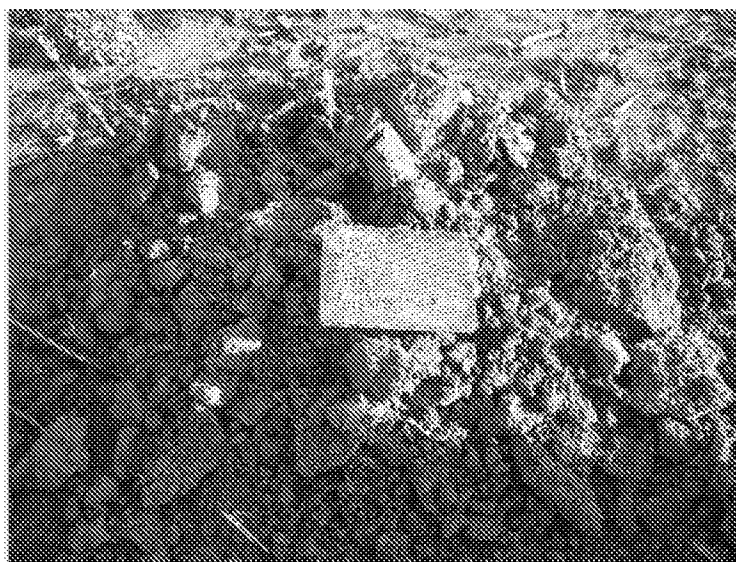
## TP109

| TRIAL PIT | SOIL INFILTRATION RATE | | STRATUM TESTED |
|---|---|---|---|
| TP109 | Test 1 | Permeability too low to calculate soil infiltration rate although continuous drop in water level recorded. | 0.25m - 0.50m: Firm, brown, slightly sandy, silty CLAY.<br>0.50m - 0.85m: Firm, brown, yellowish brown to orangish brown mottled light grey slightly gravelly, silty CLAY. |

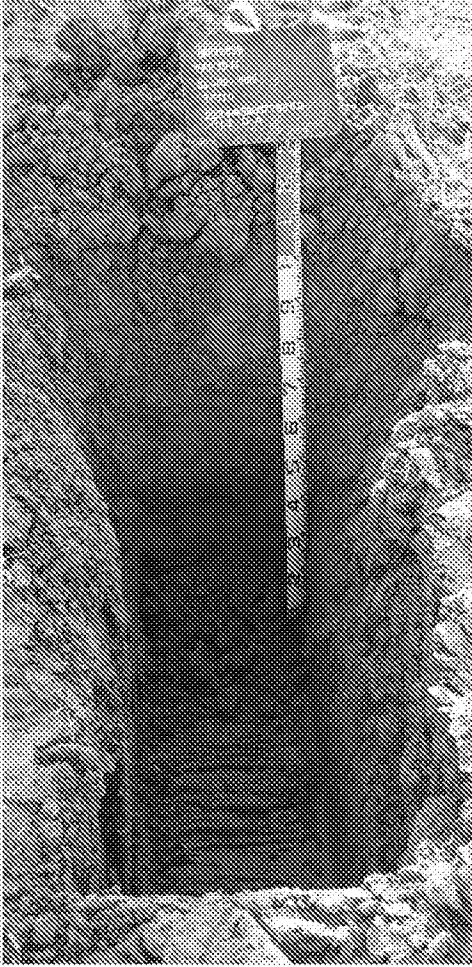
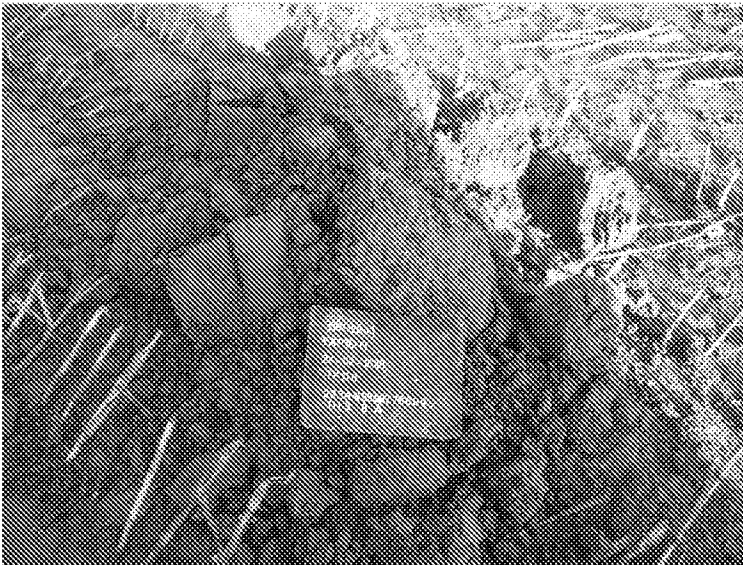
| TRIAL PIT | SOIL INFILTRATION RATE | | STRATUM TESTED |
|---|---|---|---|
| TP110 | Test 1 | Permeability too low to calculate soil infiltration rate. | 0.30m - 1.00m: Firm, brown to orangish brown, slightly gravelly silty CLAY. |

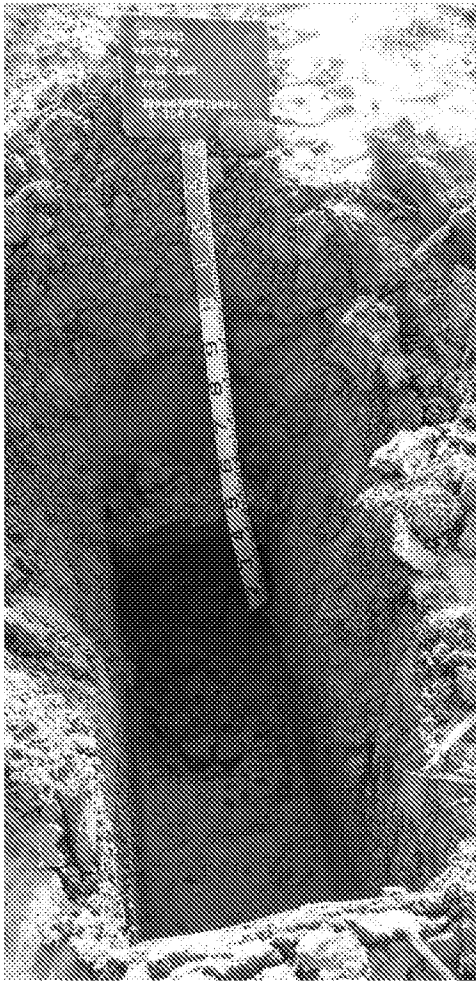
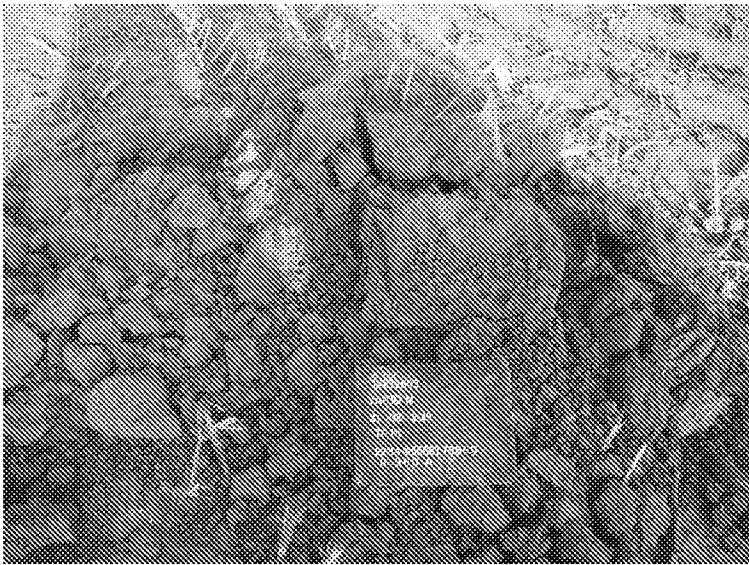
| TRIAL PIT | SOIL INFILTRATION RATE | | STRATUM TESTED |
|---|---|---|---|
| TP111 | Test 1 | Permeability too low to calculate soil infiltration rate. | 0.25m - 1.20m: Firm, brown to orangish brown with mottled light grey, slightly gravelly, silty CLAY. |

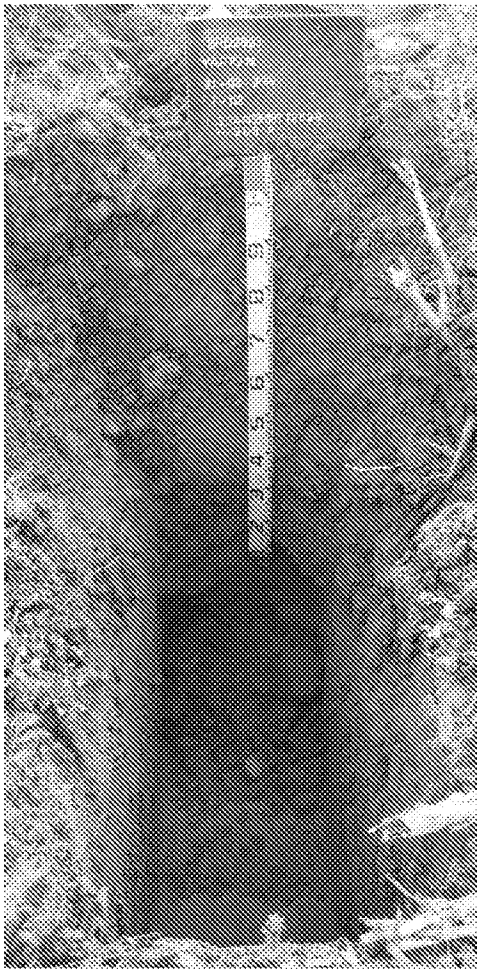
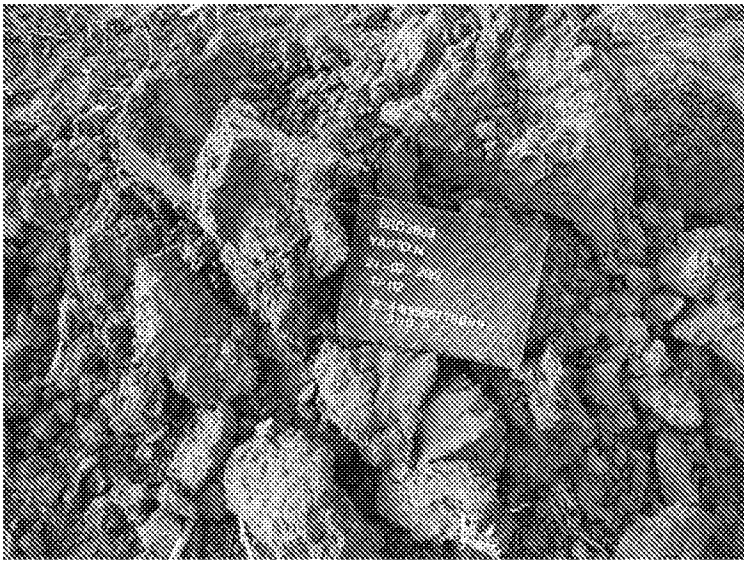
| TRIAL PIT | SOIL INFILTRATION RATE | | STRATUM TESTED |
|---|---|---|---|
| TP112 | Test 1 | Permeability too low to calculate soil infiltration rate. | 0.25m - 0.90m: Firm, brown orangish brown mottled light grey, slightly gravelly, silty, CLAY.<br>0.90m - 1.20m: Firm, wet, brown and yellowish brown mottled light grey ,slightly gravelly, silty CLAY. |

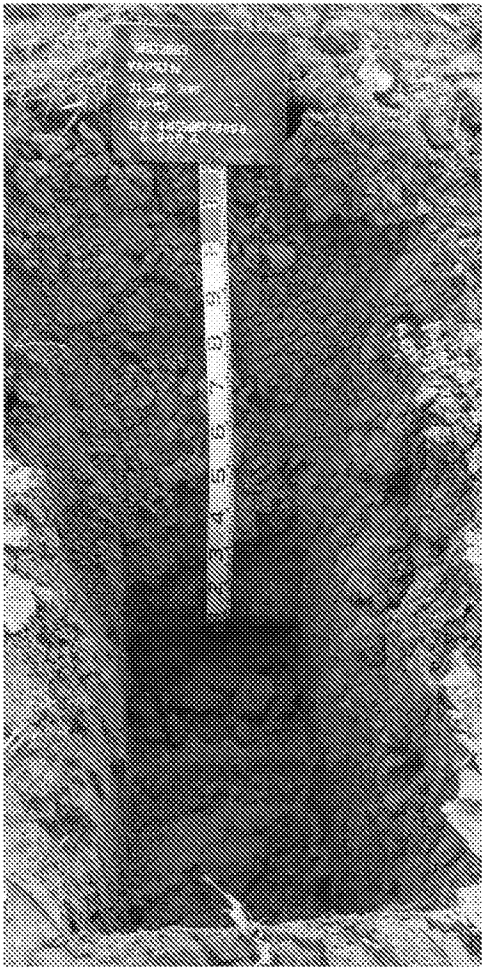
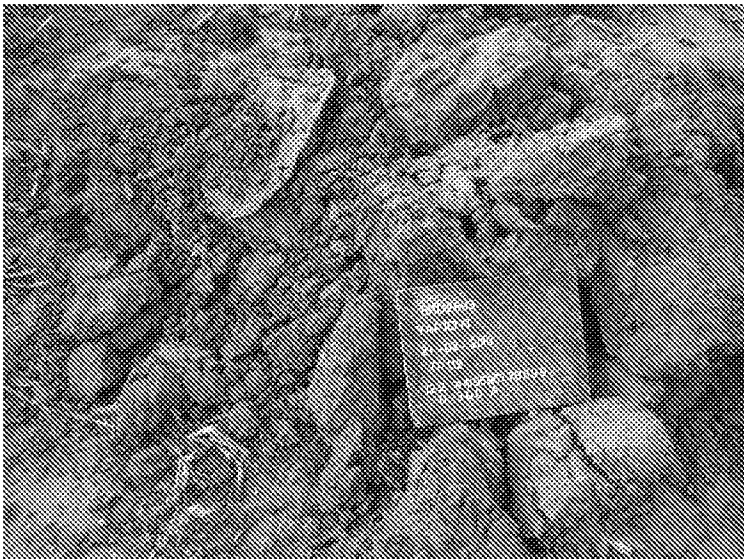
| TRIAL PIT | SOIL INFILTRATION RATE | | STRATUM TESTED |
|---|---|---|---|
| TP113 | Test 1 | Permeability too low to calculate soil infiltration rate. | 0.30m - 0.70m: Firm, light brown and yellowish brown mottled light grey, slightly gravelly, silty CLAY.<br>0.70m - 1.00m: Firm, yellowish brown and light grey, slightly gravelly, silty CLAY. |

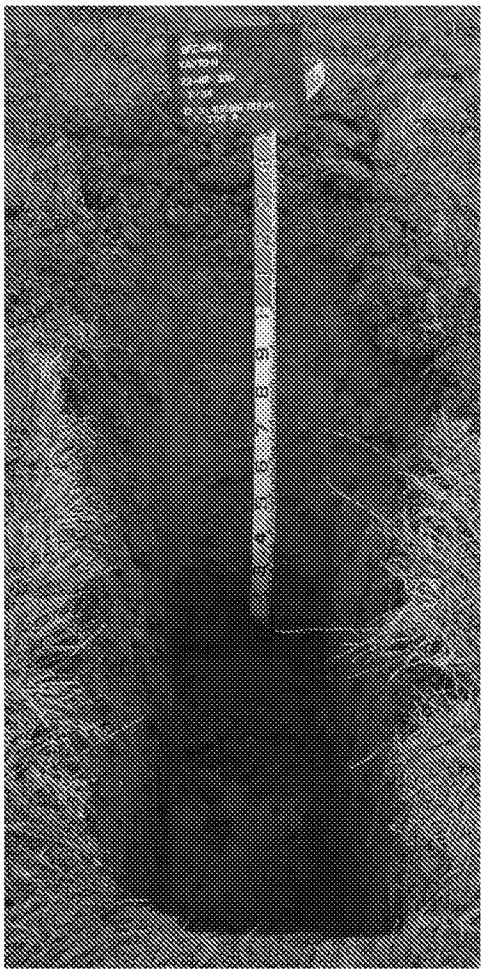
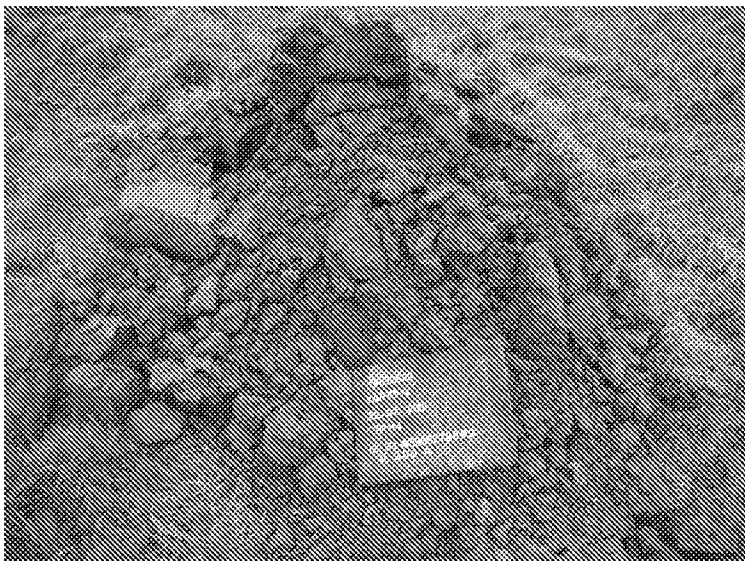
| TRIAL PIT | SOIL INFILTRATION RATE | | STRATUM TESTED |
|---|---|---|---|
| TP114 | Test 1 | Permeability too low to calculate soil infiltration rate. | 0.25m - 1.20m: Firm, orangish brown mottled light grey and brown, silty CLAY. |

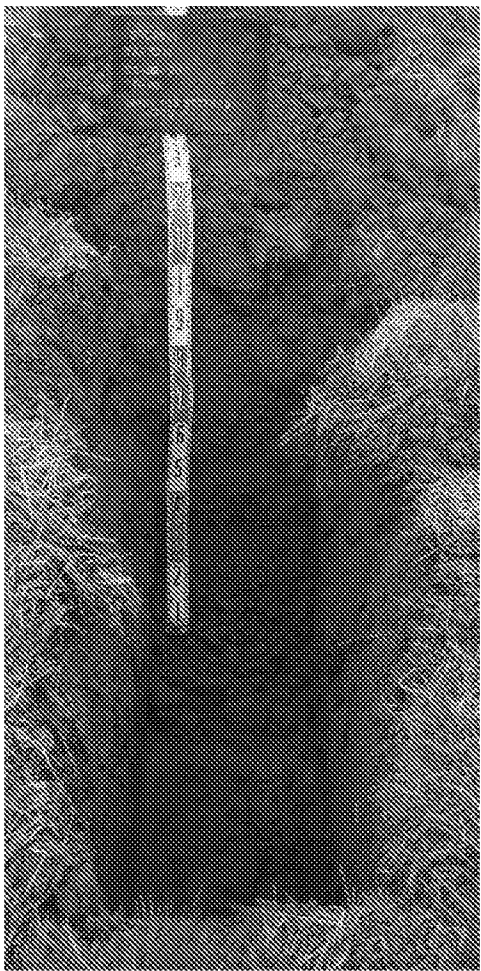
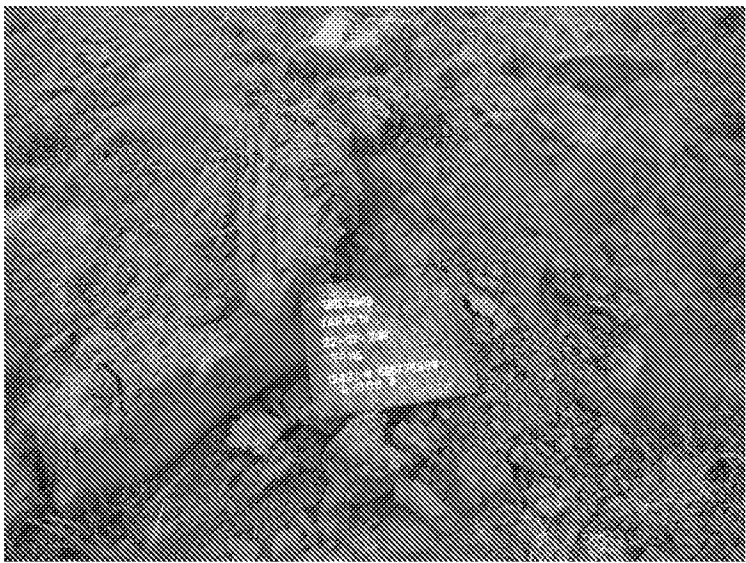
| TRIAL PIT | SOIL INFILTRATION RATE | | STRATUM TESTED |
|---|---|---|---|
| TP115 | Test 1 | Permeability too low to calculate soil infiltration rate. | 0.25m - 1.20m: Firm, orangish brown mottled light grey and brown, silty CLAY. |

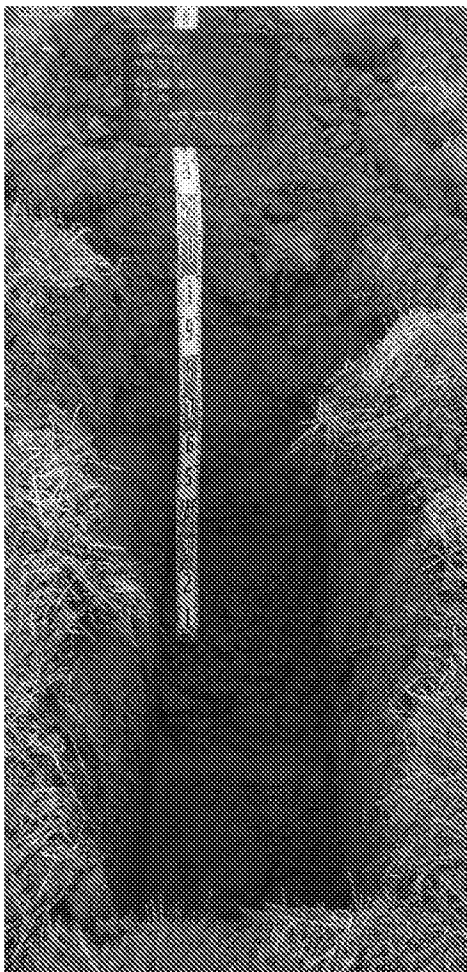
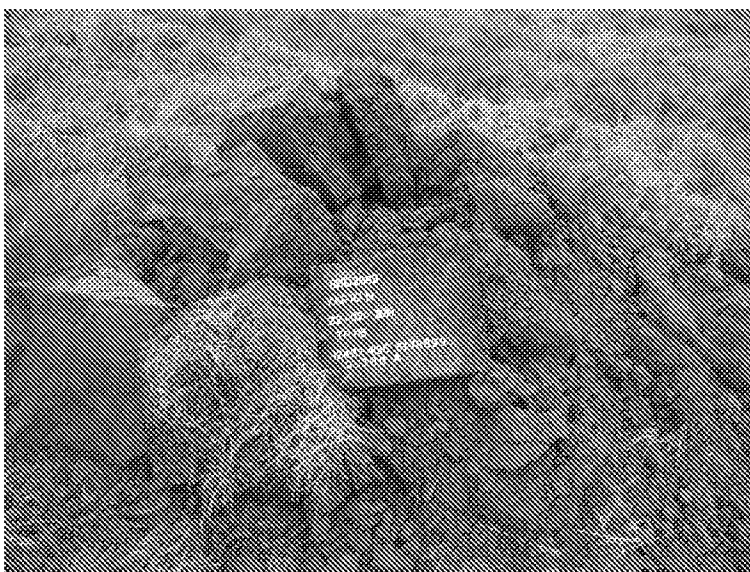
| TRIAL PIT | SOIL INFILTRATION RATE | | STRATUM TESTED |
|---|---|---|---|
| TP116 | Test 1 | Permeability too low to calculate soil infiltration rate. | 0.25m -0.50m: Firm, brown, silty CLAY.<br>0.50m -1.20m: Firm, brown, silty CLAY with occasional fine to coarse, angular to subangular flint gravel. |

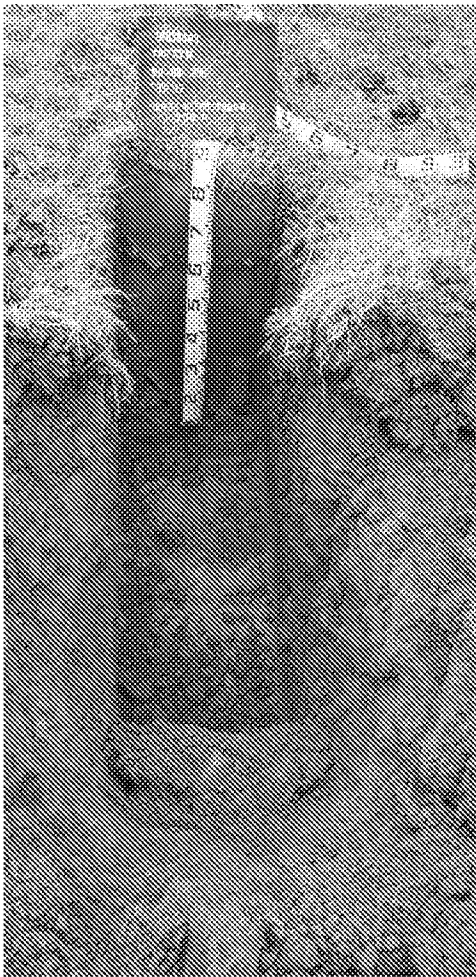
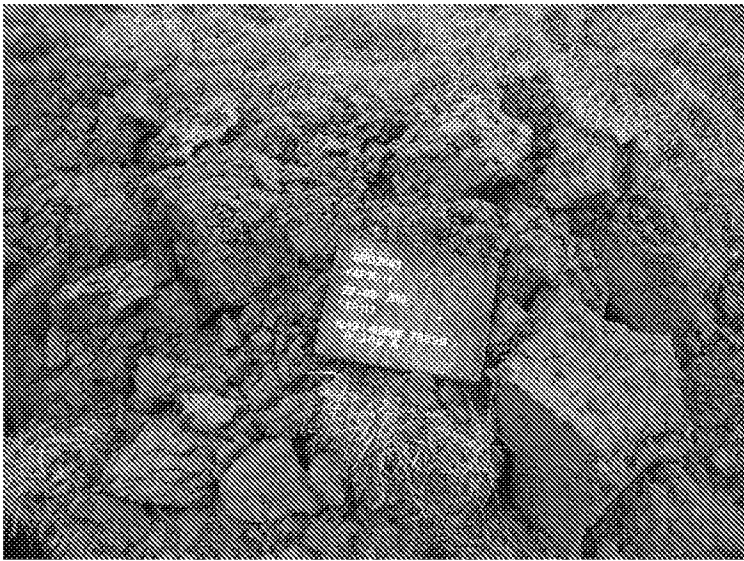
| TRIAL PIT | SOIL INFILTRATION RATE | | STRATUM TESTED |
|---|---|---|---|
| TP117 | Test 1 | Permeability too low to calculate soil infiltration rate although continuous drop in water level recorded. | 0.25m -0.50m: Firm, brown, silty CLAY.<br>0.50m - 0.85m: Firm, brown and orangish brown mottled light grey and occasional, yellowish brown, silty CLAY. |

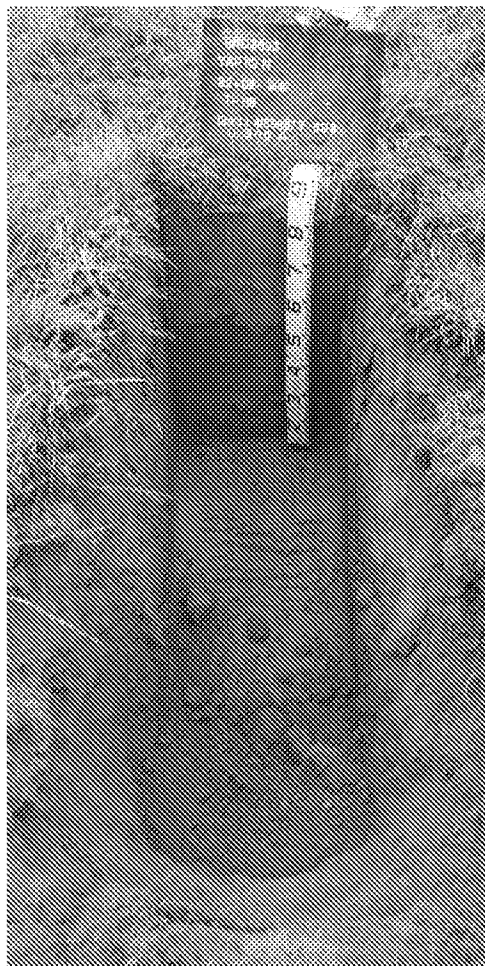
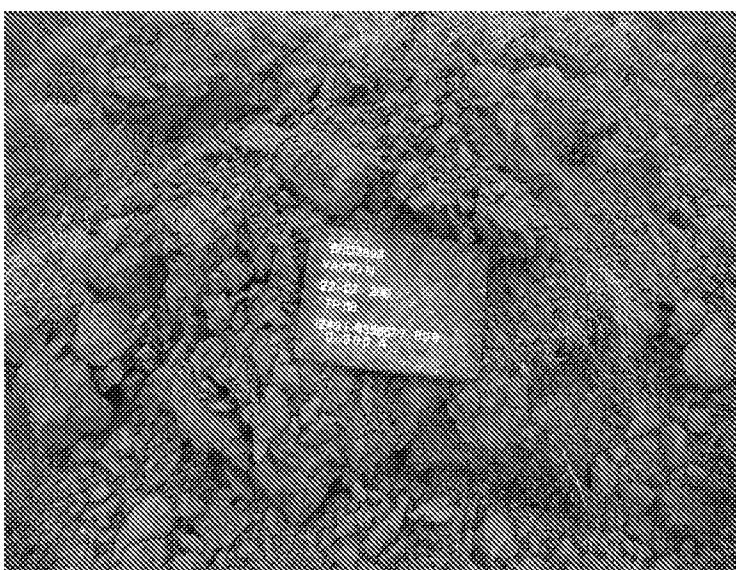
| TRIAL PIT | SOIL INFILTRATION RATE | | STRATUM TESTED |
|---|---|---|---|
| TP118 | Test 1 | Permeability too low to calculate soil infiltration rate although continuous drop in water level recorded. | 0.25m - 0.60m: Firm, brown and orangish brown, silty CLAY.<br>0.60m - 0.80m: Firm, brown and orangish brown mottled light grey, silty CLAY. |

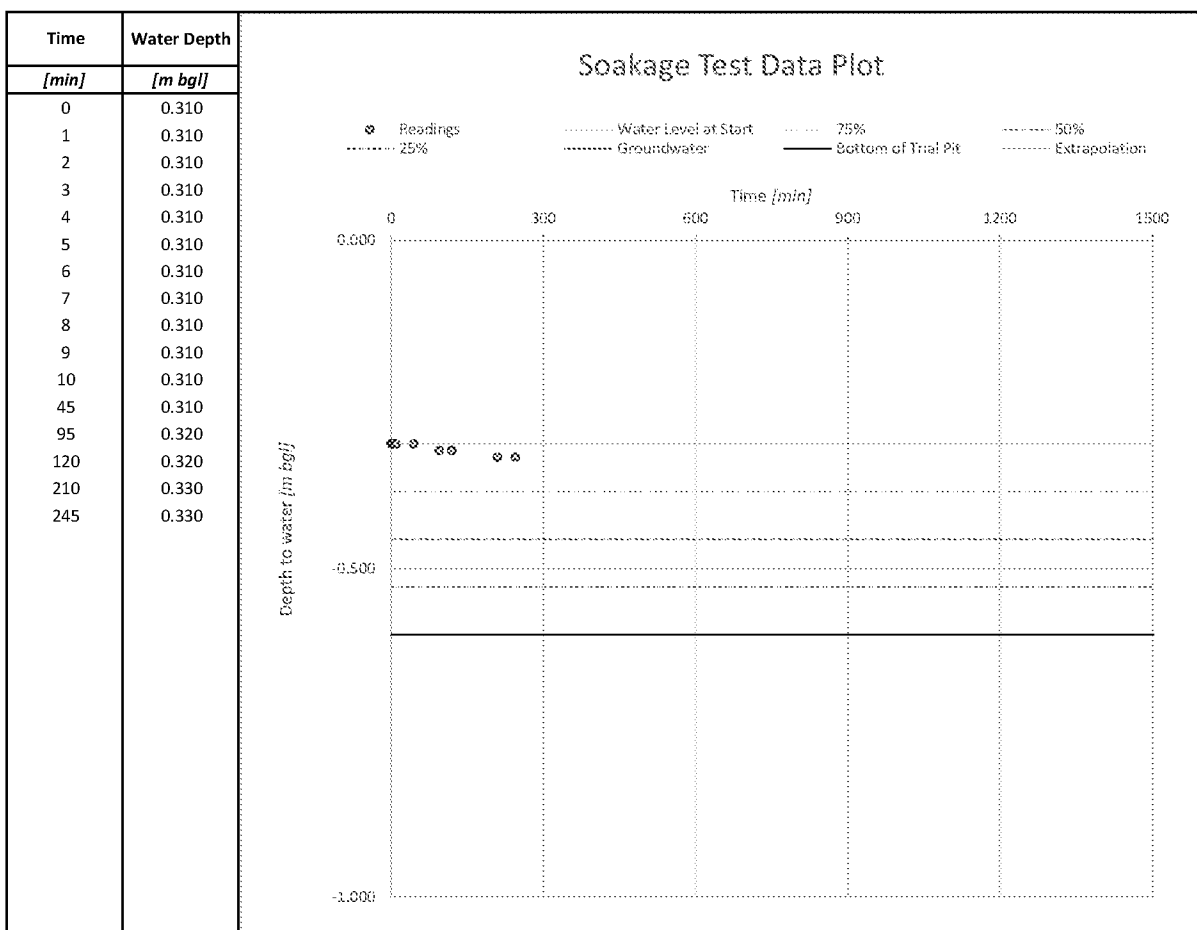
| Ground | Conditions | from - to [m bgl] | | Description |
|---|---|---|---|---|
| | | 0.30 | 0.60 | Firm, brown to orangish brown, silty CLAY with rare fine to coarse, subangular gravel of flint. |

**Remarks:** Result could not be calculated. Soakage test failed.
