# Soakaway Feasibility Report

## Land at Bilsham Road, Yapton

**BRD2693-OR3-A**

**March 2019**

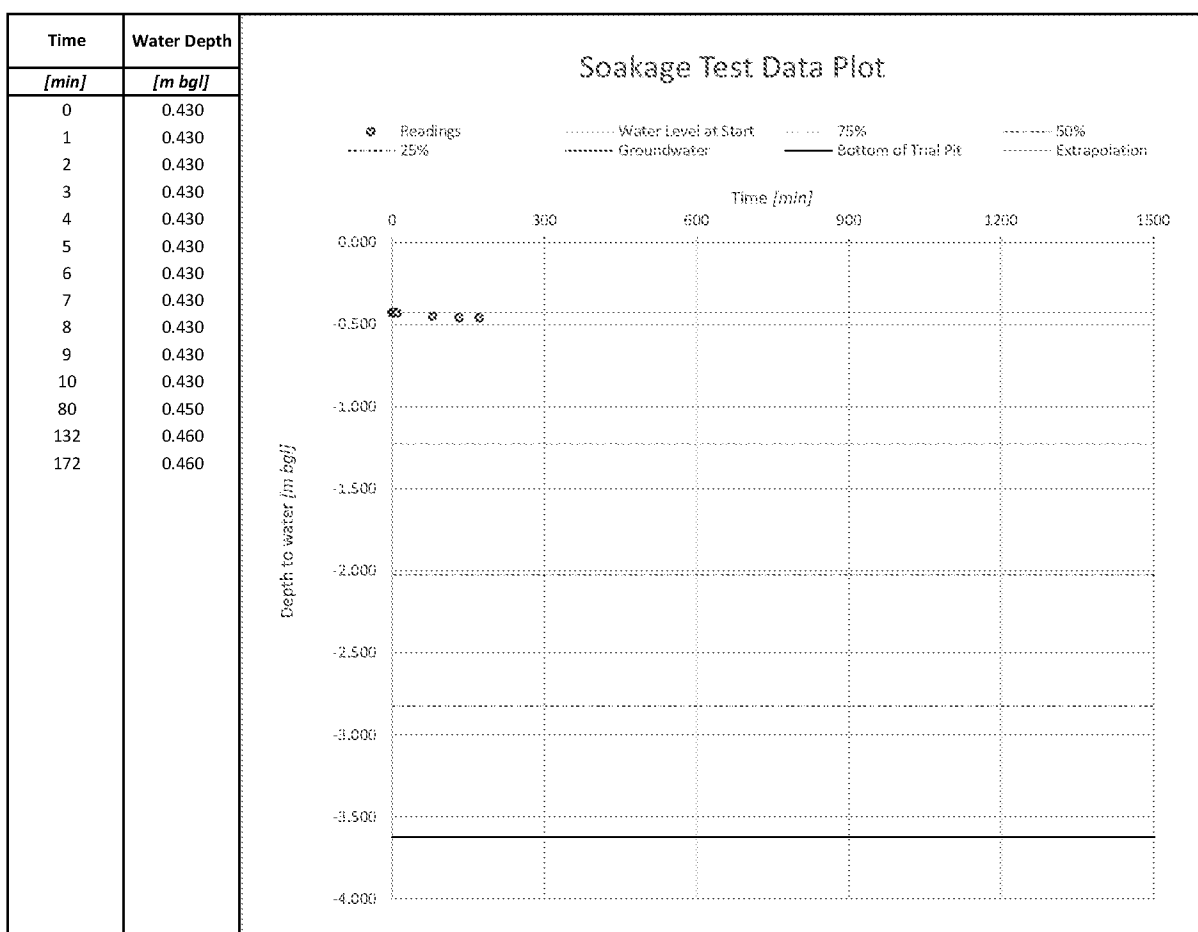
| Ground | Conditions | from - to [m bgl] | | Description |
|---|---|---|---|---|
| | | 0.30 | 0.85 | Firm, brown to orangish brown, silty CLAY with rare fine to coarse, subangular gravel of flint. |

**Remarks:** Result could not be calculated. Soakage test failed.

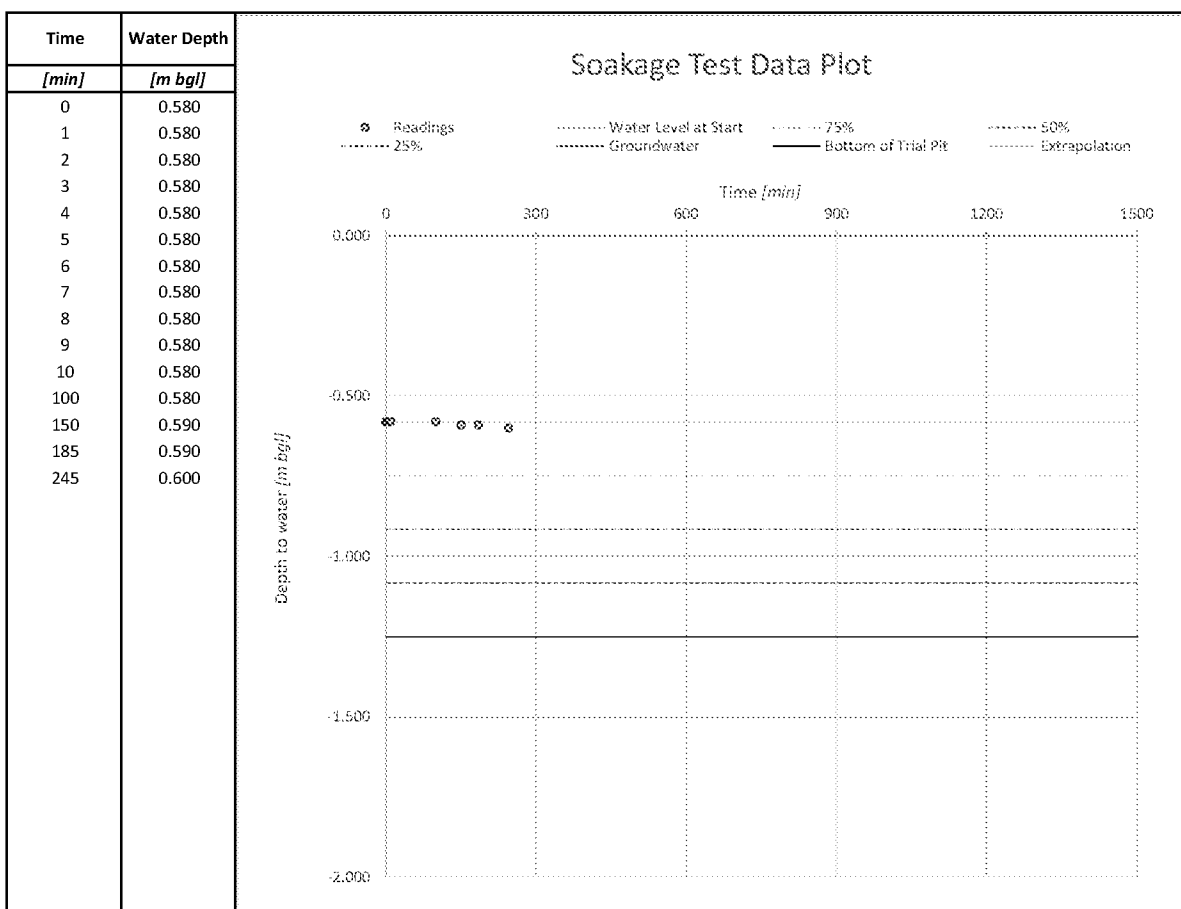
| Ground | Conditions | from - to [m bgl] | | Description |
|---|---|---|---|---|
| | | | | Firm, brown to orangish brown, silty CLAY. Occasional fine to coarse, subangular gravel of flint. |

**Remarks:** Result could not be calculated. Soakage test failed.

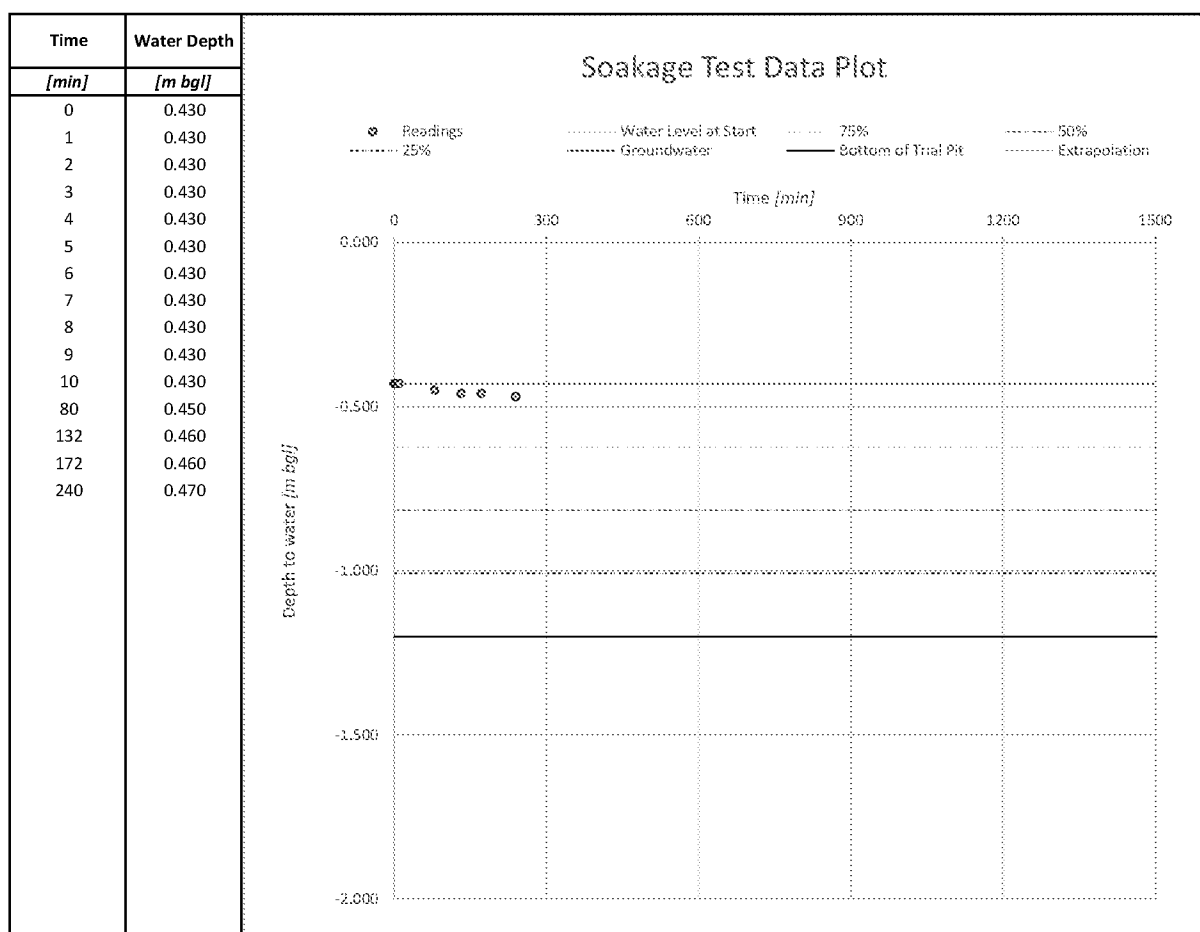
| Ground | Conditions | from - to [m bgl] | | Description |
|---|---|---|---|---|
| | | 0.30 | 1.20 | Firm, brown to orangish brown, silty CLAY with rare fine to coarse, subangular gravel of flint. |

**Remarks:** Result could not be calculated. Soakage test failed.

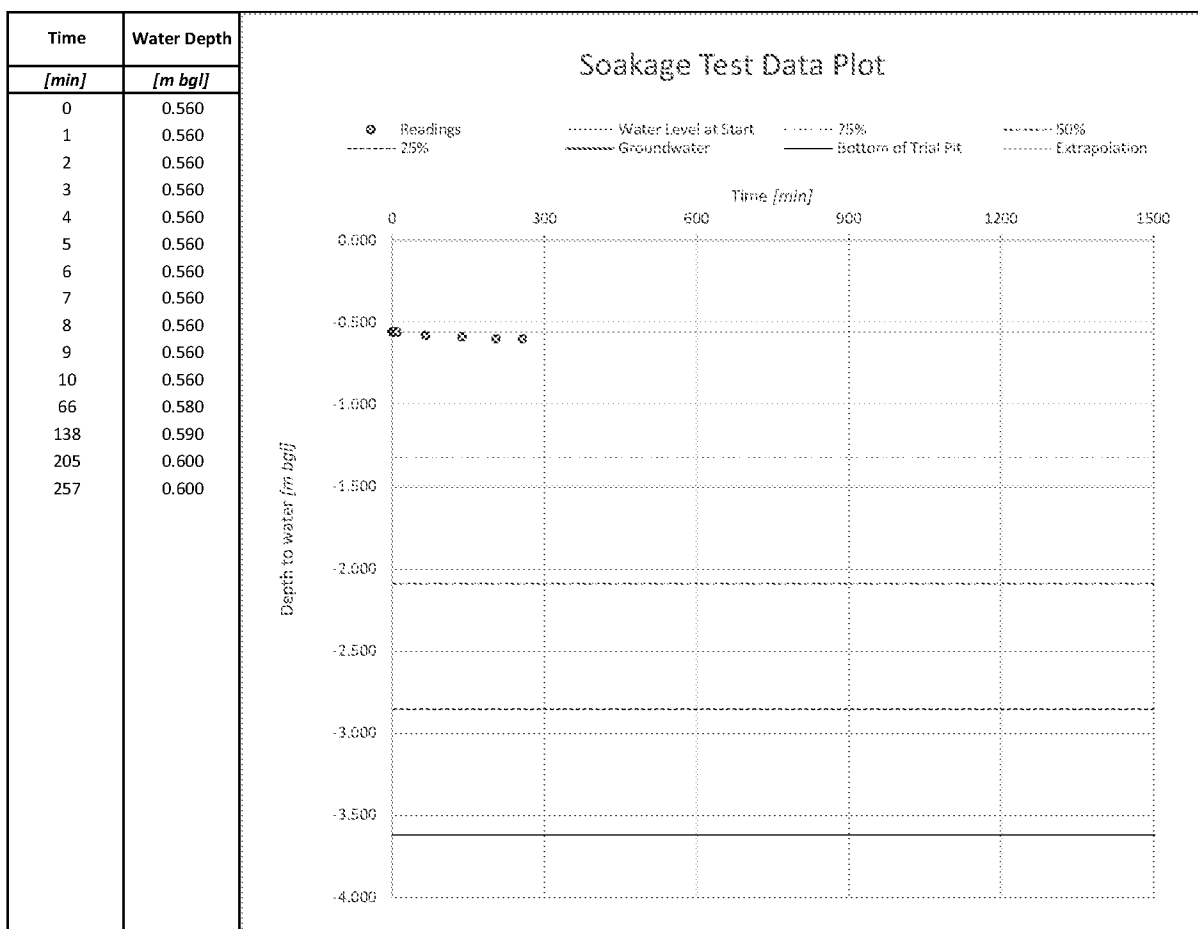
| Ground | Conditions | from - to [m bgl] | | Description |
|---|---|---|---|---|
| | | 0.70 | 1.20 | Firm, brown to orangish brown, mottled light grey, silty CLAY. Occasional gravel is fine to coarse, angular flint. |

**Remarks:** Result could not be calculated. Soakage test failed.

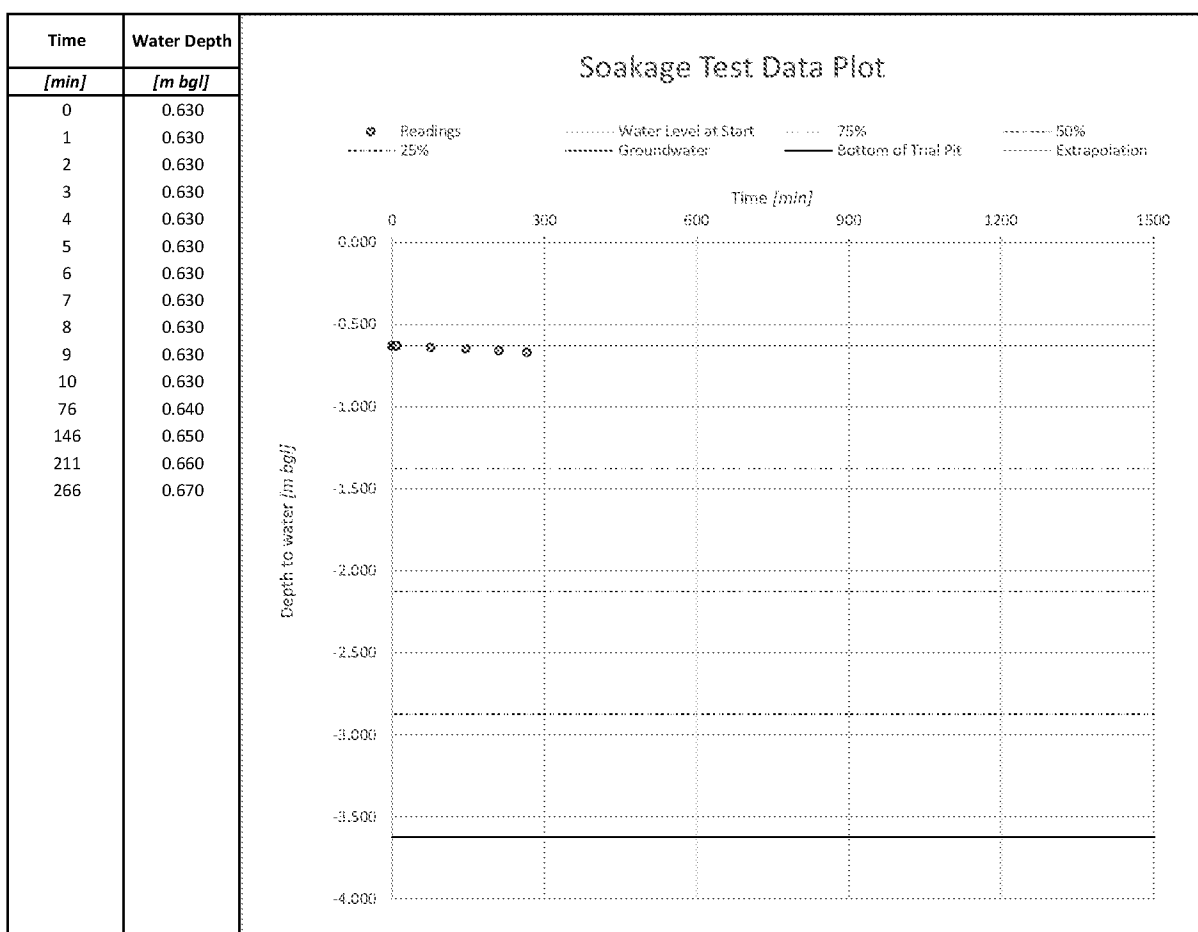
| Ground | Conditions | from - to [m bgl] | | Description |
|---|---|---|---|---|
| | | 0.30 | 1.20 | Firm, brown to orangish brown, silty CLAY with rare fine to coarse, subangular gravel of flint. |

**Remarks:** Result could not be calculated. Soakage test failed.

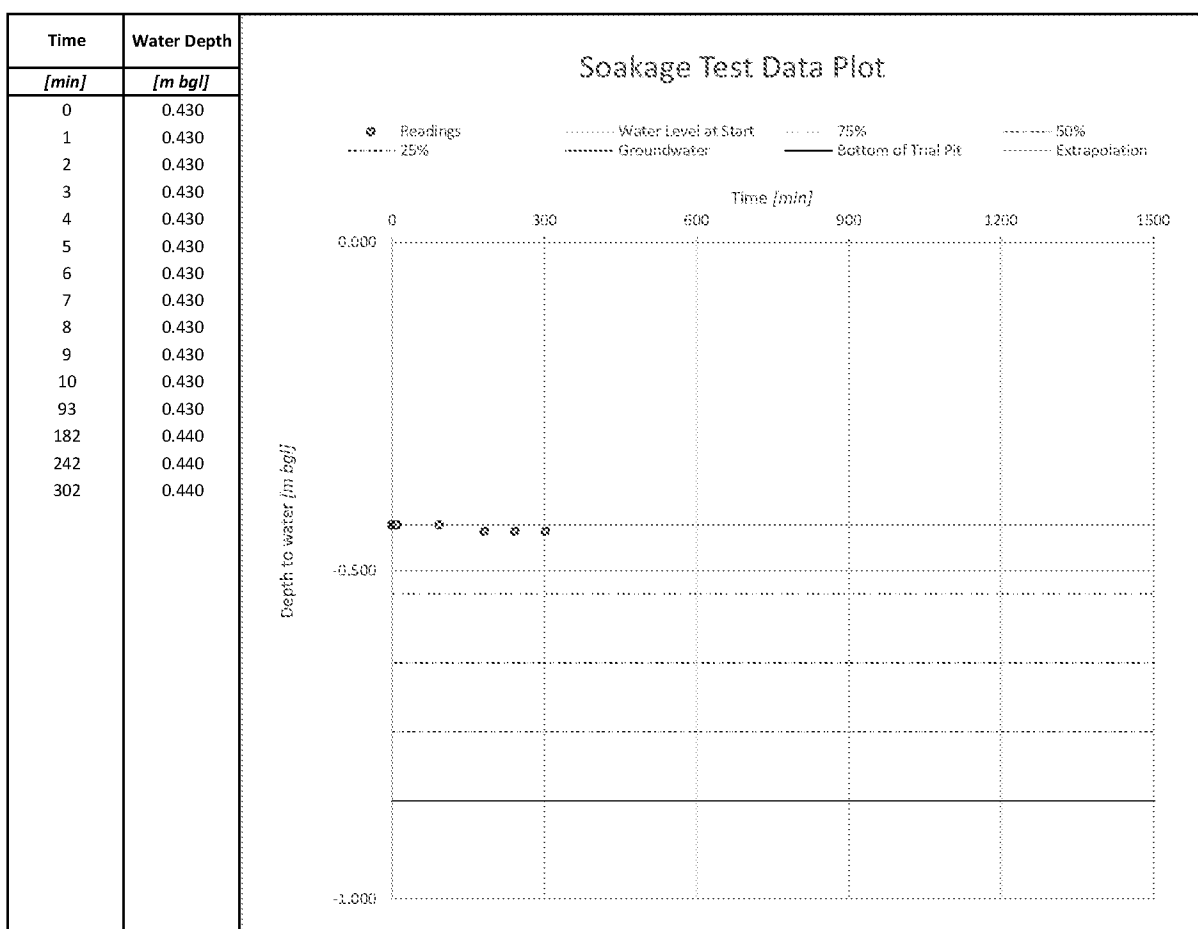
| Ground | Conditions | from - to [m bgl] | | Description |
|---|---|---|---|---|
| | | 0.40 | 0.85 | Firm, wet, brown and orangish brown mottled light grey, slightly gravelly, silty CLAY. |

**Remarks:** Result could not be calculated. Soakage test failed.

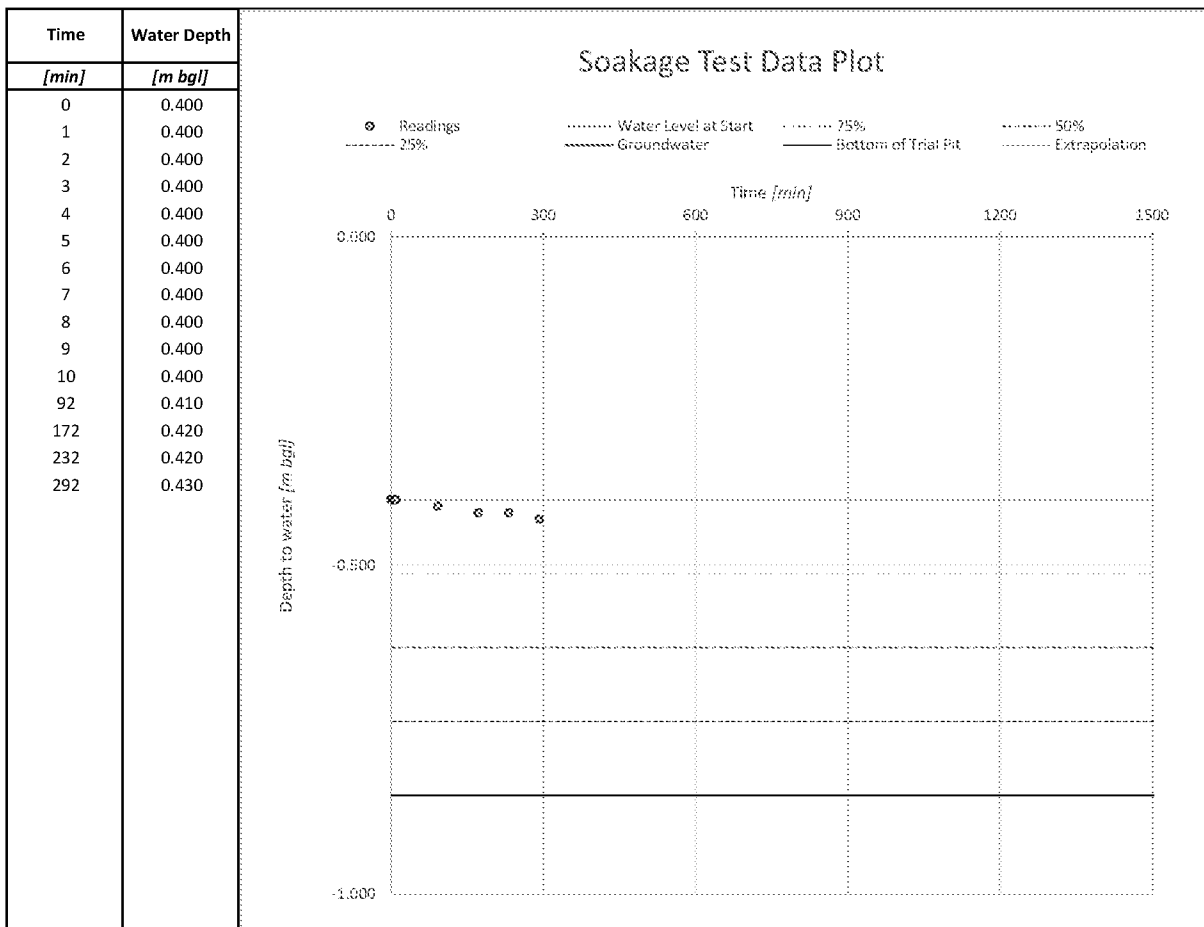
| Ground | Conditions | from - to [m bgl] | | Description |
|---|---|---|---|---|
| | | 0.30 | 0.85 | Firm, wet, brown, yellowish brown and orangish brown mottled light grey, slightly gravelly, silty CLAY. |

**Soil Infiltration Rate [m/s]: n/a**
