**LAMB FIELD, BILSHAM ROAD**

**YAPTON**

**SOIL RESOURCE SURVEY**

**TOHA Document Ref:** TOHA/21/6591/ML

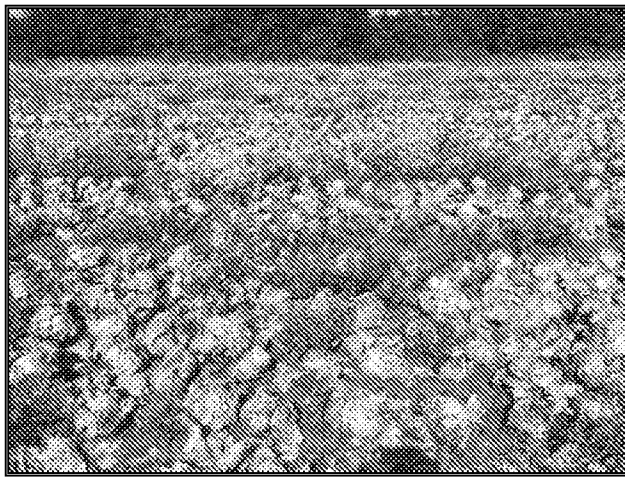
The site comprised 1 No. agricultural field, bounded to the west by Ryebank Rife, as well as hedges and fencing. The site contained an old lettuce crop. Frequent patches of standing water were observed within vehicle tracks on the exposed topsoil surface.

Plate 1: View of the site looking eastwards

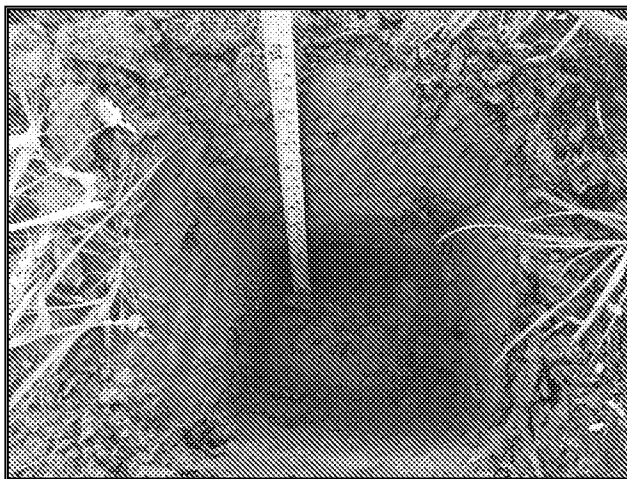
The in-situ soil profile was consistent in appearance between trial hole locations and was described as below:

Plate 3: Typical trial pit – TH3.

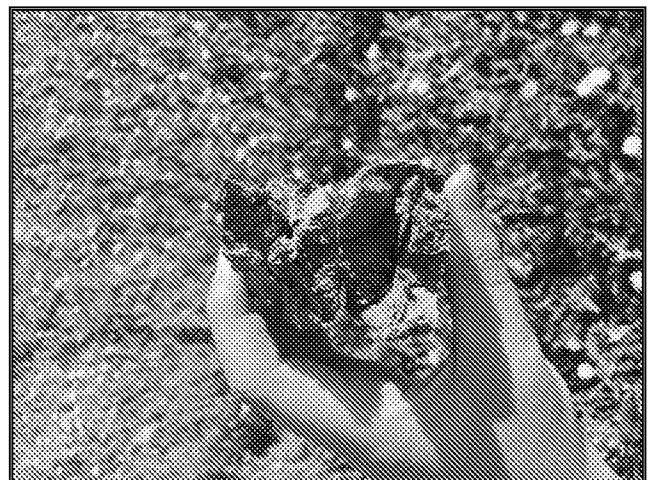
| <b>Subsoil</b><br>300/410 – 1000mm | Yellowish brown (Munsell colour 10YR 5/6), slightly moist, slightly plastic, slightly calcareous SILTY CLAY LOAM with a moderately developed, subangular blocky structure.<br><br>Slight to moderately stony, including subrounded and subangular stones up to 25mm in length. No deleterious materials were observed. Frequent mottling throughout with occasional manganese concretions. |

Plate 6: Example of mottling within the *Subsoil*.

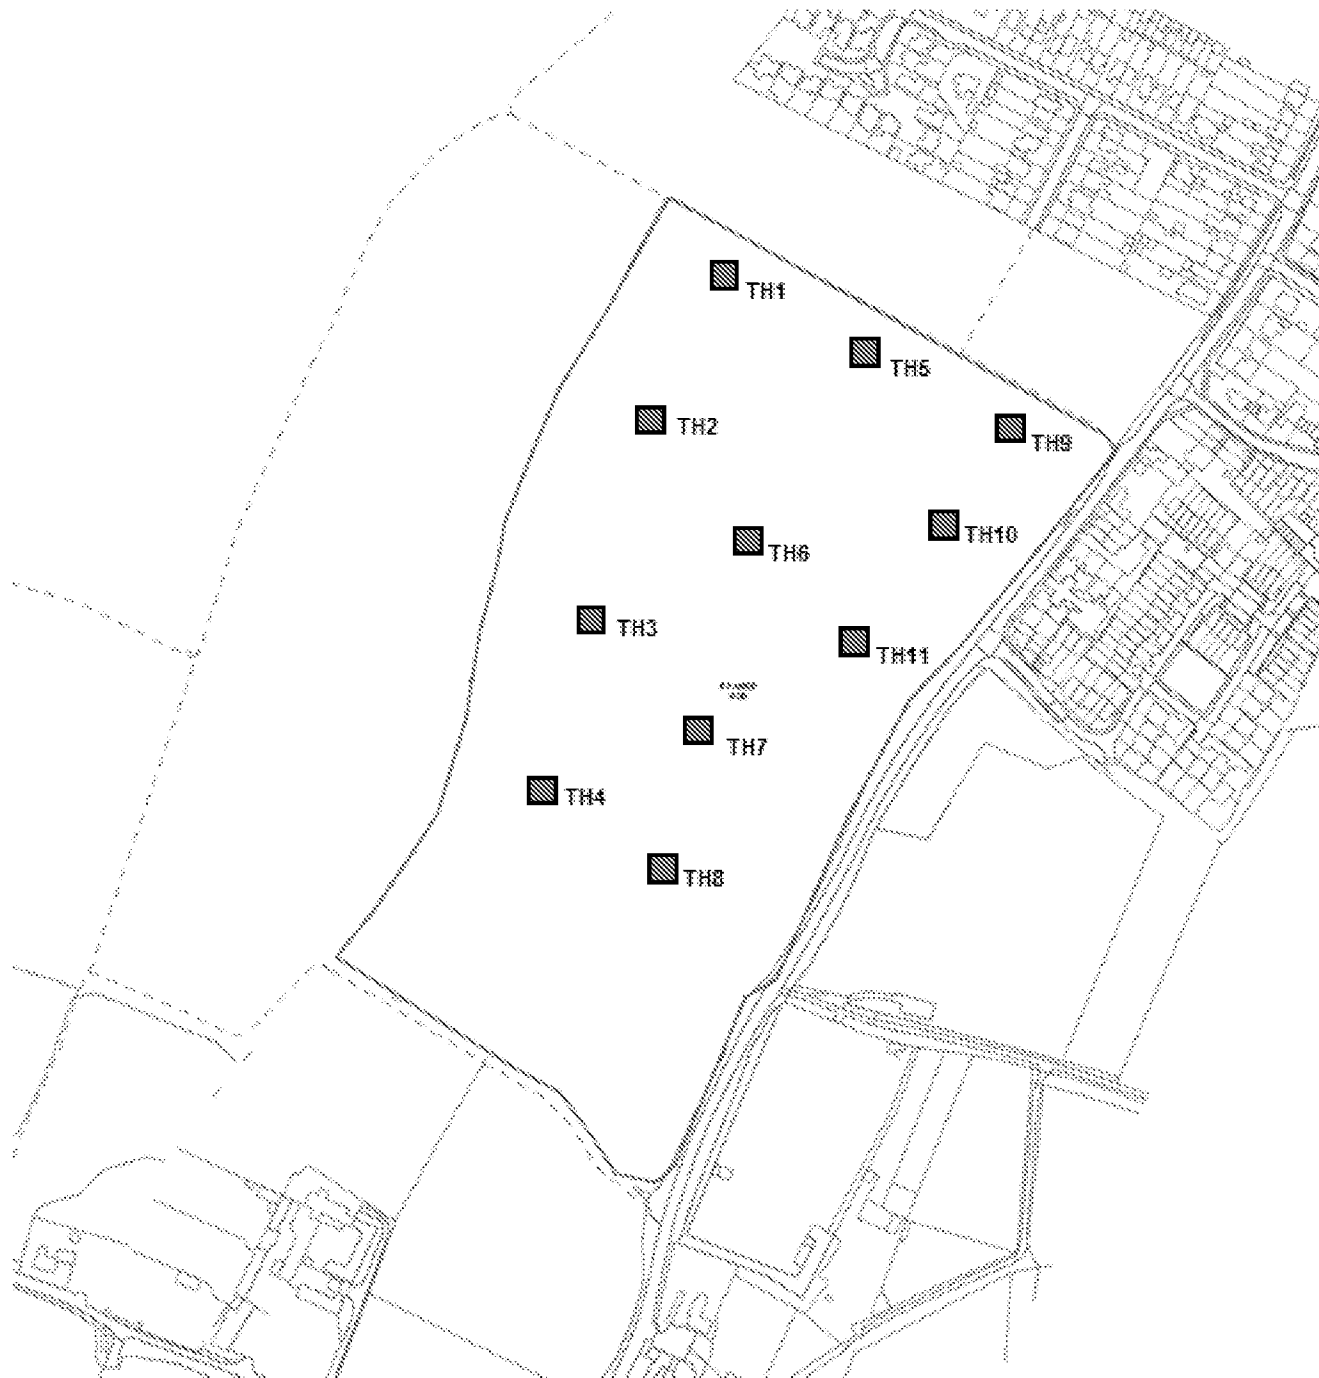
### Site Plan - Trial Hole Locations

The soils were examined by constructing a total of 11 No. hand-dug trial holes (TH) at accessible locations within the survey area. Trial holes were excavated to a maximum depth of 1.0m (ground conditions permitting). The sample locations are shown on the site plan in **Appendix 1**. This vegetation restricted access across the site during the site walkover, and therefore limited the locations available for examination to within the tramlines and outer perimeter.
