# Road Safety Audit – B2132 Bilsham Road, Yapton

**Stage:** 2

**Location:** B2132 Bilsham Road, Yapton, West Sussex

**Site:** Proposed new development accesses

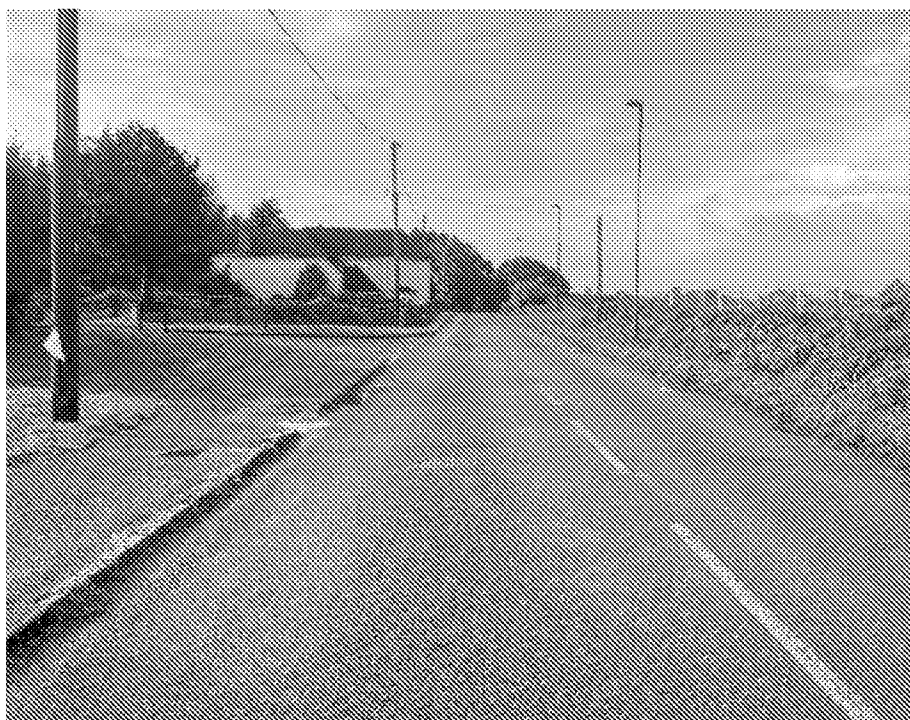
*The proposed priority junction south of Graham Road taken from the B2132 Bilsham Road, looking south-westward. Graham Road is shown on the left-hand side of the photograph. The new access is indicated by the arrow.*

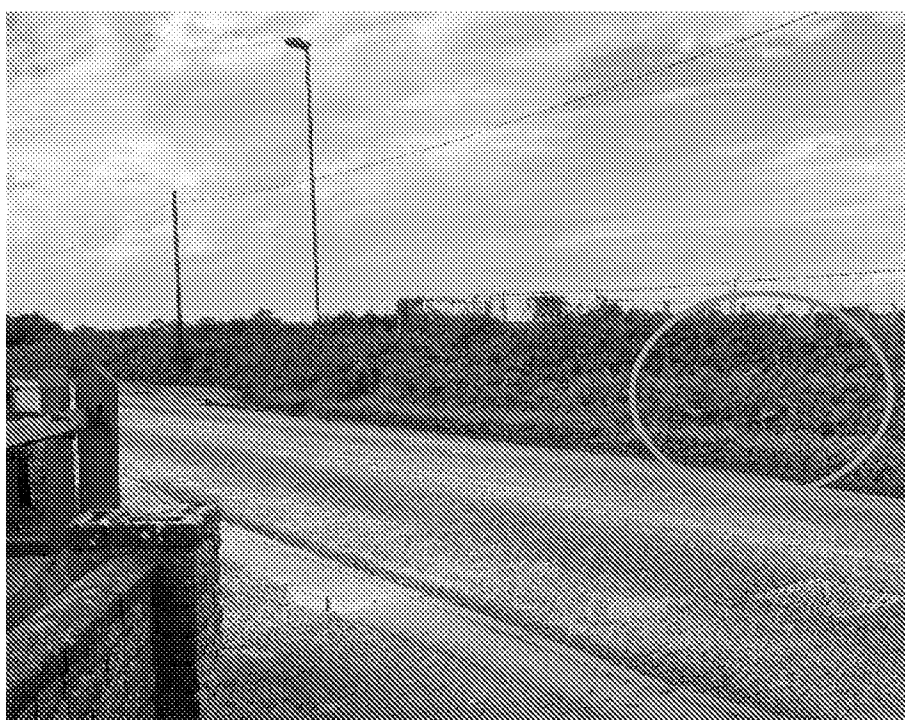
*The proposed priority junction south of Graham Road, taken from the south-east side of the B2132 Bilsham Road looking north-westward. The site of the new access is circled.*

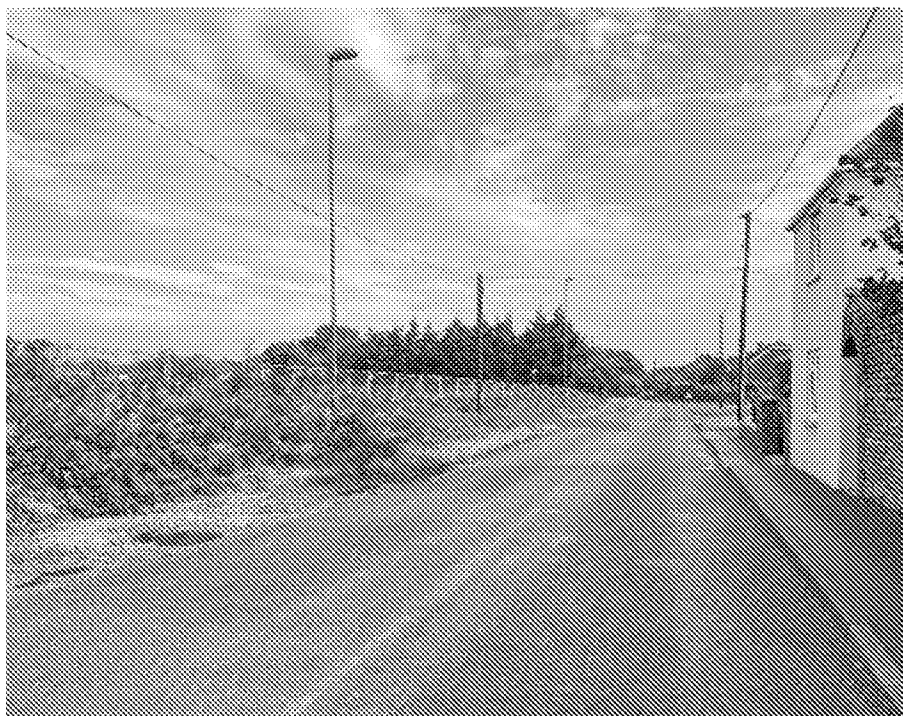
*The proposed priority junction south of Graham Road, taken from the B2132 Bilsham Road, looking north-eastwards. The site of the new access is arrowed.*

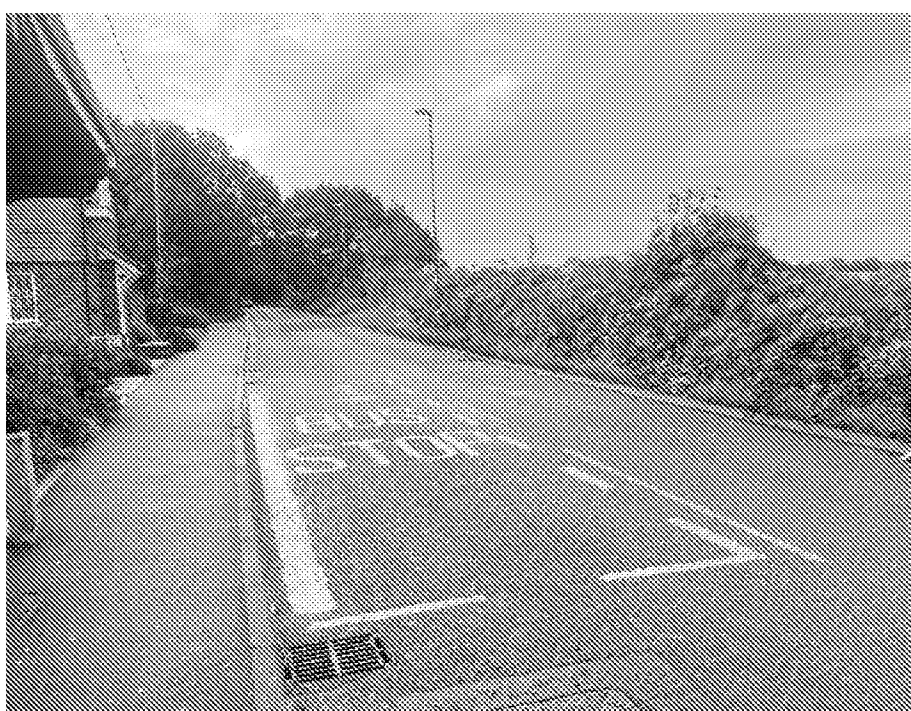
*The proposed priority junction north of Taylors Close, taken from the B2132 Bilsham Road, looking south-westward. The location of the proposed vehicular access is arrowed.*

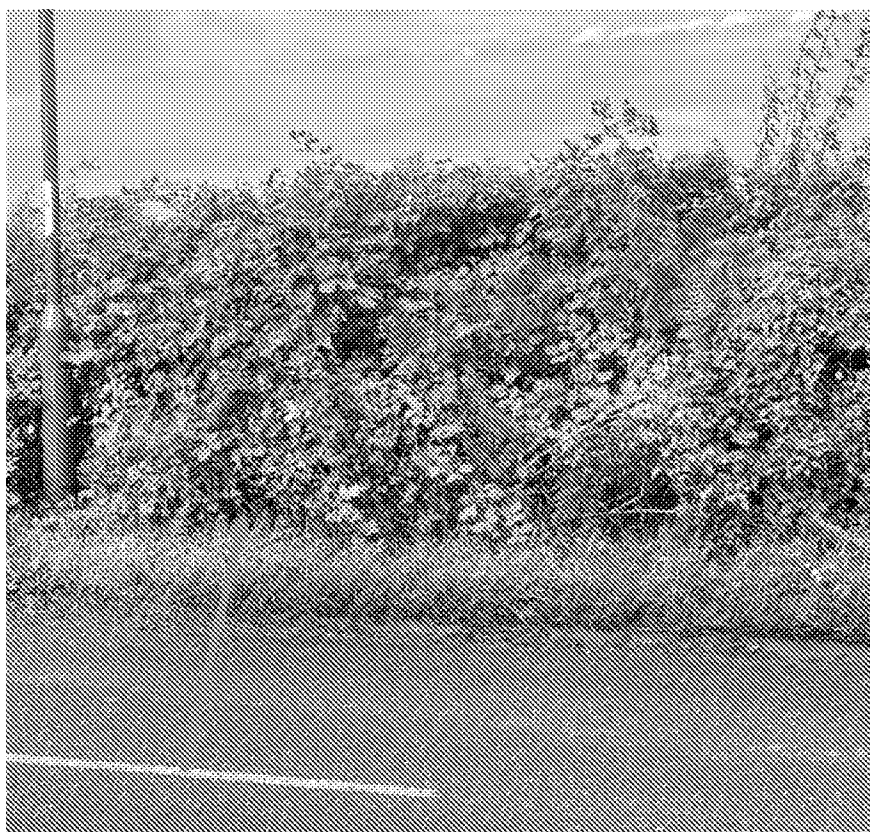
*The proposed priority junction north of Taylors Close, taken from the south-east side of the B2132 Bilsham Road looking north-westward. The proposed new vehicular access is arrowed.*

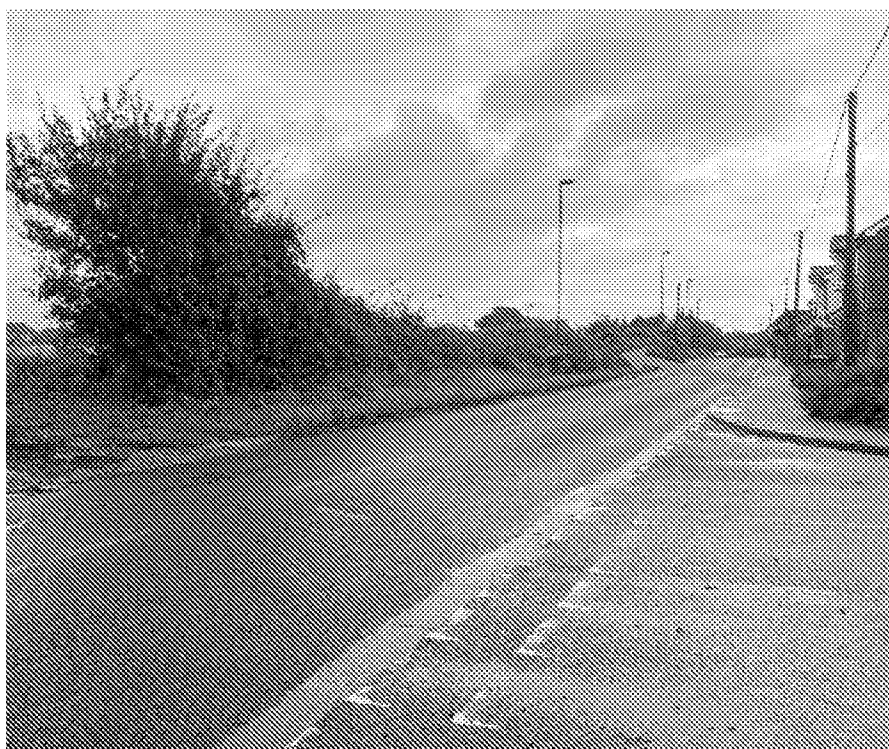
*The proposed priority junction north of Taylors Close, taken from Taylors Close looking north-eastwards along the B2132 Bilsham Road.*

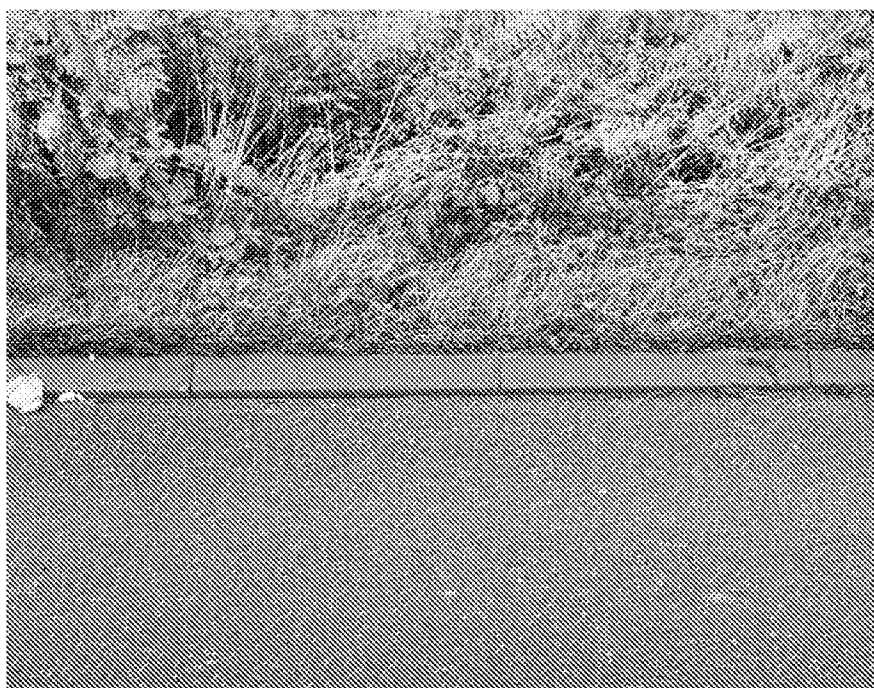
### **2.1 Problem**

**Location** – B2132 Bilsham Road north-west side.

**Summary** – Risk of conflict between motor vehicles and vulnerable road users.

No footway construction details have been supplied to the Audit Team. Half-battered kerbs currently exist on the north-west side of the B2132 Bilsham Road increasing the risk of motor vehicles mounting the proposed footway and coming into conflict with vulnerable road users.

**Recommendation** – Install HB2 type kerbs along the front edge of the proposed footway.

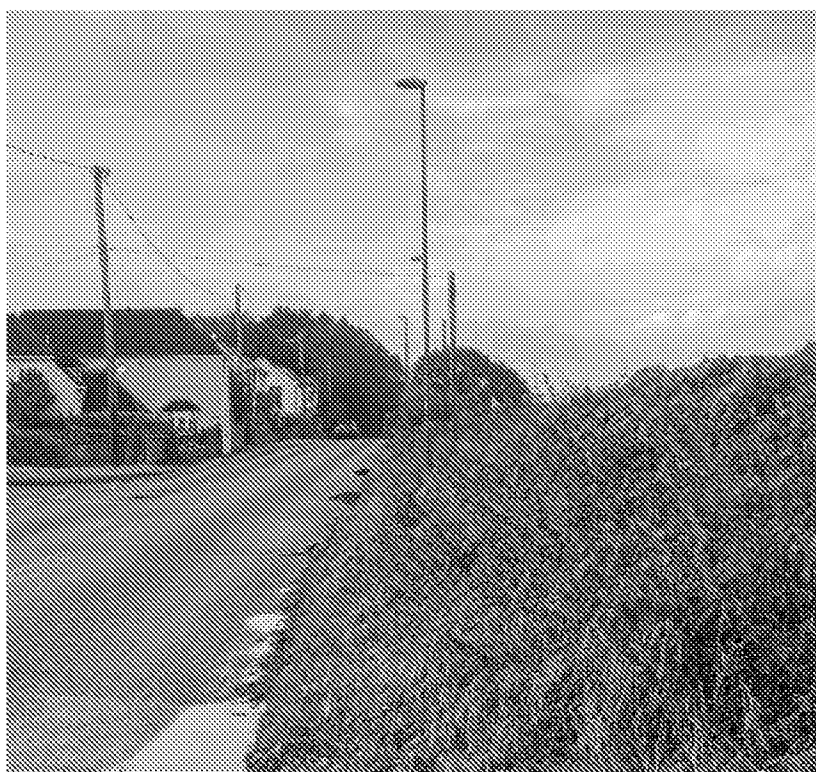
## 2.2 Problem

**Location** – B2132 Bilsham Road north-west side.

**Summary** – Risk of conflict between motor vehicles and vulnerable road users.

Lighting columns exist within the highway verge on the north-west side of the B2132 Bilsham Road which will be located within the proposed two-metre footway, reducing the effective width, forcing pedestrians into the live carriageway placing them in conflict with motor vehicles.

**Recommendation** – Relocate the existing lighting columns to the back edge of the footway or behind the footway.

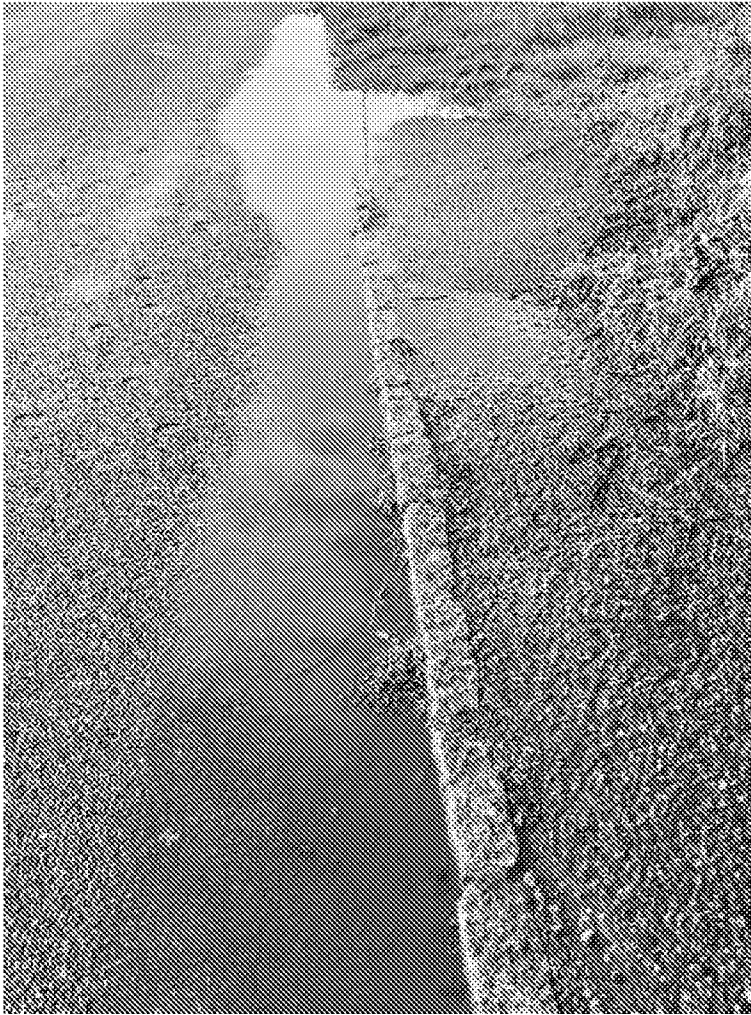
## 2.4 Problem

**Location** – B2132 Bilsham Road north-west side.

**Summary** – Risk of loss of control collisions.

No drainage details have been provided and there is evidence of ponding on the north side of the B2132 increasing the risk of loss of control collisions.

**Recommendation** – Ensure that the carriageway is adequately drained.

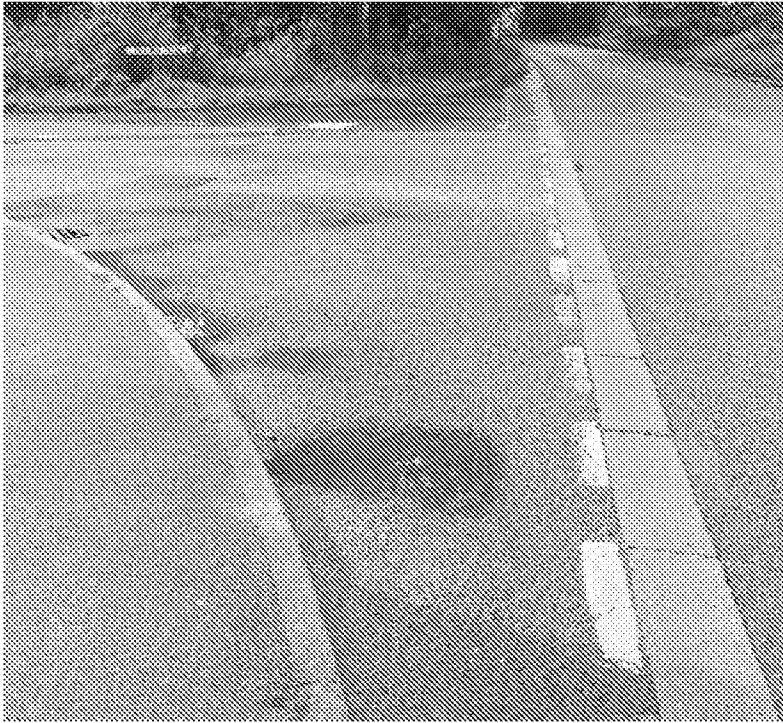
## 2.5 Problem

**Location** – Taylors Close

**Summary** – Pedestrians slips and falls.

There is evidence of ponding on both sides of Taylors Close, in the vicinity of the proposed dropped kerb pedestrian crossing point, increasing the risk of pedestrian slips and falls.

**Recommendation** – Ensure that the carriageway is adequately drained.

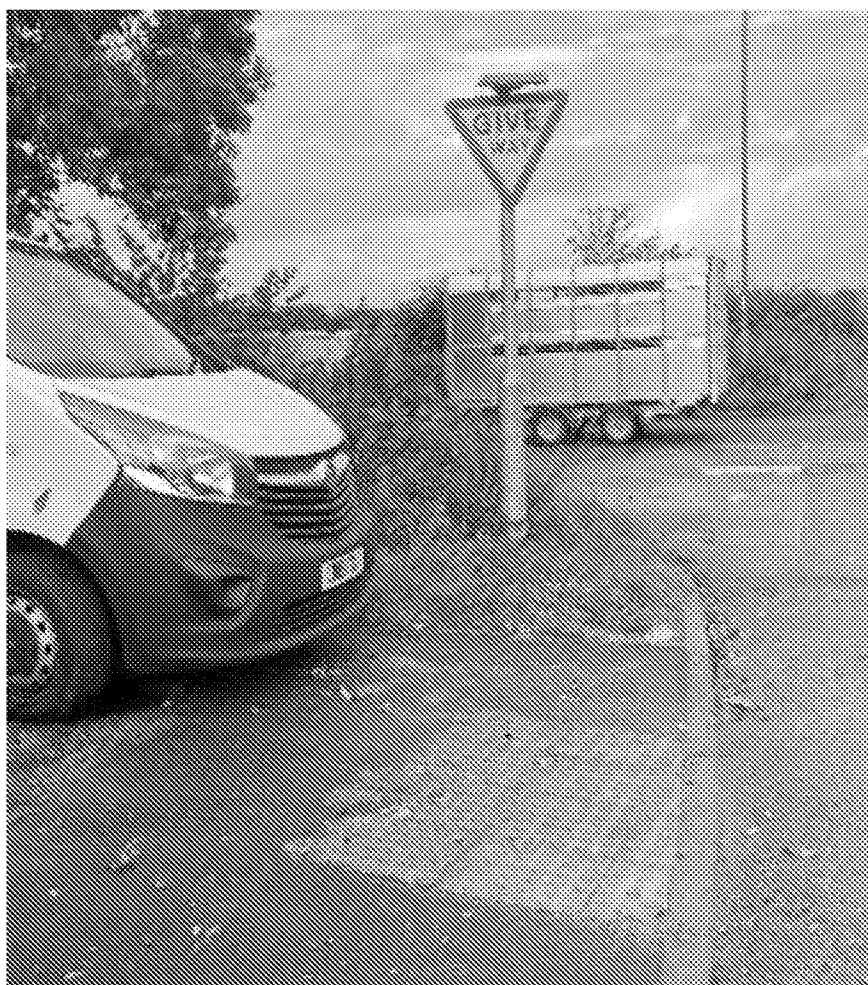
## 2.6 Problem

**Location** – Taylors Close south-west side.

**Summary** – Risk of conflict between motor vehicles and vulnerable road users.

An illuminated Diagram Number 602 'Give Way' highway sign and street naming plate exist on the south-west side of Taylors Close which will be located within the proposed two-metre-wide footway to the allotment, reducing the effective width of the footway, forcing pedestrians into the live carriageway placing them in conflict with motor vehicles.

**Recommendation** – Relocate the highway sign and street naming plate to the back edge of the footway or behind the footway.

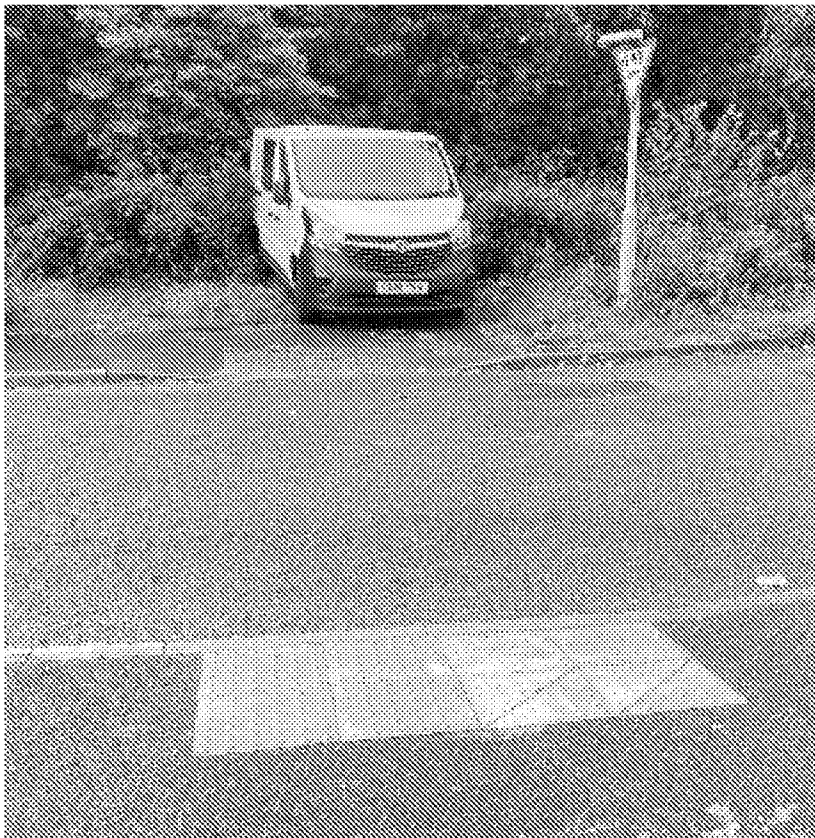
## 2.7 Problem

**Location** – Taylors Close south-west side.

**Summary** – Risk of conflict between motor vehicles and vulnerable road users.

The proposed dropped kerb pedestrian crossing across the bellmouth of Taylors Close makes the existing dropped kerb crossing point redundant. The existing dropped kerb on the south-west side of Taylors Close is currently being used by motor vehicles to access an off-street parking area to the rear of the footway, increasing the risk of conflict between vulnerable road users and motor vehicles.

**Recommendation** – Remove the existing tactile paving on both sides of Taylors Close and reinstate the existing dropped kerb crossing point with full height kerbs.

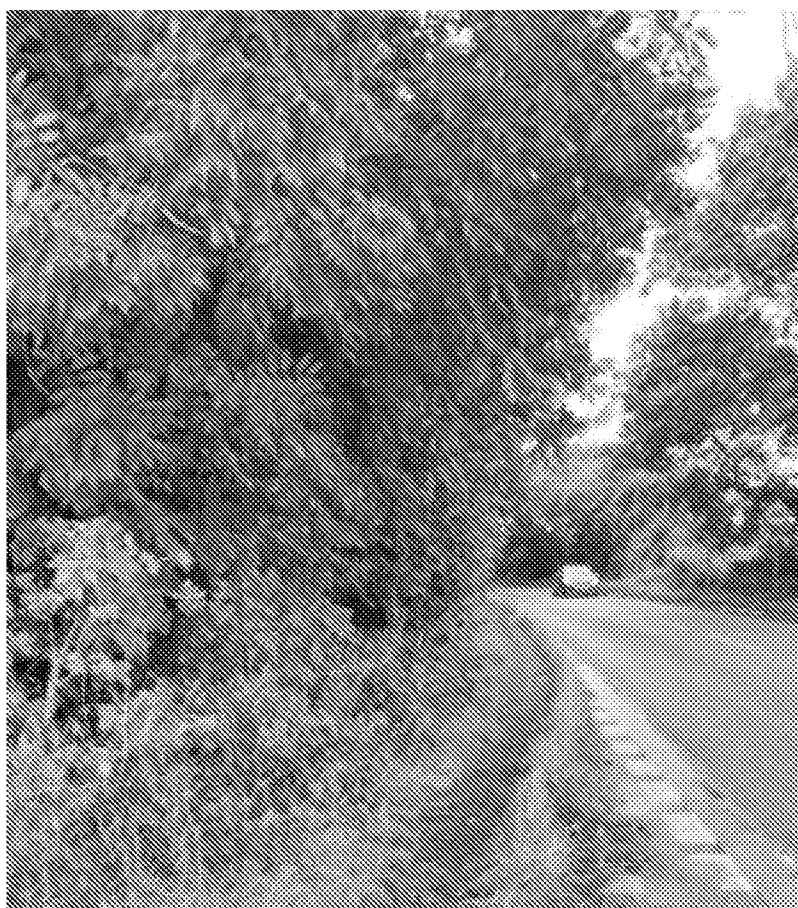
## 2.8 Problem

**Location** – B2132 south-east side.

**Summary** – Risk of conflict between motor vehicles and vulnerable road users.

Existing overhanging vegetation and scrub will obstruct the proposed two-metre-wide footway to the allotments forcing pedestrians into the live carriageway placing them in conflict with motor vehicles.

**Recommendation** – Cut back the vegetation as part of an on-going planned maintenance regime or remove the vegetation.

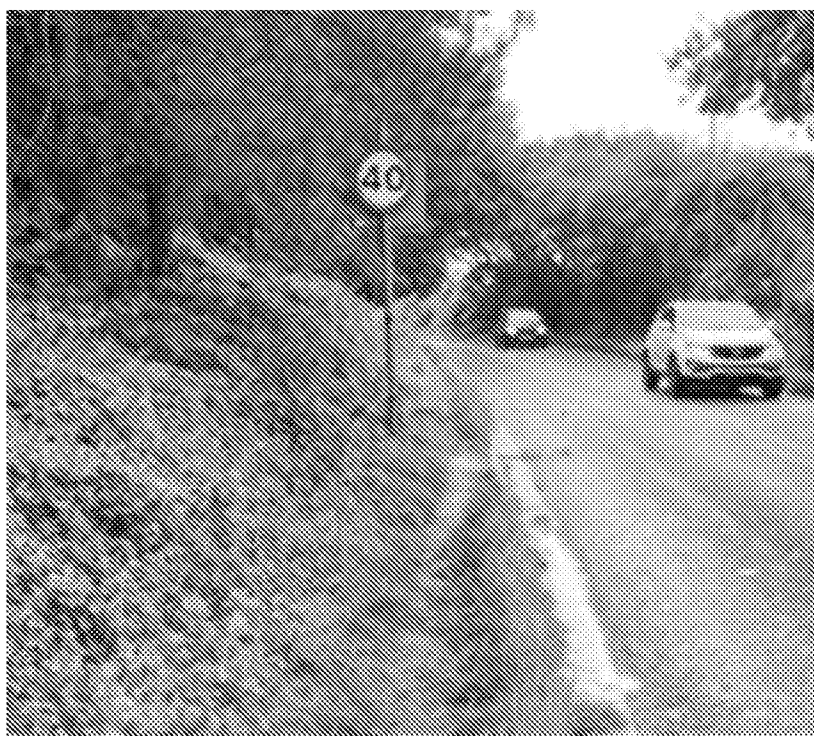
## 2.9 Problem

**Location** – B2132 south-east side.

**Summary** – Risk of conflict between motor vehicles and vulnerable road users.

The existing Diagram Number 670 speed limit highway signage will be located within the proposed two-metre-wide footway to the allotments forcing pedestrians into the live carriageway placing them in conflict with motor vehicles.

**Recommendation** – Relocate the highway sign to the back edge of the footway or behind the footway.

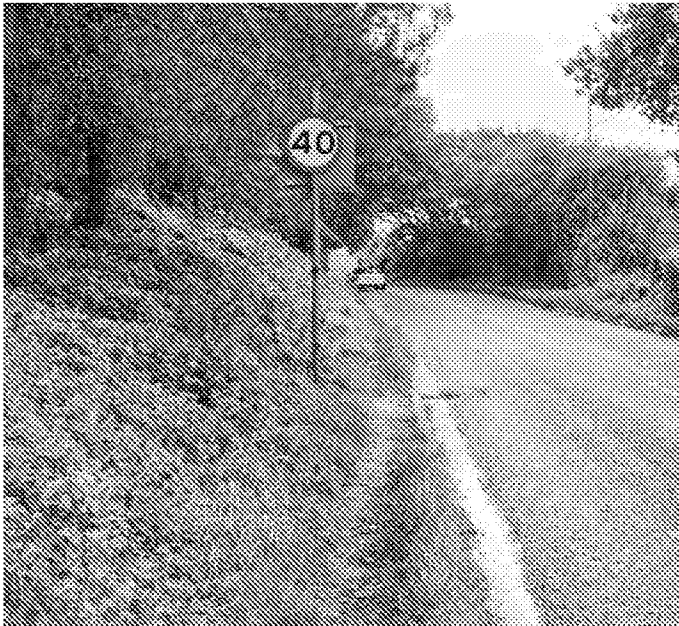
## 2.10 Problem

**Location** – B2132 Bilsham Road.

**Summary** – Risk of conflict between motor vehicles and vulnerable road users.

The vegetation to the left from the dropped kerb pedestrian crossing point proposed to be constructed across the B2132, south-west of its priority junction with Taylors Close, will obstruct inter-visibility between vulnerable road users and drivers, increasing the risk of conflict between the two users.

**Recommendation** – Cut back the vegetation as part of an on-going planned maintenance regime or remove the vegetation.

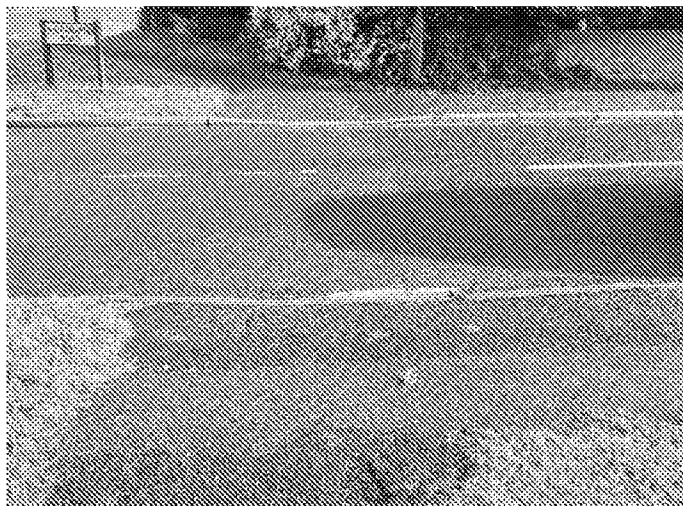
**3.1** A dropped kerb pedestrian crossing exists across Graham Road which does not include the provision of tactile paving. The Audit Team recommend that tactile paving is installed to assist visually impaired pedestrians in locating the crossing point.

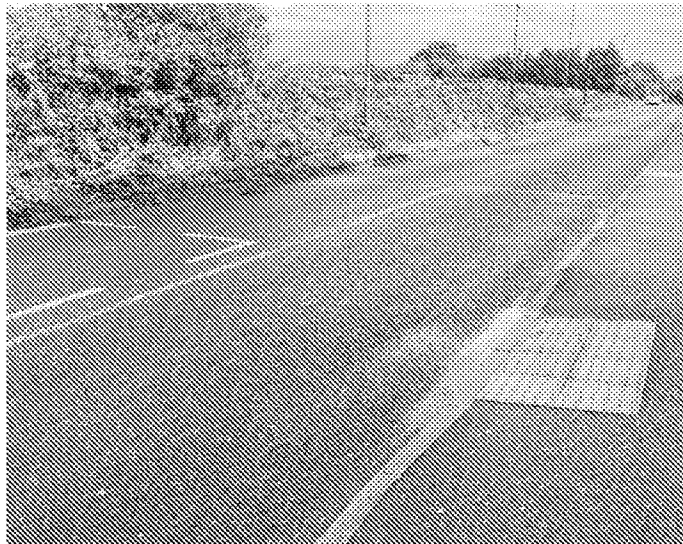
**3.2** The proposed dropped kerb across the B2132 Bilsham Road, between the existing bus stops renders the current dropped kerb on the south-east side of the B2132 redundant. The Audit Team recommend that the tactile paving be removed and the existing dropped and transition kerbs be reinstated with full height kerbs.

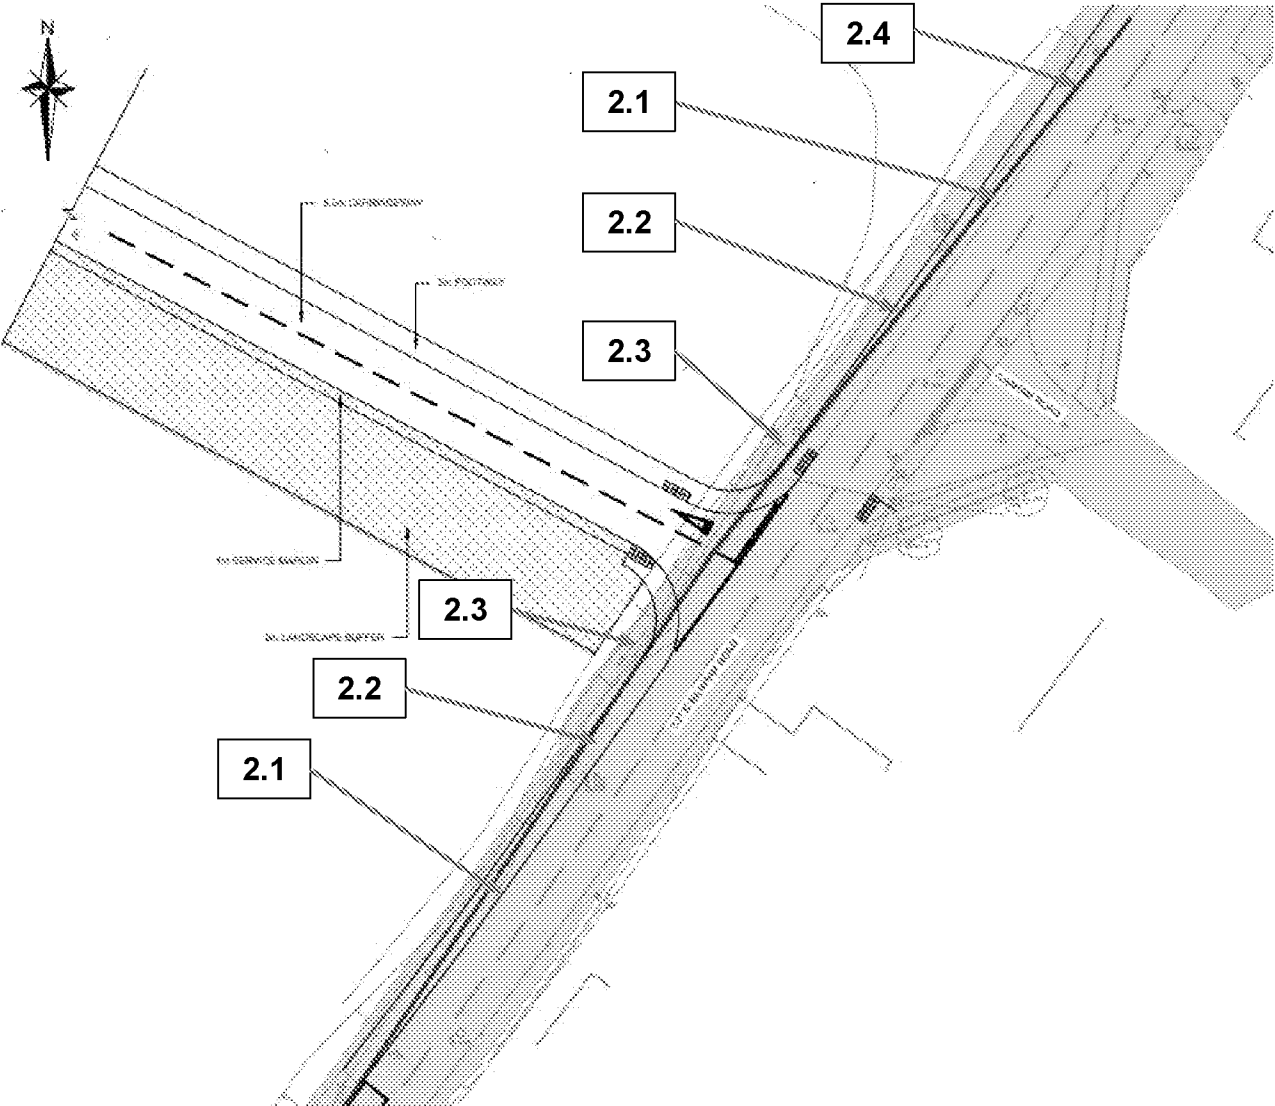
Appendix B: Key Plan showing Audit Problems

## **2. Safety Issues Raised in this Stage 2 Road Safety Audit.** (see Appendix B for locations)
