# **SuDS and Drainage Report**

Church Farm House, Church Lane, Yapton BN18 0EP

Ref: **C3267**

**CGS Civils Ltd**  
Richard Cobden House  
Lion Street  
Chichester  
West Sussex  
PO19 1LW

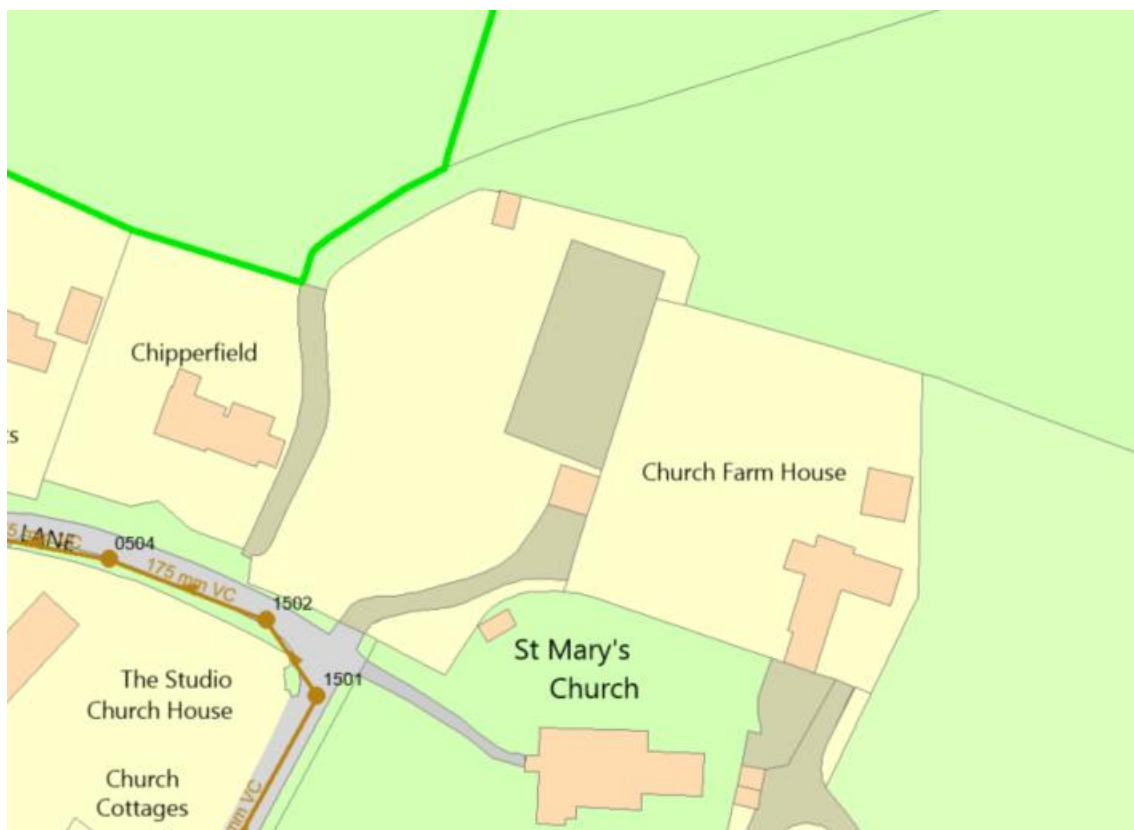
Fig 3. Southern Water Sewer Records

- 4.1.1 It is not currently known how the existing site discharges surface water runoff, however, as it is a tennis court it is presumed to freely discharge to ground via infiltration. There is no existing foul water network serving the tennis court; however, it is presumed that the adjacent Church Farm House discharges foul water into the public foul sewer within Church Lane.

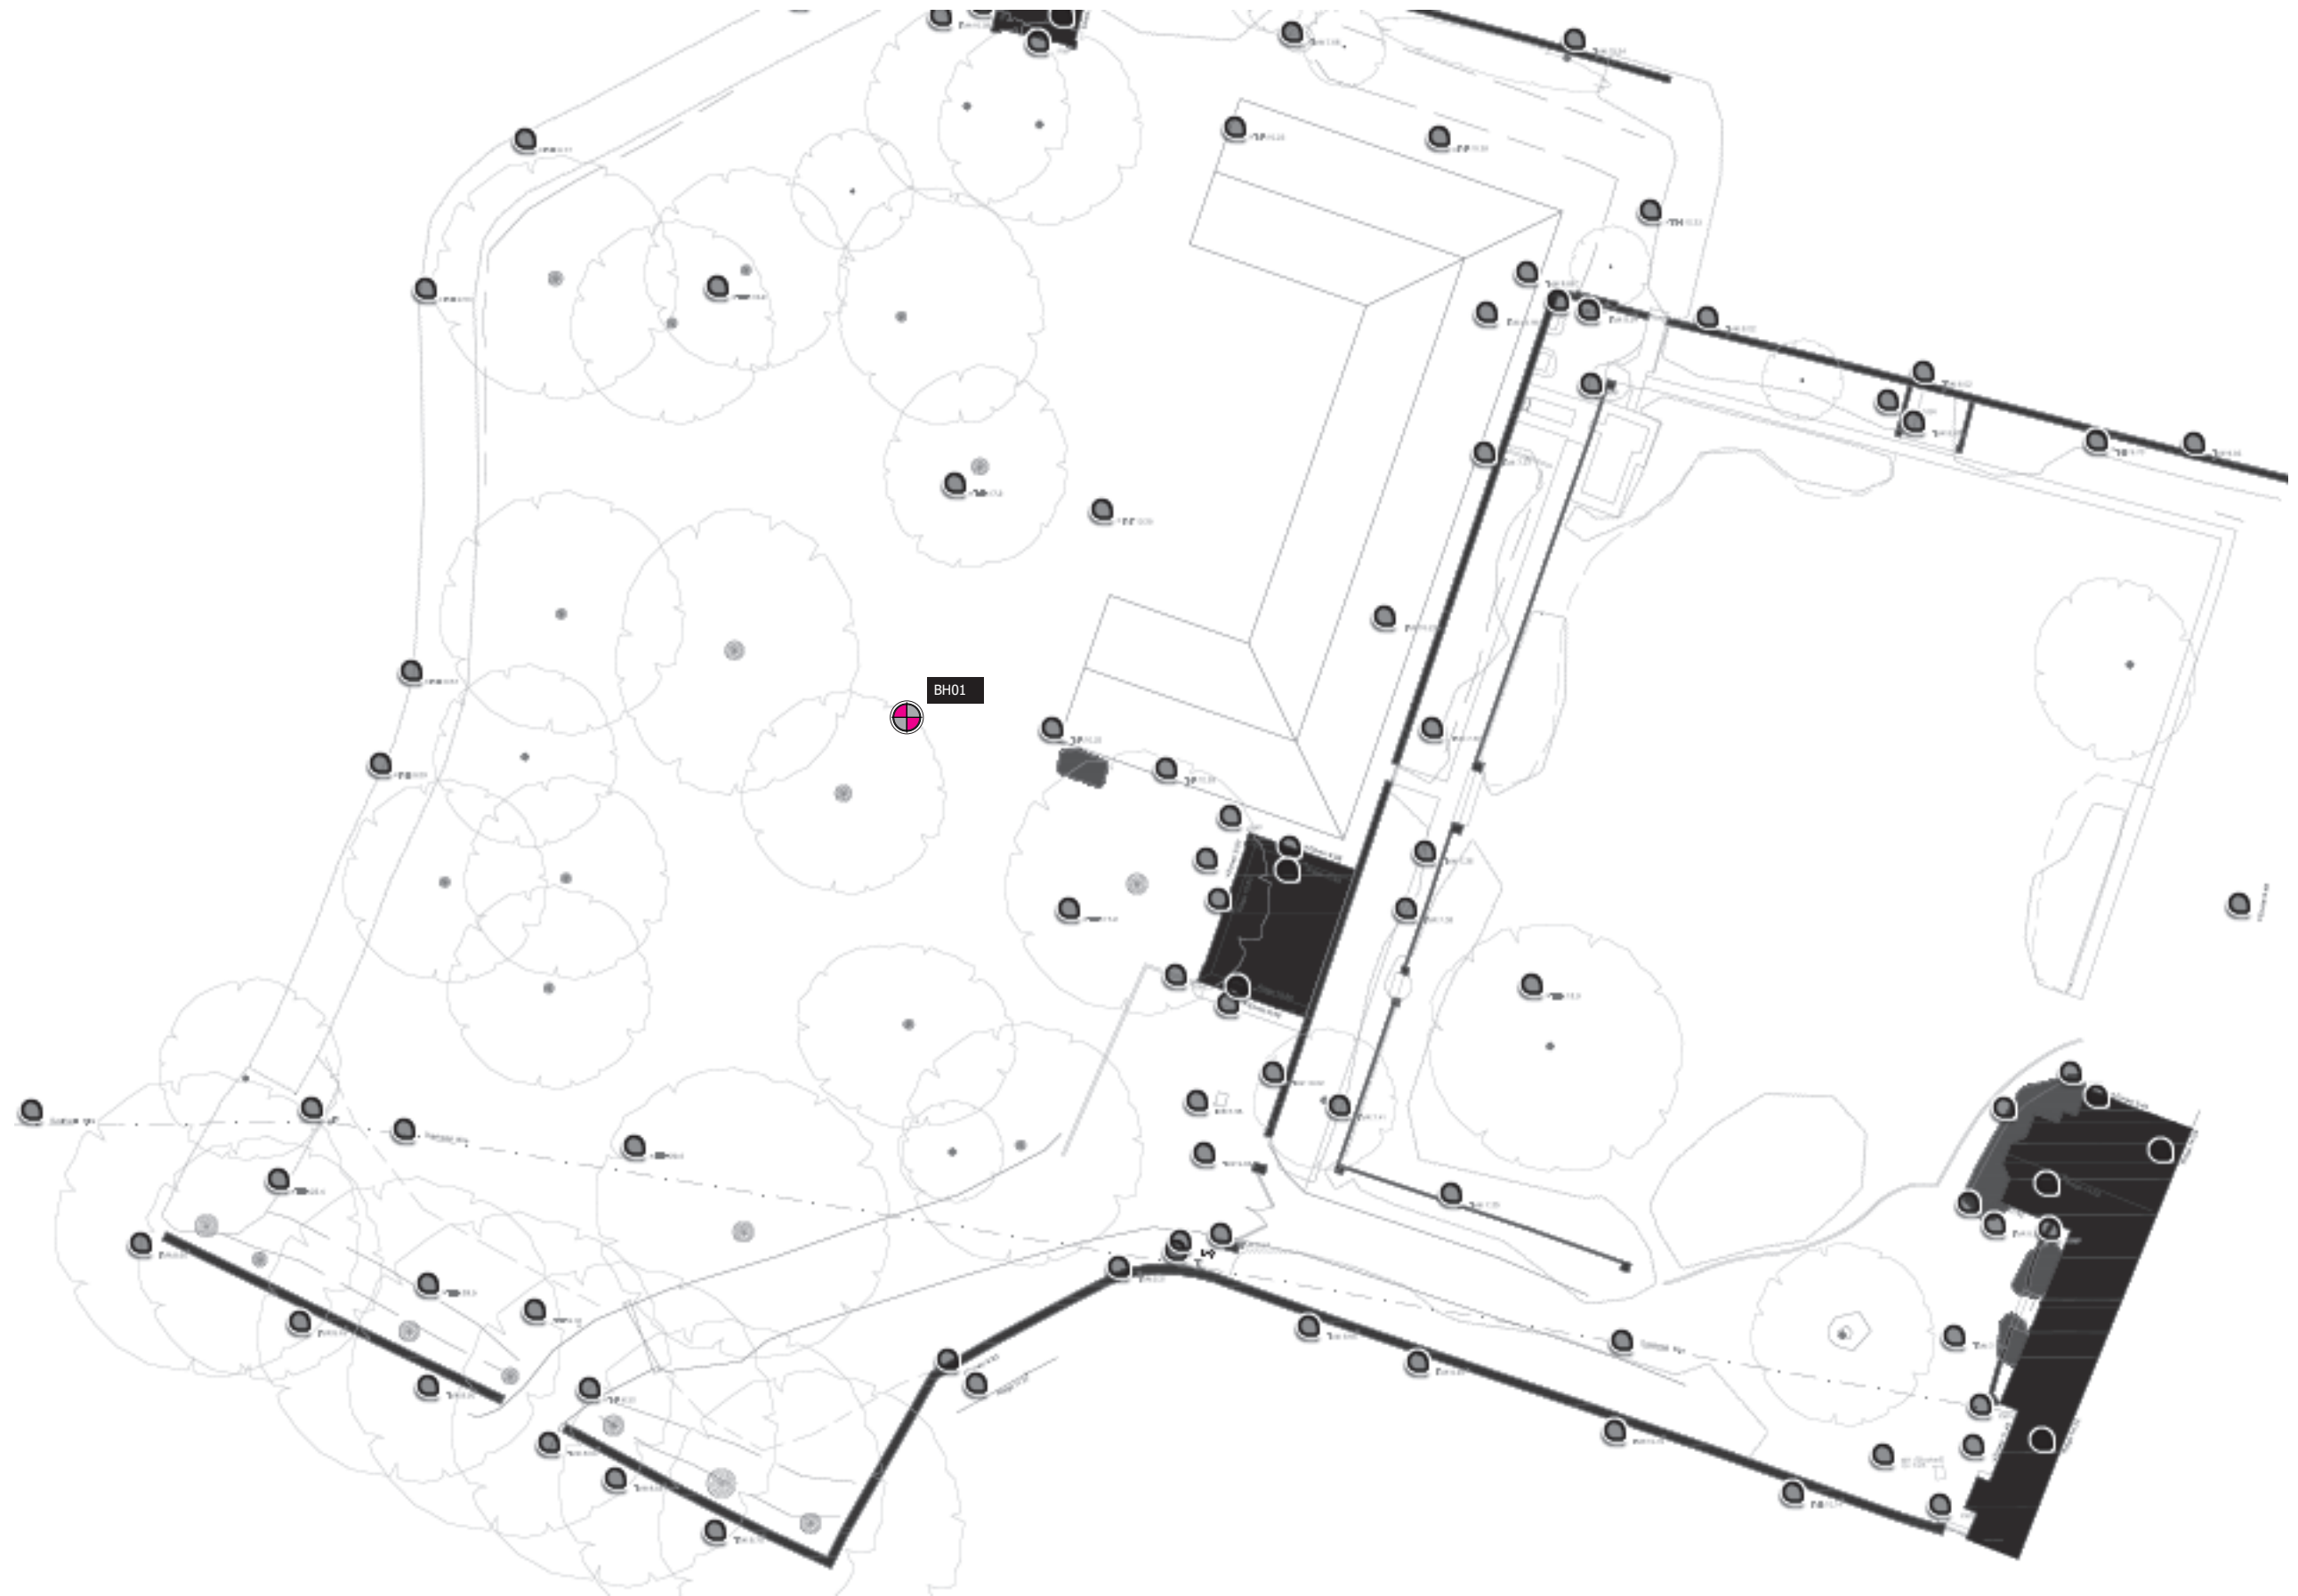
| Scale | NTS | | Project no: | NN1892 | Figure no: FIGURE 1 |

Fieldwork was undertaken on 22 October 2024. The site works consisted of the advancement of a single groundwater well installation (BH01) advanced to a depth of 4.00m bgl. A borehole location plan is included as **Figure 1** of this report.

| Date | 25/10/2024 | | Title: INVESTIGATION LOCATION PLAN | | |

The borehole location was set out based on site access and logged by a Geo-Environmental Consultant from E3S. The borehole log is presented as **Appendix A** of this letter. Groundwater was not encountered within the borehole when dipped post construction.
